Runaway Train

Introduction

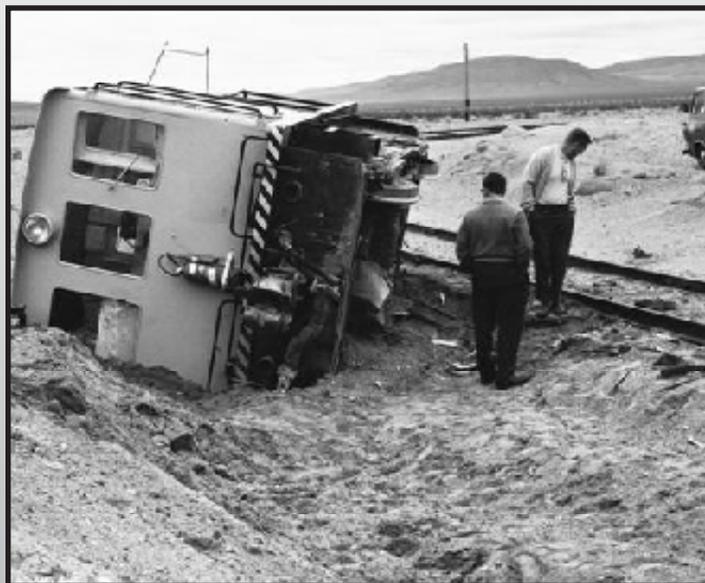
The derailed locomotive lies 180 degrees from its direction of travel as investigators inspect the site.

Careful examination of the runaway train's wheels found that all four wheels had flat spots on one side as a result of brake locking.

The final investigation report concluded that the accident was caused by too great a load for the locomotive. Grease and moisture on the tracks, lack of sanding equipment on the locomotive, and no brakes on the flatcar were all contributing factors to the wreck.
