**Mission Support and Test Services, LLC
Nevada National Security Site
Mercury, NV 89023
RE: Mercury North (Area 23); Mercury, NV
1,500,000 Gallon GST
September 16, 2018
Mr. Kevin Olsen
Scientist 1
(702) 295-0485
Job No. 318448-A**

**Mission Support and Test Services, LLC
Nevada National Security Site
Mercury, NV 89023
RE: Camp South (Area 12); Mercury, NV
500,000 Gallon GST
September 13, 2018
Mr. Kevin Olsen
Scientist 1
(702) 295-0485
Job No. 318448-D**

**Mission Support and Test Services, LLC
Nevada National Security Site
Mercury, NV 89023
RE: Well 4/4a South (Area 6); Mercury, NV
150,000 Gallon GST
September 24, 2018
Mr. Kevin Olsen
Scientist 1
(702) 295-0485
Job No. 318448-H**

**Mission Support and Test Services, LLC
Nevada National Security Site
Mercury, NV 89023
RE: C-1 North (Area 6); Mercury, NV
50,000 Gallon GST
September 21, 2018
Mr. Kevin Olsen
Scientist 1
(702) 295-0485
Job No. 318448-O**

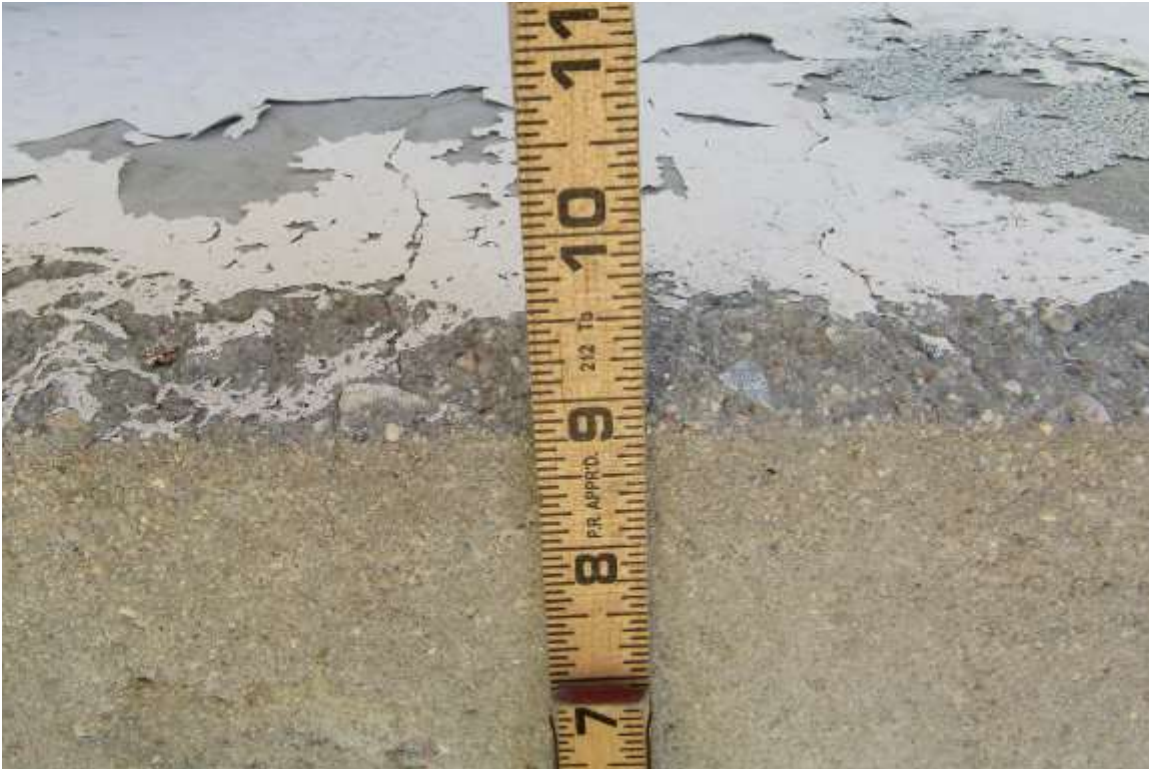
Photo shows the area around the tank foundation is properly graded and in compliance with **AWWA D100-11; 12.7.1 Height aboveground.**

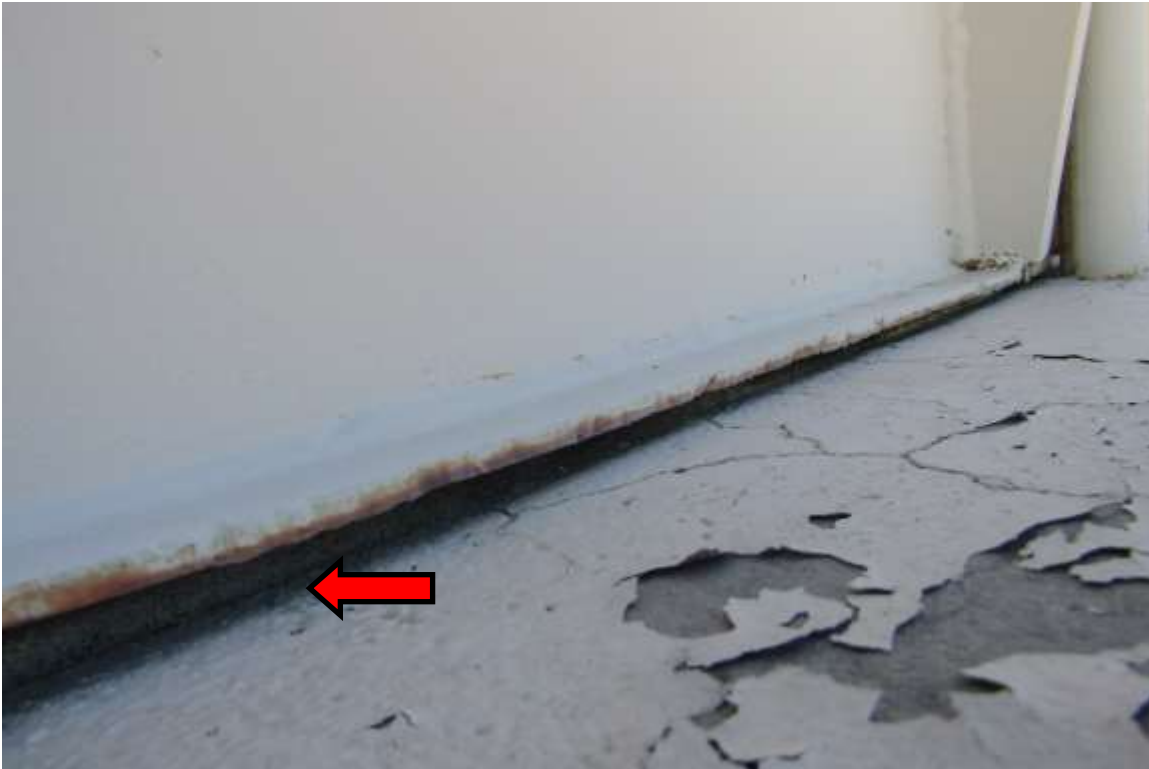
Photo shows the condition of the foundation. **NFPA 22-2018; 12.2.1.2** states, "... the junction of the tank bottom and the top of the concrete foundation shall be tightly sealed to prevent water from entering the base." We recommend repairing any cracks and spalling in the concrete with a commercial non-shrinking grout, caulking/grouting around the base of the tank to foundation connection to prevent water from entering under the tank, then sealing the foundation with a sealant.

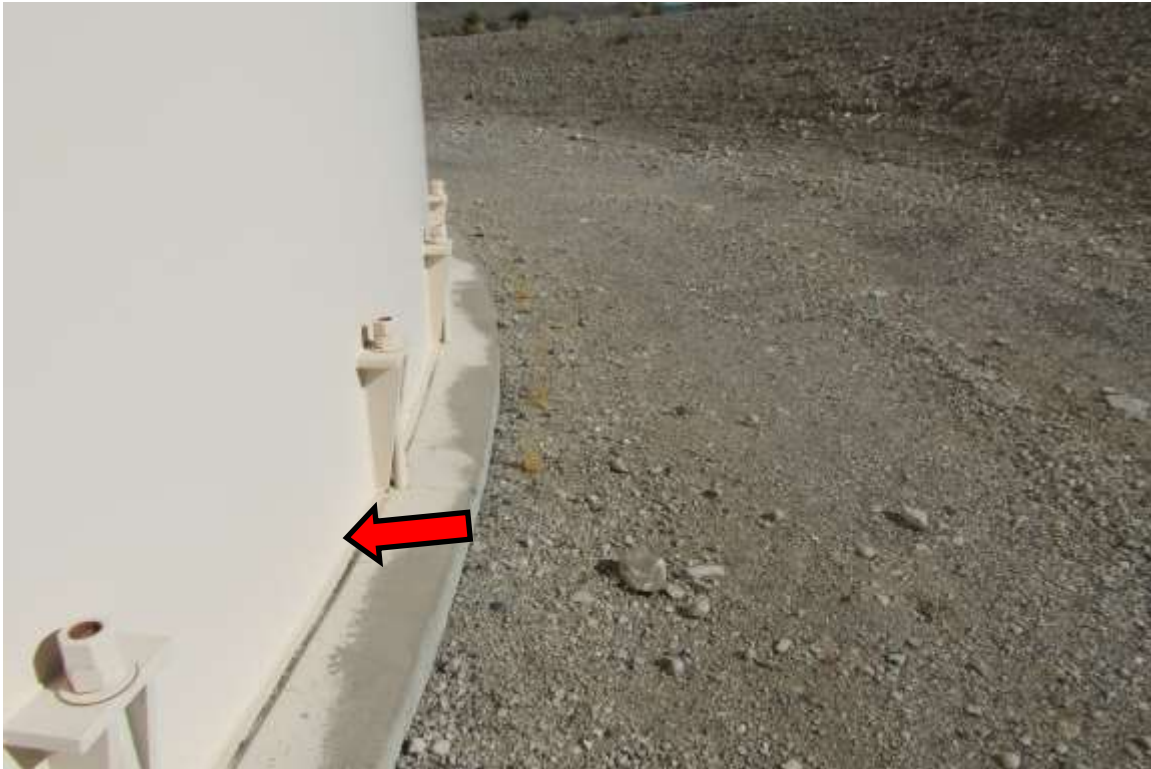
Photo shows the tank has no grounding system. We recommend electrically grounding the tank for lightning protection as required by **OSH Act of 1970 Section 5** and **NFPA 780-2017; 5.4 Metal Towers and Tanks**.

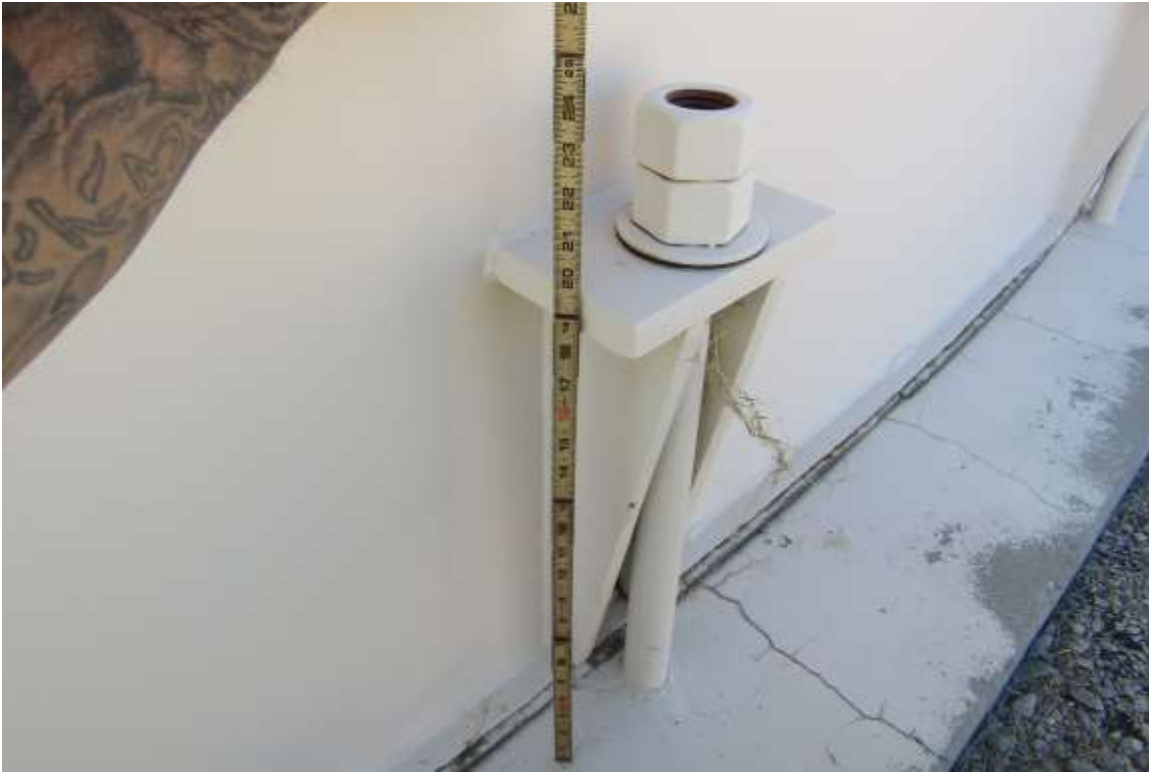
Photo shows the condition of one (1) of the fifty-one (51) anchor bolts. **AWWA D100-11; 3.8.1.1 Required anchorage** states, "For ground-supported flat-bottom reservoirs and standpipes, mechanical anchorage shall be provided when the wind or seismic loads exceed the limits for self-anchored tanks." We recommend cleaning the area around the anchor bolts then tightening the jam nuts to specifications.

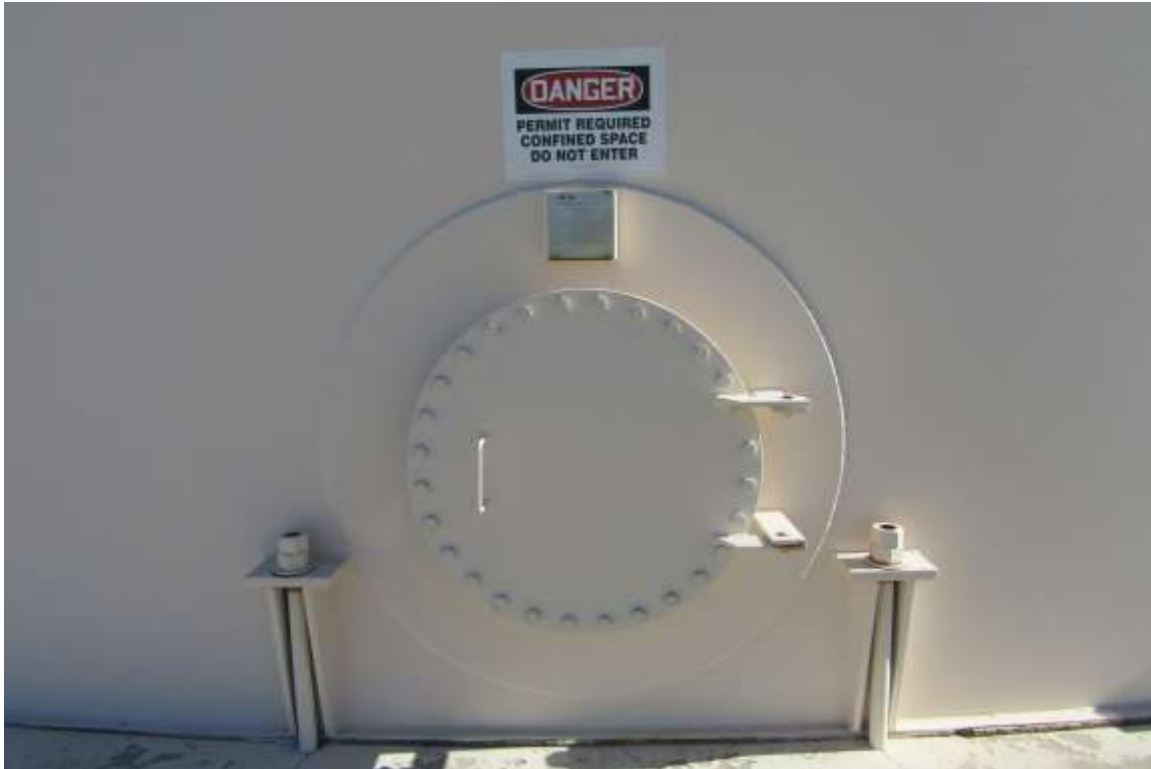
Photo shows the condition of the 24" primary shell manway, which is in compliance with [AWWA D100-11; 7.4.4 Shell manholes, 14.7.2.1.1, NFPA 22-2018; 14.7.2.1.1](#) and [OSHA 1910.146\(c\)\(2\) Confined spaces](#).

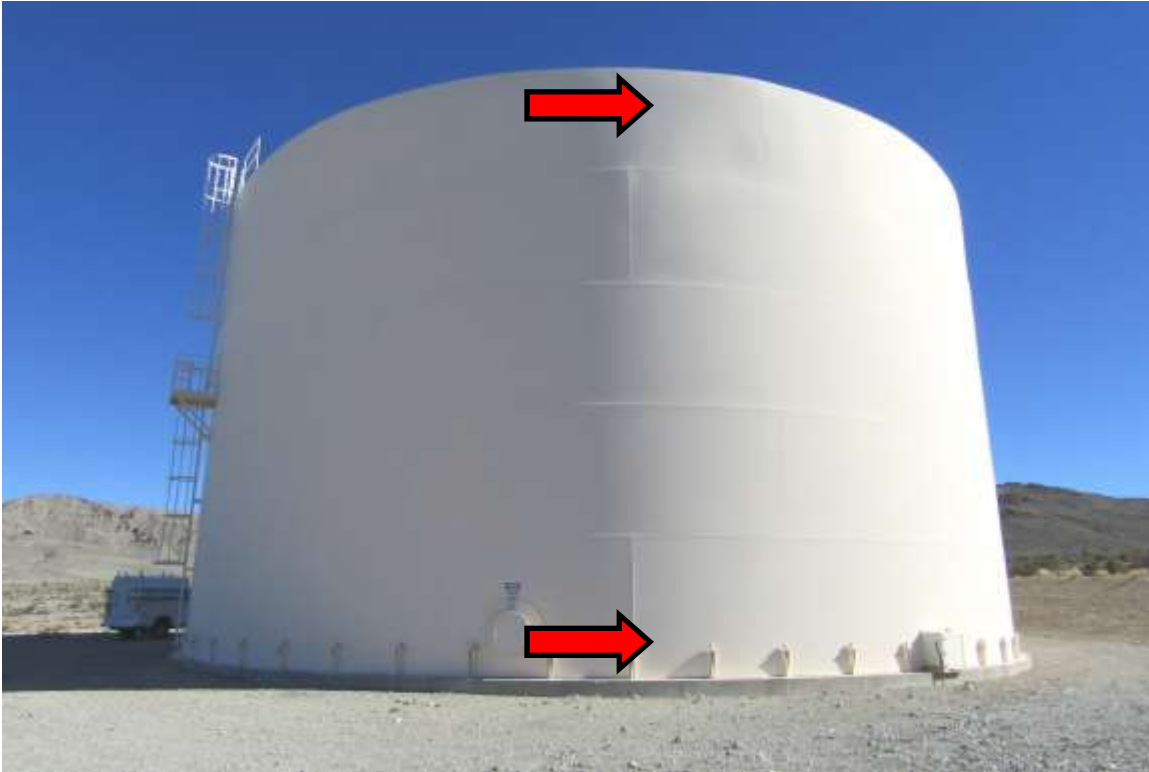
Photo shows the tank is not equipped with a liquid level indicator. **NFPA 22-2018; 14.1.8* Water-Level Gauge** states, "A water-level gauge of suitable design shall be provided. It shall be carefully installed, adjusted, and properly maintained." We recommend installing a liquid level indicator, complete with target board and float.

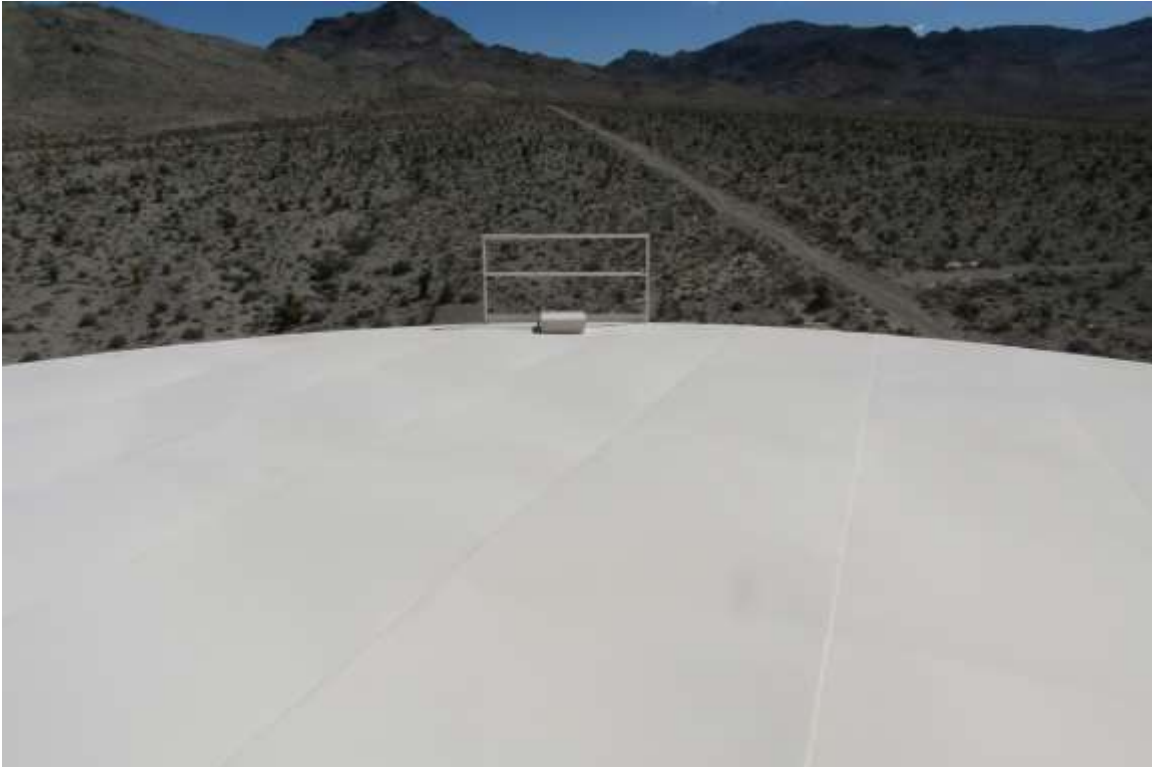
Photo shows the tank roof edge is not equipped with a required handrail system for fall protection. **OSHA 1910.28(b)(1)(i)** states, "...the employer must ensure that each employee on a walking-working surface with an unprotected side or edge that is 4 feet (1.2 m) or more above a lower level is protected from falling by one or more of the following: **1910.28(b)(1)(i)(A) Guardrail systems.**"

We recommend installing an **OSHA** compliant 42" high handrail system around the circumference of the tank roof, complete with intermediate rail, toeboard and a swing gate at the junction of the shell-to-roof access ladder and tank roof.

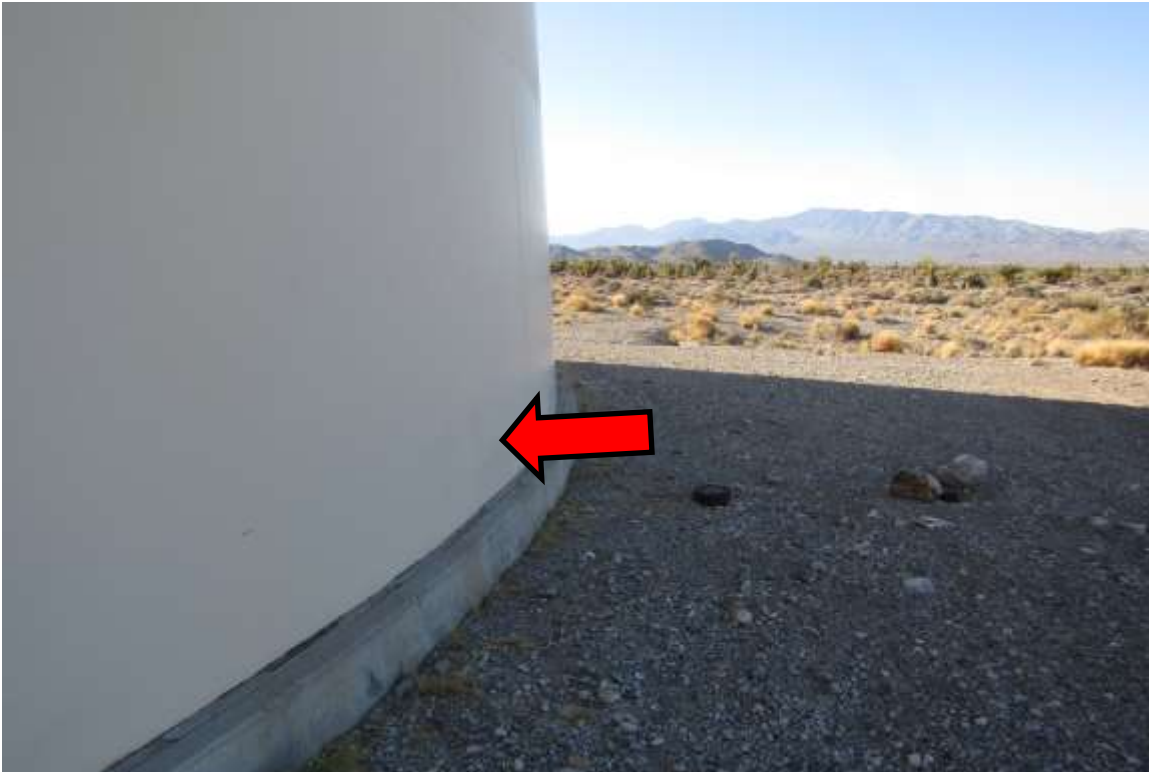
Photo shows the condition of the shell. Currently there is no drain valve. We recommend installing a frost proof drain valve near the shell-to-floor connection, complete with a locking device to prevent unauthorized draining of the tank and a splash pad to direct water away from the foundation.

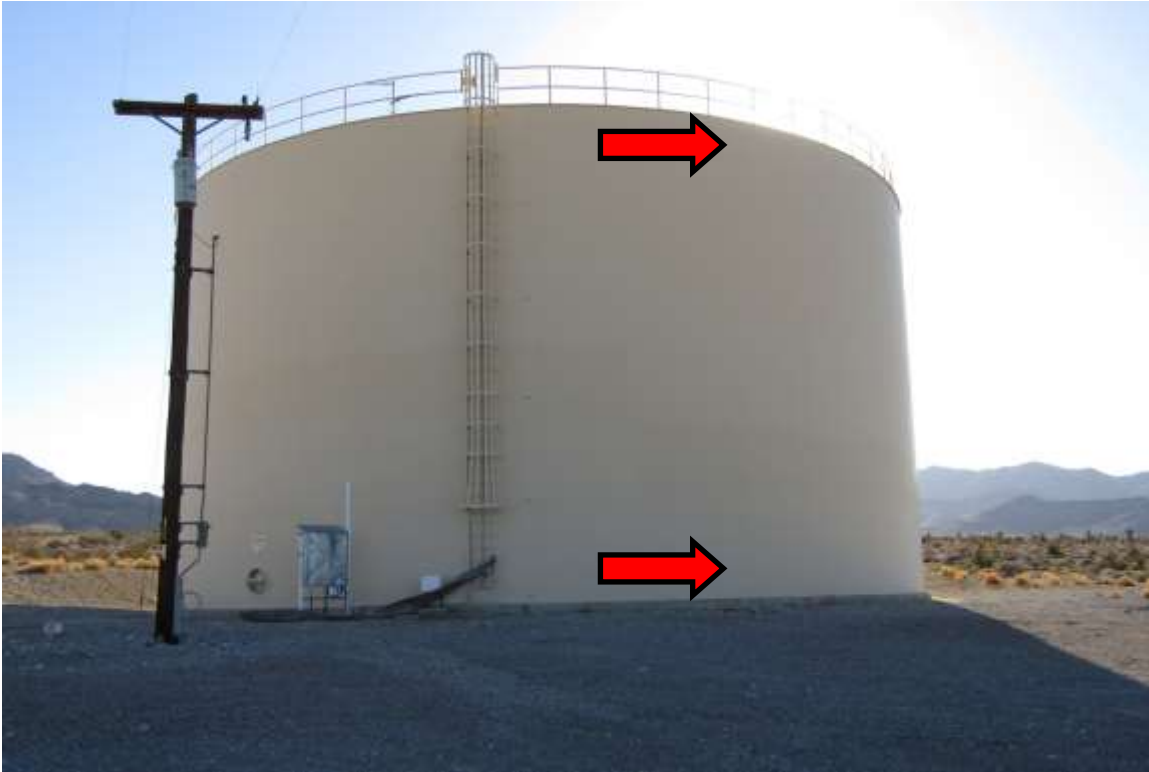
Photo shows the tank is not equipped with a liquid level indicator. We recommend installing a liquid level indicator, complete with target board and float.

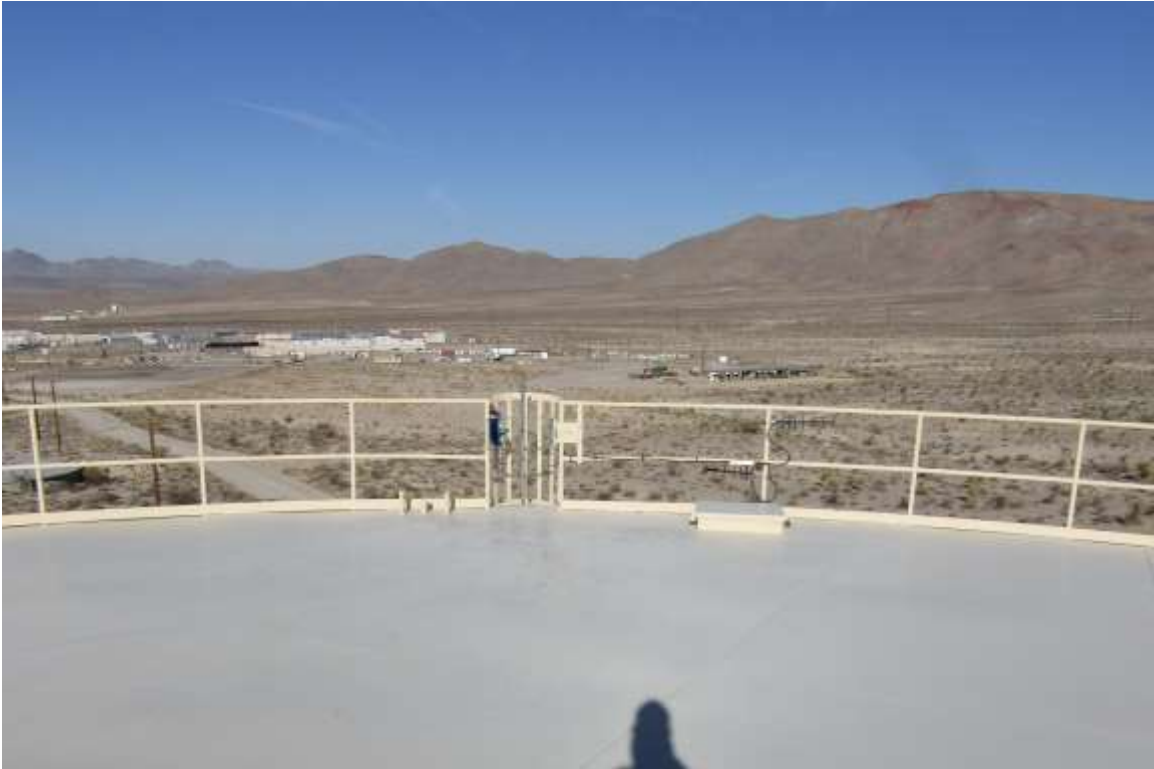
Photo shows the tank roof edge is equipped with a 42" high compliant handrail system for fall protection as required by **OSHA 1910.28(b)(1)**. The handrail system is equipped with an intermediate rail and toeboard.

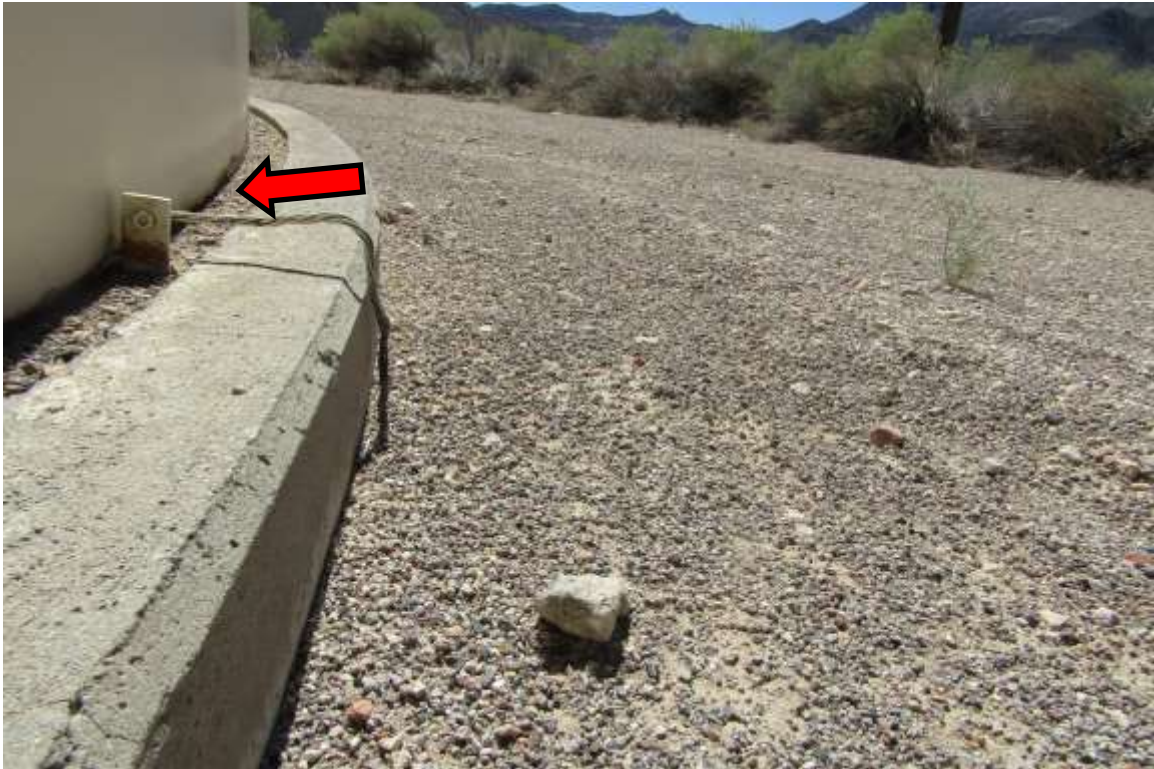
Photo shows the tank is electrically grounded for lightning protection as required by **OSH Act of 1970 Section 5** and appears to be in good condition.

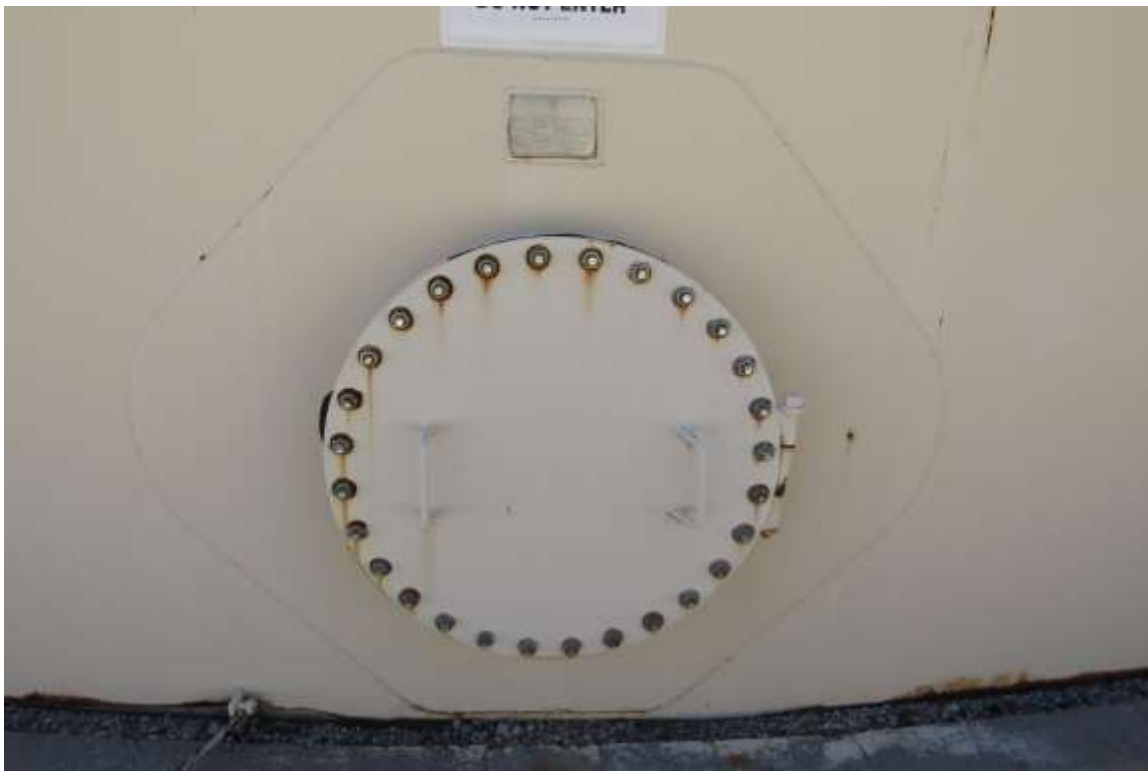
Photo shows the condition of the 24" primary shell manway. The following is required for the tank to be in compliance with **AWWA D100-11; 7.4.4 Shell man-holes, NFPA 22-2018; 14.7.2.1.1** and **OSHA 1910.146(c)(2) Confined spaces**.

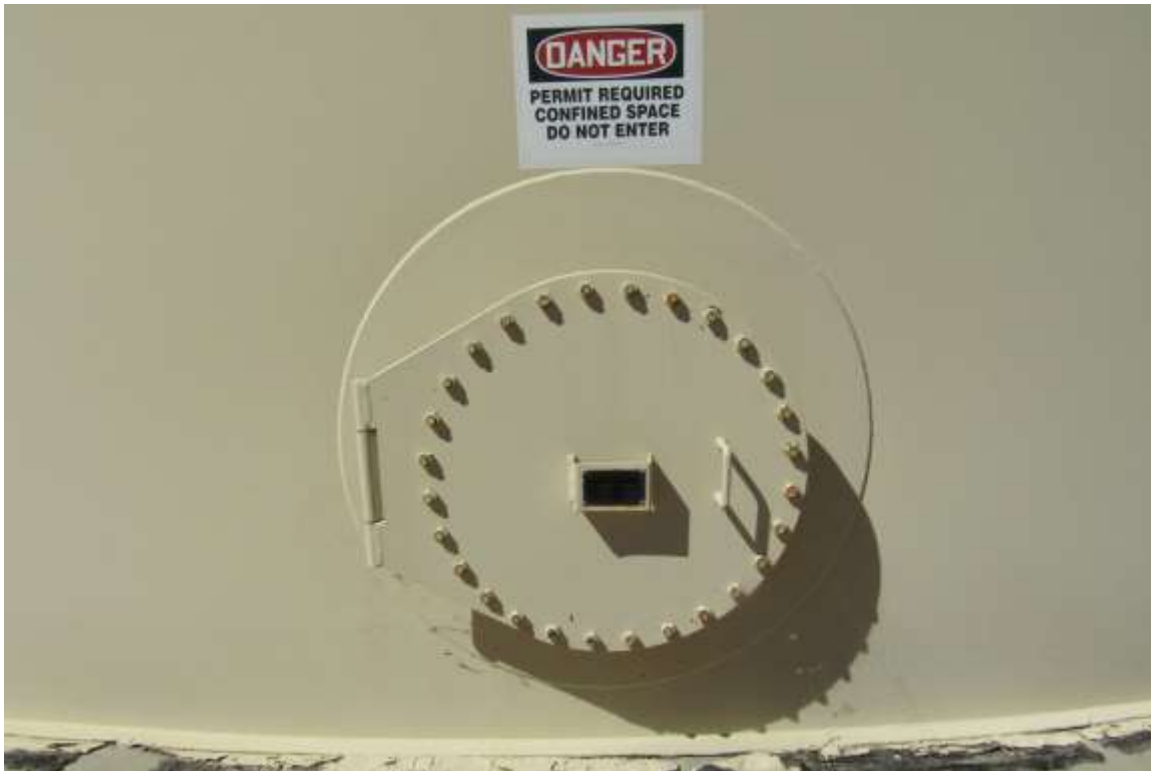
Photo shows the condition of the 24" primary shell manway. The following is required for the tank to be in compliance with **AWWA D100-11; 7.4.4 Shell man-holes, NFPA 22-2018; 14.7.2.1.1** and **OSHA 1910.146(c)(2) Confined spaces**.

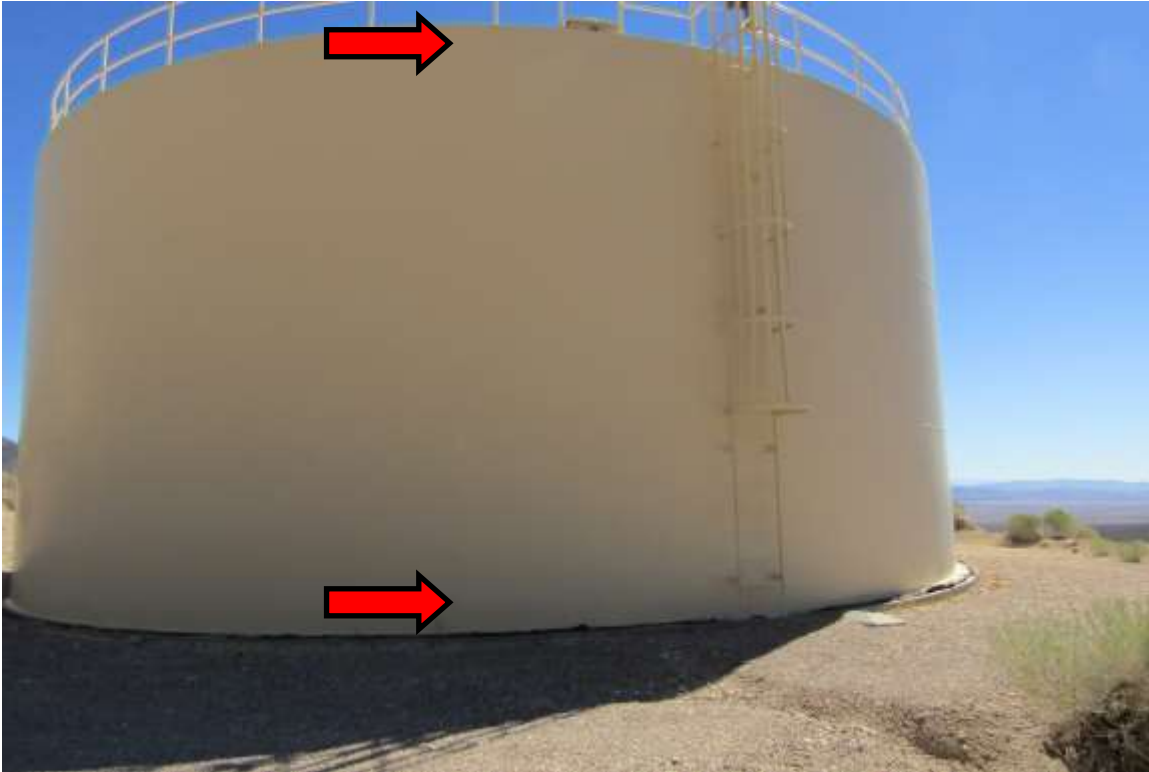
Photo shows the tank is not equipped with a liquid level indicator. We recommend installing a liquid level indicator, complete with target board and float.

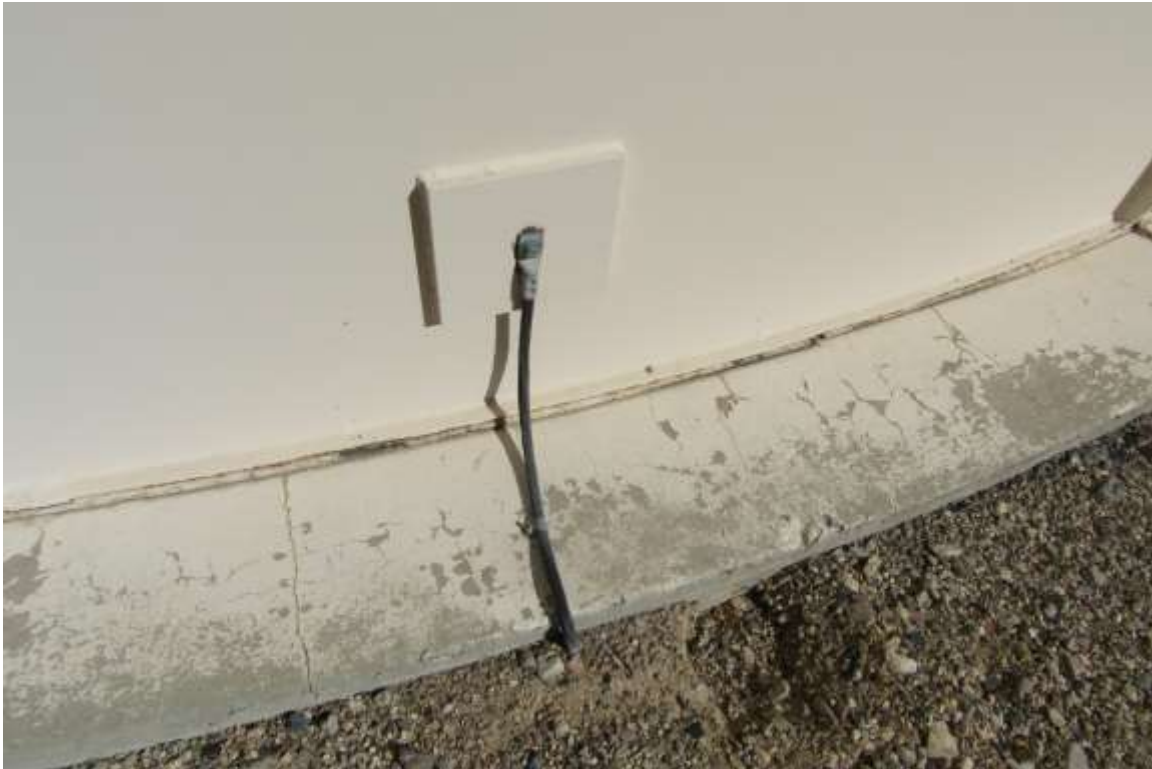
Photo shows the tank is electrically grounded for lightning protection as required by **OSH Act of 1970 Section 5** and **NFPA 780-2017; 5.4 Metal Towers and Tanks** and appears to be in good condition.

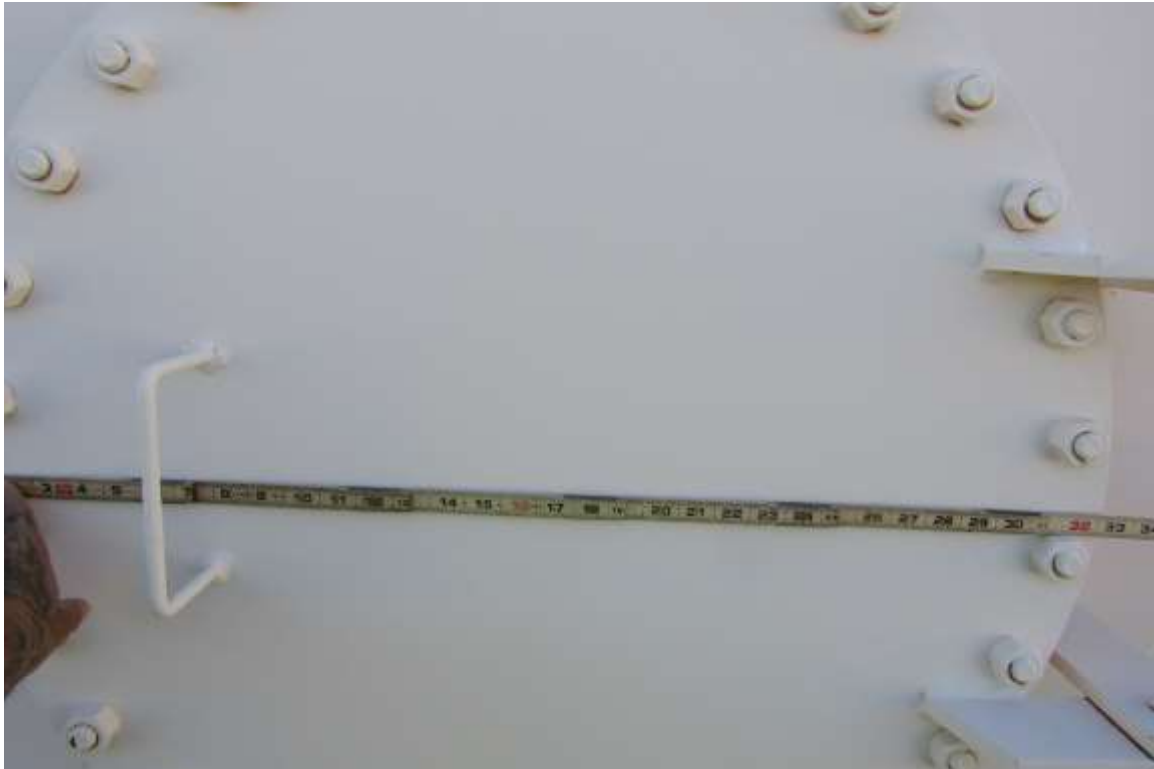
Photo shows the condition of the 24" primary shell manway, which is in compliance with [AWWA D100-11; 7.4.4 Shell manholes](#), [NFPA 22-2018; 14.7.2.1.1](#) and [OSHA 1910.146\(c\)\(2\) Confined spaces](#).

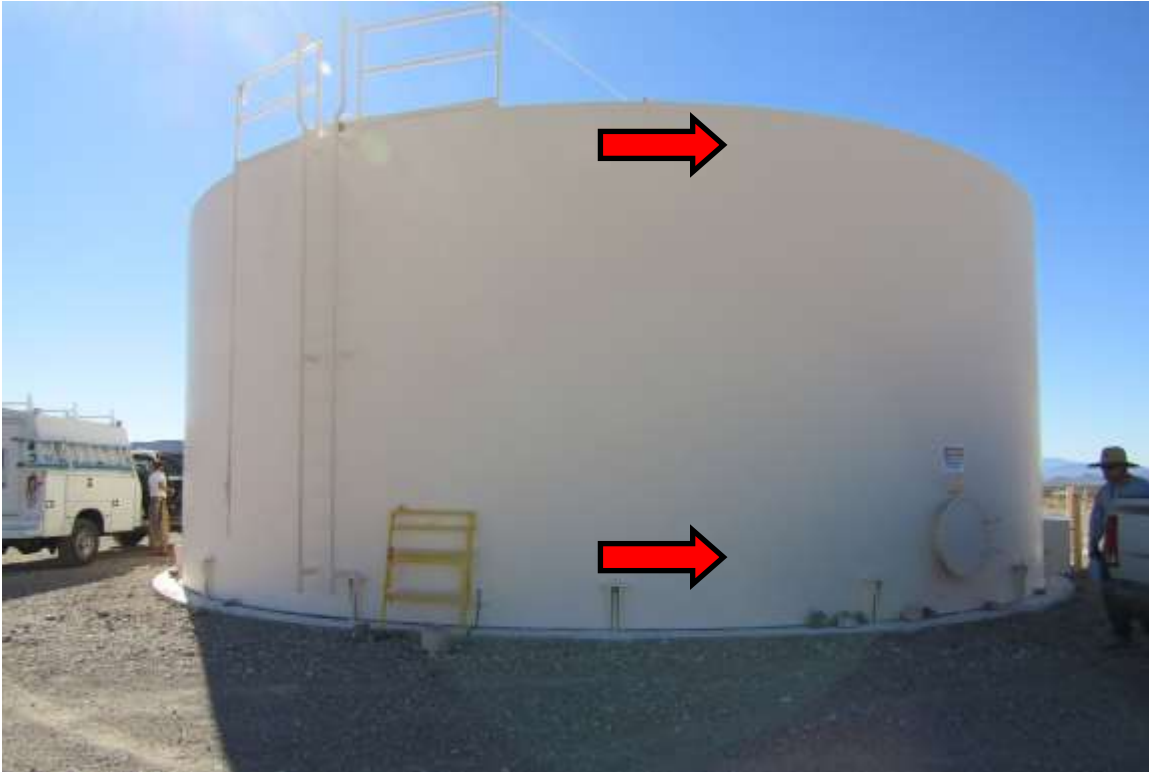
Photo shows the tank is not equipped with a liquid level indicator. **NFPA 22-2018; 14.1.8* Water-Level Gauge** states, "A water-level gauge of suitable design shall be provided. It shall be carefully installed, adjusted, and properly maintained." We recommend installing a liquid level indicator, complete with target board and float.

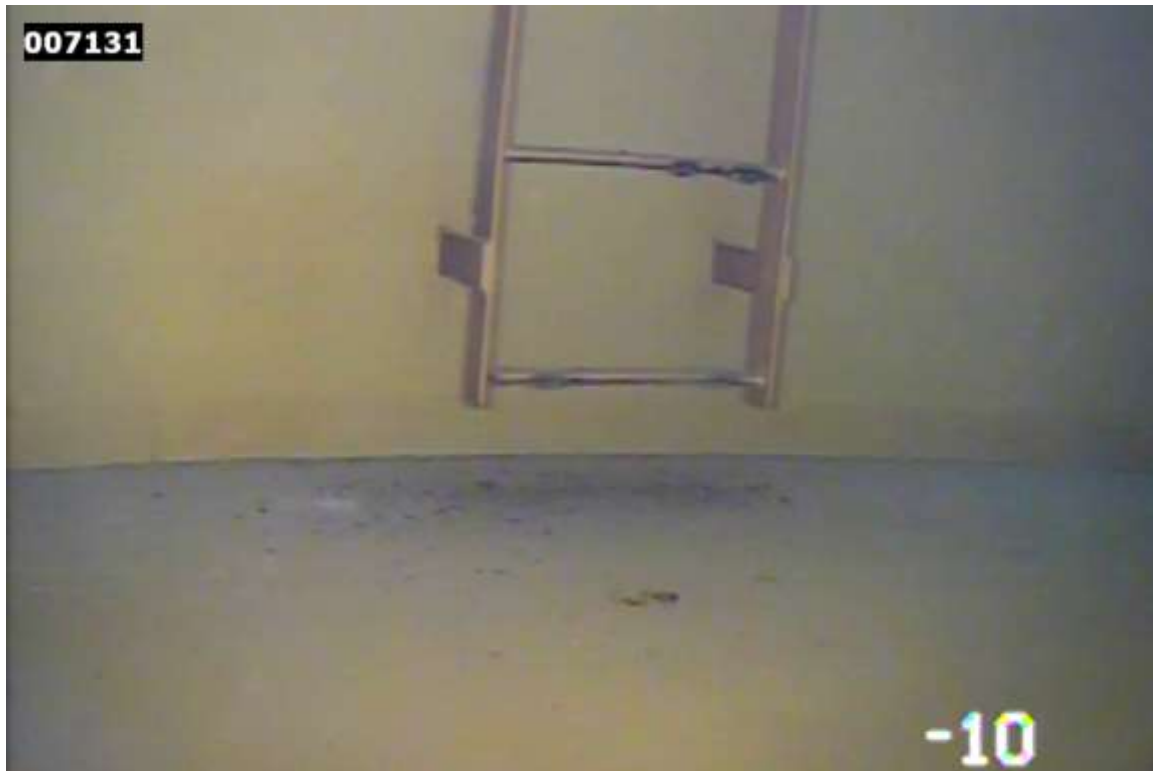
Primary interior access ladder in above photo is 16" wide, but is not equipped with anti-skid rungs. We recommend installing anti-skid rung covers and a cable type ladder safety device on the primary interior access ladder.

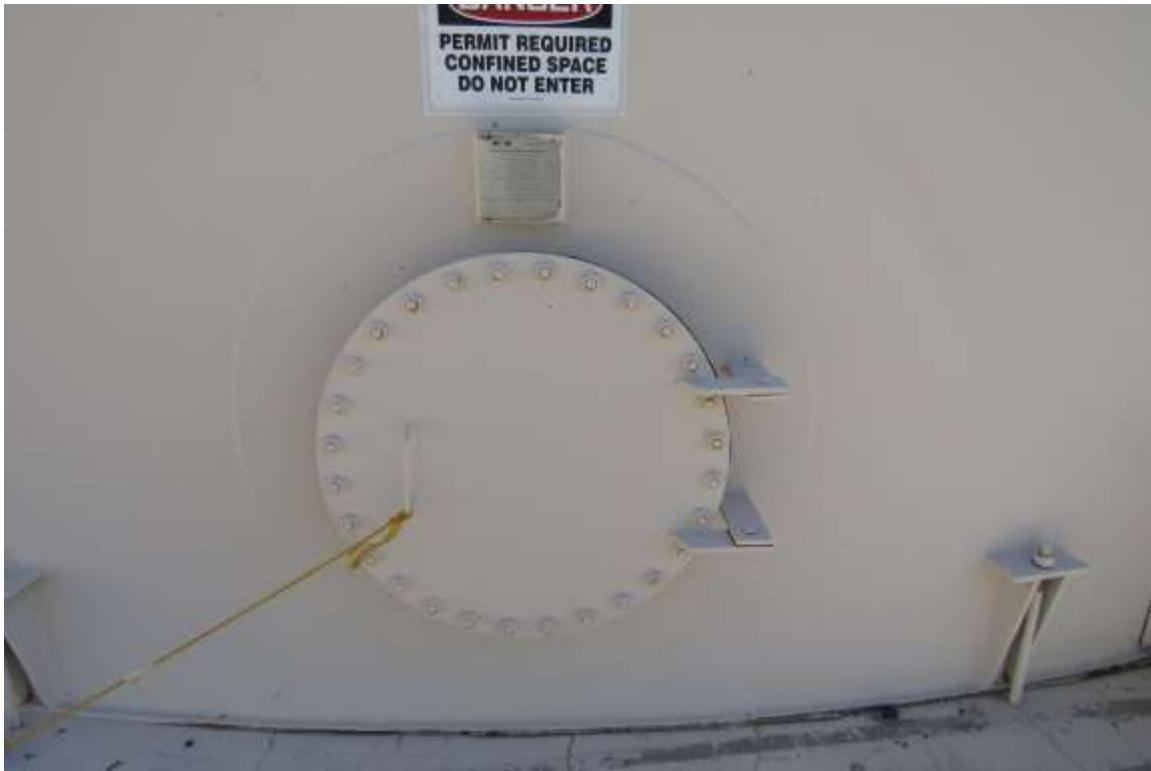
Photo shows the condition of the 24" primary shell manway, which is in compliance with [AWWA D100-11; 7.4.4 Shell manholes](#), [NFPA 22-2018; 14.7.2.1.1](#) and [OSHA 1910.146\(c\)\(2\) Confined spaces](#).

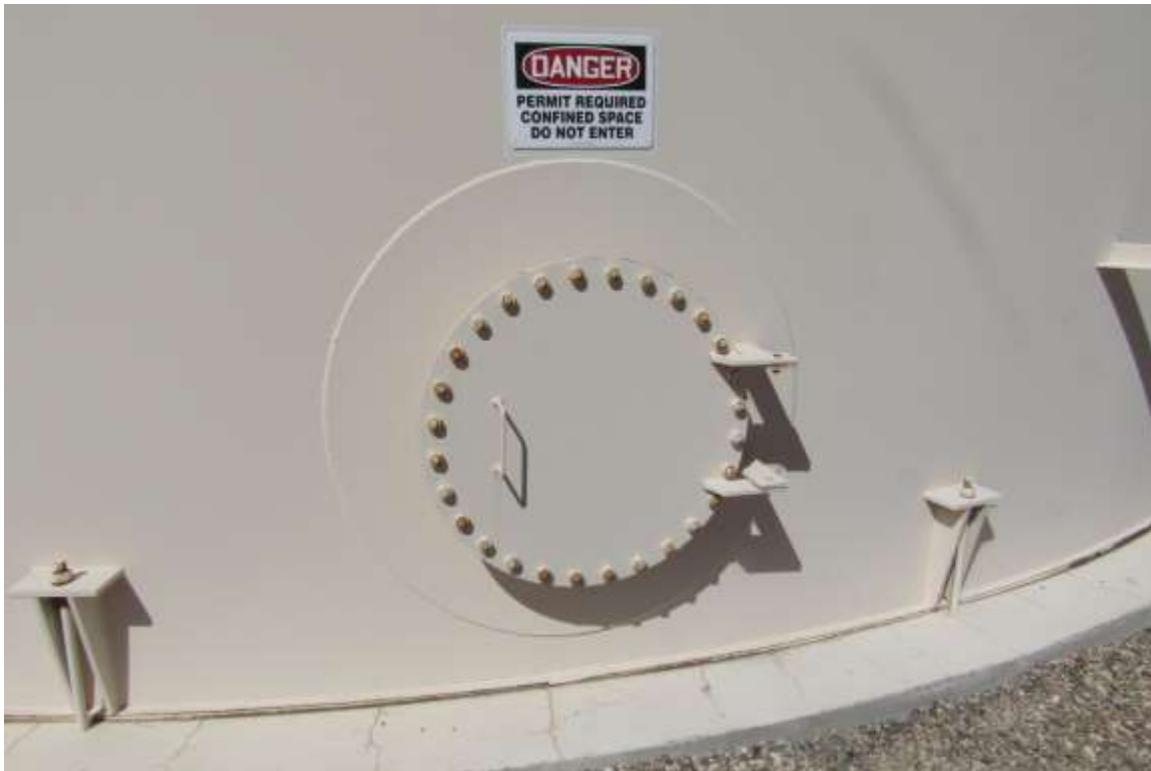
Photo shows the condition of the 24" secondary shell manway. The following is required for the tank to be in compliance with **AWWA D100-11; 7.4.4 Shell man-holes**, **NFPA 22-2018; 14.7.2.1.1** and **OSHA 1910.146(c)(2) Confined spaces**.

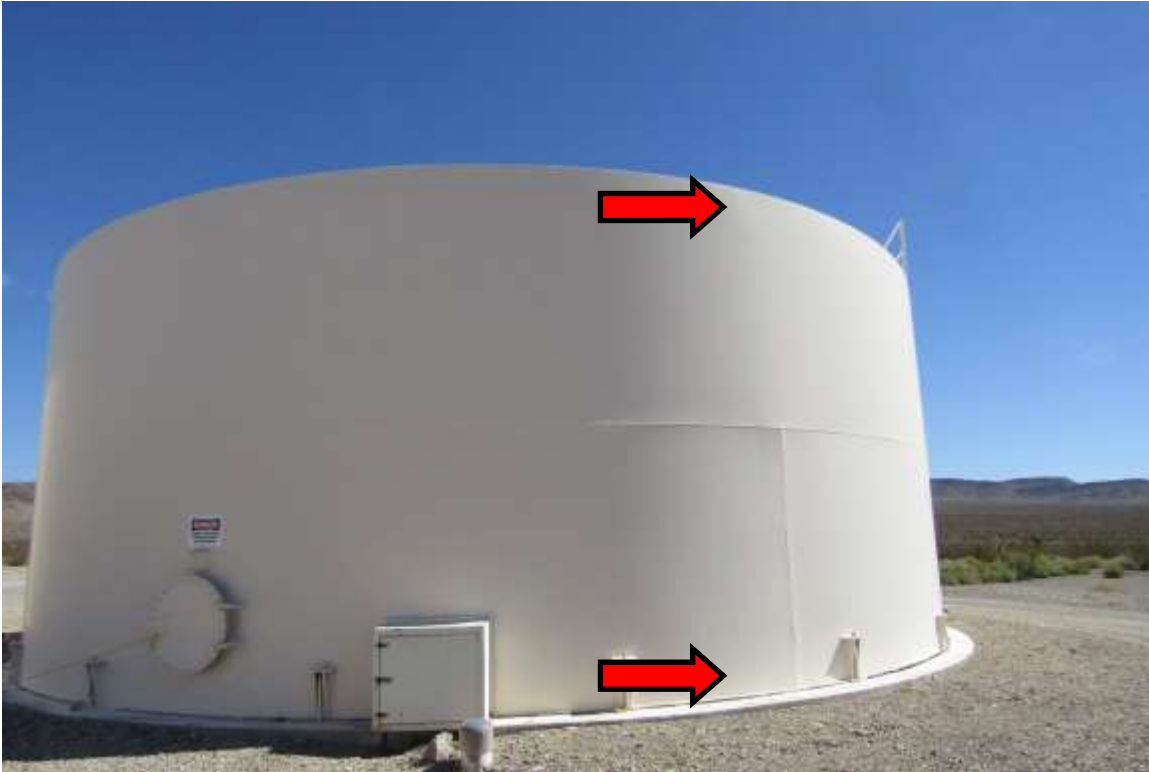
Photo shows the tank is not equipped with a liquid level indicator. **NFPA 22-2018; 14.1.8* Water-Level Gauge** states, "A water-level gauge of suitable design shall be provided. It shall be carefully installed, adjusted, and properly maintained." We recommend installing a liquid level indicator, complete with target board and float.

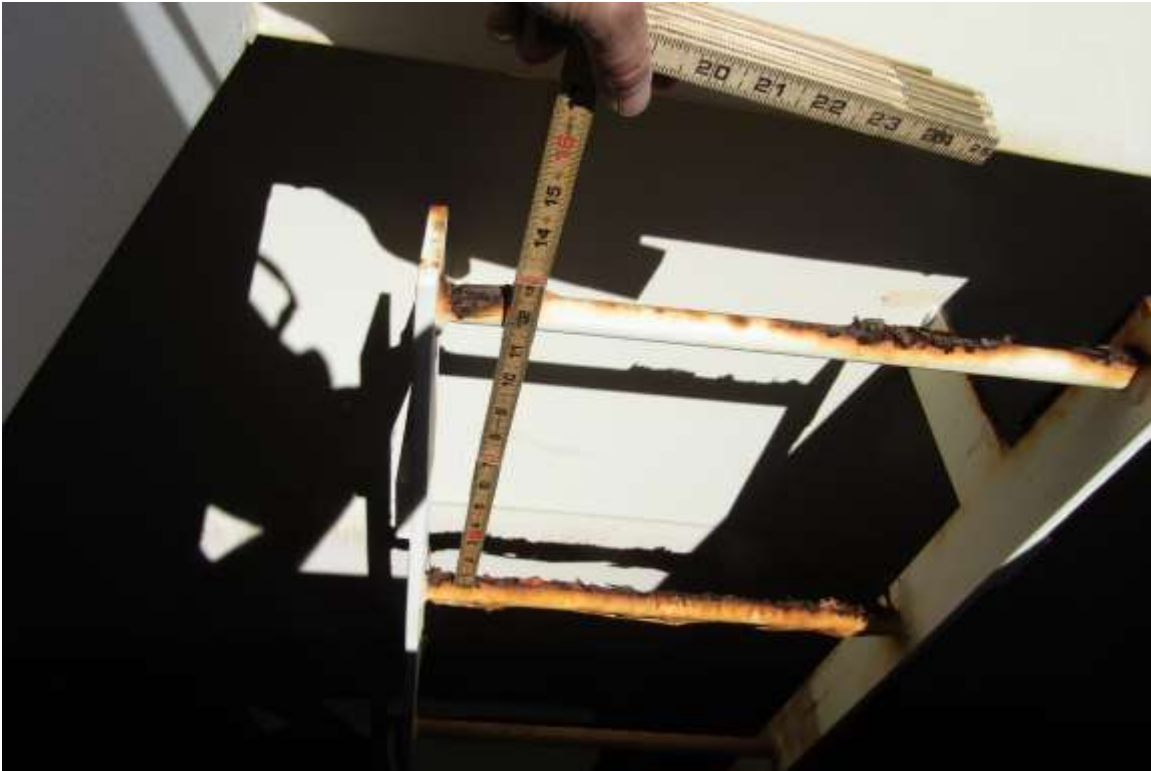
Primary interior access ladder in above photo is 16" wide, but is not equipped with anti-skid rungs and is seriously deteriorated. **OSHA 1910.23(b)(10)** states, "Any ladder with structural or other defects is immediately tagged "Dangerous: Do Not Use" or with similar language in accordance with § **1910.145** and removed from service until repaired in accordance with § **1910.22(d)**, or replaced; ... " We recommend installing an **OSHA** compliant interior access ladder complete with standoffs every 10' on center, and a cable type ladder safety device at the primary roof hatch.

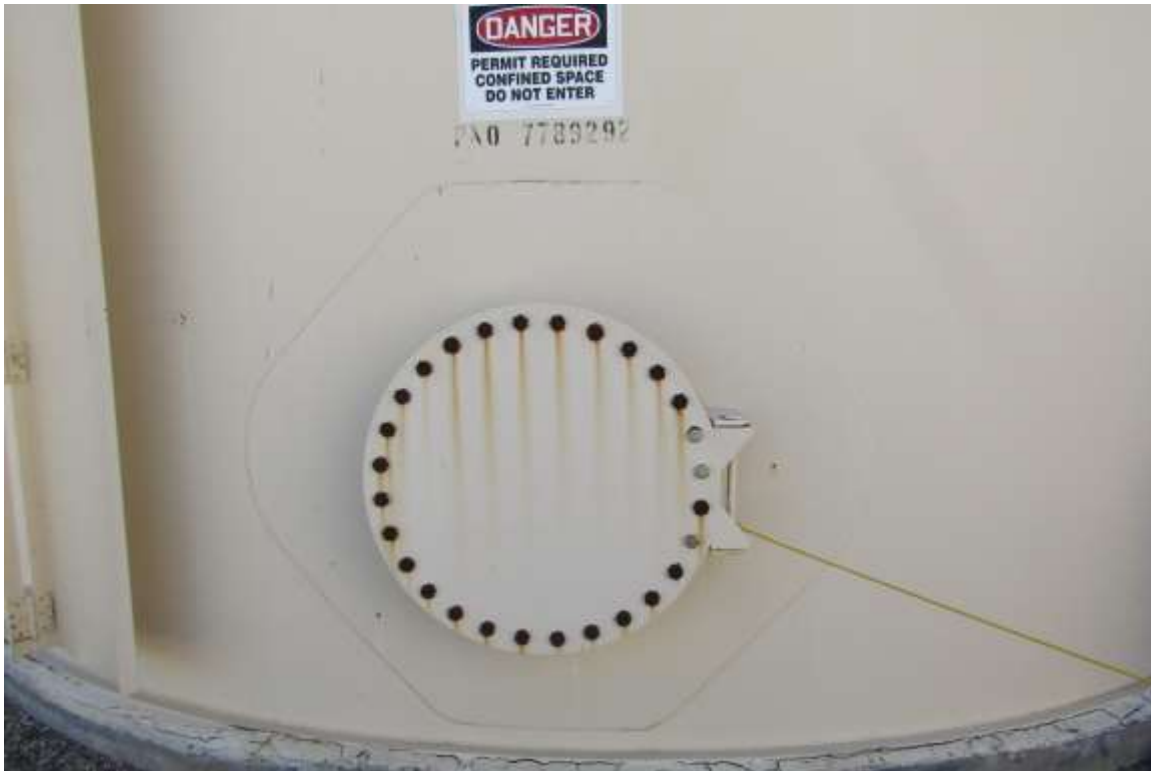
Photo shows the condition of the 24" primary shell manway. The following is required for the tank to be in compliance with **AWWA D100-11; 7.4.4 Shell man-holes** and **OSHA 1910.146(c)(2) Confined spaces**.
