**Mission Support and Test Services, LLC
Nevada National Security Site
Mercury, NV 89023
RE: Mercury North (Area 23); Mercury, NV
1,500,000 Gallon GST
September 16, 2018
Mr. Kevin Olsen
Scientist 1
(702) 295-0485
Job No. 318448-A**

**Mission Support and Test Services, LLC
Nevada National Security Site
Mercury, NV 89023
RE: Camp South (Area 12); Mercury, NV
500,000 Gallon GST
September 13, 2018
Mr. Kevin Olsen
Scientist 1
(702) 295-0485
Job No. 318448-D**

**Mission Support and Test Services, LLC
Nevada National Security Site
Mercury, NV 89023
RE: Well 4/4a South (Area 6); Mercury, NV
150,000 Gallon GST
September 24, 2018
Mr. Kevin Olsen
Scientist 1
(702) 295-0485
Job No. 318448-H**

**Mission Support and Test Services, LLC
Nevada National Security Site
Mercury, NV 89023
RE: C-1 North (Area 6); Mercury, NV
50,000 Gallon GST
September 21, 2018
Mr. Kevin Olsen
Scientist 1
(702) 295-0485
Job No. 318448-O**

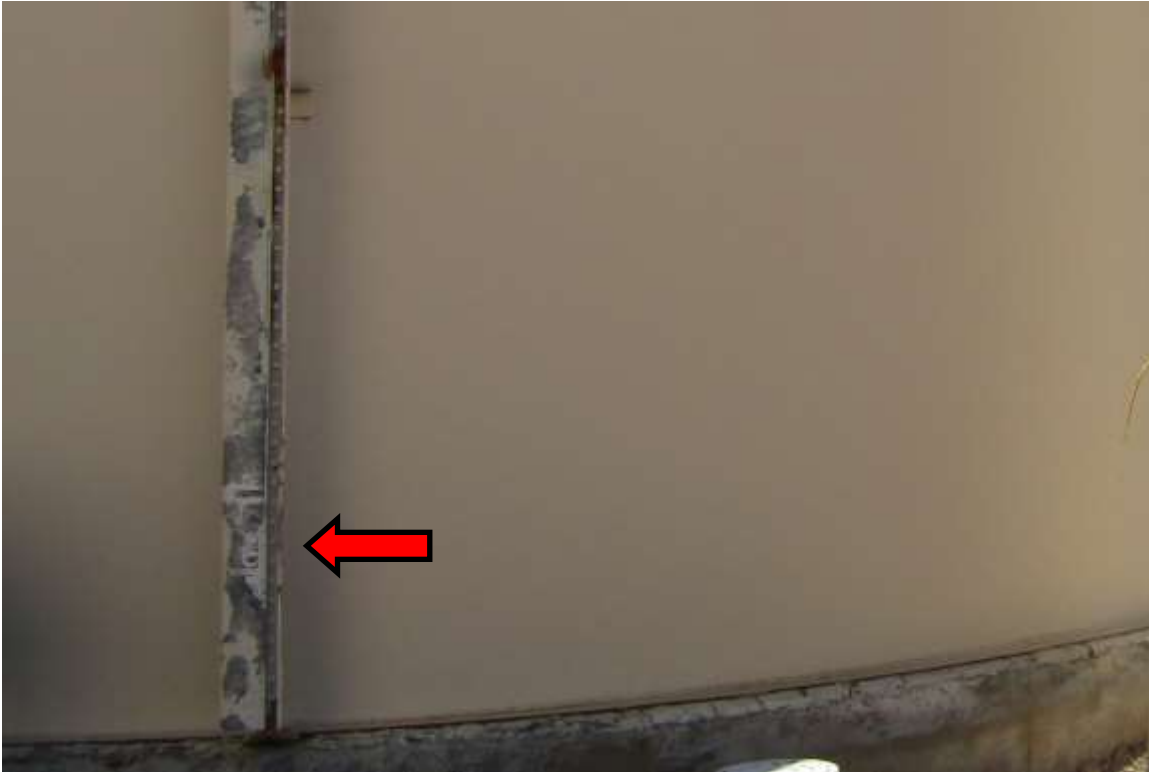
Photo shows the condition of the liquid level indicator. Due to the condition of the indicator, we recommend replacing the existing liquid level indicator.

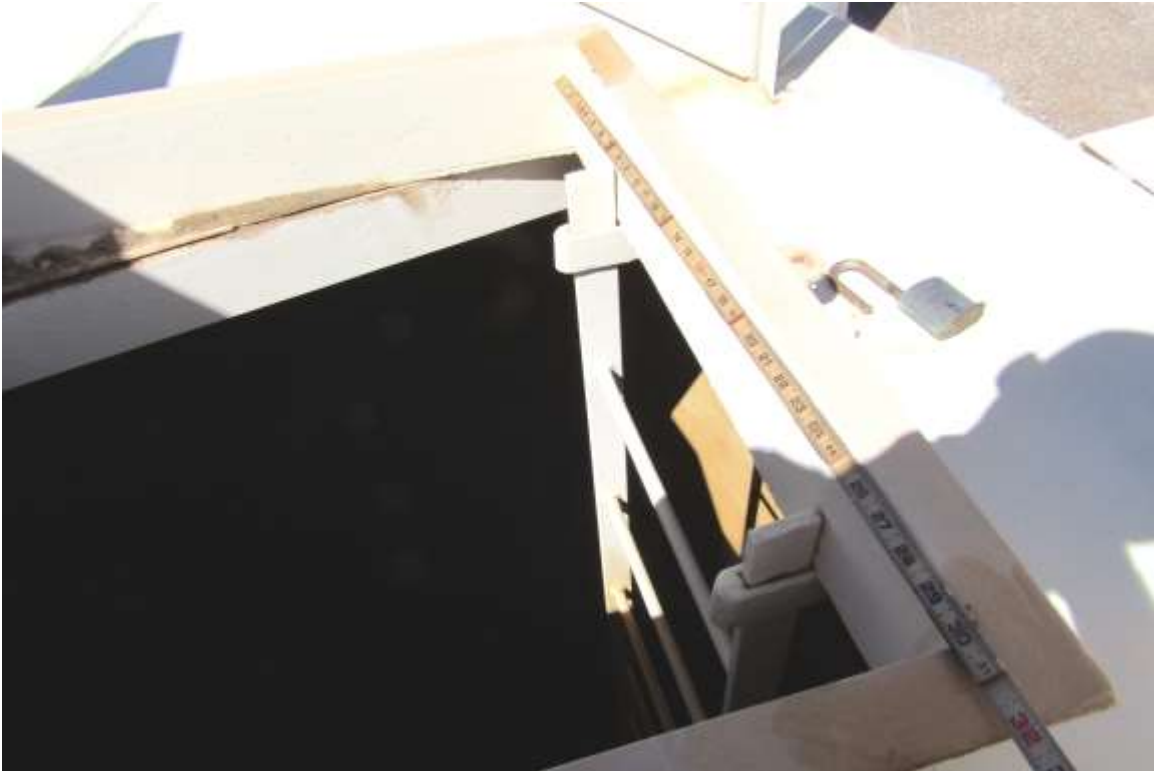
Primary interior access ladder in above photo is 18" wide, but is not equipped with anti-skid rungs. We recommend installing anti-skid rung covers and a cable type ladder safety device on the primary interior access ladder.

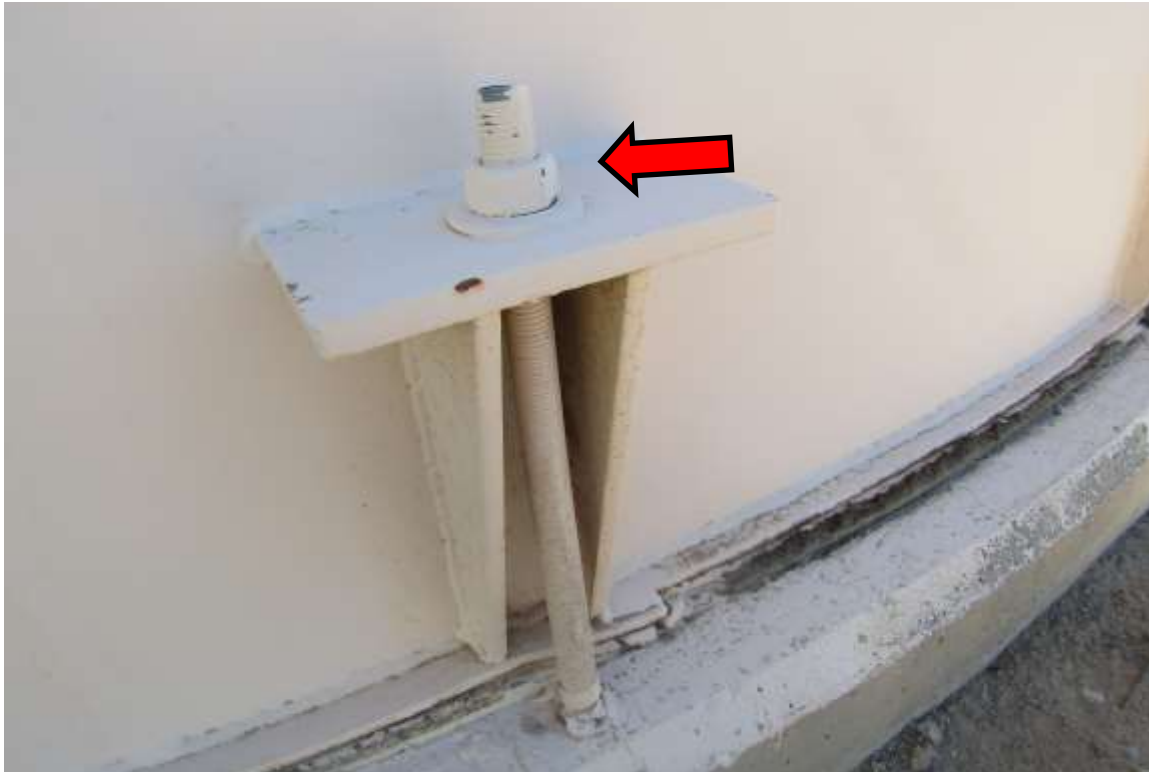
Photo shows the condition of one (1) of the twenty-one (21) anchor bolts. **AW-WA D100-11; 3.8.1.1 Required anchorage** states, "For ground-supported flat-bottom reservoirs and standpipes, mechanical anchorage shall be provided when the wind or seismic loads exceed the limits for self-anchored tanks." We recommend cleaning the area around the anchor bolts, tightening the anchor nuts, then tack welding the circumference of the nut-to-base plate connections and bolt-to-nut connections to reinforce.

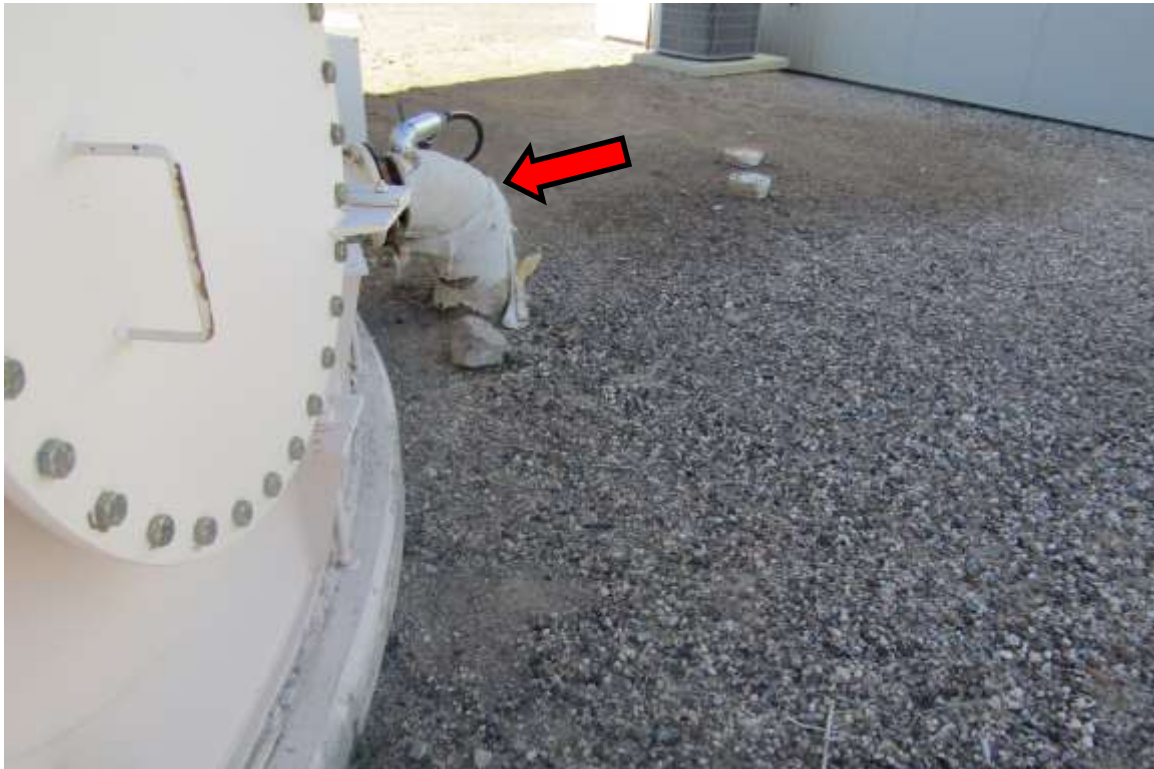
Photo shows the existing drain valve, which appears to be in good condition.

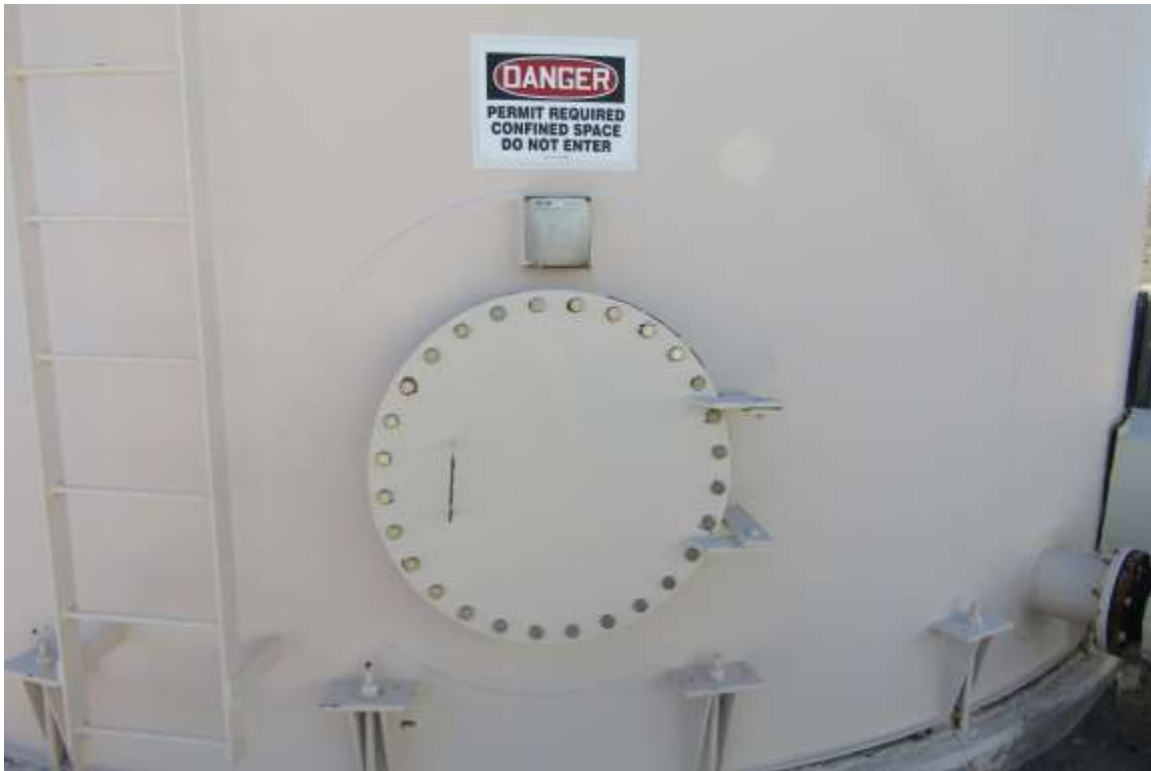
Photo shows the condition of the 24" primary shell manway, which is in compliance with [AWWA D100-11; 7.4.4 Shell manholes](#), [NFPA 22-2018; 14.7.2.1.1](#) and [OSHA 1910.146\(c\)\(2\) Confined spaces](#).

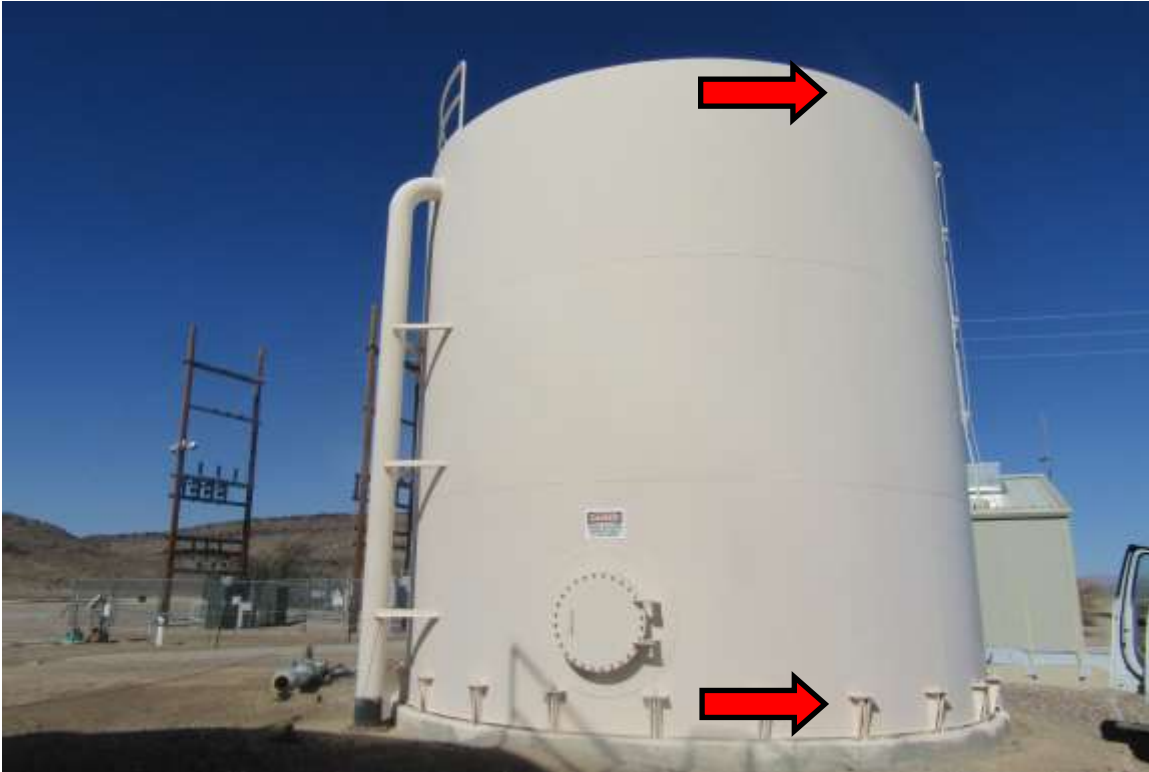
Photo shows the tank is not equipped with a liquid level indicator. **NFPA 22-2018; 14.1.8* Water-Level Gauge** states, "A water-level gauge of suitable design shall be provided. It shall be carefully installed, adjusted, and properly maintained." We recommend installing a liquid level indicator, complete with target board and float.

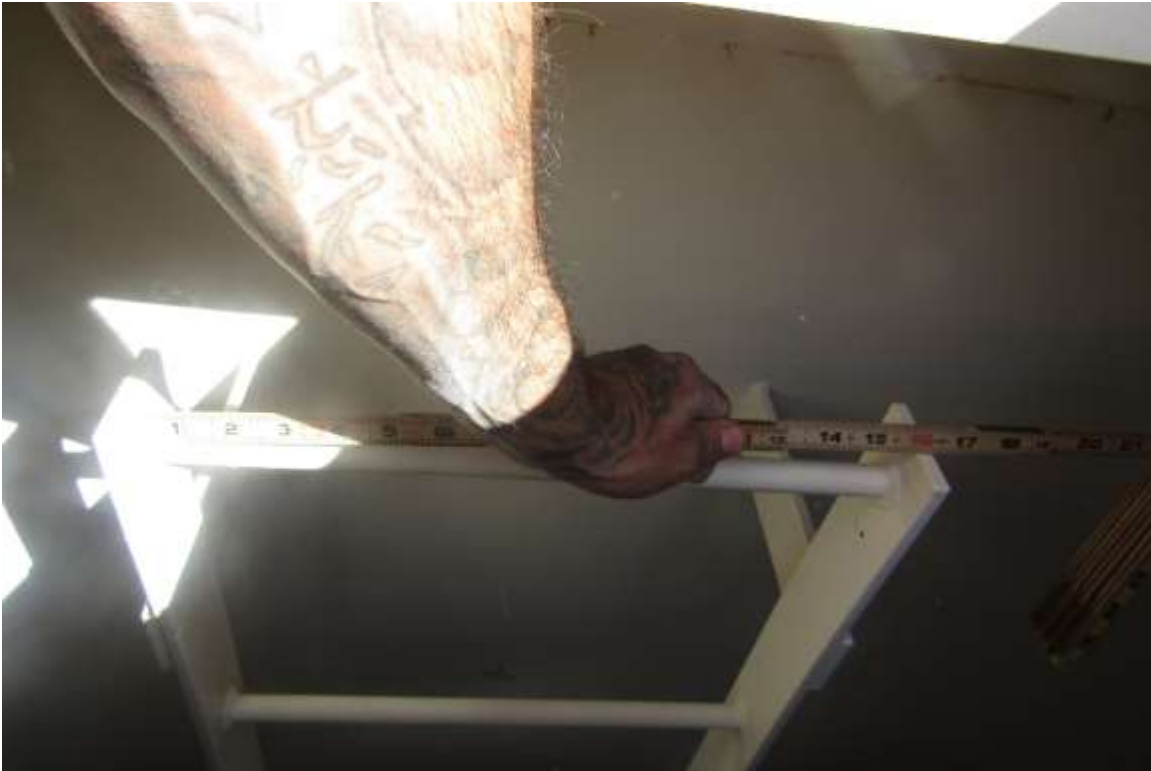
Primary interior access ladder in above photo is 16" wide, but is not equipped with anti-skid rungs. We recommend installing anti-skid rung covers and a cable type ladder safety device on the primary interior access ladder.

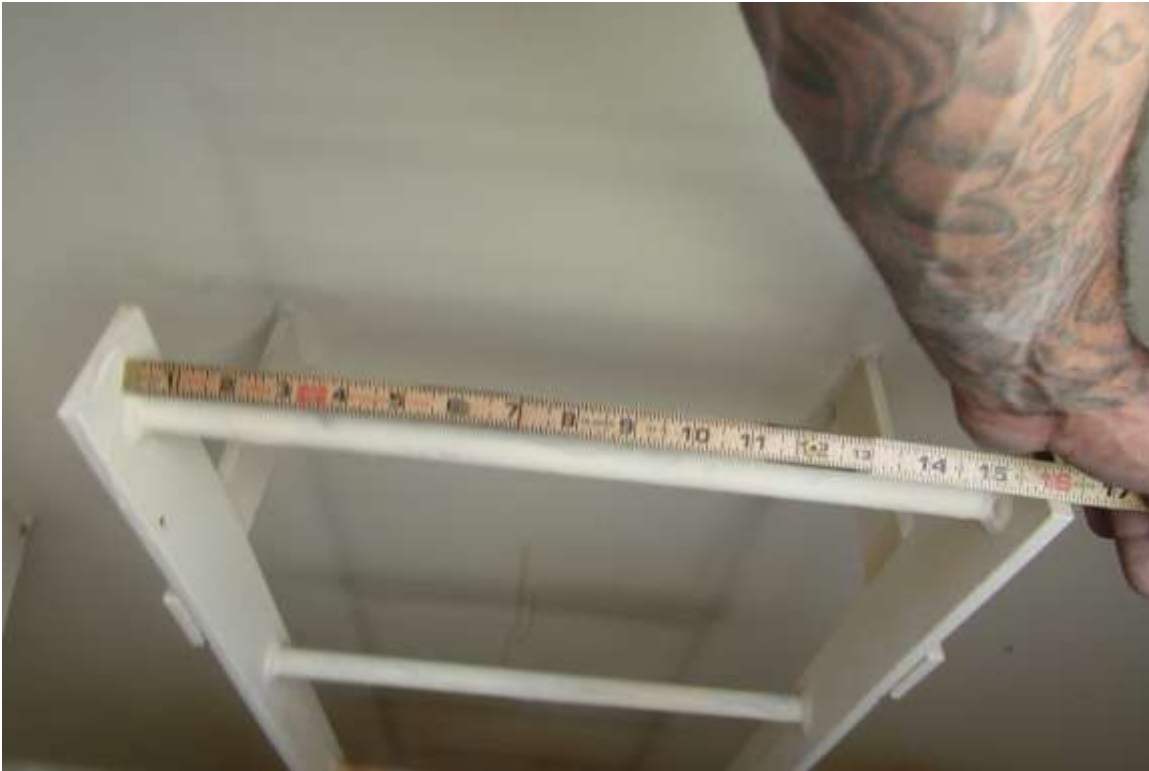
Secondary interior access ladder in above photo is 16" wide, but is not equipped with anti-skid rungs. We recommend installing anti-skid rung covers and a cable type ladder safety device on the secondary interior access ladder.

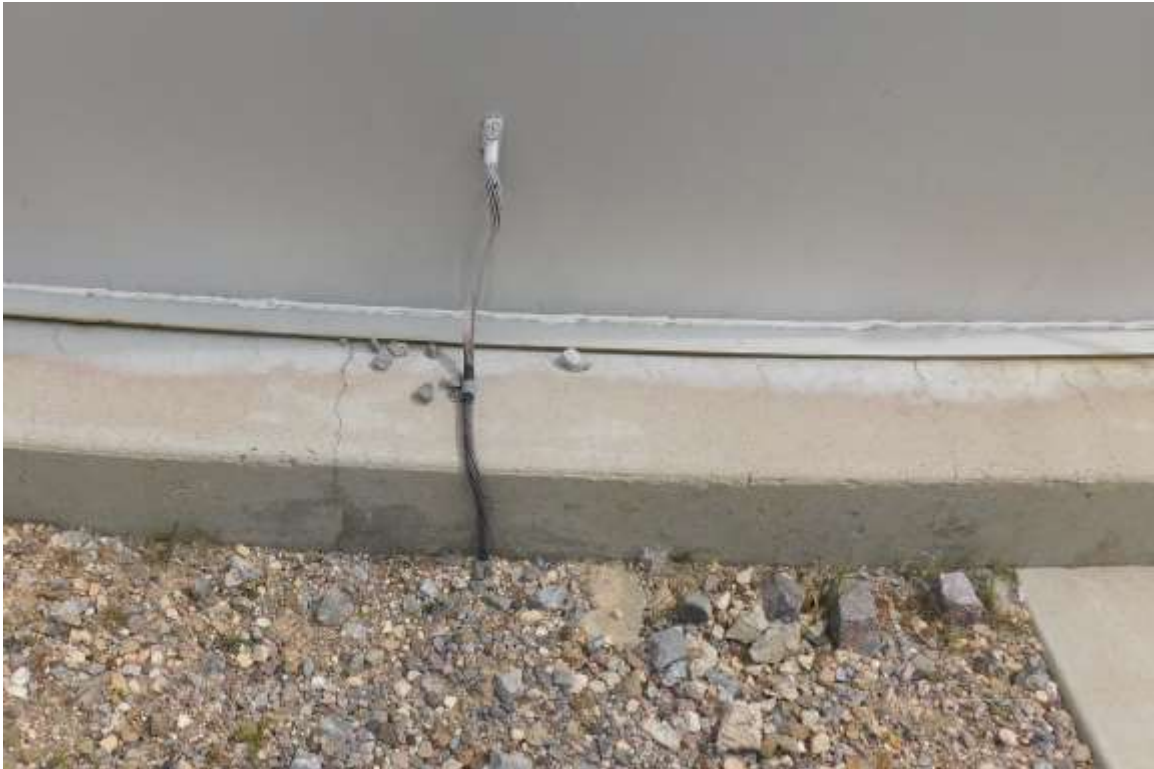
Photo shows the tank is electrically grounded for lightning protection as required by **OSH Act of 1970 Section 5** and appears to be in good condition.

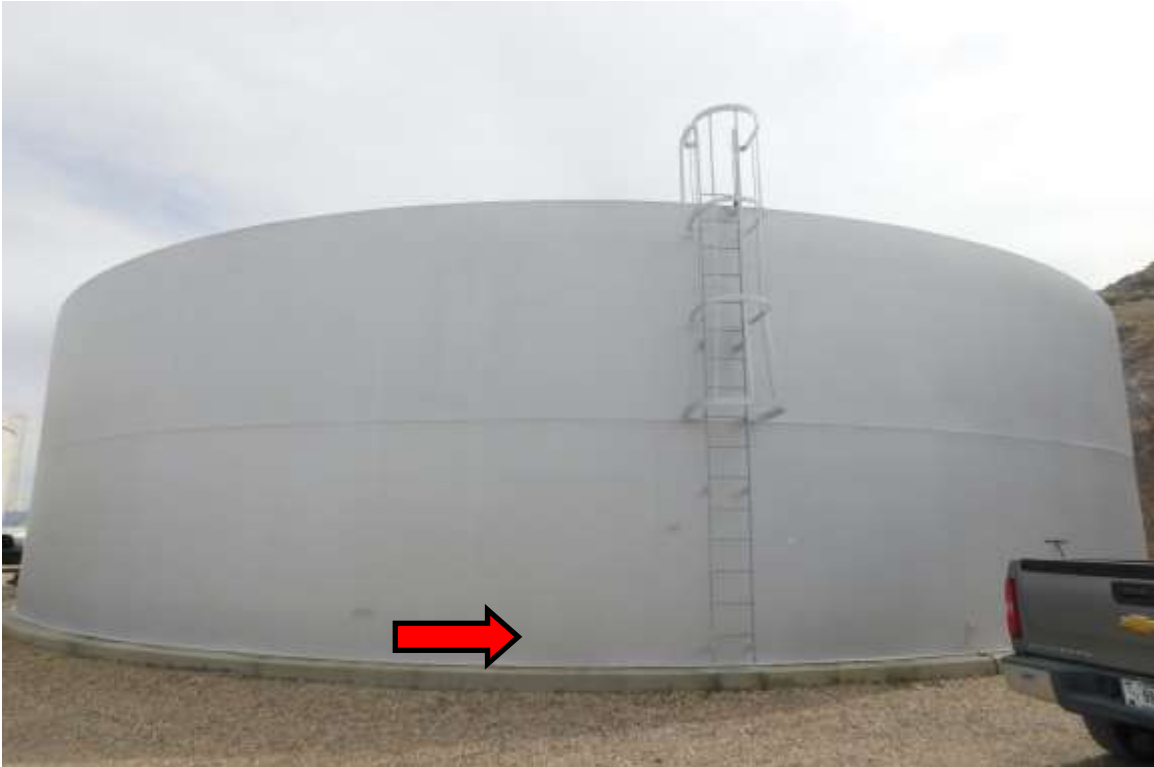
Photo shows the condition of the shell. Currently there is no drain valve. We recommend installing a frost proof drain valve near the shell-to-floor connection, complete with a locking device to prevent unauthorized draining of the tank and a splash pad to direct water away from the foundation.

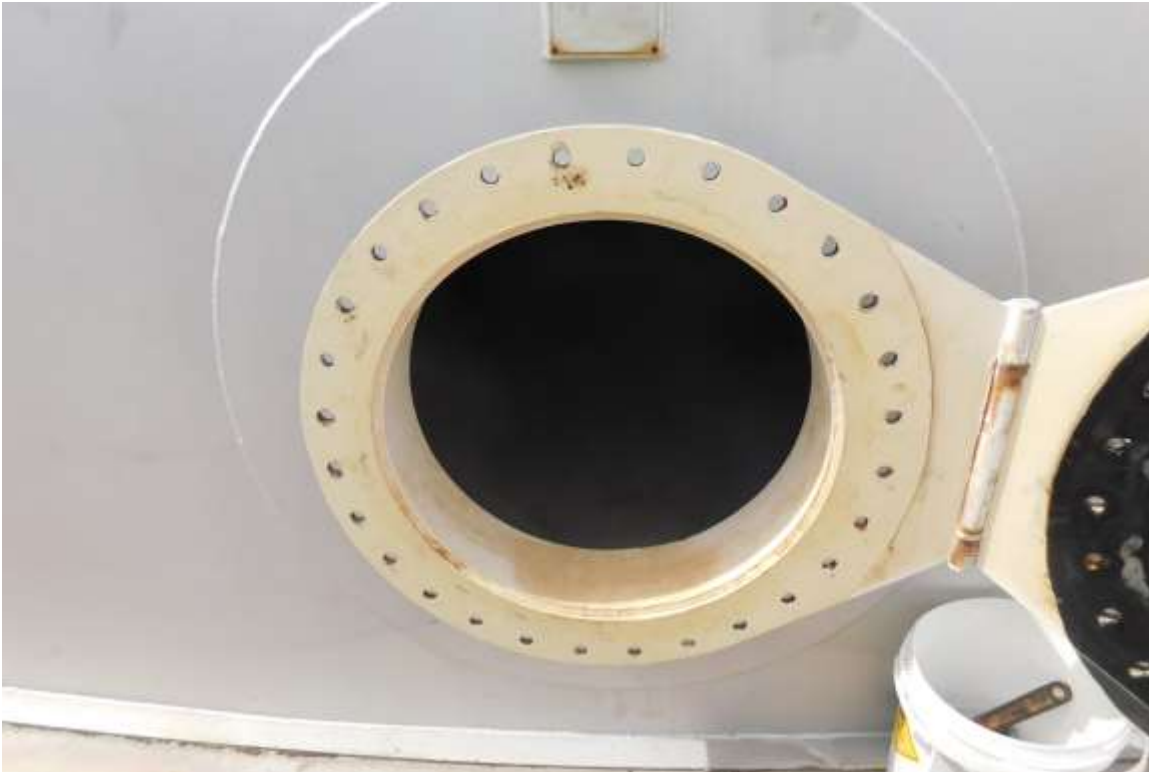
Photo shows the condition of the 24" primary shell manway. The following is required for the tank to be in compliance with **AWWA D100-11; 7.4.4 Shell man-holes** and **OSHA 1910.146(c)(2) Confined spaces**.

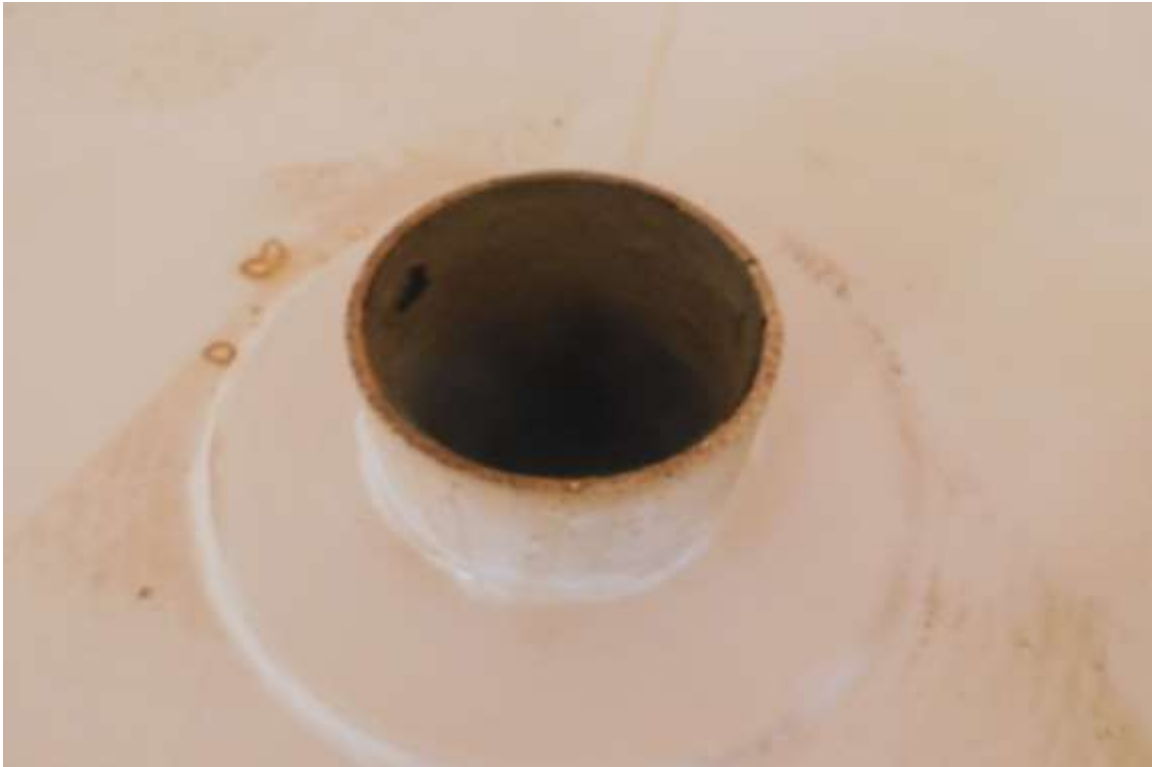
Photo shows a fill pipe on the tank interior. A temperature difference between the water in the top and bottom of a tank, even as little as 1-2 degrees Fahrenheit, is an indication of thermal stratification and the tank water not being completely mixed. Incomplete mixing would result in short-circuiting, and localized increase in water age would develop inside the tank. This typically leads to water quality problems, such as loss of residual, DBP spikes, HPC spikes, bacteria regrowth, formation of bio-film, changes in pH and dissolved oxygen. We recommend installing a mixing system. Electrical work to be done by others if required.

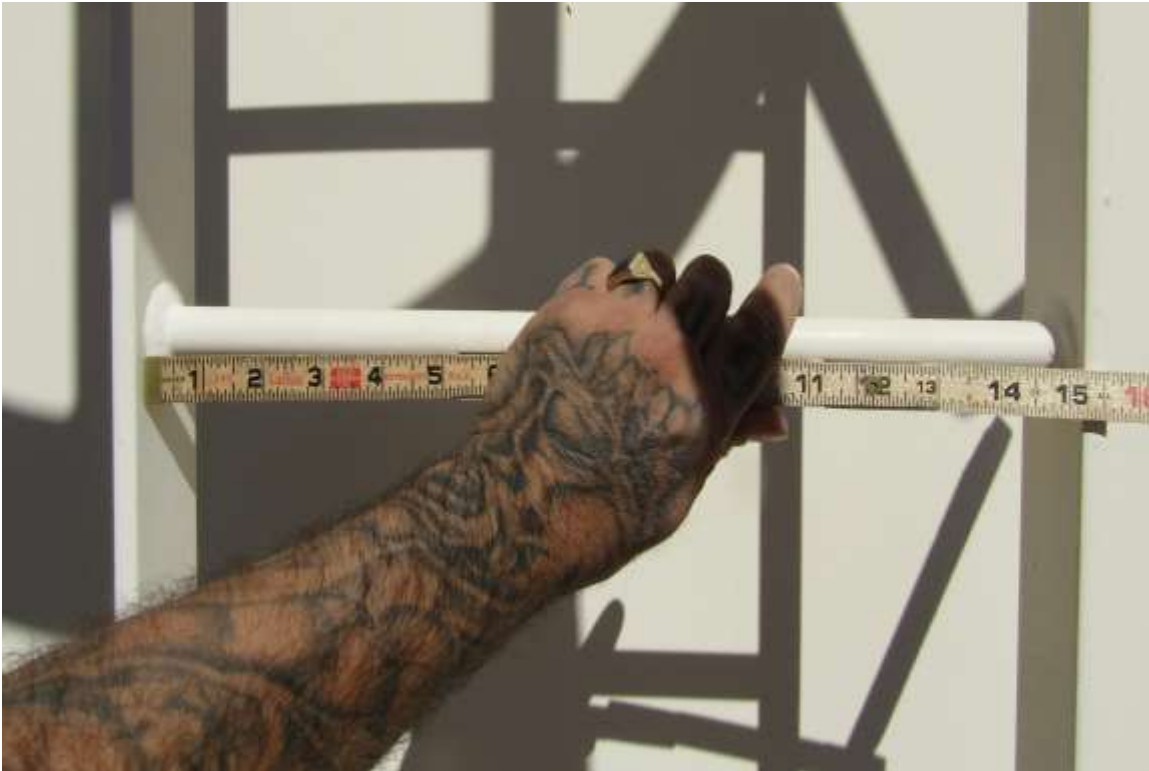
Shell access ladder in above photo is not equipped with anti-skid rungs, and is only 15" wide. **OSHA 1910.23(b)(4)** states, "Ladder rungs, steps, and cleats have a minimum clear width of... 16 inches (41 cm) (measured before installation of ladder safety systems) for fixed ladders,..." We recommend installing an **OSHA** compliant shell access ladder complete with standoffs every 10' on center, a cable type ladder safety device, a lockable ladder guard to prevent unauthorized access and posting a **Fall Protection Required** sign at the base of the ladder.

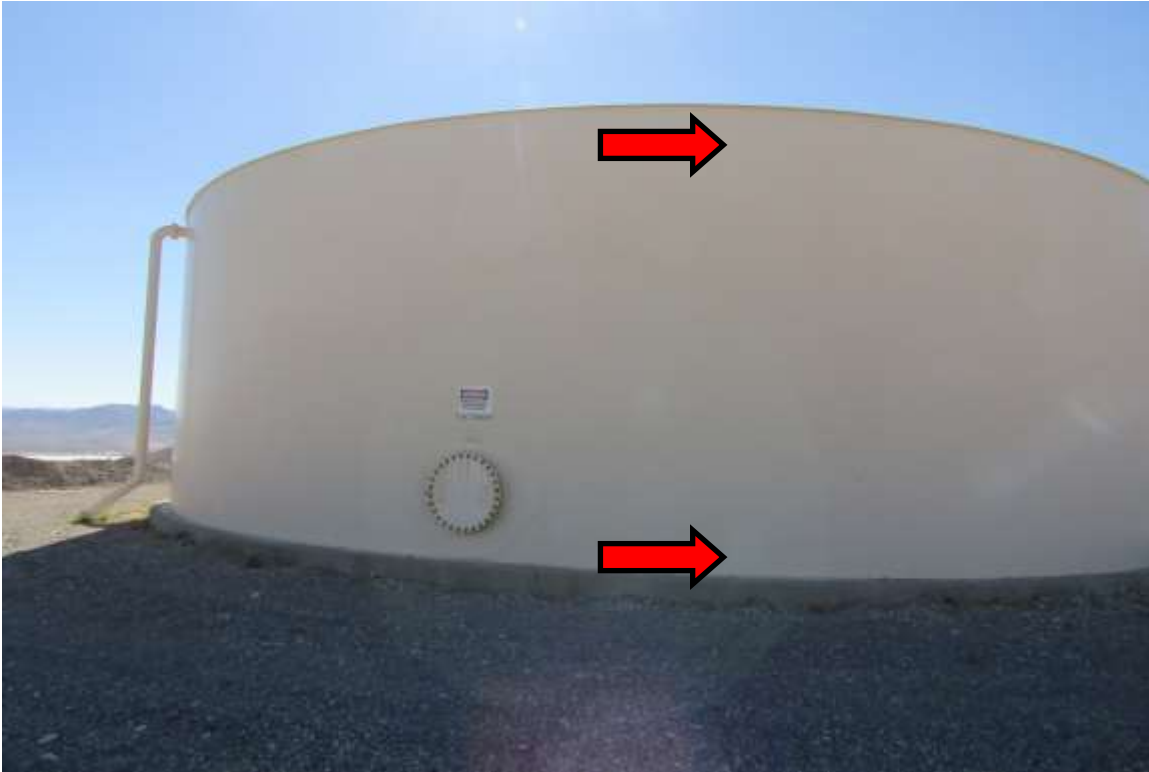
Photo shows the tank is not equipped with a liquid level indicator. We recommend installing a liquid level indicator, complete with target board and float.

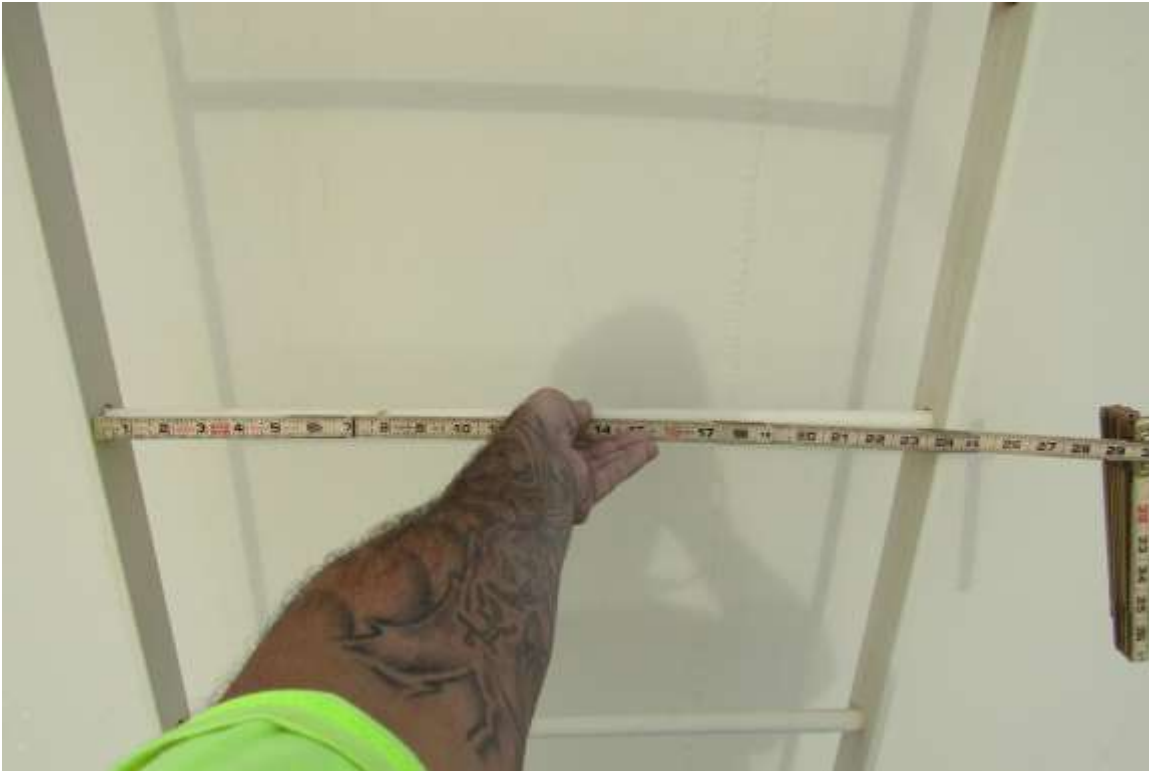
Shell access ladder in above photos is 16" wide, but is not equipped with anti-skid rungs. We recommend installing anti-skid rung covers, a cable type ladder safety device, a lockable ladder guard to prevent unauthorized access, and posting a **Fall Protection Required** sign at the base of the ladder.

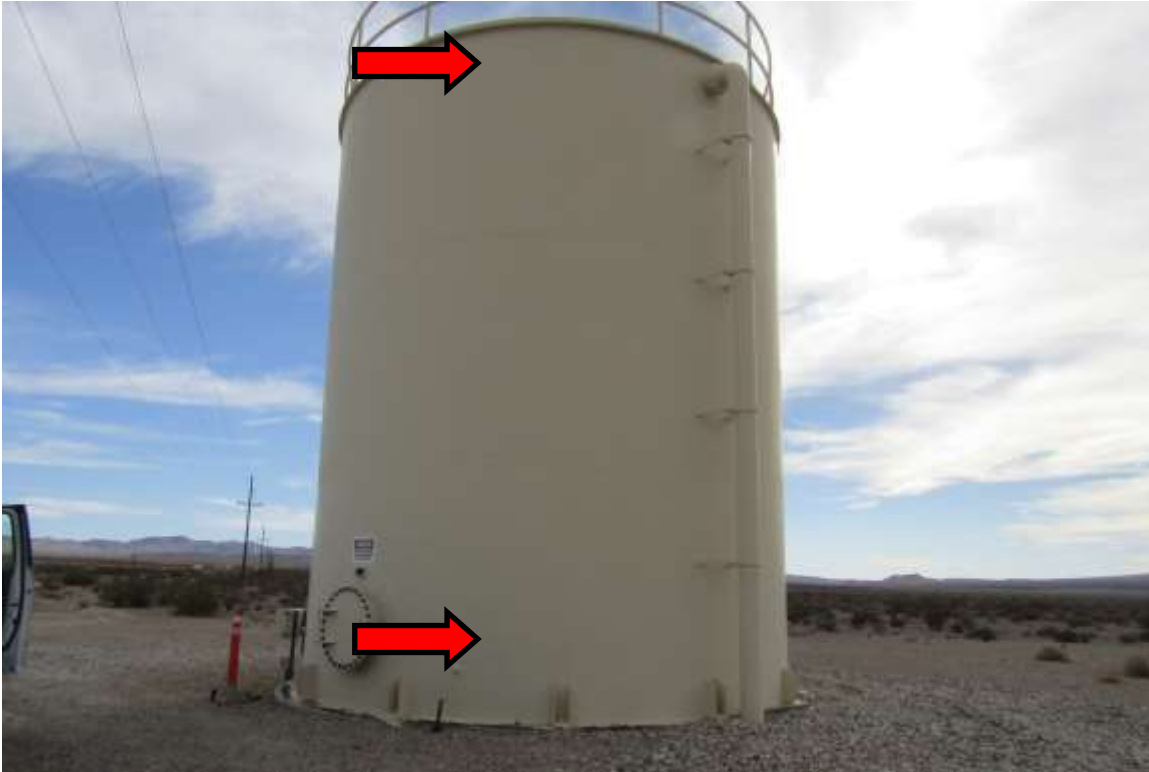
Photo shows the tank is not equipped with a liquid level indicator. We recommend installing a liquid level indicator, complete with target board and float.

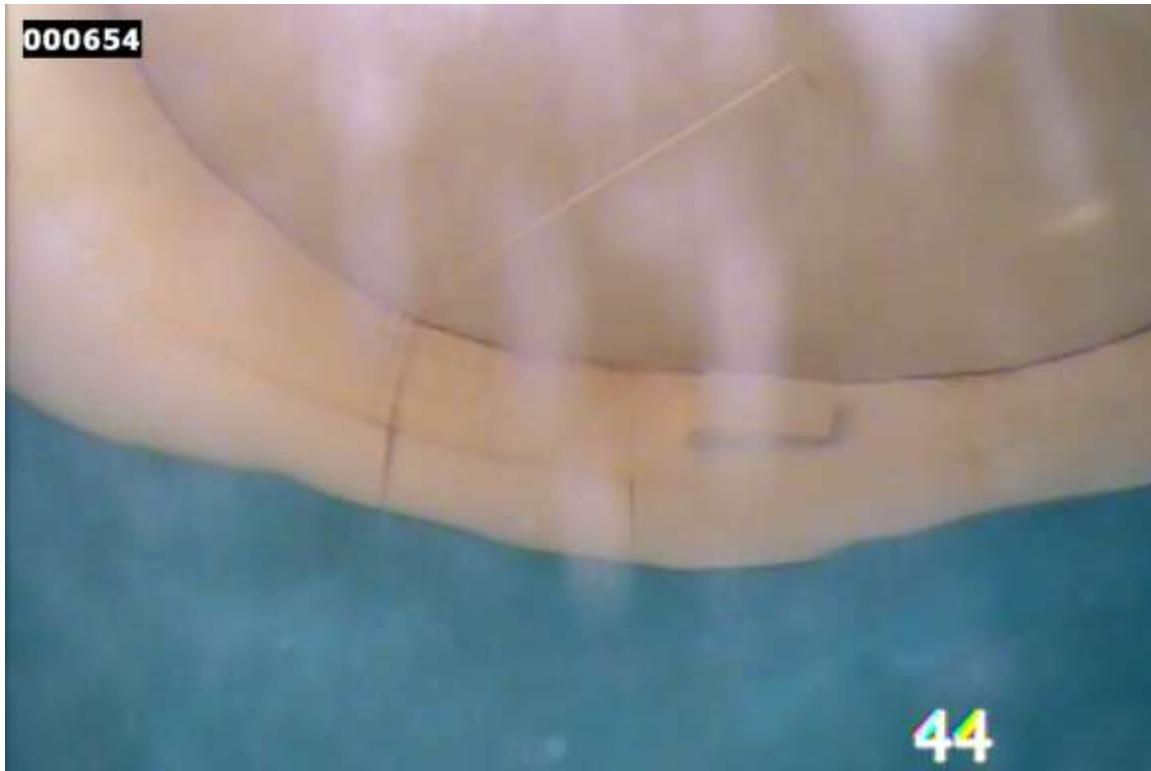
Photo shows the interior roof, which appears to be in good condition.

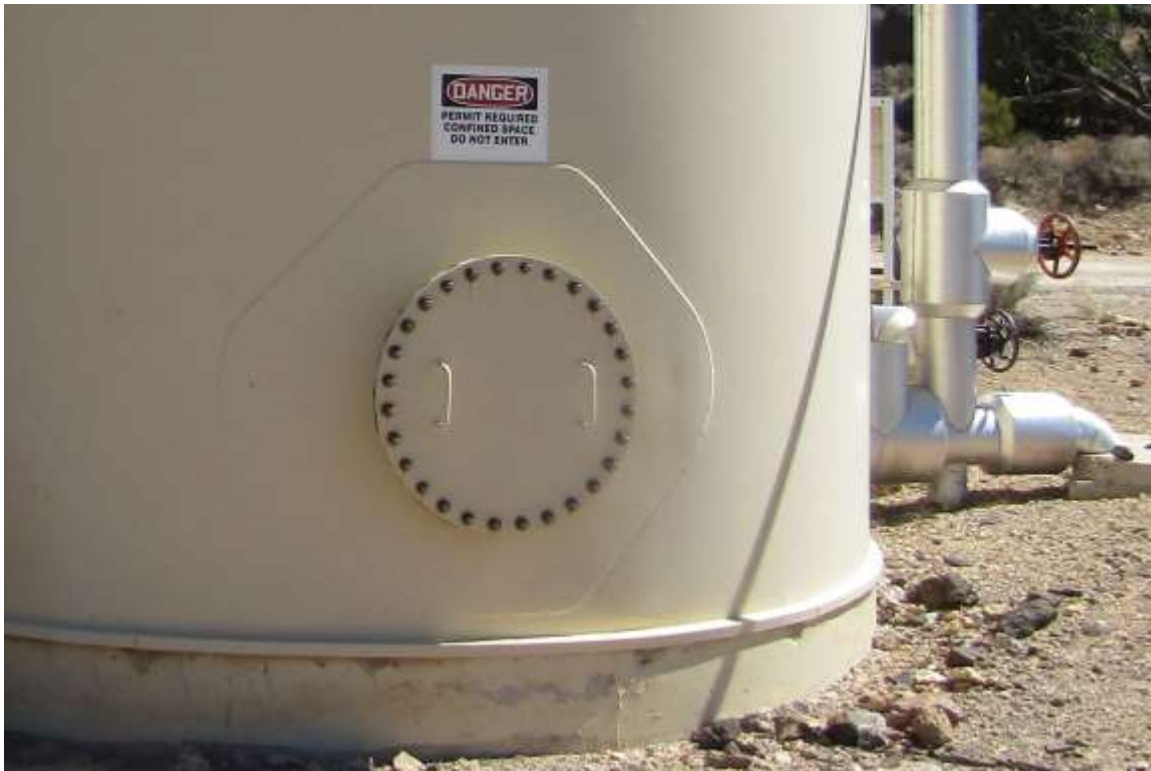
Photo shows the condition of the 24" primary shell manway. The following is required for the tank to be in compliance with **AWWA D100-11; 7.4.4 Shell manholes, NFPA 22-2018; 14.7.2.1.1 and OSHA 1910.146(c)(2) Confined spaces.**

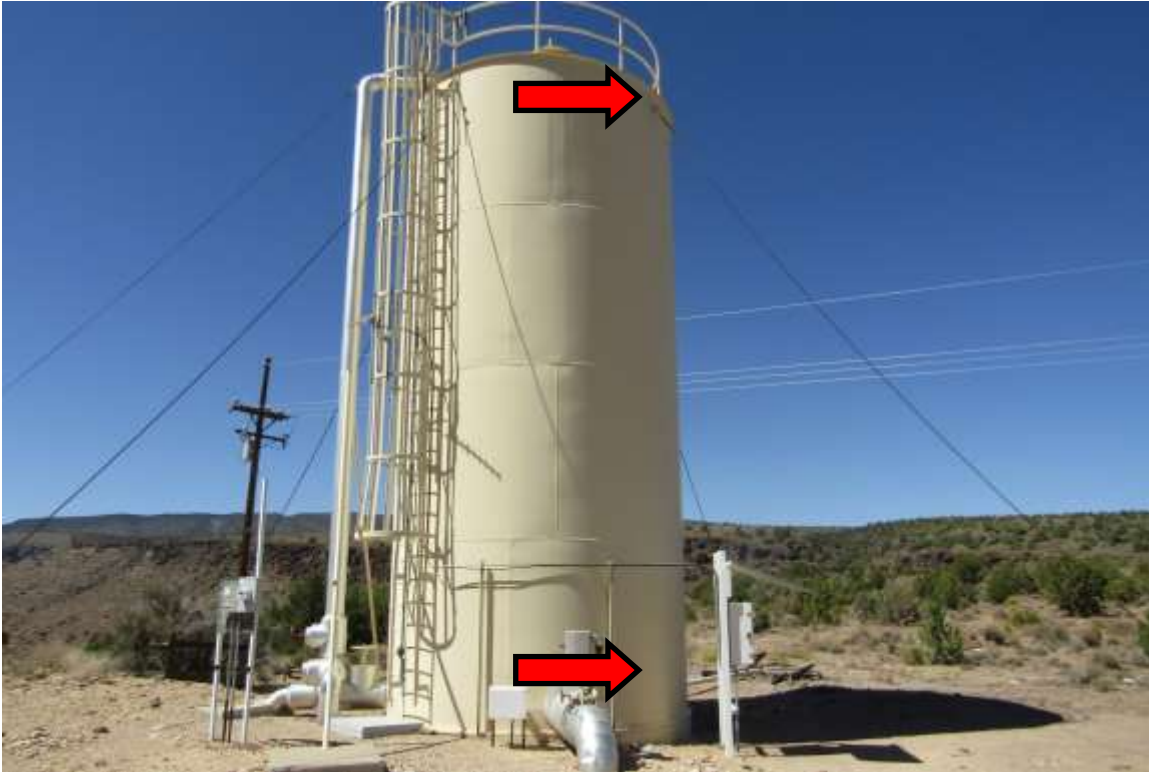
Photo shows the tank is not equipped with a liquid level indicator. **NFPA 22-2018; 14.1.8* Water-Level Gauge** states, "A water-level gauge of suitable design shall be provided. It shall be carefully installed, adjusted, and properly maintained." We recommend installing a liquid level indicator, complete with target board and float.

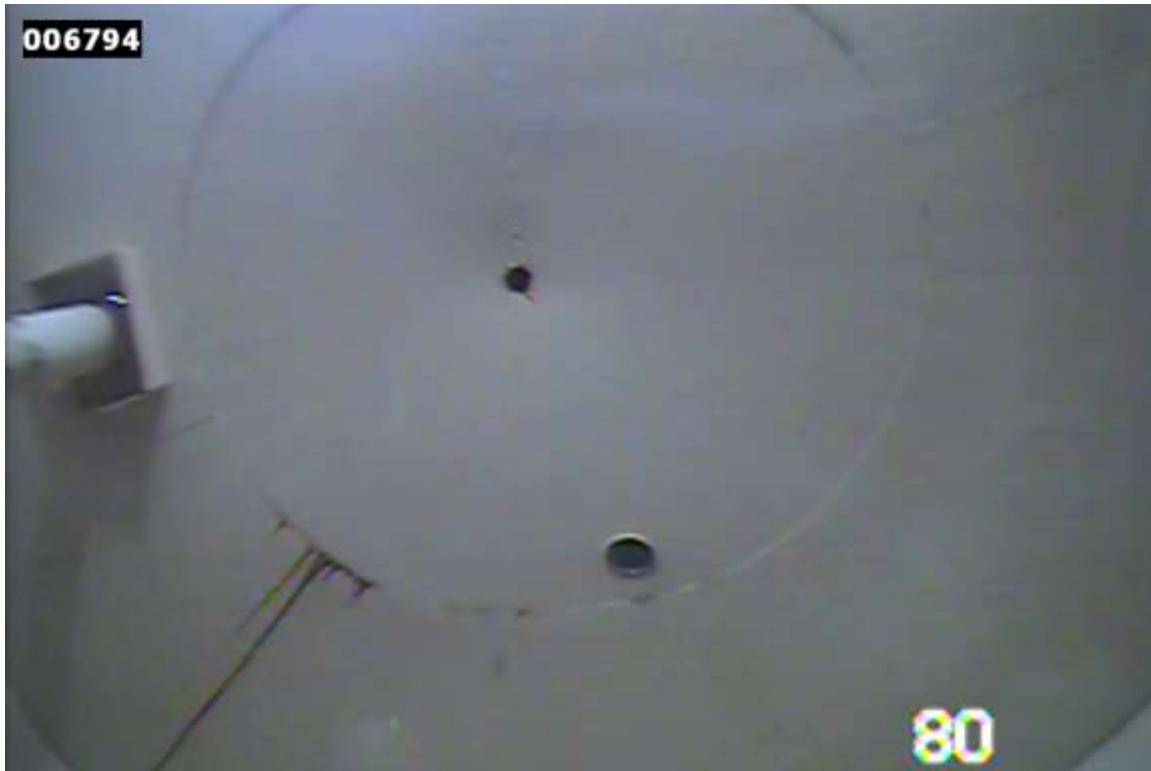
Photo shows the interior roof, which appears to be in good condition.

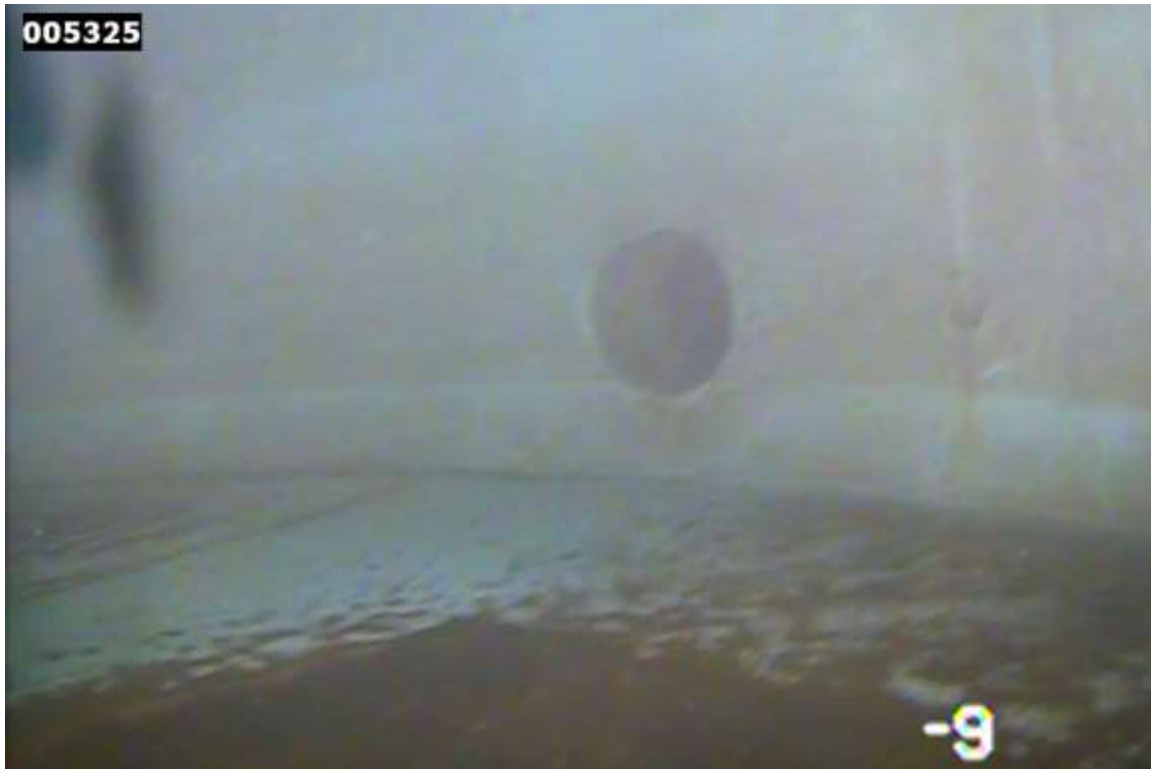
Photo shows a suction pipe on the interior of the tank. **NFPA 22-2018; 14.2.13.1** states, “ The discharge outlet for every suction tank shall be equipped with an anti-vortex plate assembly.” We recommend installing an elbow be added to the existing suction pipe in the down direction and installing a properly sized anti-vortex plate on the elbow to prevent formation of a vortex.

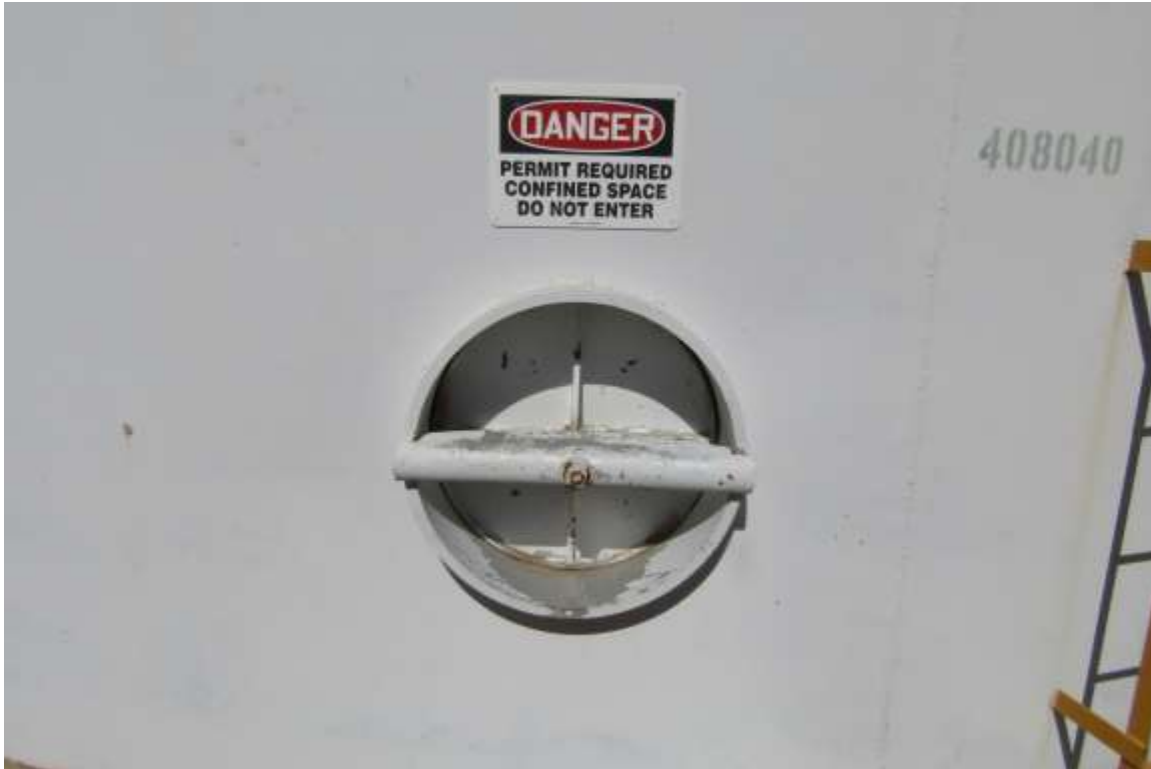
Photo shows the condition of the 24" primary shell manway. The following is required for the tank to be in compliance with **AWWA D100-11; 7.4.4 Shell man-holes** and **OSHA 1910.146(c)(2) Confined spaces**.

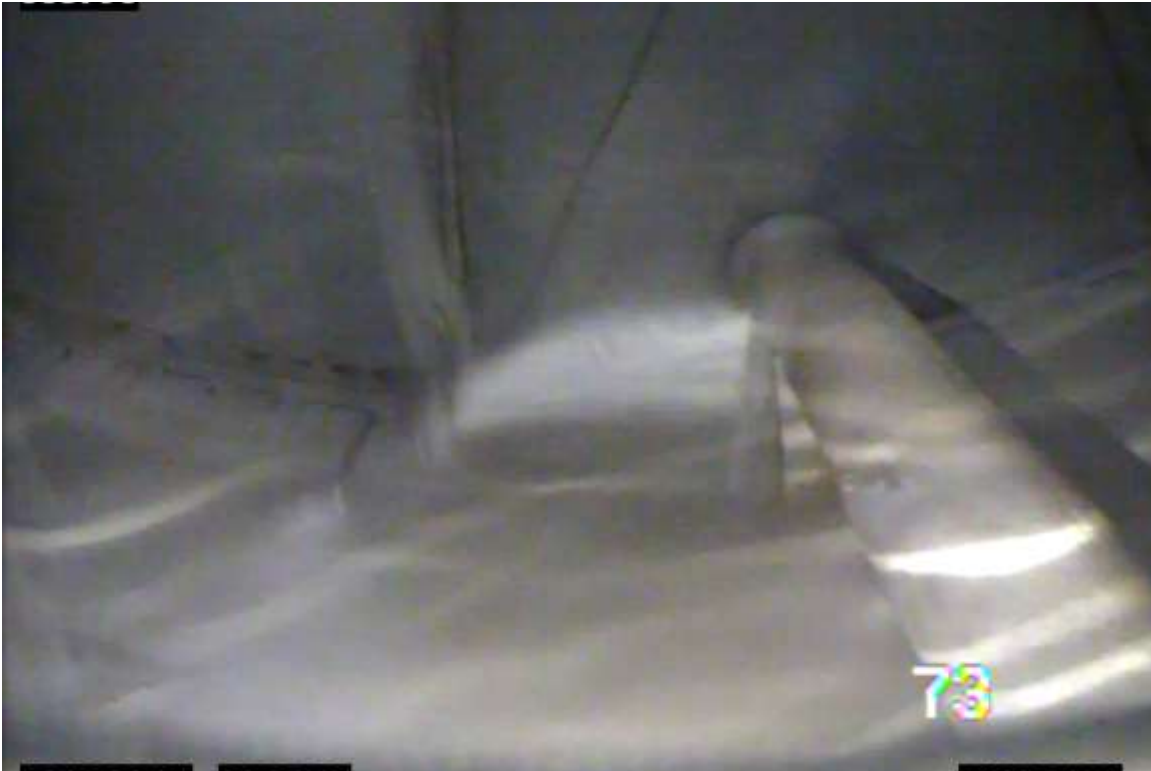
Photo shows the condition of the overflow pipe system. **AWWA D100-11; 7.3 Overflow** states, "An internal overflow is defined as an overflow with piping inside the tank container. The consequences of an overflow failure, which can empty the tank contents, shall be considered when an internal overflow is provided." We recommend replacing the internal overflow system with a properly sized exterior overflow system, which will be complete with a weir box on the interior, standoffs every 10' on center extended to grade, an elbow fitted with a flapper valve and screen to prevent the ingress of contaminants, and a splash pad to direct the water away from the tank foundation.
