**Mission Support and Test Services, LLC
Nevada National Security Site
Mercury, NV 89023
RE: Mercury North (Area 23); Mercury, NV
1,500,000 Gallon GST
September 16, 2018
Mr. Kevin Olsen
Scientist 1
(702) 295-0485
Job No. 318448-A**

**Mission Support and Test Services, LLC
Nevada National Security Site
Mercury, NV 89023
RE: Camp South (Area 12); Mercury, NV
500,000 Gallon GST
September 13, 2018
Mr. Kevin Olsen
Scientist 1
(702) 295-0485
Job No. 318448-D**

**Mission Support and Test Services, LLC
Nevada National Security Site
Mercury, NV 89023
RE: Well 4/4a South (Area 6); Mercury, NV
150,000 Gallon GST
September 24, 2018
Mr. Kevin Olsen
Scientist 1
(702) 295-0485
Job No. 318448-H**

**Mission Support and Test Services, LLC
Nevada National Security Site
Mercury, NV 89023
RE: C-1 North (Area 6); Mercury, NV
50,000 Gallon GST
September 21, 2018
Mr. Kevin Olsen
Scientist 1
(702) 295-0485
Job No. 318448-O**

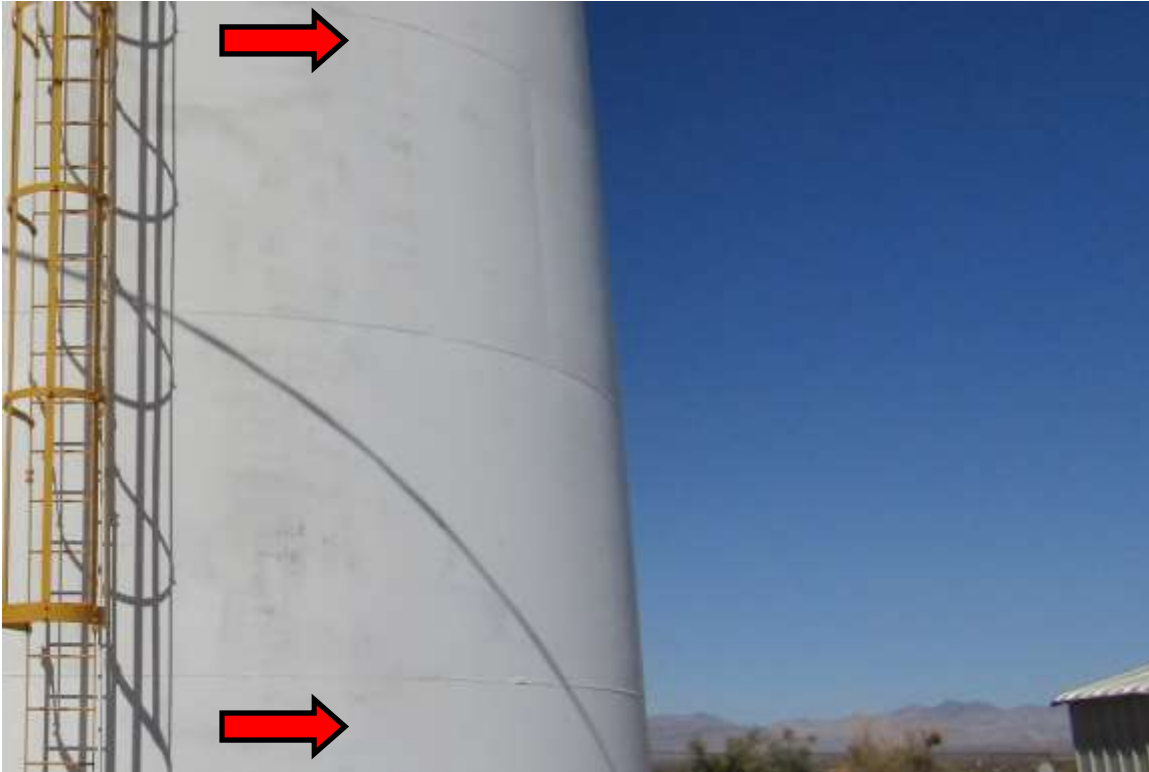
Photo shows the tank is not equipped with a liquid level indicator. We recommend installing a liquid level indicator, complete with target board and float.

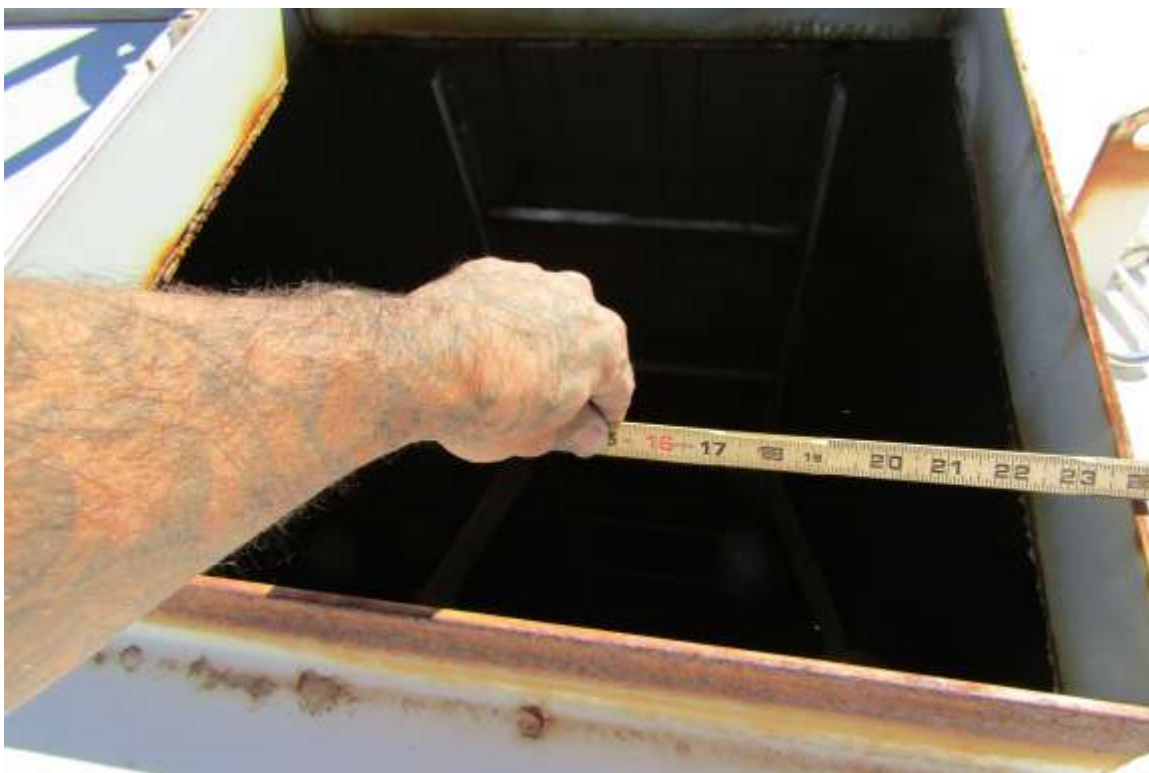
Photo shows the condition of the 24" primary roof hatch. Roof openings on this tank require the following to be in compliance with **AWWA D100-11; 7.4.3 Roof openings** and **OSHA 1910.146(c)(2) Confined spaces**.

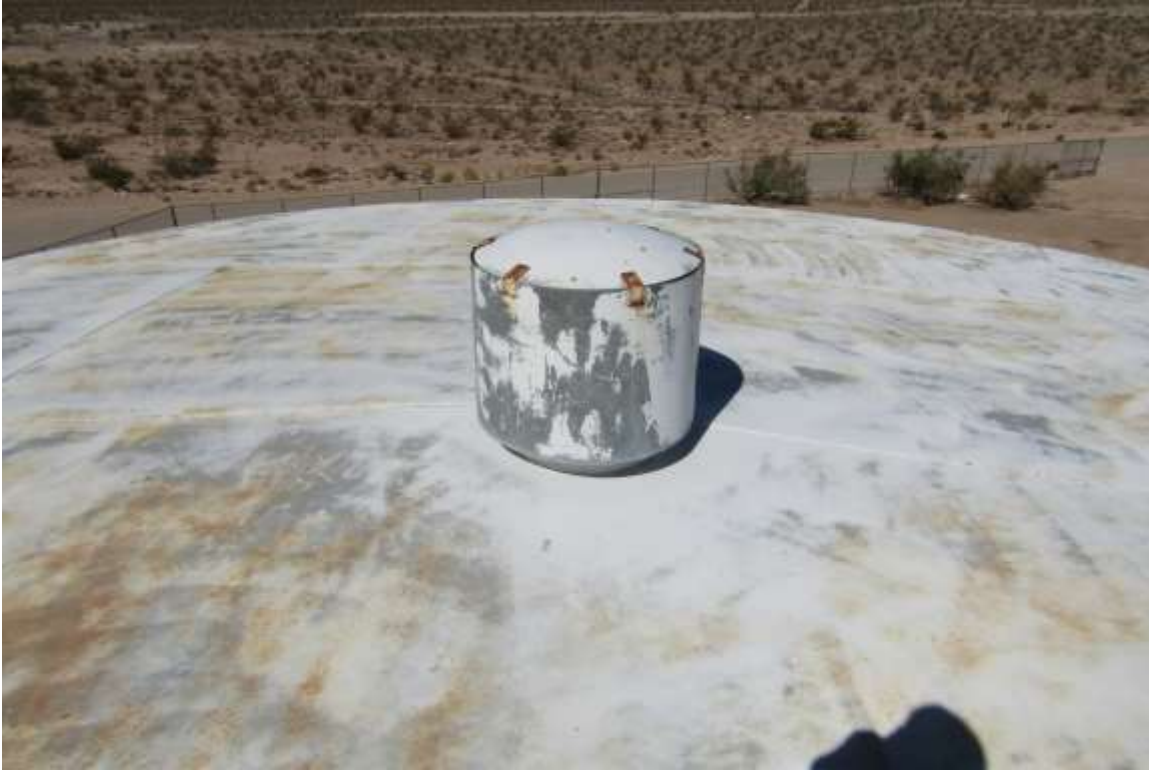
Photo shows the condition of the existing 18" roof vent. **This vent is allowing the ingress of rain and wind-borne contaminants into the water system. An improperly vented tank may cause external pressure to act on the tank which can cause buckling even at low pressure differential.** We recommend replacing the existing roof vent with a vacuum-pressure, frost proof vent and screen.

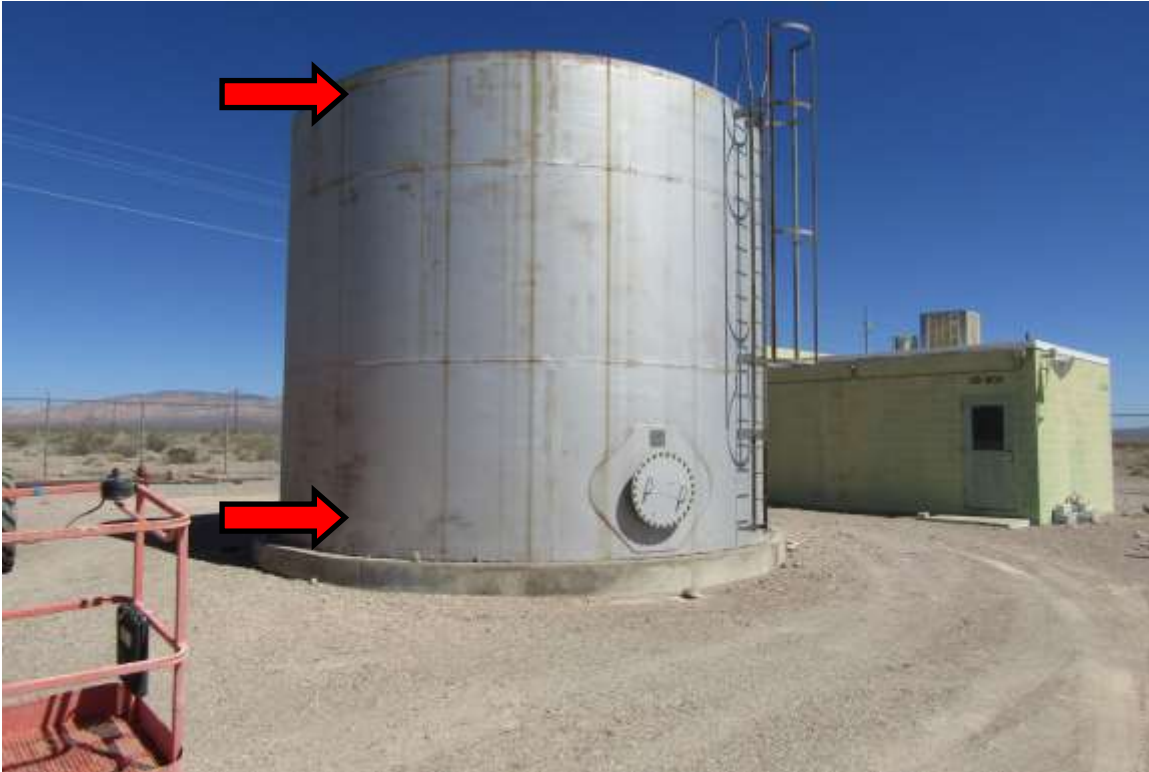
Photo shows the tank is not equipped with a liquid level indicator. We recommend installing a liquid level indicator, complete with target board and float.
