Runaway Train

Introduction

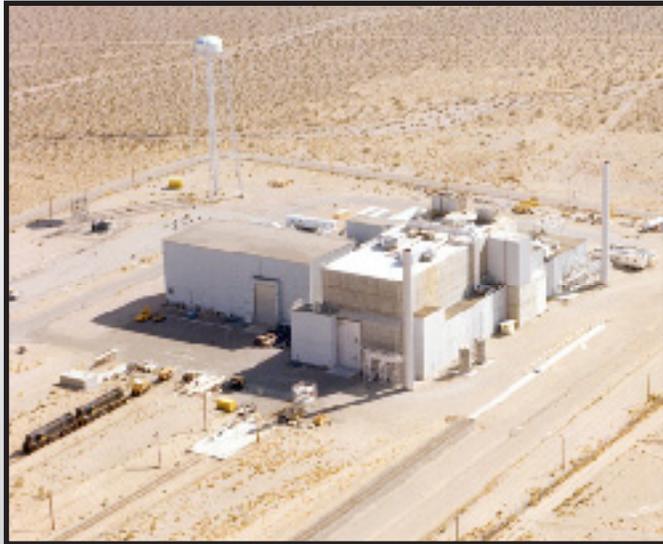
The Jackass & Western Railroad (lower left) at the Engine-Maintenance Assembly Disassembly facility.
