**Mission Support and Test Services, LLC
Nevada National Security Site
Mercury, NV 89023
RE: Mercury North (Area 23); Mercury, NV
1,500,000 Gallon GST
September 16, 2018
Mr. Kevin Olsen
Scientist 1
(702) 295-0485
Job No. 318448-A**

**Mission Support and Test Services, LLC
Nevada National Security Site
Mercury, NV 89023
RE: Camp South (Area 12); Mercury, NV
500,000 Gallon GST
September 13, 2018
Mr. Kevin Olsen
Scientist 1
(702) 295-0485
Job No. 318448-D**

**Mission Support and Test Services, LLC
Nevada National Security Site
Mercury, NV 89023
RE: Well 4/4a South (Area 6); Mercury, NV
150,000 Gallon GST
September 24, 2018
Mr. Kevin Olsen
Scientist 1
(702) 295-0485
Job No. 318448-H**

**Mission Support and Test Services, LLC
Nevada National Security Site
Mercury, NV 89023
RE: C-1 North (Area 6); Mercury, NV
50,000 Gallon GST
September 21, 2018
Mr. Kevin Olsen
Scientist 1
(702) 295-0485
Job No. 318448-O**

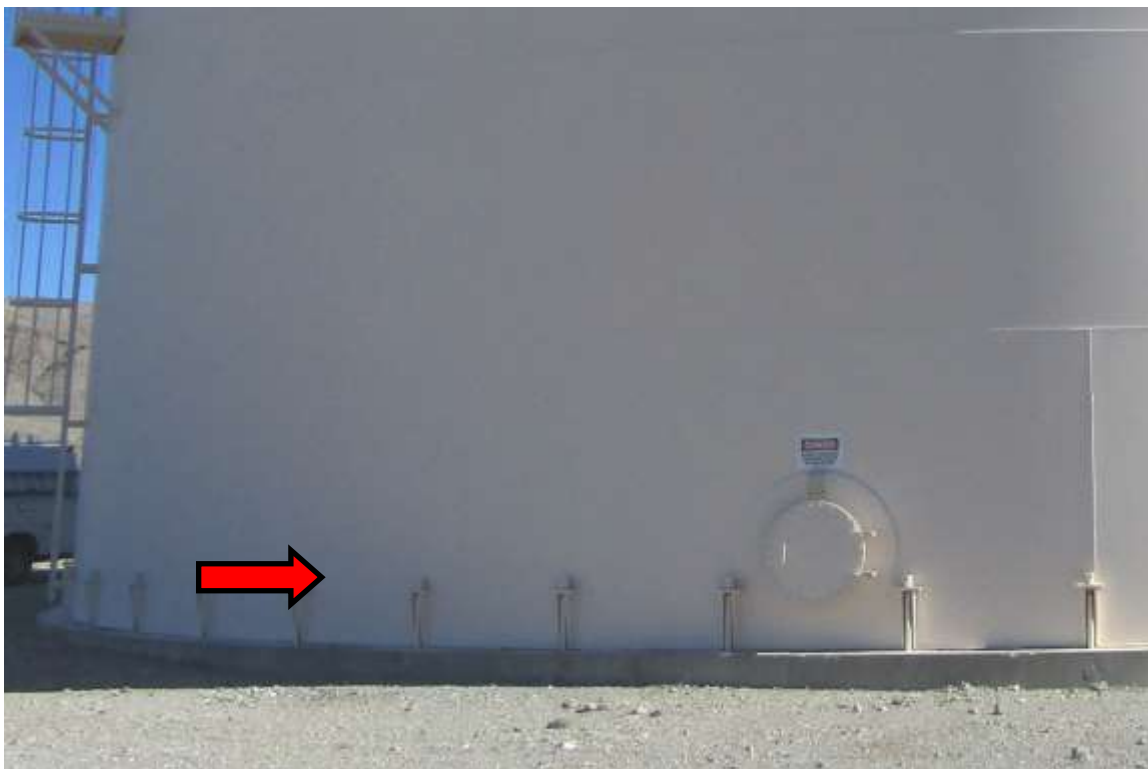
Photo shows the condition of the shell. Currently there is no drain valve. We recommend installing a frost proof drain valve near the shell-to-floor connection, complete with a locking device to prevent unauthorized draining of the tank and a splash pad to direct water away from the foundation.

**Splash pad to be installed by owner.*

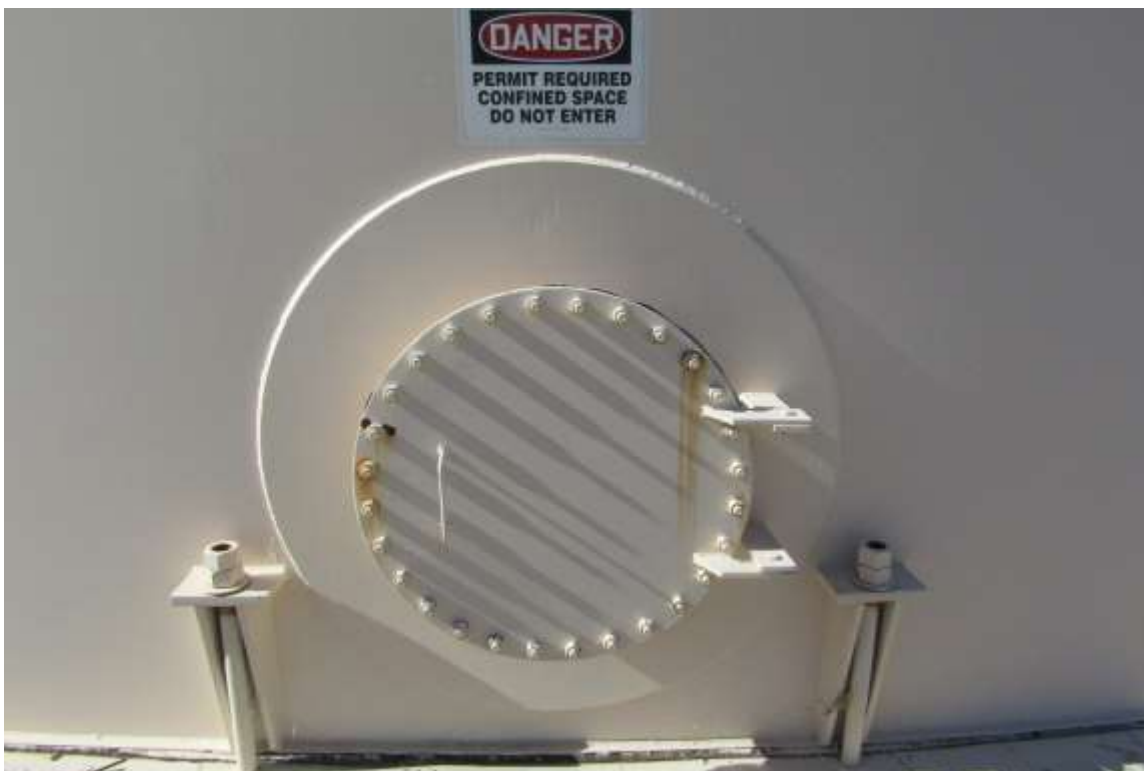
Photo shows the condition of the 24" primary shell manway. The following is required for the tank to be in compliance with **AWWA D100-11; 7.4.4 Shell manholes, NFPA 22-2018; 14.7.2.1.1, NFPA 22-2018; 14.7.2.1.1 and OSHA 1910.146(c)(2) Confined spaces.**

We recommend:

Replace 24" manway with 30" manway
Post **Confined Space Entry** sign
Install maintenance free galvanized steel bolts

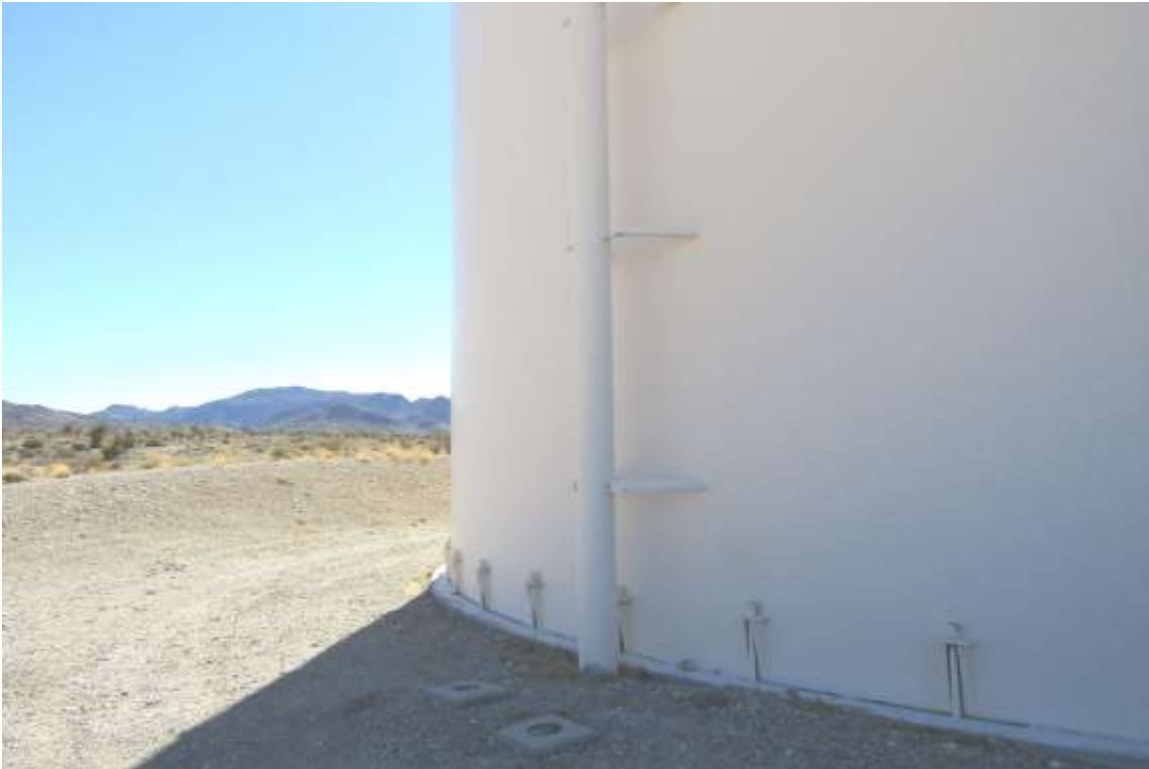
Photo shows the 12" overflow pipe system, which appears to be in good condition.

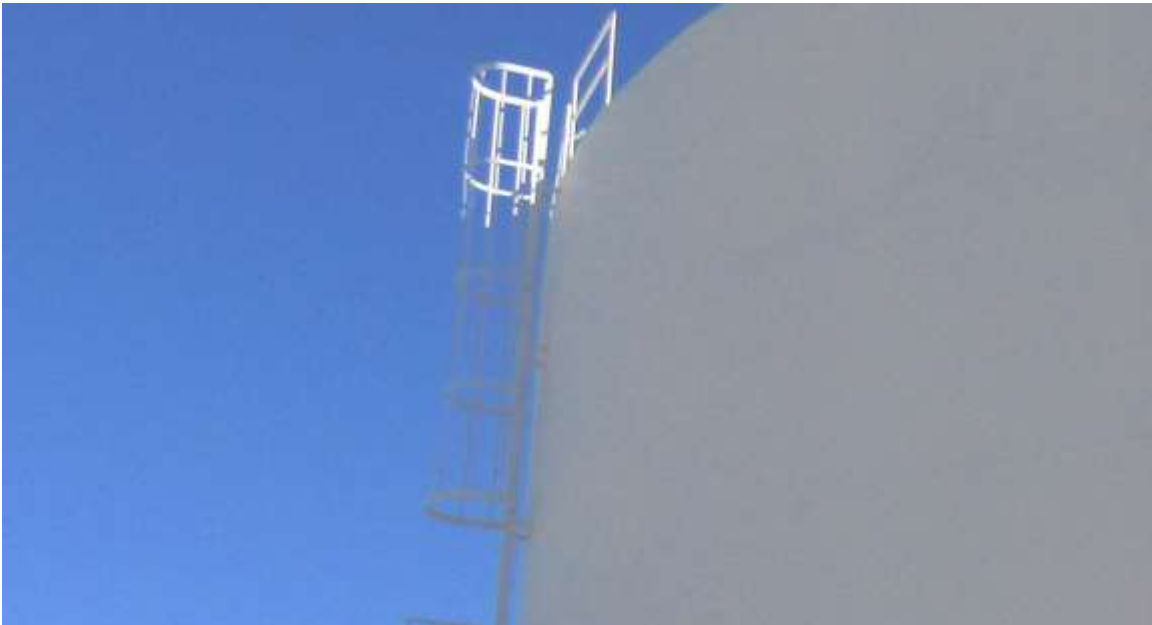
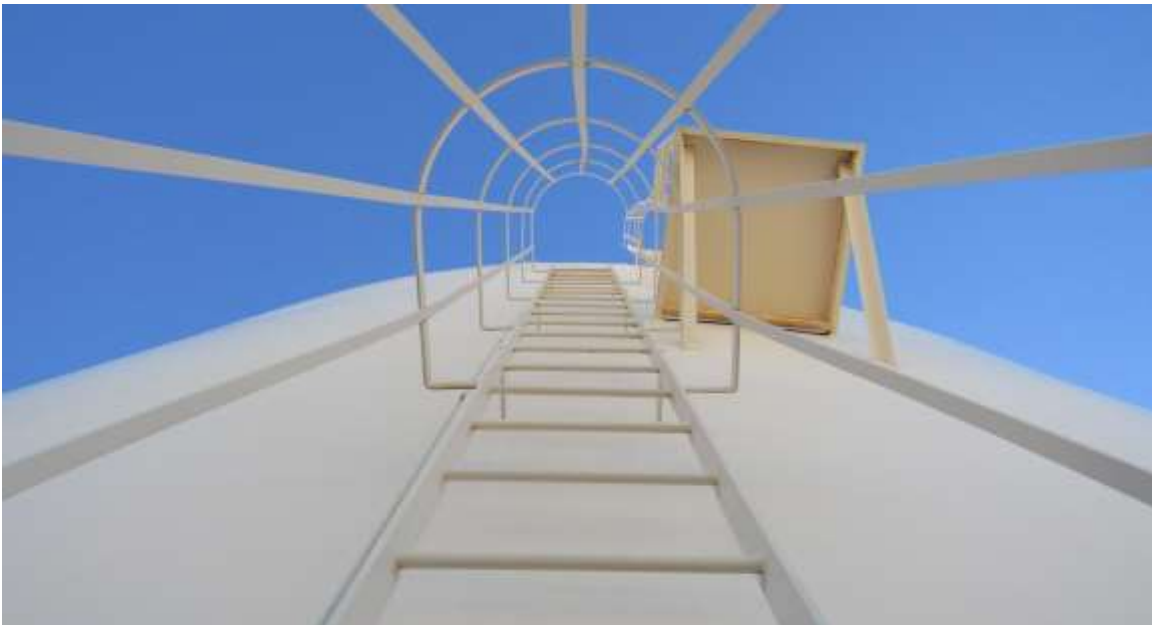
Shell access ladders in above photos are 16" wide, but are not equipped with anti-skid rungs. We recommend installing anti-skid rung covers, cable type ladder safety devices, a lockable ladder guard to prevent unauthorized access, and posting a **Fall Protection Required** sign at the base of the ladder.

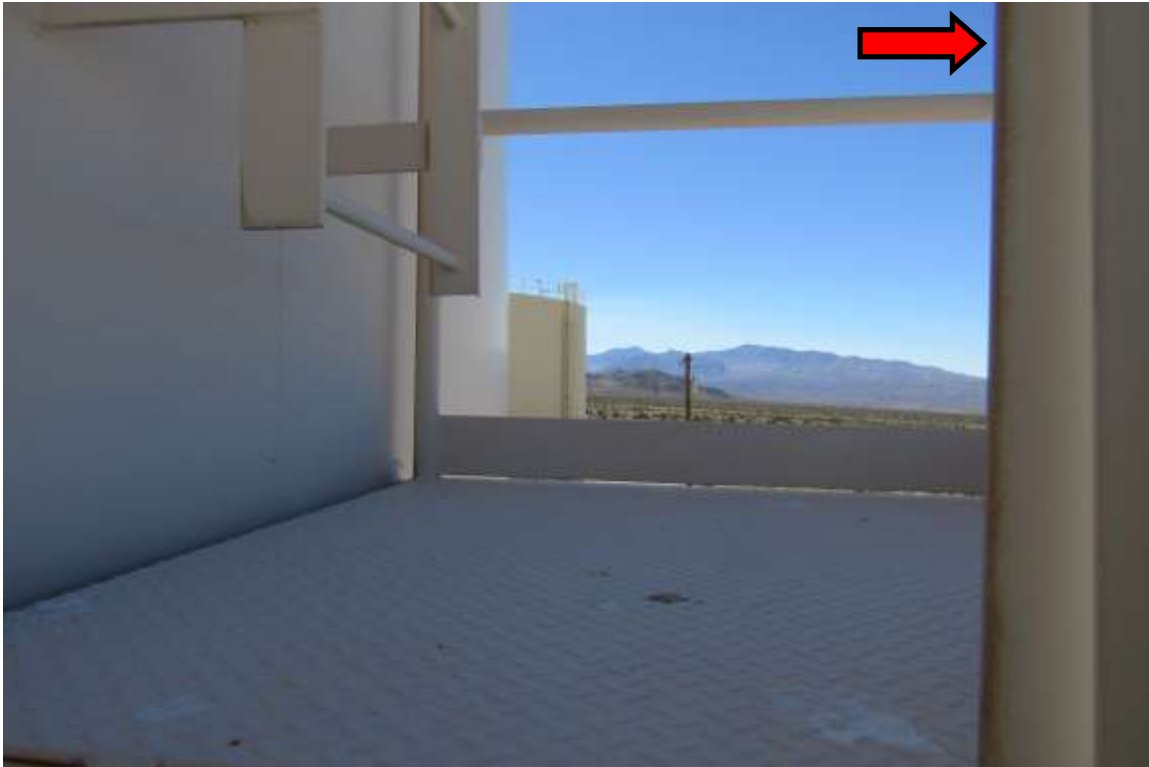
Photo shows the condition of the shell access standoff platform, which is equipped with an anti-skid floor and a 43" high **OSHA** compliant handrail system, complete with an intermediate rail and toeboard. We recommend installing a swing gate at the access standoff platform.

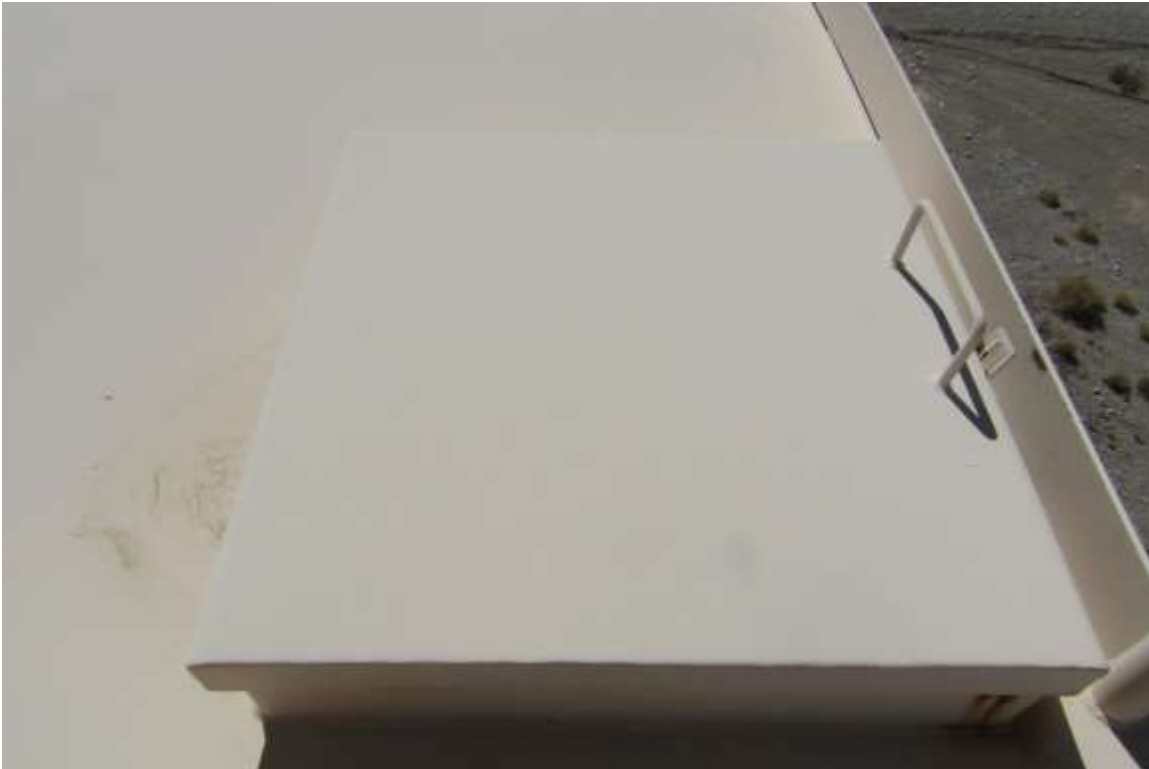
Photo shows the condition of the 24" primary roof hatch. Roof openings on this tank require the following to be in compliance with **AWWA D100-11; 7.4.3 Roof openings** and **OSHA 1910.146(c)(2) Confined spaces**.

We recommend:

Post **Confined Space Entry** sign

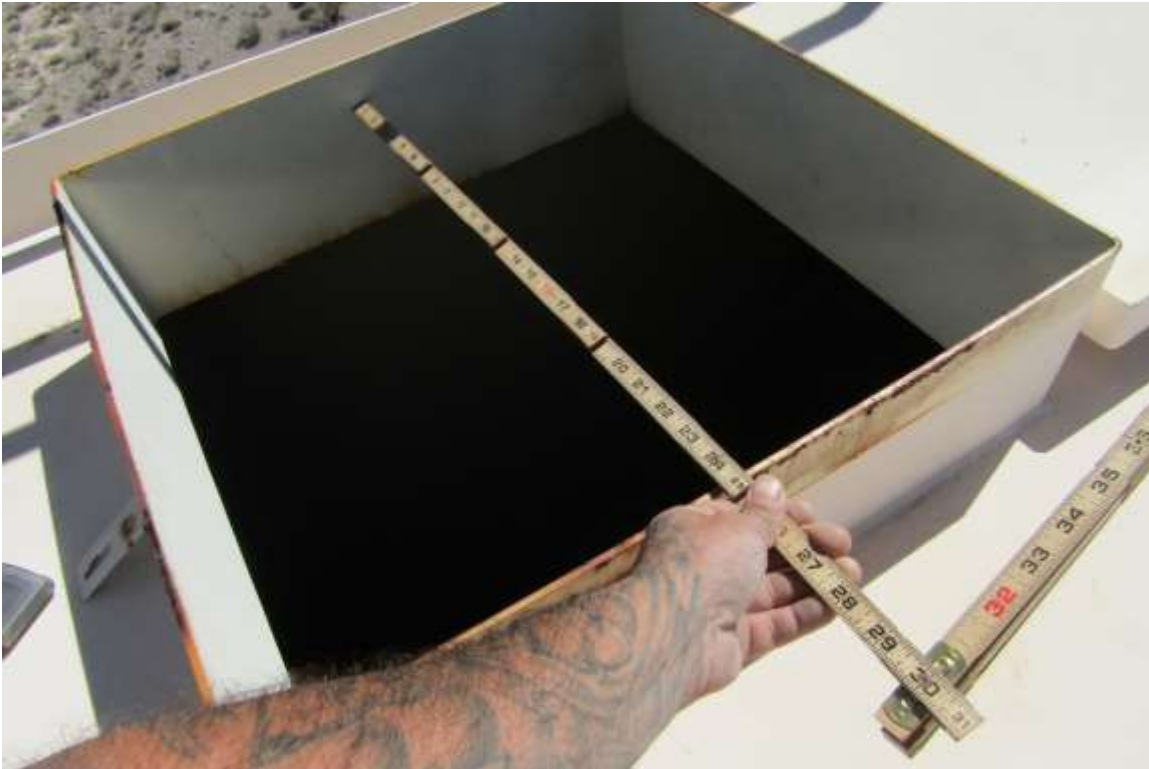
Photo shows the condition of the 24" secondary roof hatch. Roof openings on this tank require the following to be in compliance with **AWWA D100-11; 7.4.3 Roof openings** and **OSHA 1910.146(c)(2) Confined spaces**.

We recommend:

We further recommend installing an **OSHA** compliant interior access ladder complete with standoffs every 10' on center, and a cable type ladder safety device at the secondary roof hatch.

**In cold climates it's up to the owner's discretion on placement of internal ladders.*

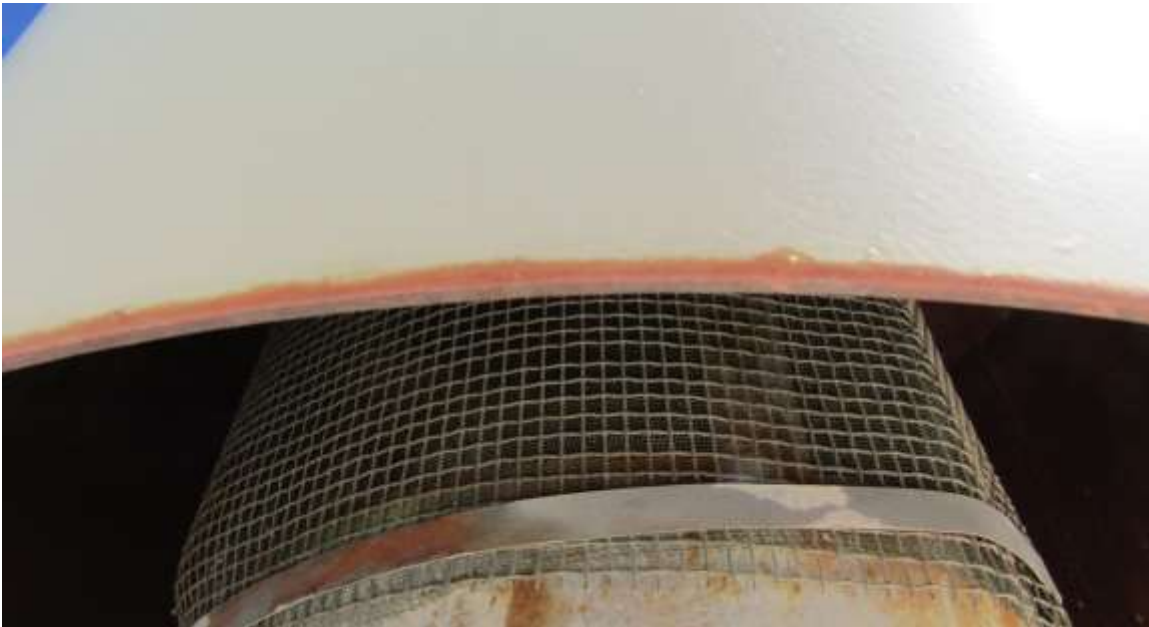
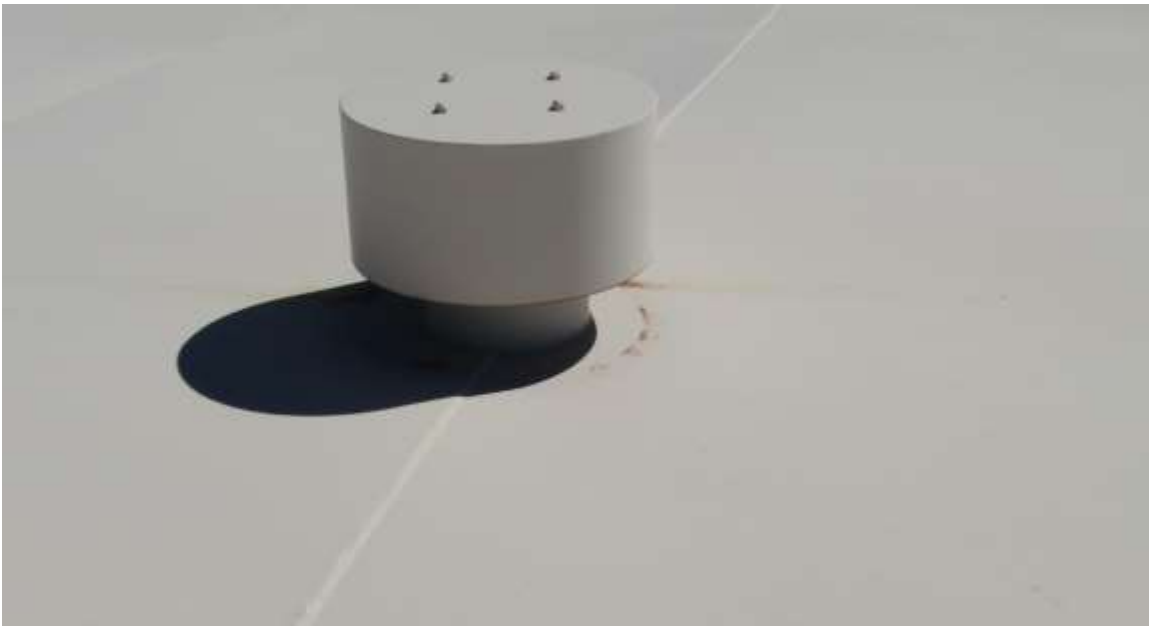
Photos show the existing 12" roof vent, which appears to be in good condition.

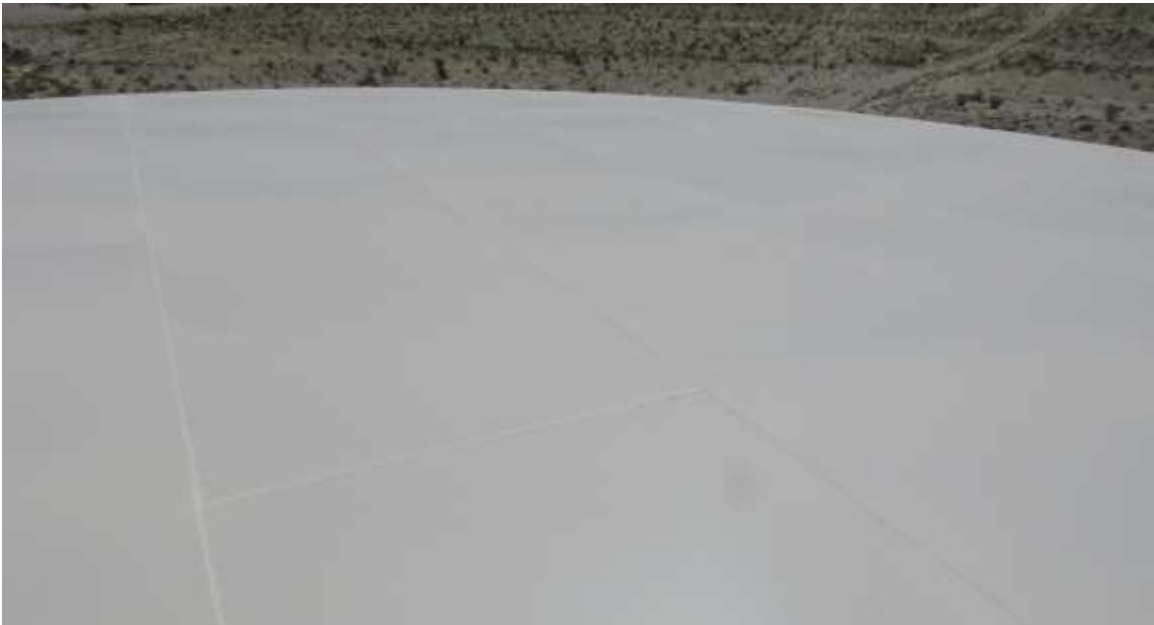
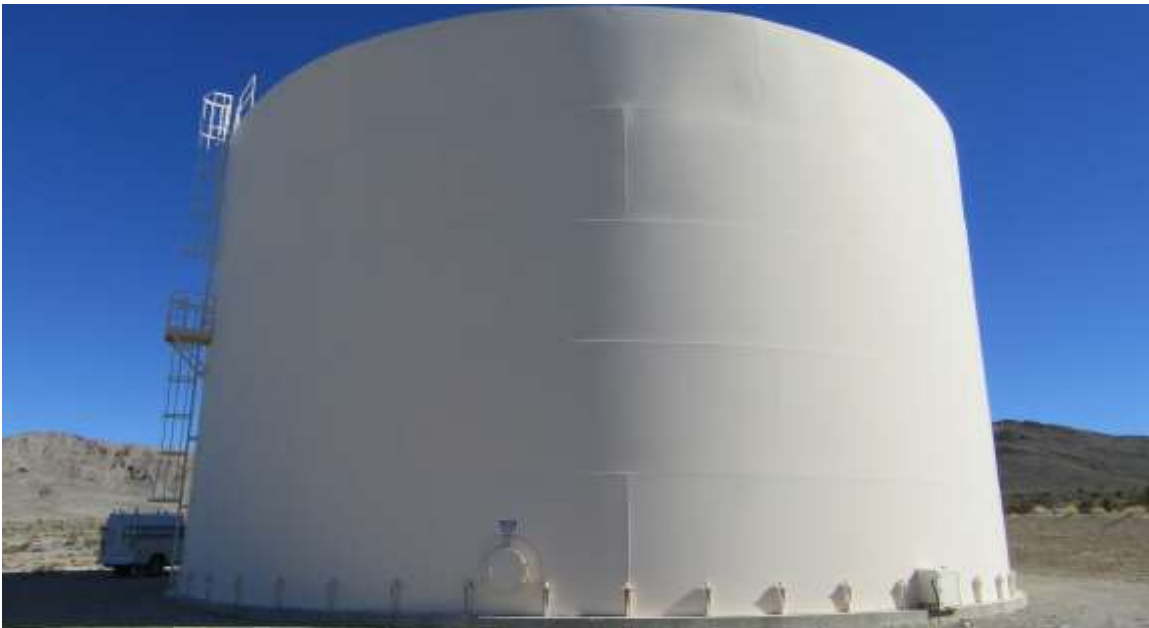
Photos show the tank exterior coating system. The overall exterior coating system appears to be in good condition. We recommend re-evaluating the tank exterior at next inspection cycle.

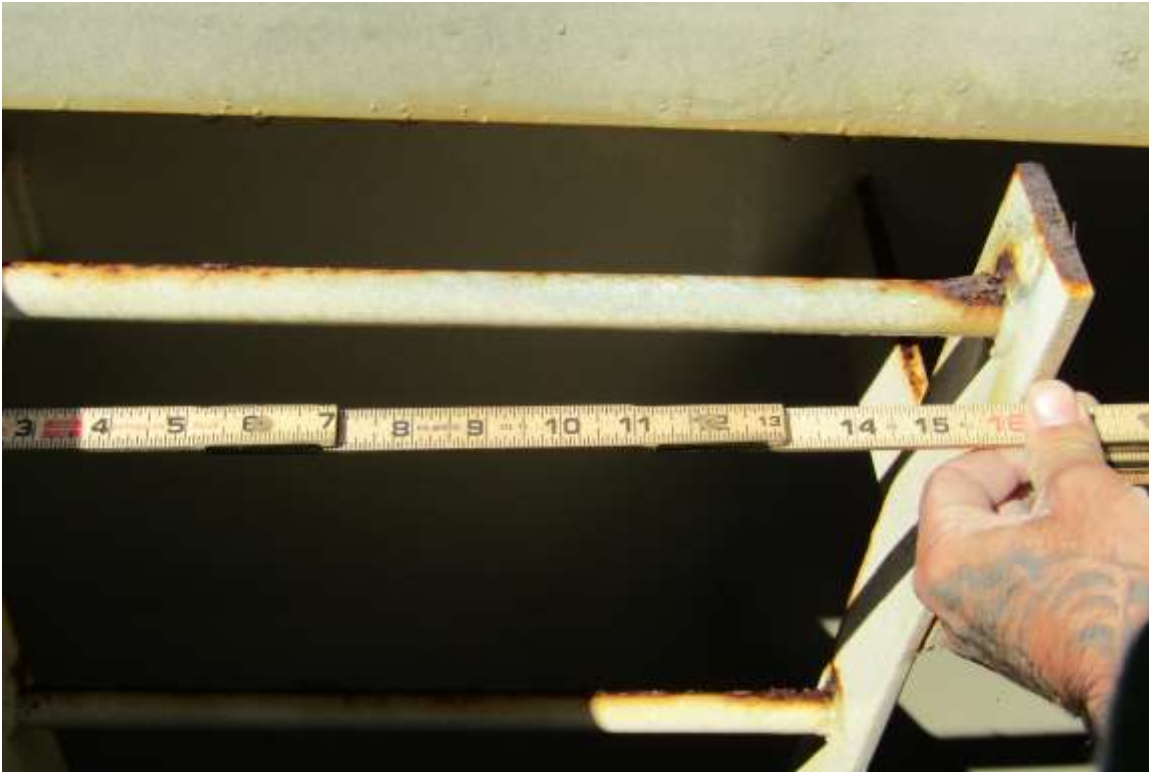
Primary interior access ladder in above photo is 16" wide, but is not equipped with anti-skid rungs. We recommend installing anti-skid rung covers and a cable type ladder safety device on the primary interior access ladder.

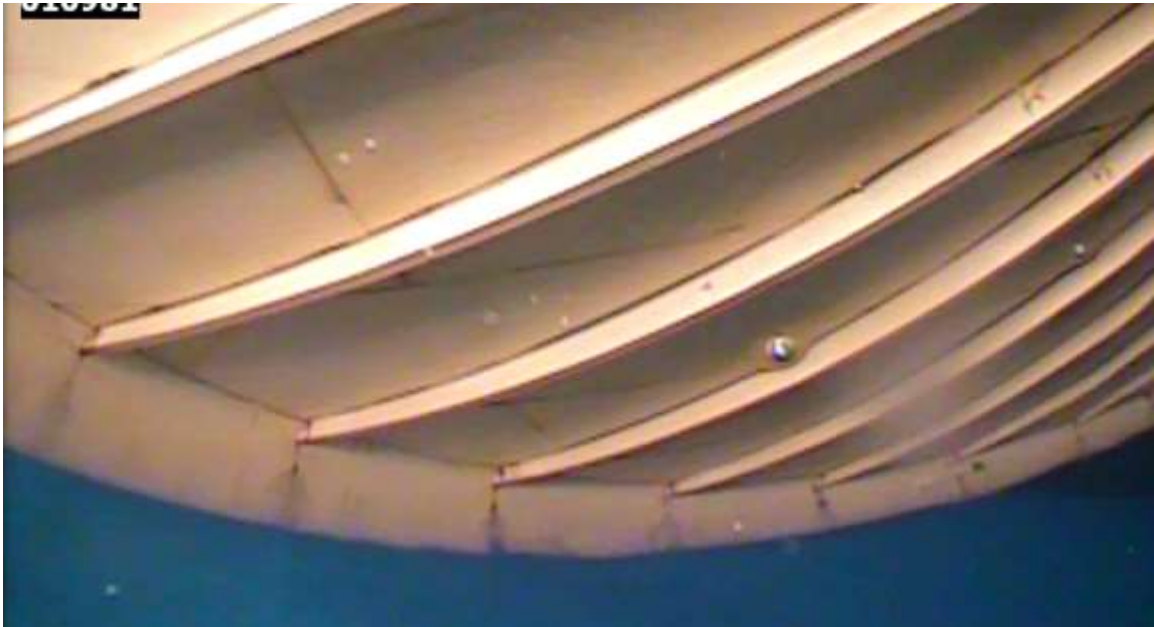
Top photo shows the interior roof lap seams, which appear to be in good condition.

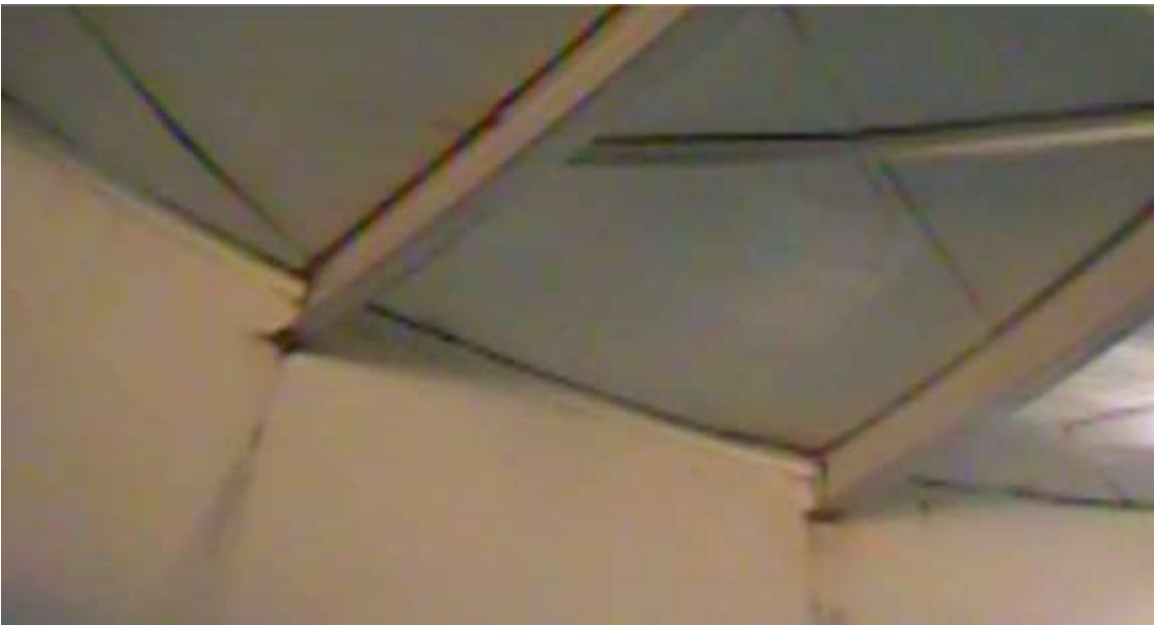
Bottom photo shows the interior roof-to-rim angle connection, which appears to be in good condition.

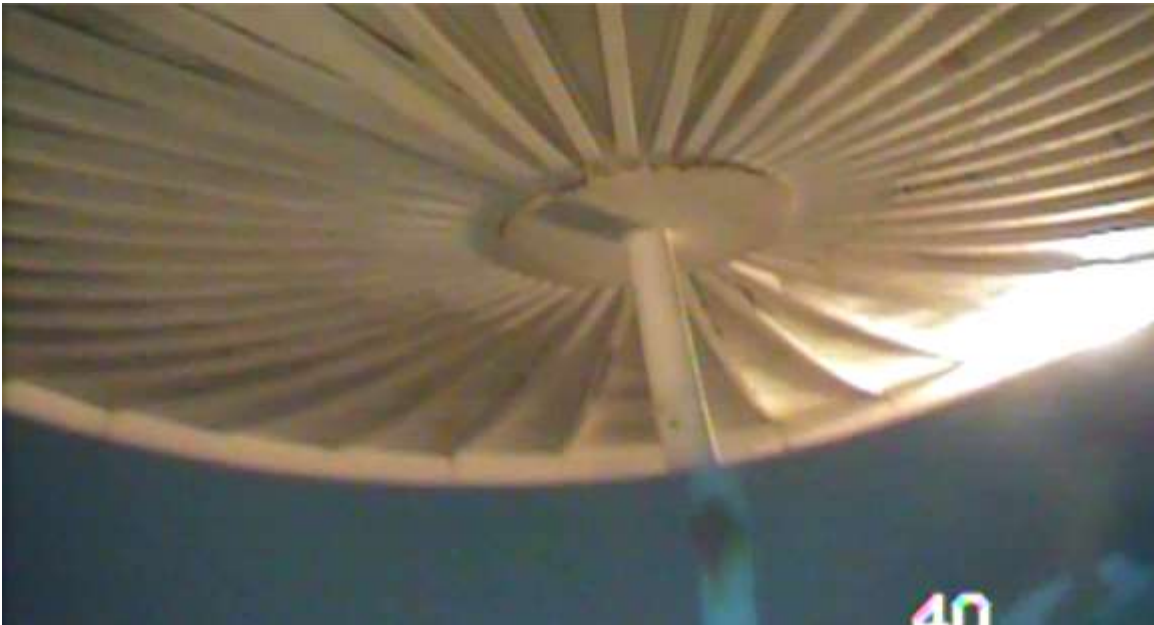
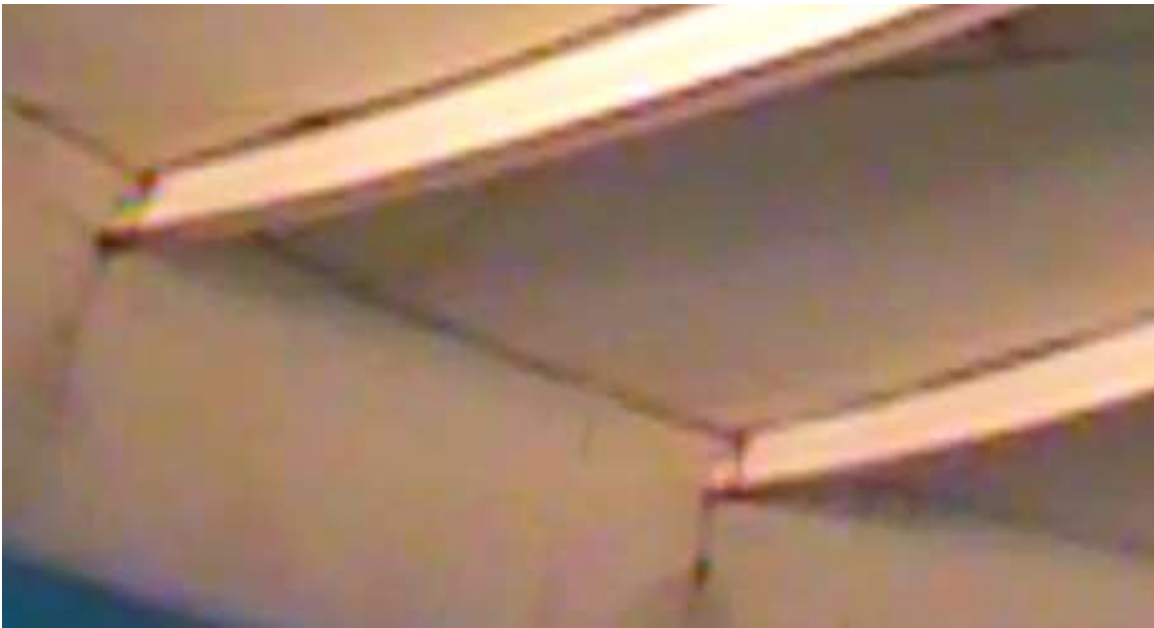
Photos show the rafter-to-support column and rafter-to-shell connections, which appear to be in good condition.

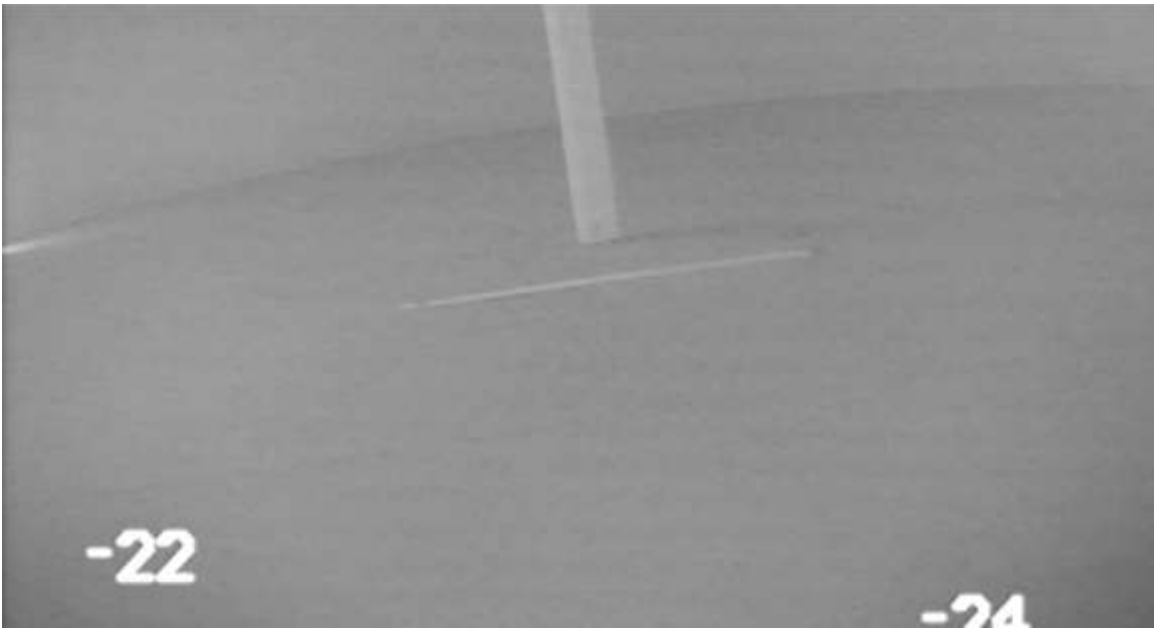
Bottom photo shows the support column baseplate-to-floor connection, which appears to be in good condition.

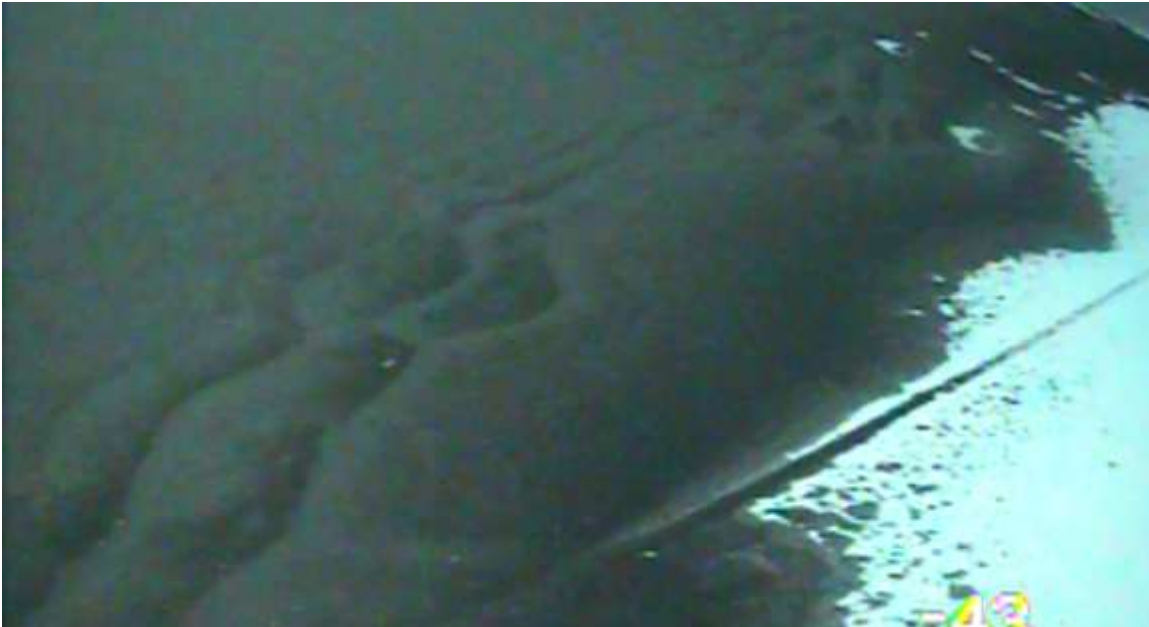
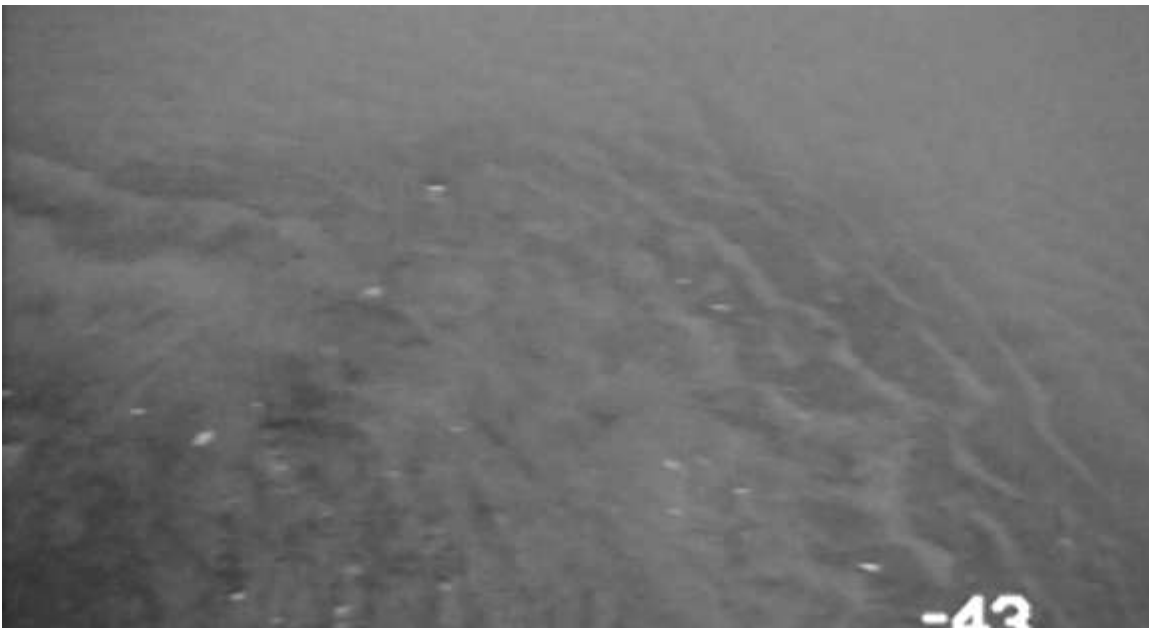
Photos show sediment and debris on the tank interior before a cleanout was performed.

We recommend installing a passive cathodic protection system.

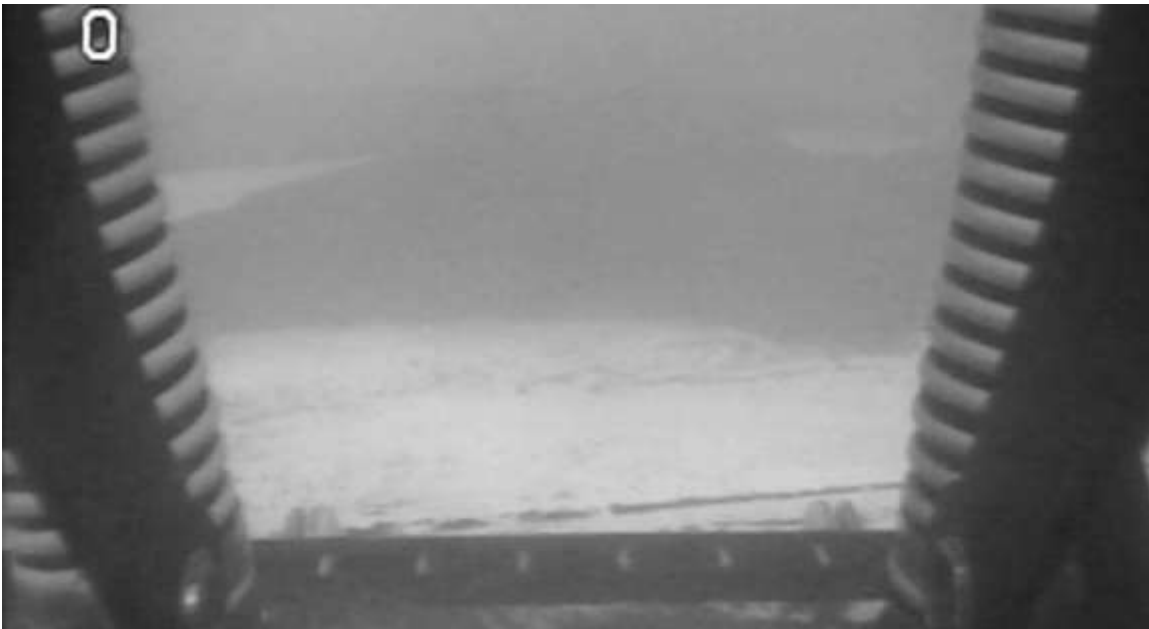
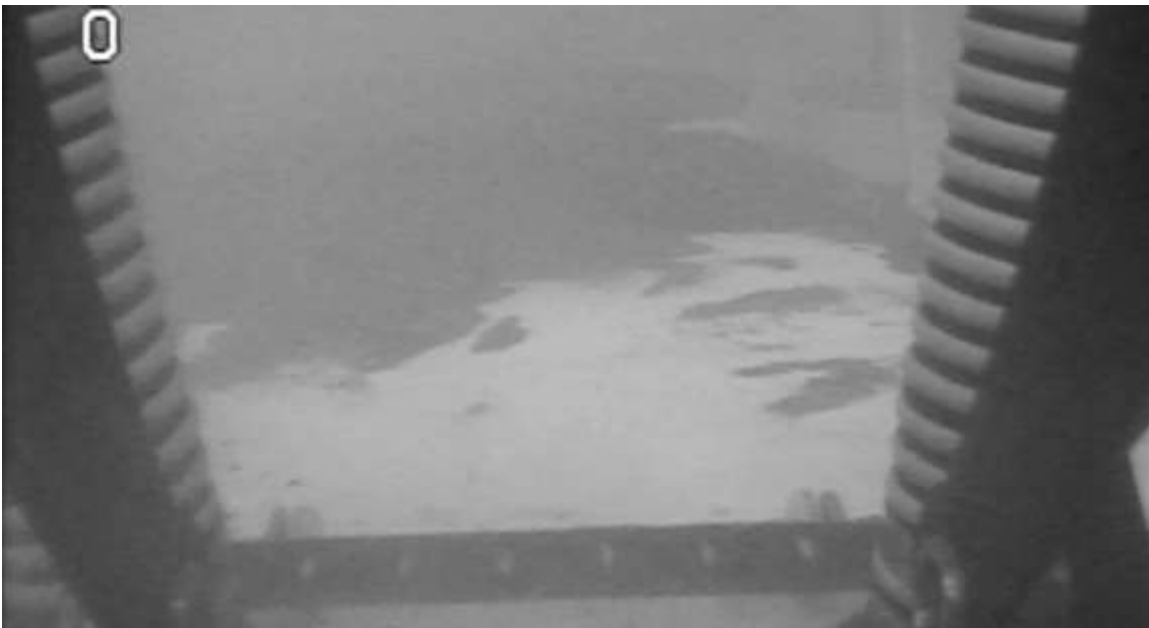
Photos show the tank interior during a cleanout.

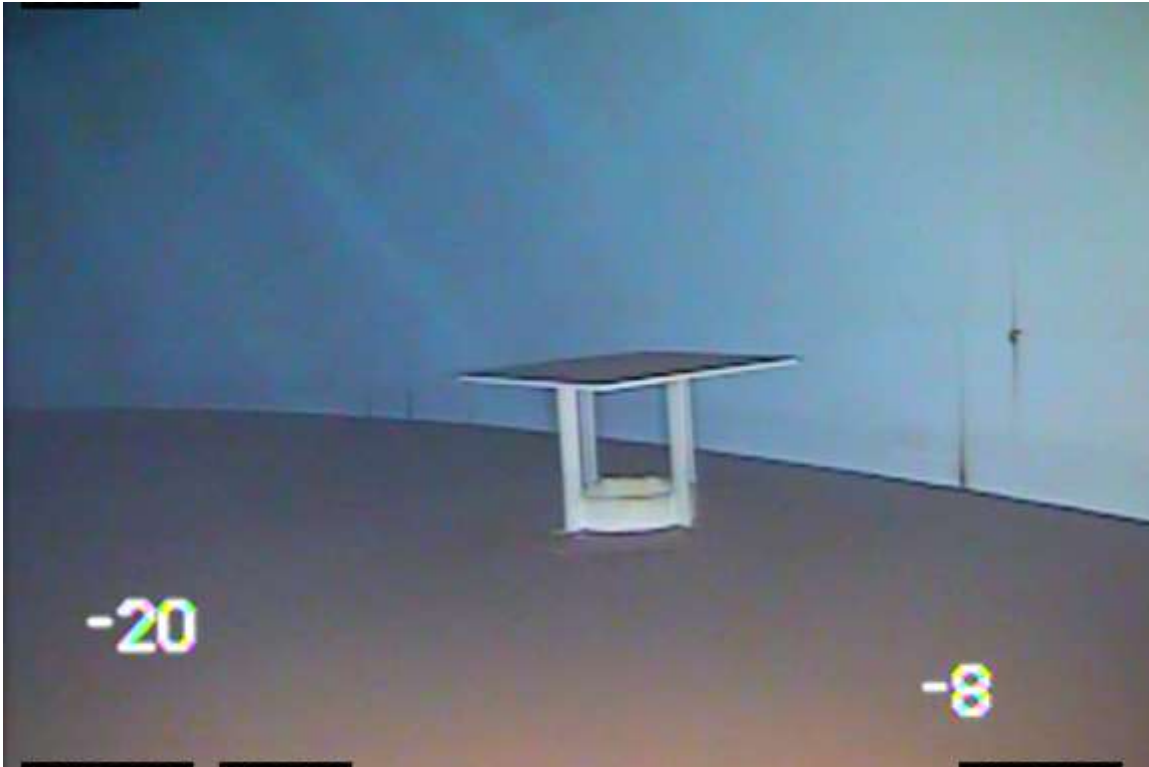
Photo shows a suction pipe on the interior of the tank, which is equipped with a properly sized anti-vortex plate to prevent formation of a vortex.

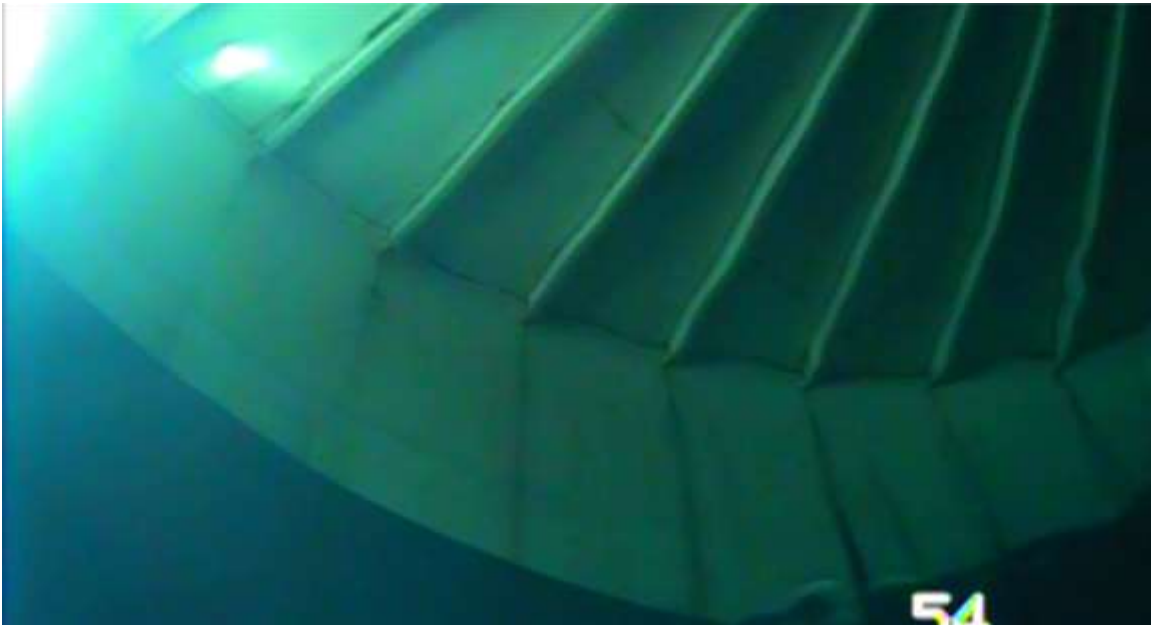
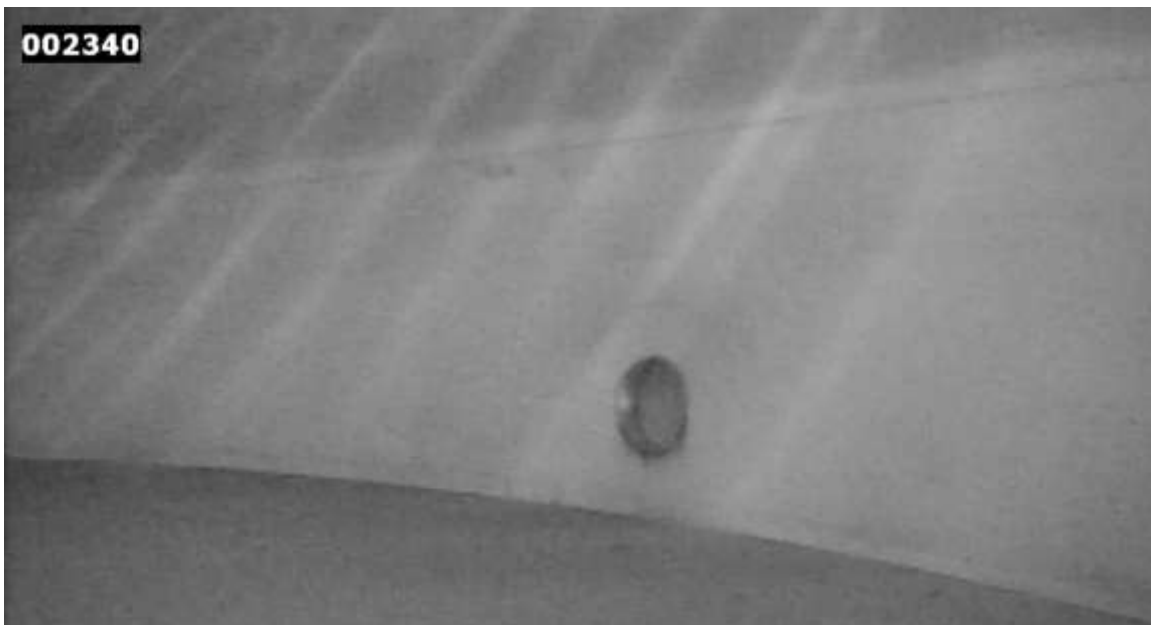
Photos show the tank interior coating system. The overall interior coating system appears to be in good condition. We recommend pressure washing the tank interior with biodegradable detergent injection (minimum 3,500 psi at 3.0 gpm), then re-evaluating the tank interior at next inspection cycle.

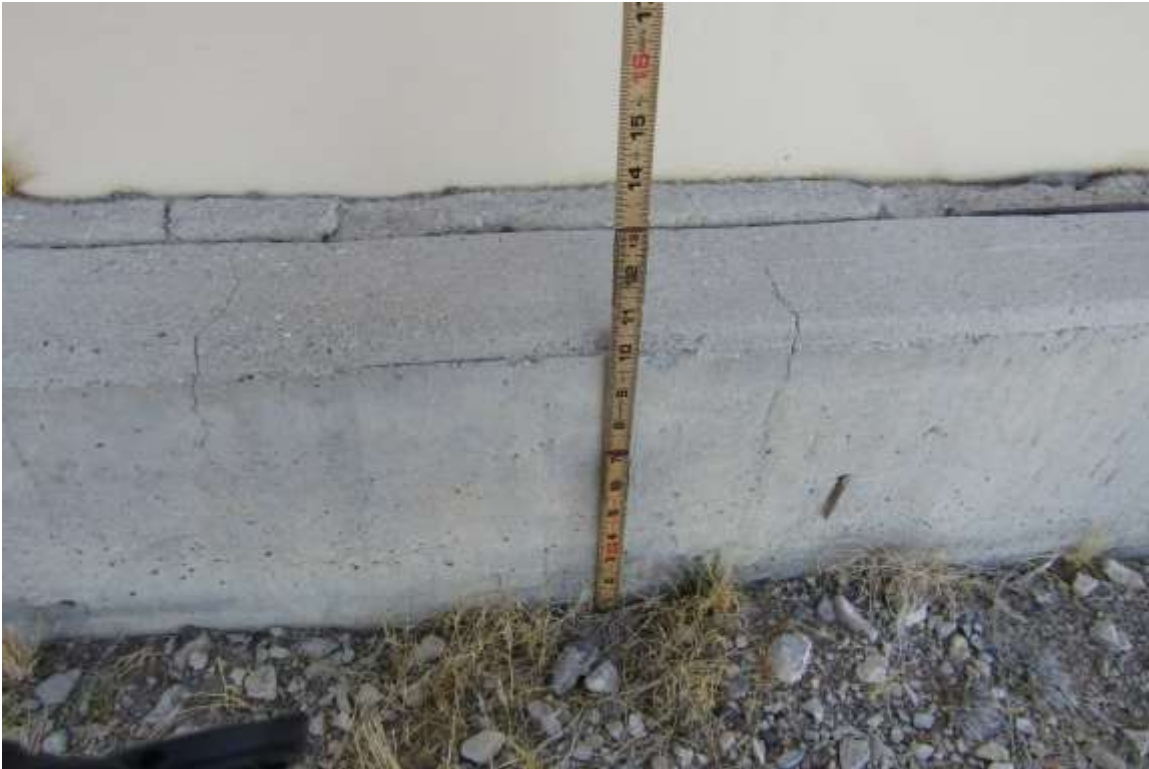
Photo shows the area around the tank foundation is properly graded and in compliance with **AWWA D100-11; 12.7.1 Height aboveground.**

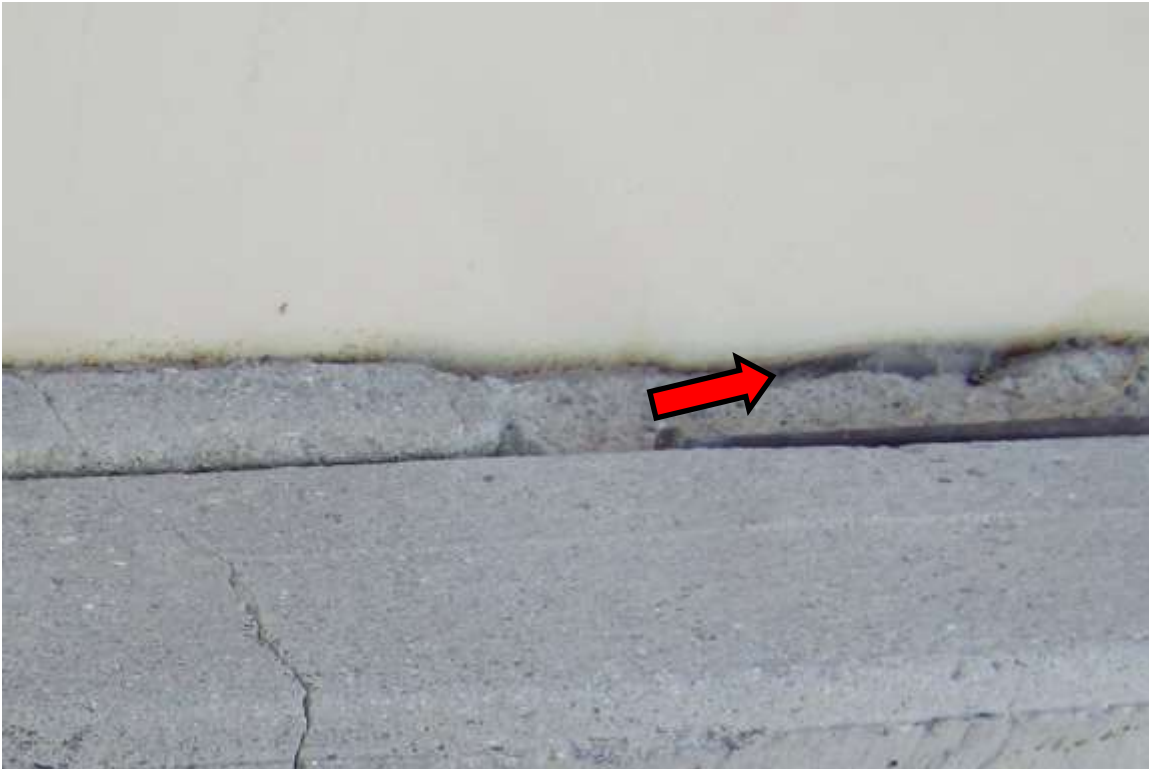
Photo shows the condition of the foundation. We recommend repairing any cracks and spalling in the concrete with a commercial non-shrinking grout, caulking/grouting around the base of the tank to foundation connection to prevent water from entering under the tank, then sealing the foundation with a sealant.
