**Mission Support and Test Services, LLC
Nevada National Security Site
Mercury, NV 89023
RE: Mercury North (Area 23); Mercury, NV
1,500,000 Gallon GST
September 16, 2018
Mr. Kevin Olsen
Scientist 1
(702) 295-0485
Job No. 318448-A**

**Mission Support and Test Services, LLC
Nevada National Security Site
Mercury, NV 89023
RE: Camp South (Area 12); Mercury, NV
500,000 Gallon GST
September 13, 2018
Mr. Kevin Olsen
Scientist 1
(702) 295-0485
Job No. 318448-D**

**Mission Support and Test Services, LLC
Nevada National Security Site
Mercury, NV 89023
RE: Well 4/4a South (Area 6); Mercury, NV
150,000 Gallon GST
September 24, 2018
Mr. Kevin Olsen
Scientist 1
(702) 295-0485
Job No. 318448-H**

**Mission Support and Test Services, LLC
Nevada National Security Site
Mercury, NV 89023
RE: C-1 North (Area 6); Mercury, NV
50,000 Gallon GST
September 21, 2018
Mr. Kevin Olsen
Scientist 1
(702) 295-0485
Job No. 318448-O**

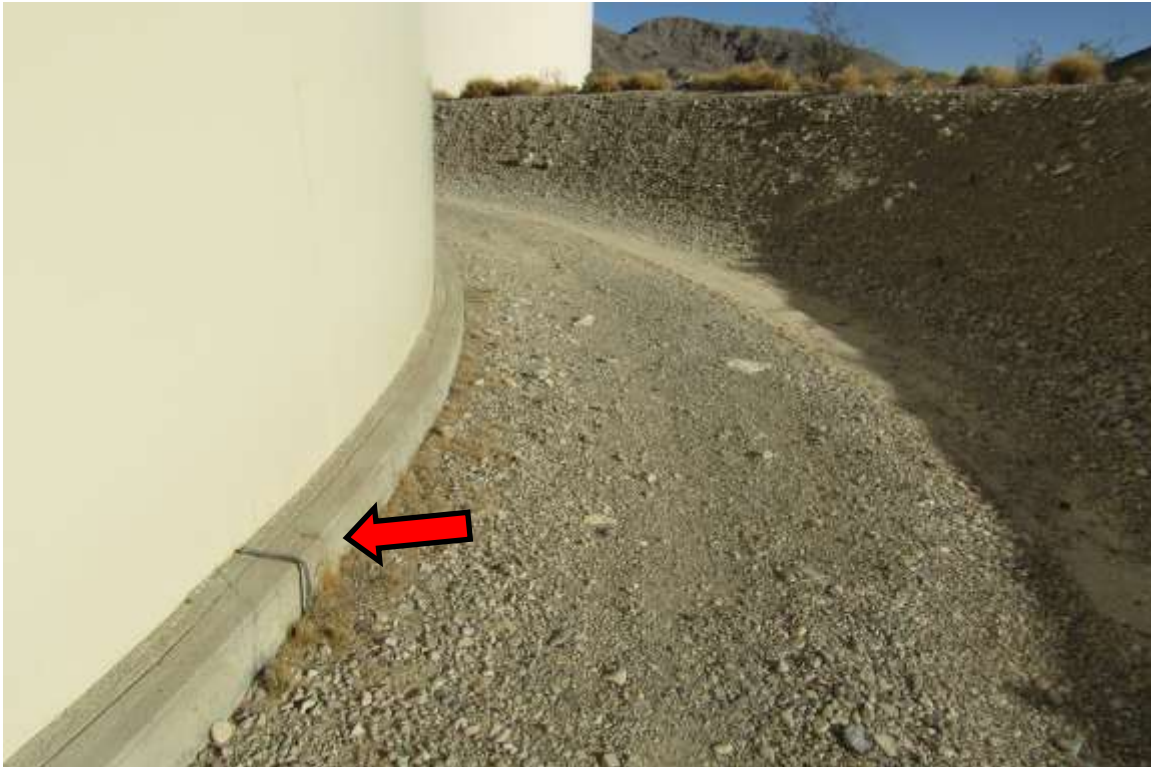
Photo shows the tank is electrically grounded for lightning protection as required by **OSH Act of 1970 Section 5** and appears to be in good condition.

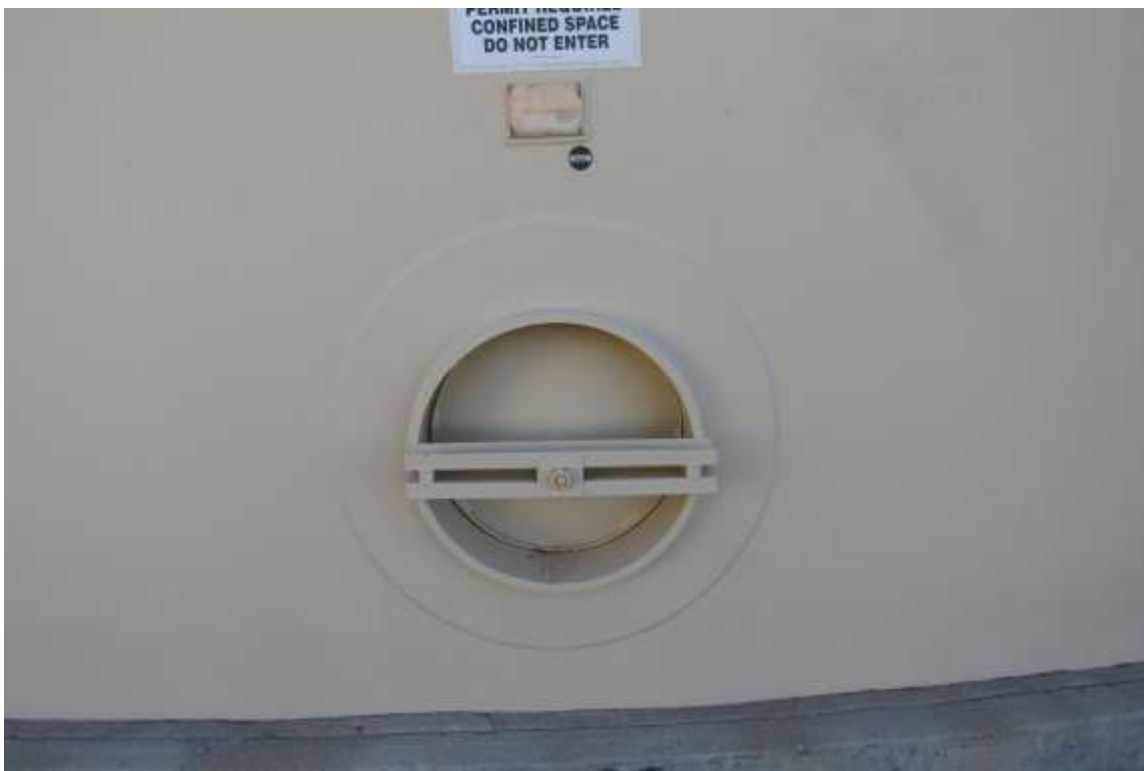
Photo shows the condition of the 24" primary shell manway. The following is required for the tank to be in compliance with **AWWA D100-11; 7.4.4 Shell man-holes** and **OSHA 1910.146(c)(2) Confined spaces**.

We recommend:

Install 30" secondary shell manway 180° from primary manway
Post **Confined Space Entry** sign

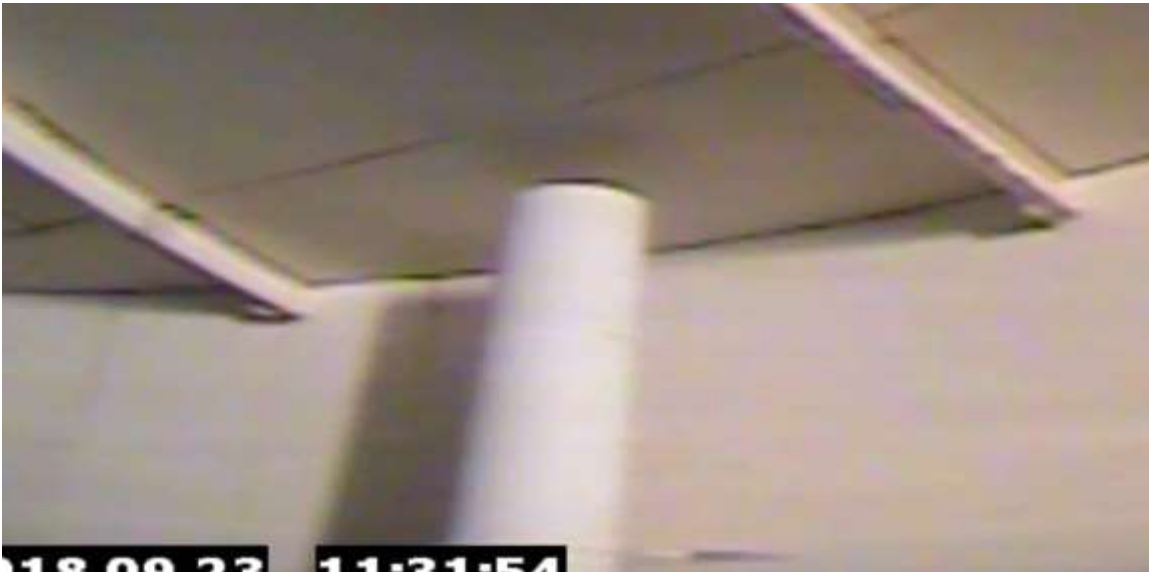
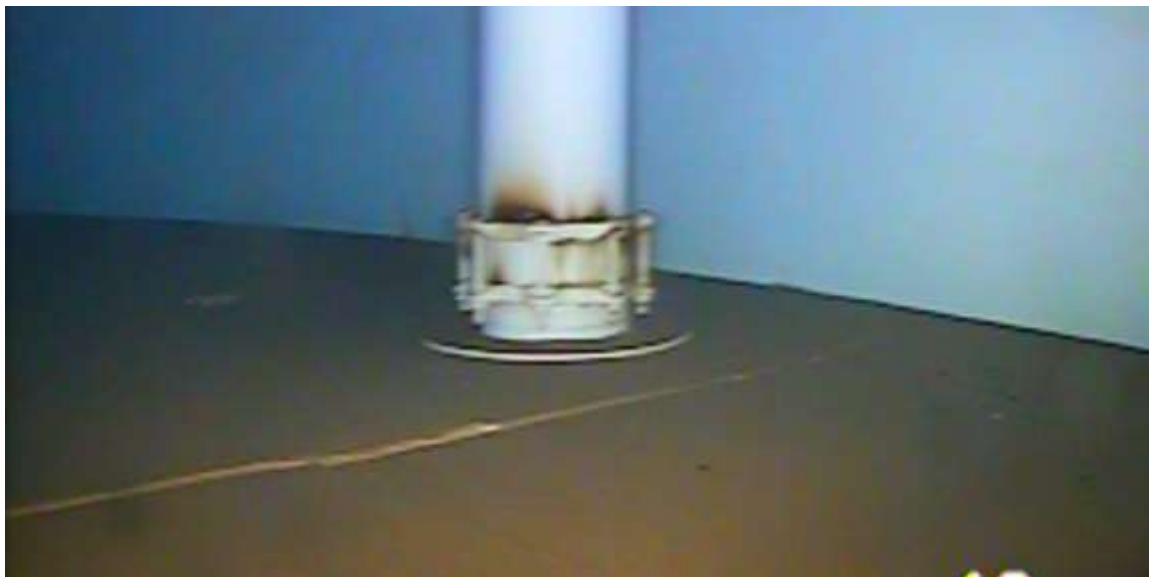
Photos show the condition of the overflow pipe system. **AWWA D100-11; 7.3 Overflow** states, "An internal overflow is defined as an overflow with piping inside the tank container. The consequences of an overflow failure, which can empty the tank contents, shall be considered when an internal overflow is provided." We recommend replacing the internal overflow system with a properly sized exterior overflow system, which will be complete with a weir box on the interior, standoffs every 10' on center extended to grade, an elbow fitted with a flapper valve and screen to prevent the ingress of contaminants, and a splash pad to direct the water away from the tank foundation.

**Splash pad to be installed by owner.*

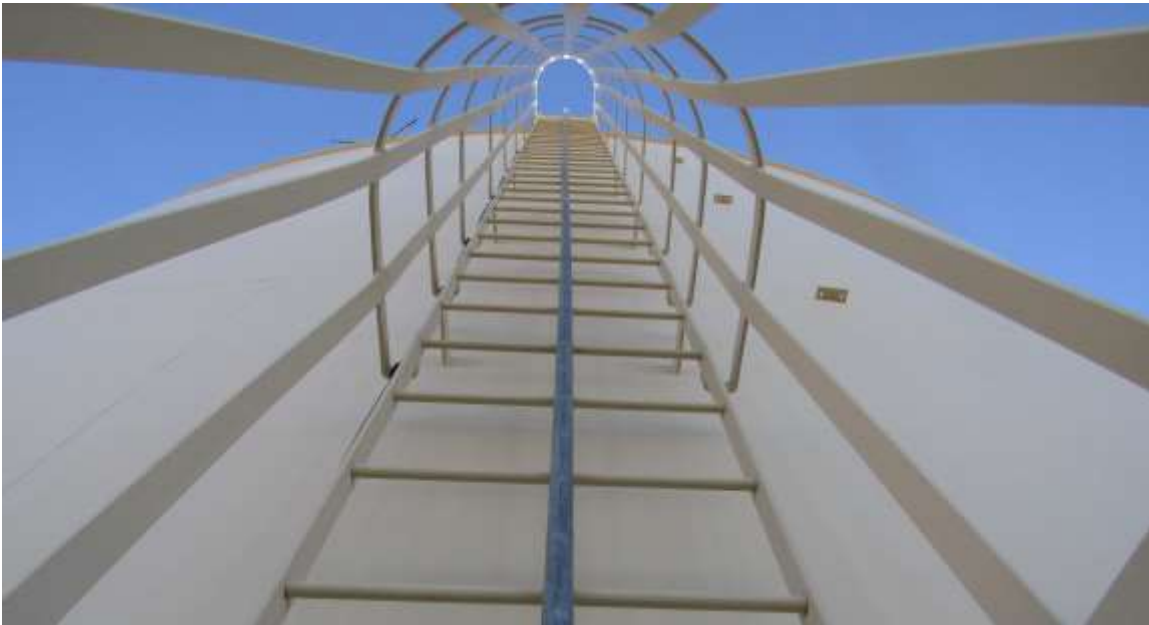
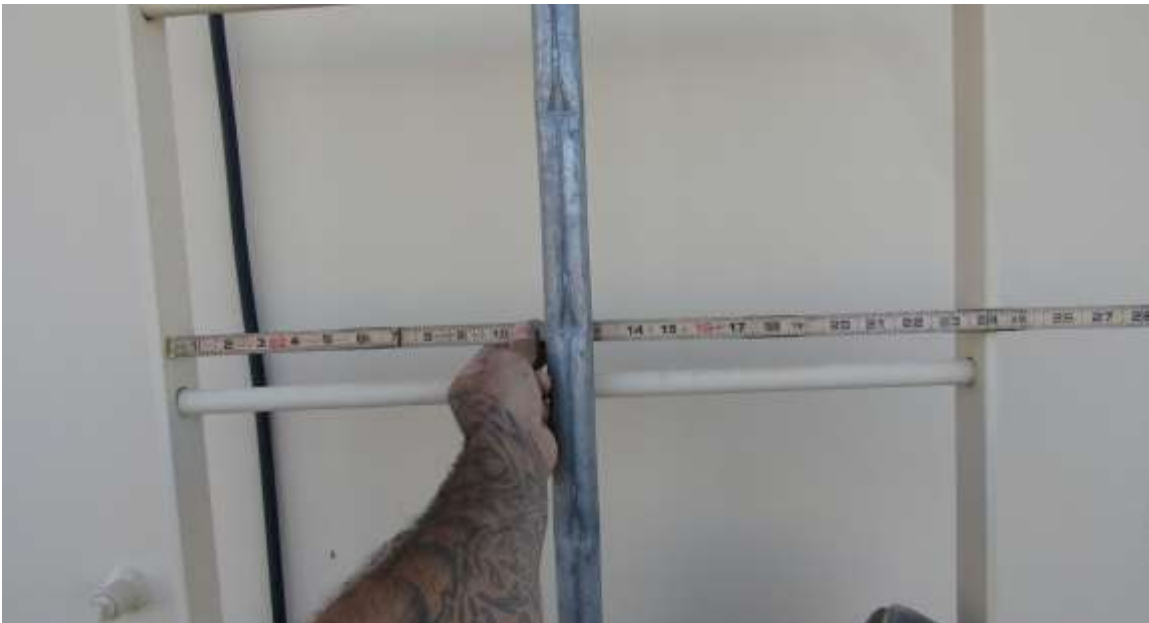
Shell access ladder in above photos is 24" wide, but is not equipped with anti-skid rungs. We recommend installing anti-skid rung covers, replacing the notched rail safety climb with a cable type ladder safety device, a lockable ladder guard to prevent unauthorized access, and posting a **Fall Protection Required** sign at the base of the ladder.

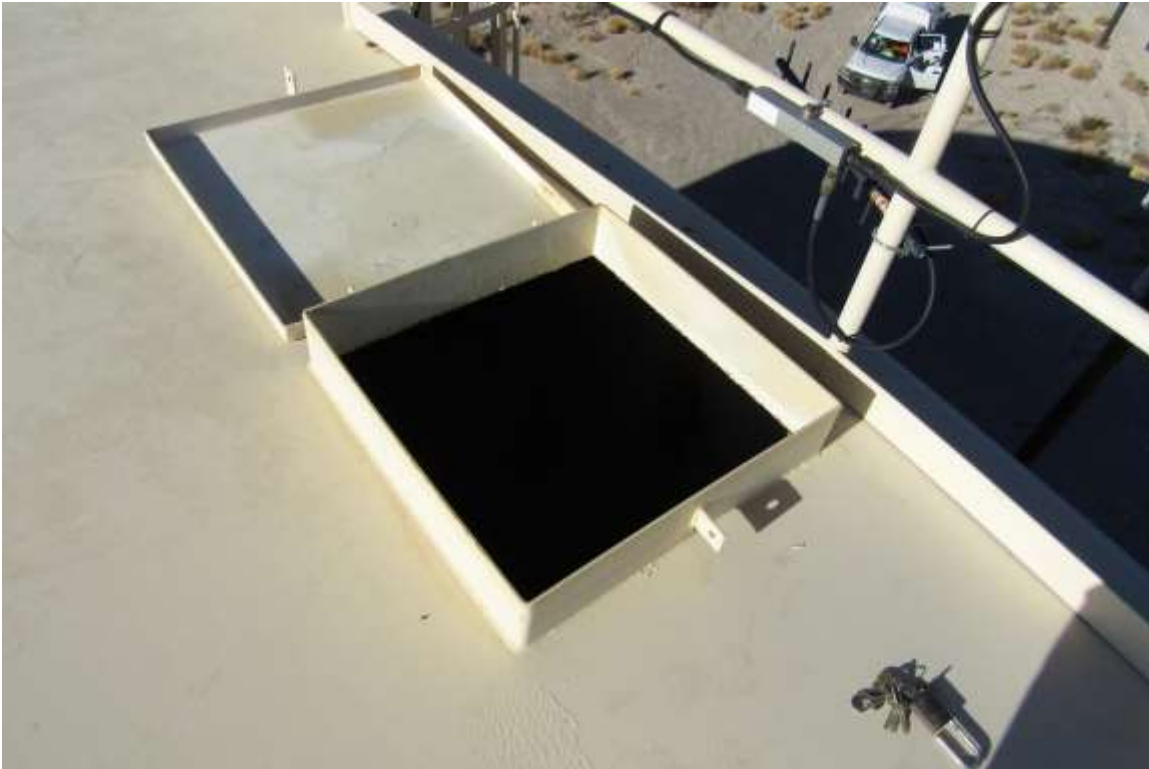
Photo shows the condition of the 30" primary roof hatch. Roof openings on this tank require the following to be in compliance with **AWWA D100-11; 7.4.3 Roof openings** and **OSHA 1910.146(c)(2) Confined spaces**.

We recommend:

We further recommend installing **OSHA** compliant interior access ladders complete with standoffs every 10' on center, and cable type ladder safety devices at the primary and suggested secondary roof hatches.

**In cold climates it's up to the owner's discretion on placement of internal ladders.*

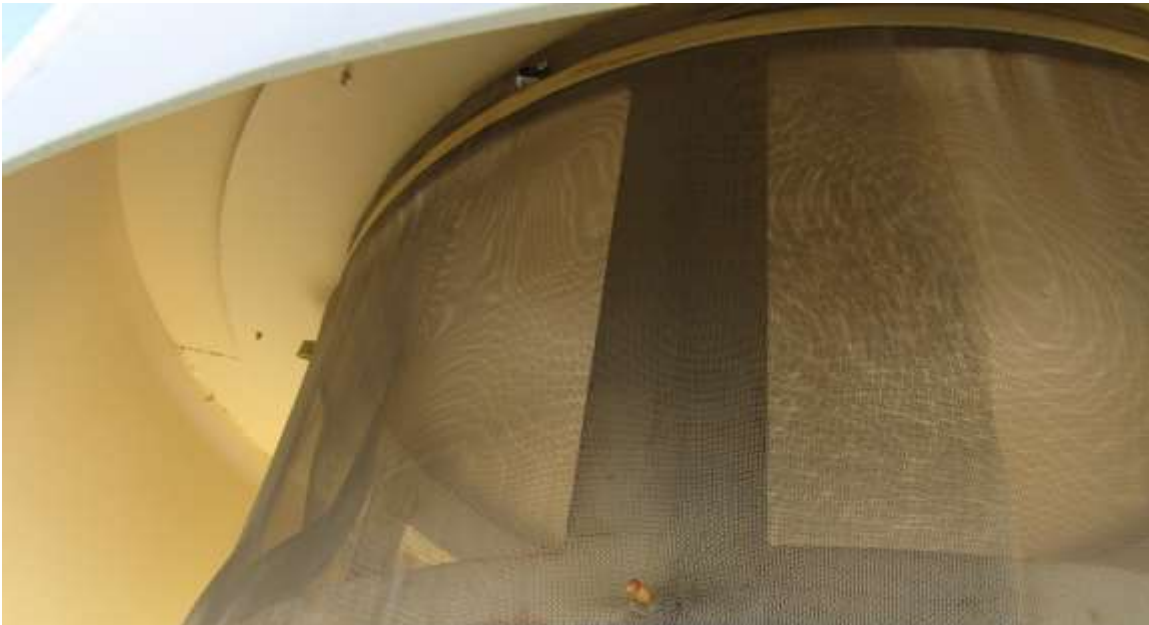
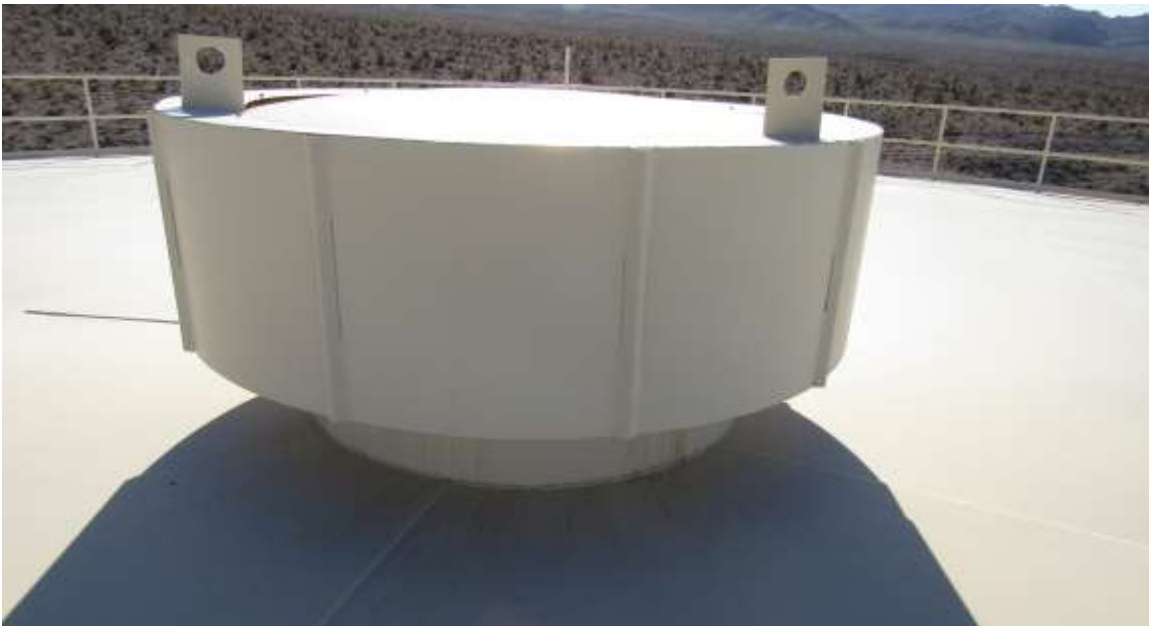
Photos show the existing roof vent, which appears to be in good condition.

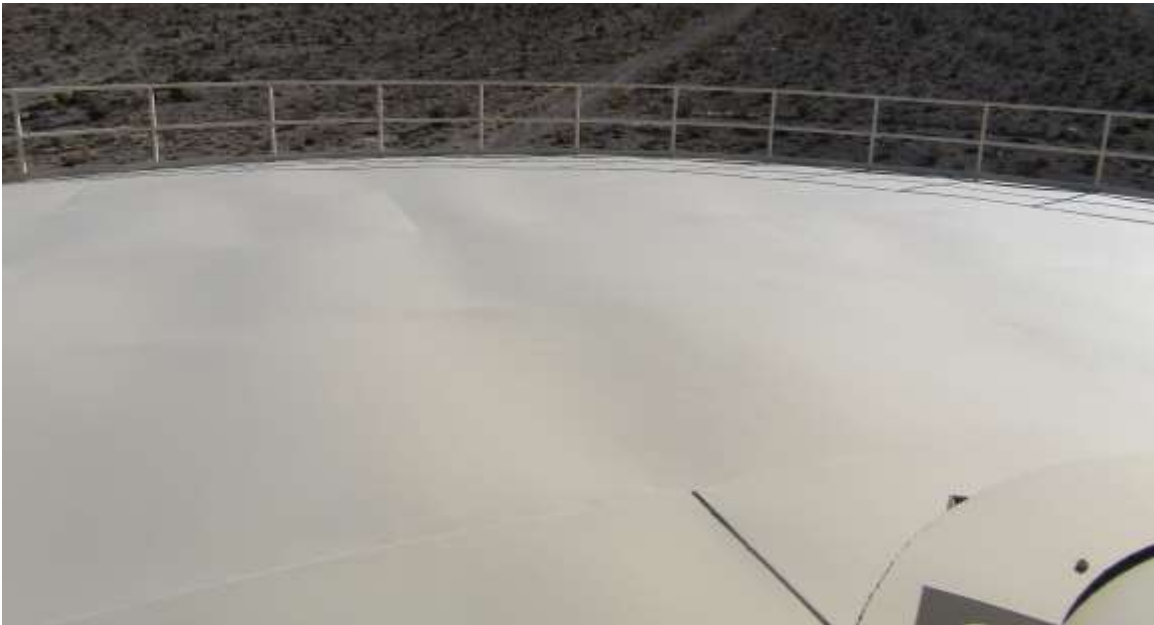
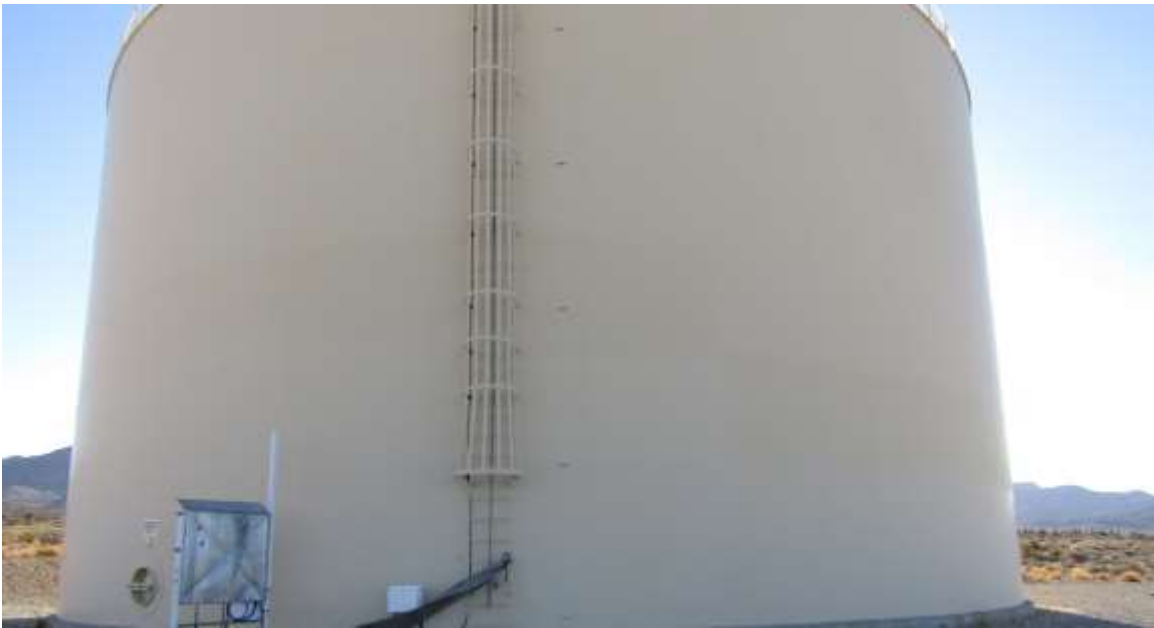
Photos show the tank exterior coating system. The overall exterior coating system appears to be in good condition. We recommend re-evaluating the tank exterior at next inspection cycle.

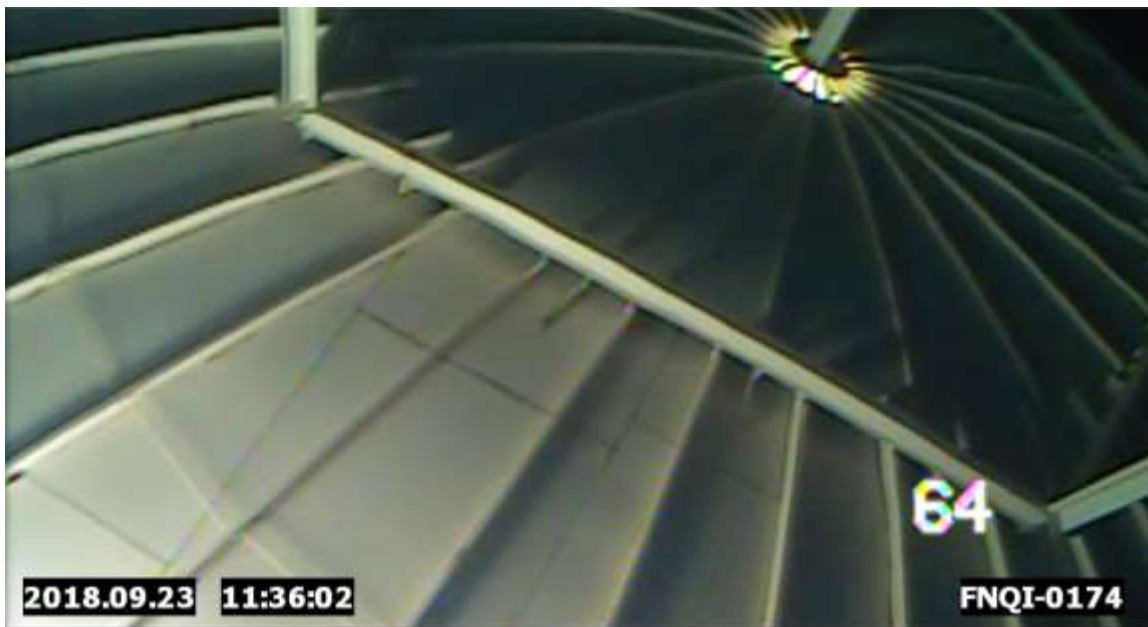
Top photo shows the interior roof lap seams, which appear to be in good condition.

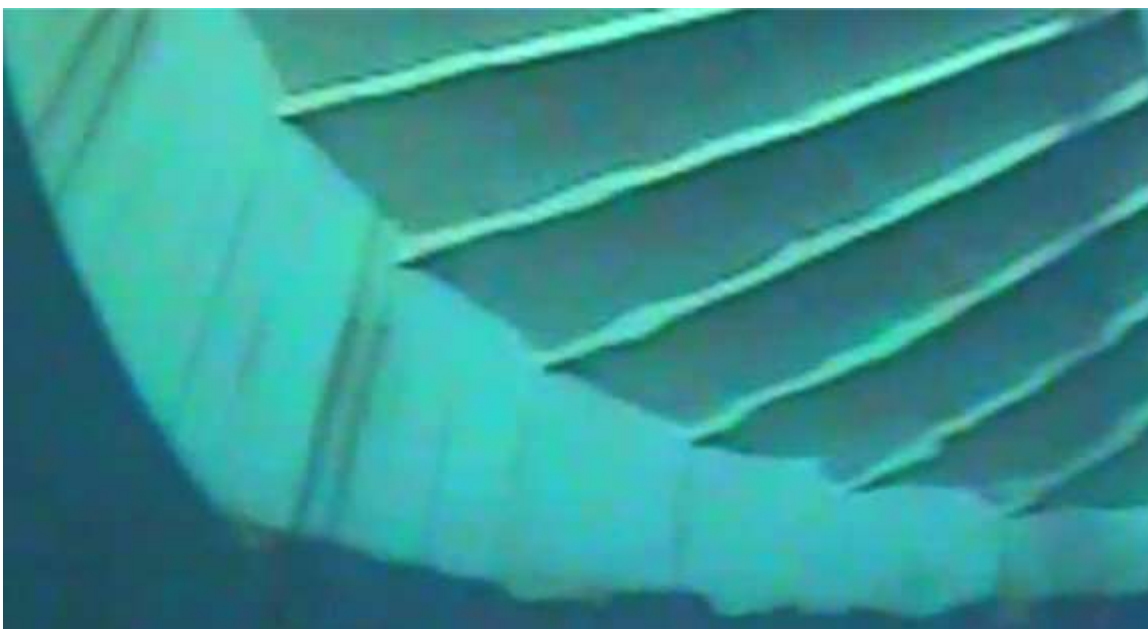
Bottom photo shows the interior roof-to-rim angle connection, which appears to be in good condition.

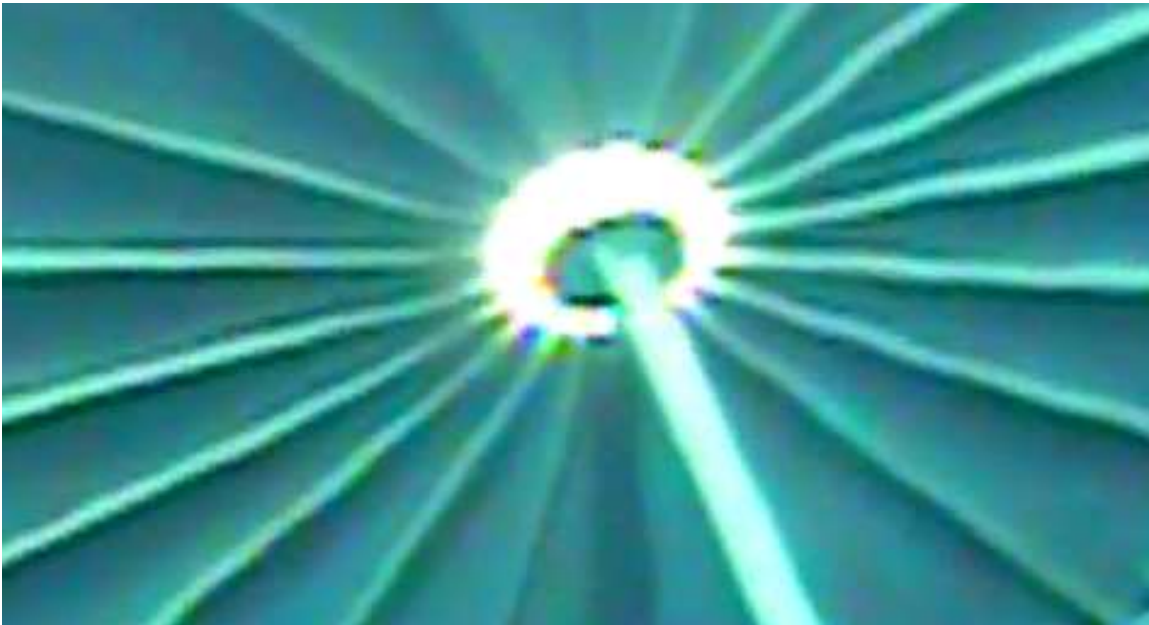
Photos show the rafter-to-support column and rafter-to-shell connections, which appear to be in good condition.

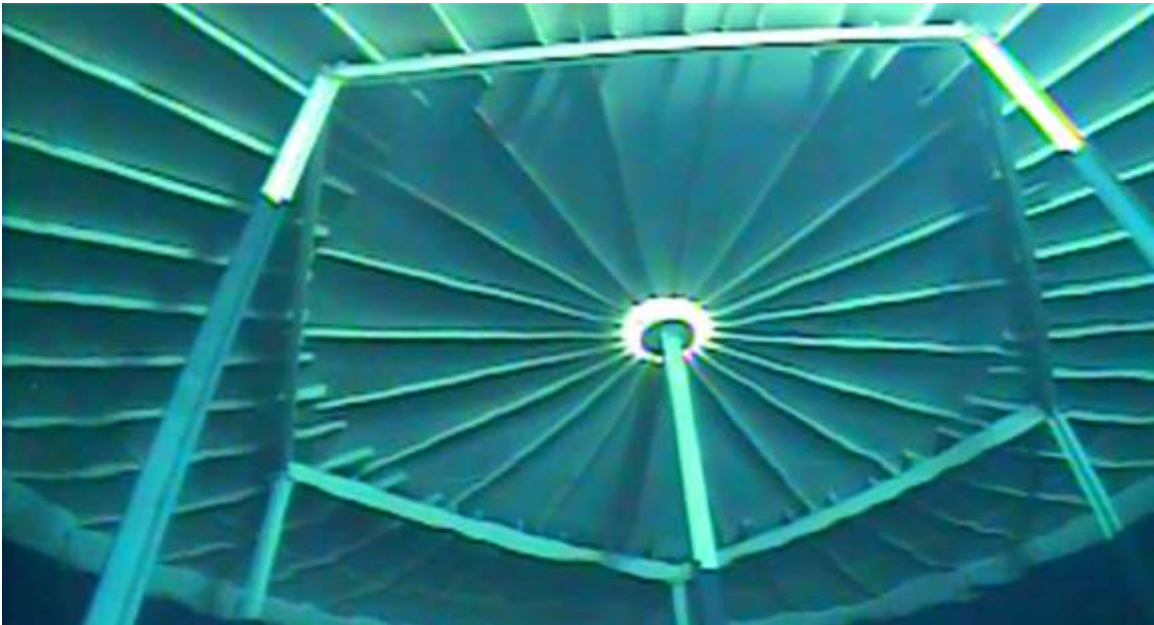
Top photo shows one (1) of the six (6) center support columns, which appear to be in good condition.

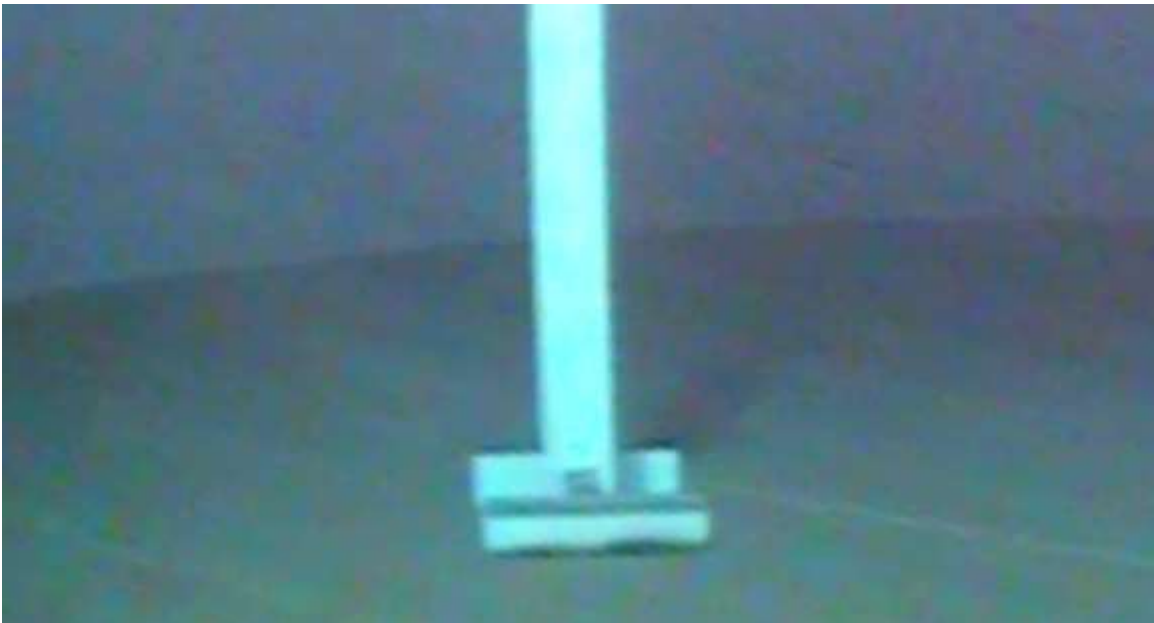
Bottom photo shows one (1) of the six (6) support column baseplate-to-floor connections, which appear to be in good condition.

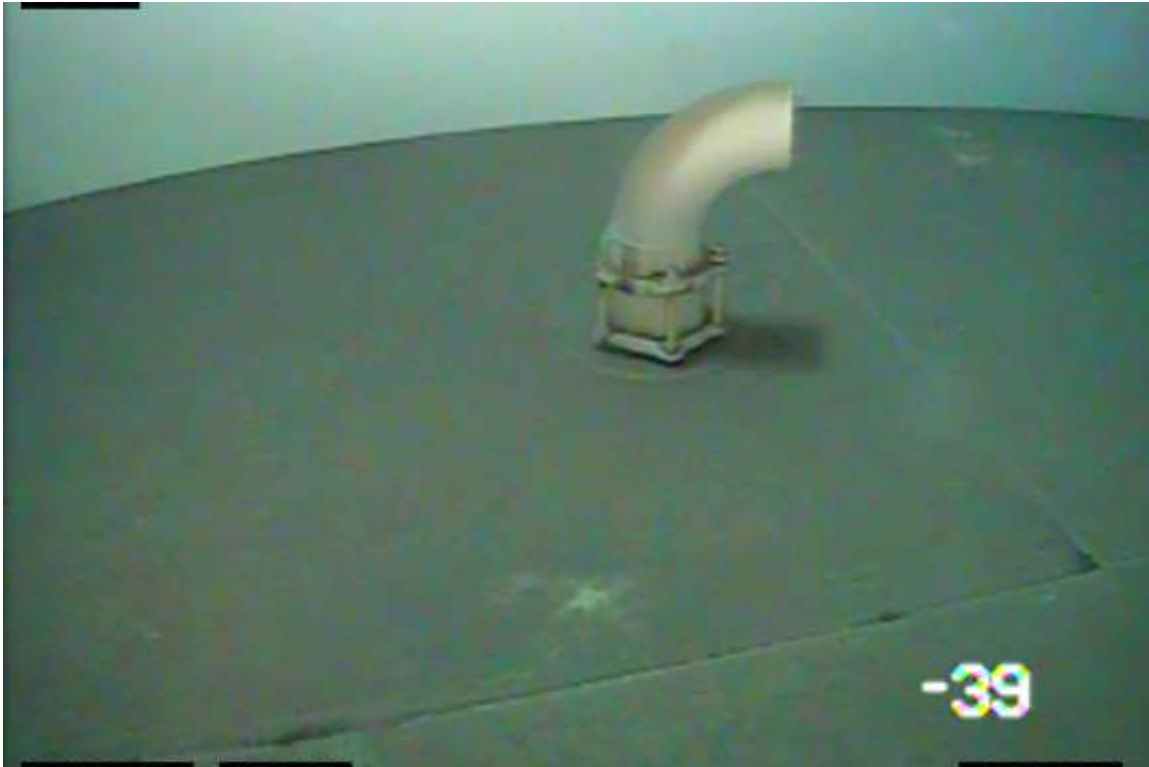
Photo shows a fill pipe on the tank interior. A temperature difference between the water in the top and bottom of a tank, even as little as 1-2 degrees Fahrenheit, is an indication of thermal stratification and the tank water not being completely mixed. Incomplete mixing would result in short-circuiting, and localized increase in water age would develop inside the tank. This typically leads to water quality problems, such as loss of residual, DBP spikes, HPC spikes, bacteria regrowth, formation of bio-film, changes in pH and dissolved oxygen. We recommend installing a mixing system. Electrical work to be done by others if required.

17	Install a mixing system. Electrical work to be done by others if required.		X			
18	Install a passive cathodic protection system.					X
20	Pressure wash the tank interior with biodegradable detergent injection (minimum 3,500 psi at 3.0 gpm), then re-evaluate the tank interior at next inspection cycle.					X

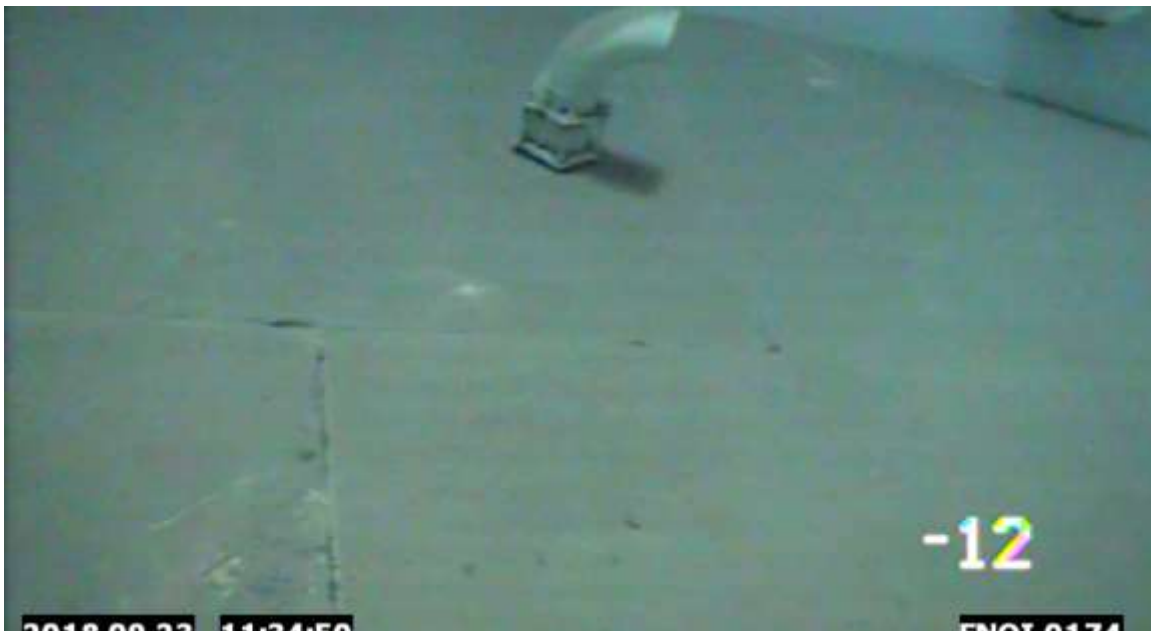
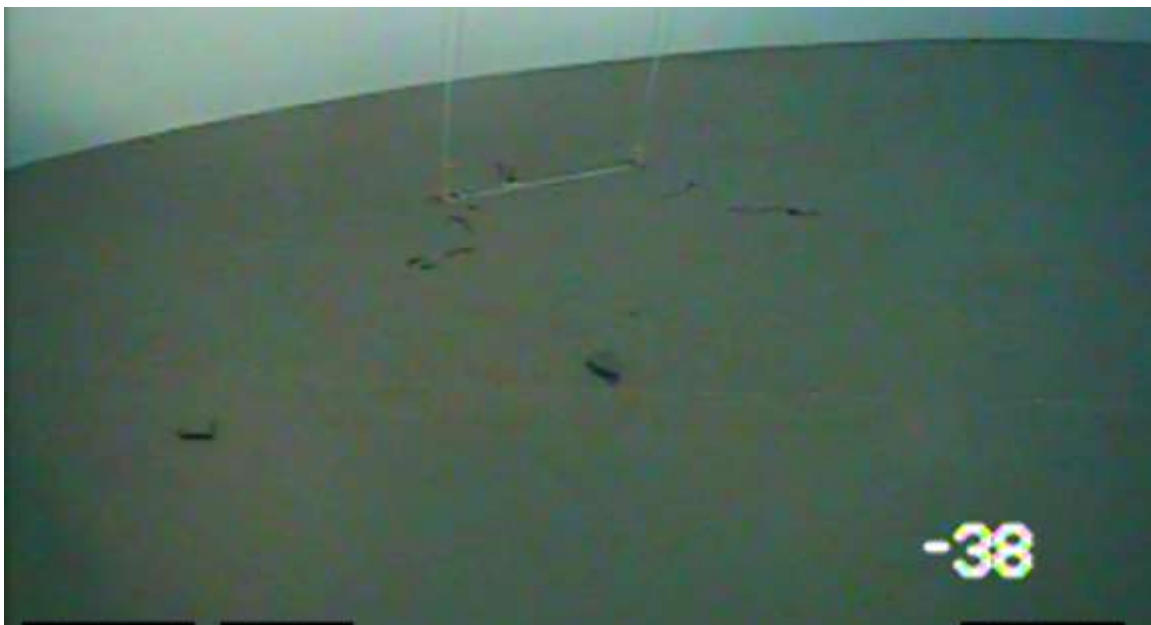
Photos show sediment and debris on the tank interior before a cleanout was performed.

We recommend installing a passive cathodic protection system.

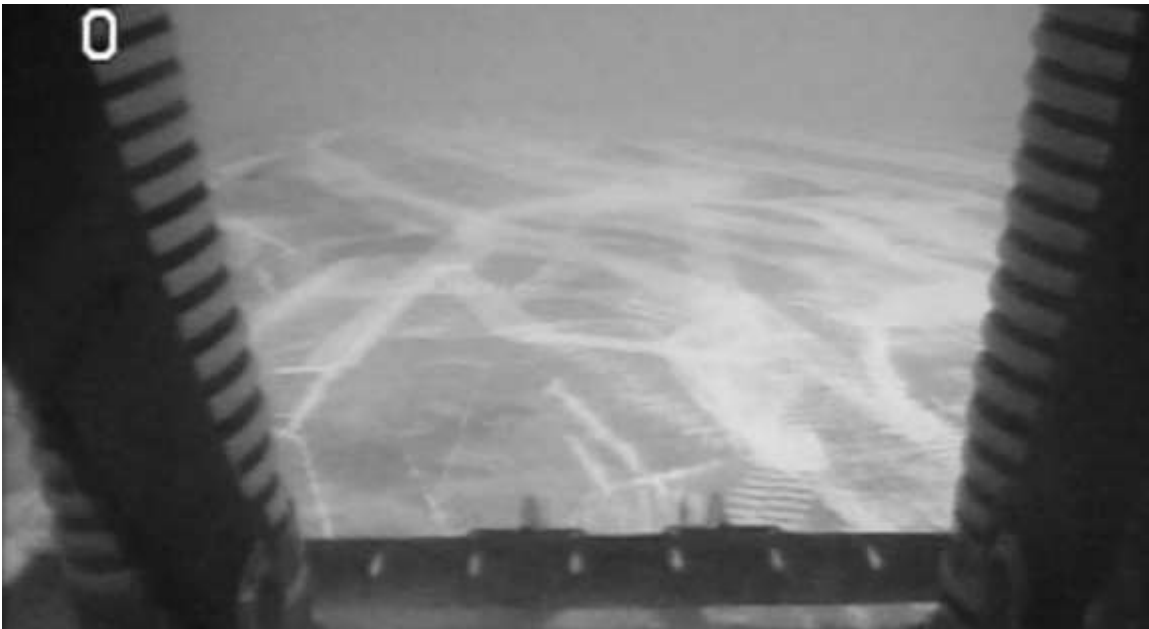
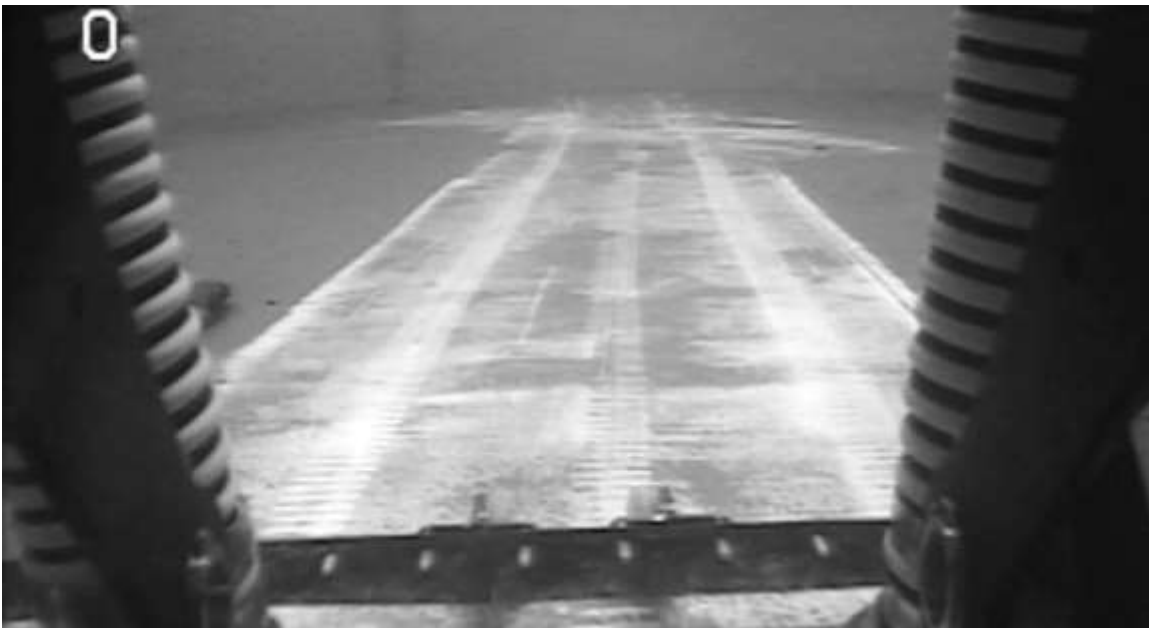
Photos show the tank interior during a cleanout.

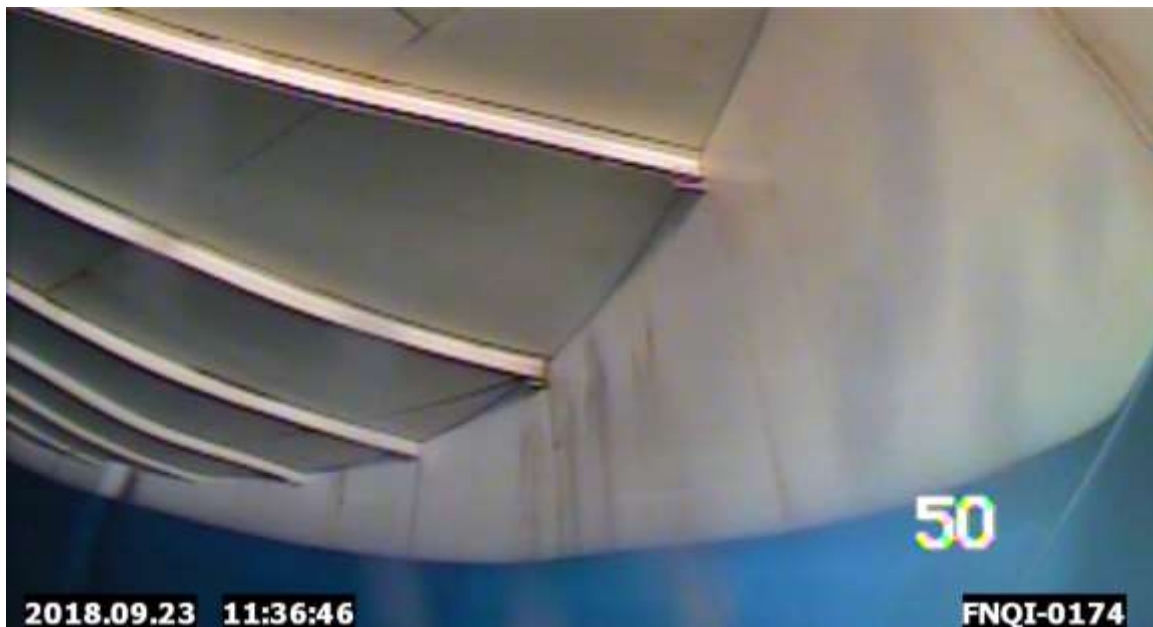
Photos show the tank interior coating system. The overall interior coating system appears to be in good condition. We recommend pressure washing the tank interior with biodegradable detergent injection (minimum 3,500 psi at 3.0 gpm), then re-evaluating the tank interior at next inspection cycle.

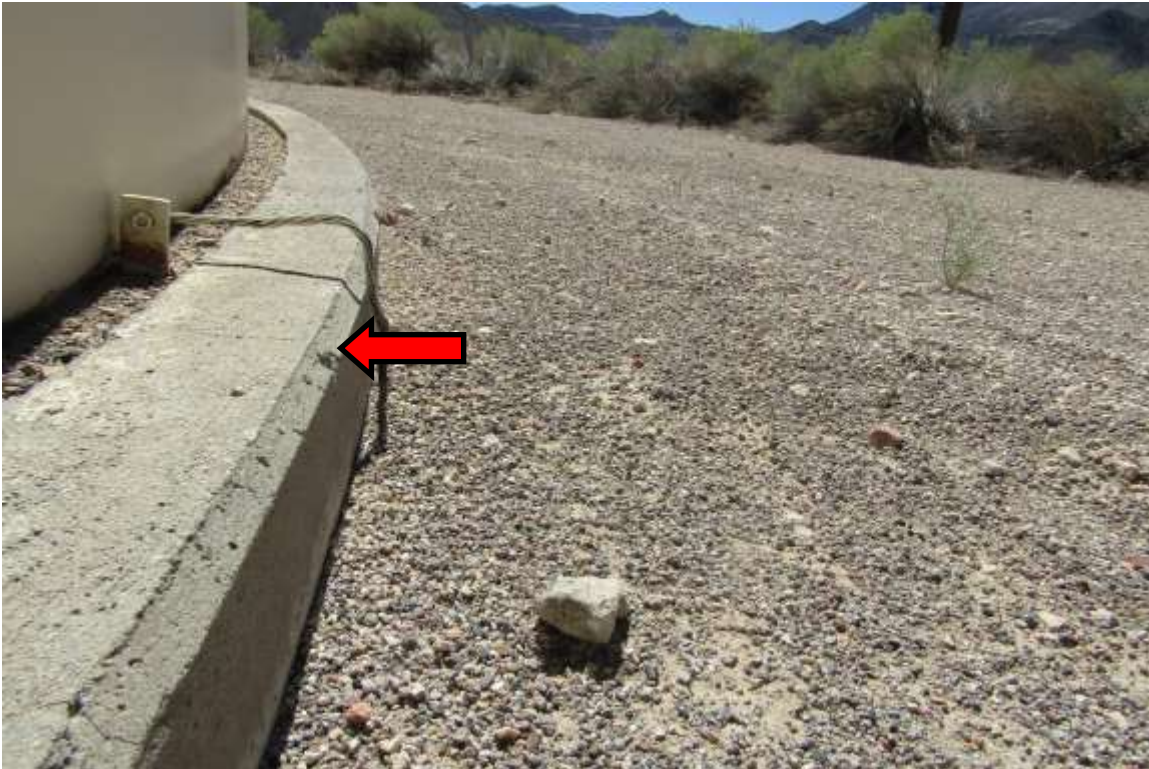
Photo shows the condition of the foundation. We recommend repairing any cracks and spalling in the concrete with a commercial non-shrinking grout, then sealing the foundation with a sealant.

Page #	Work Proposed	Critical Deficiency	NON-Critical Deficiency	OSHA	Structural	Preventive Maintenance
3	Repair any cracks and spalling in the concrete with a commercial non-shrinking grout.					X
	Seal the foundation with a sealant.					X
5	Install a locking device and a splash pad on the existing drain valve. <i>Splash pad to be installed by owner.</i>		X			
6	Install 30" secondary shell manway 180° from primary manway.		X	X		
	Post Confined Space Entry sign on primary shell manway.			X		
7	Disconnect the overflow pipe from the underground drain, install an air break complete with a flapper valve and screen.		X			
8	Install a compliant exterior shell access ladder complete with standoffs every 10' on center.			X		
	Install a cable type ladder safety device on exterior shell access ladder.			X		
	Install a lockable ladder guard on exterior shell access ladder.					X
	Post Fall Protection Required sign at base of exterior shell access ladder.			X

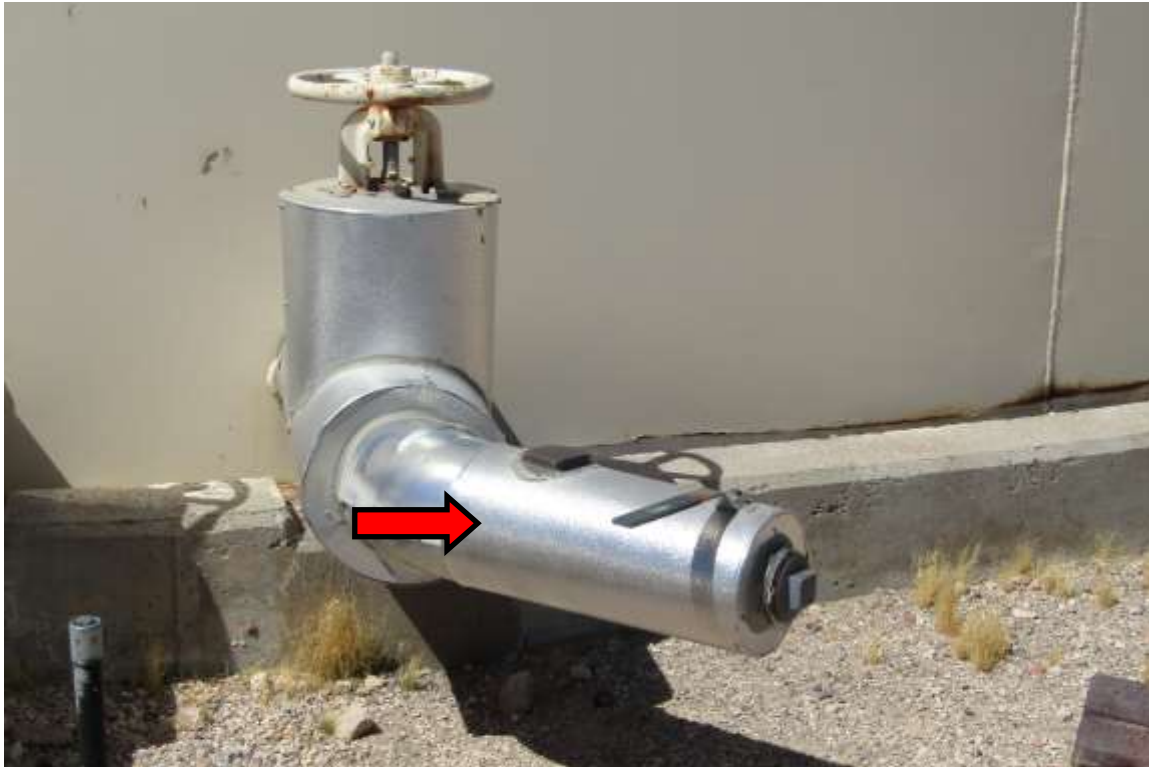
Photo shows the condition of the existing drain valve, which is not equipped with a locking device or splash pad. We recommend installing a locking device to prevent unauthorized draining of the tank and a splash pad to direct water away from the foundation.

**Splash pad to be installed by owner.*

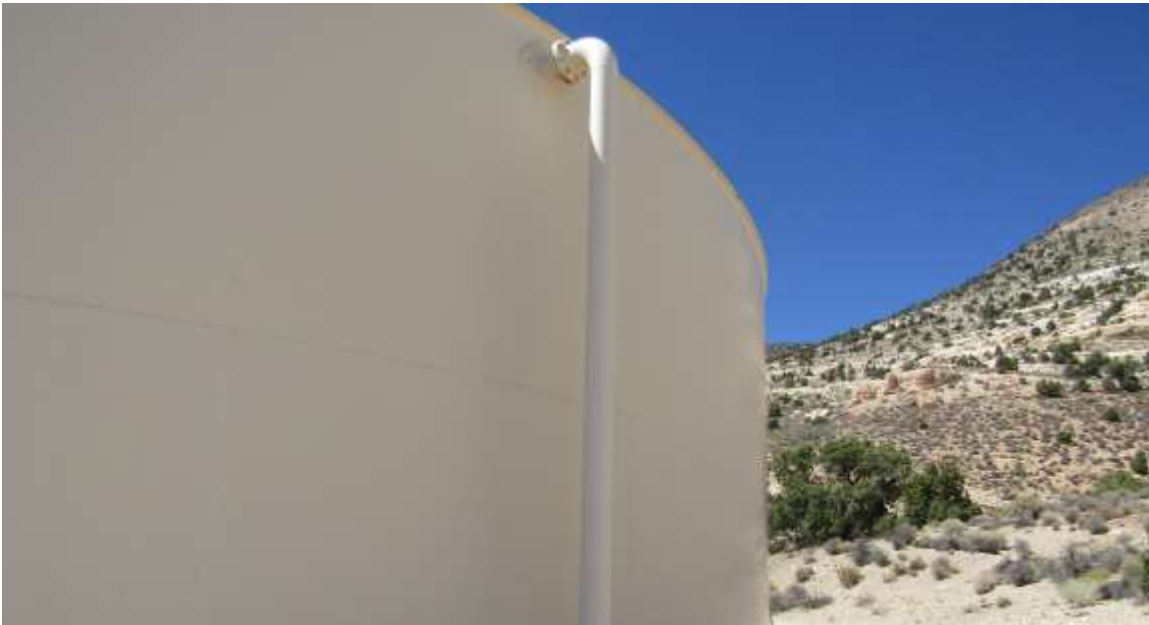
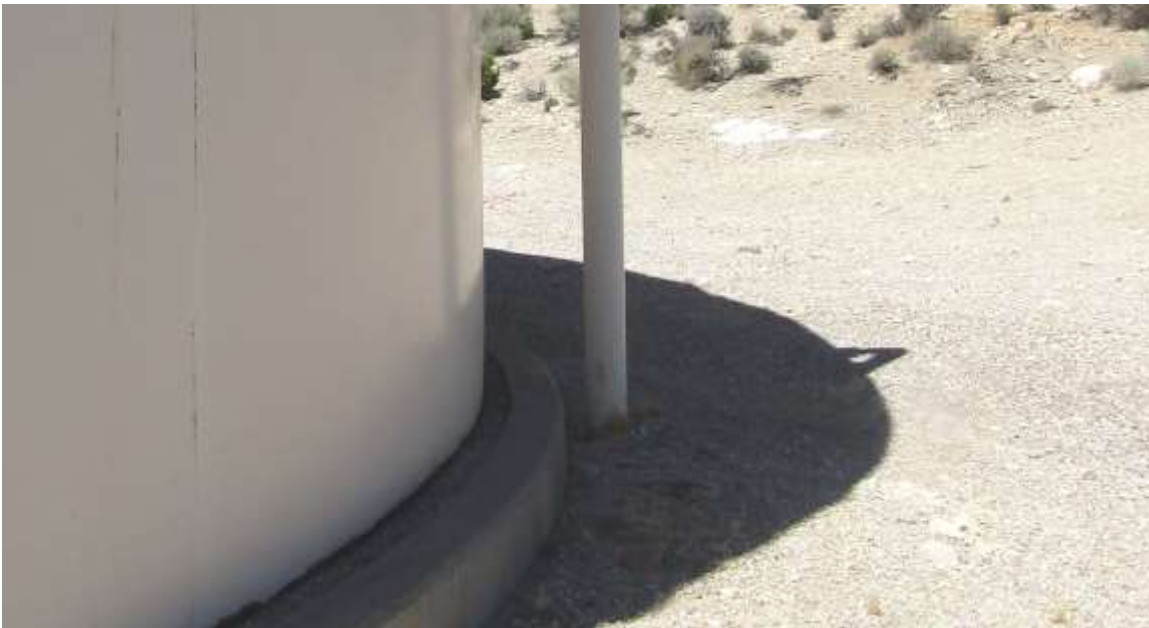
Photos show the condition of the 6" overflow pipe system. We recommend disconnecting the pipe from the underground drain then installing an air break complete with a flapper valve and screen to prevent the ingress of contaminants into the water supply.

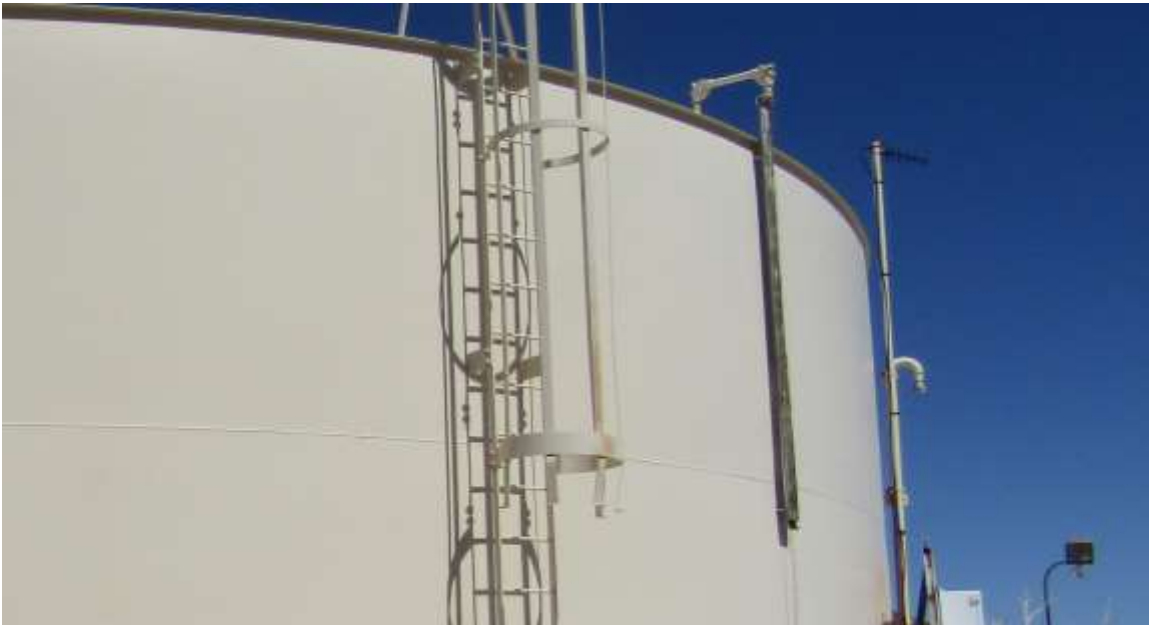
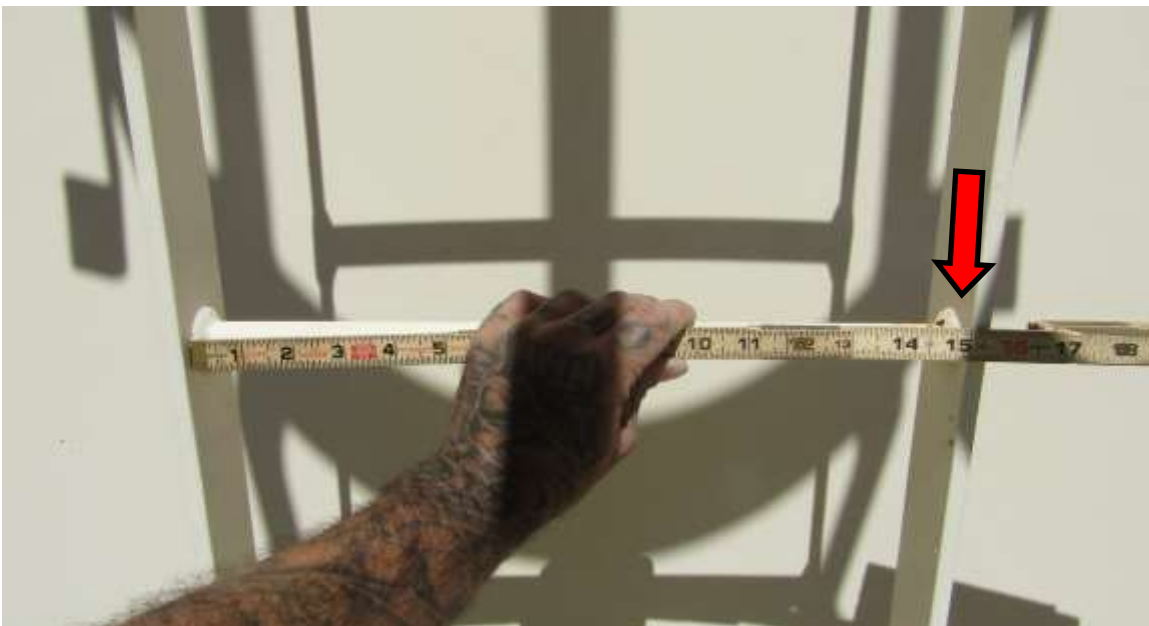
Shell access ladder in above photos is not equipped with anti-skid rungs, and is only 15" wide. **OSHA 1910.23(b)(4)** states, "Ladder rungs, steps, and cleats have a minimum clear width of... 16 inches (41 cm) (measured before installation of ladder safety systems) for fixed ladders,..." We recommend installing an **OSHA** compliant shell access ladder complete with standoffs every 10' on center, a cable type ladder safety device, a lockable ladder guard to prevent unauthorized access and posting a **Fall Protection Required** sign at the base of the ladder.
