**Mission Support and Test Services, LLC
Nevada National Security Site
Mercury, NV 89023
RE: Mercury North (Area 23); Mercury, NV
1,500,000 Gallon GST
September 16, 2018
Mr. Kevin Olsen
Scientist 1
(702) 295-0485
Job No. 318448-A**

**Mission Support and Test Services, LLC
Nevada National Security Site
Mercury, NV 89023
RE: Camp South (Area 12); Mercury, NV
500,000 Gallon GST
September 13, 2018
Mr. Kevin Olsen
Scientist 1
(702) 295-0485
Job No. 318448-D**

**Mission Support and Test Services, LLC
Nevada National Security Site
Mercury, NV 89023
RE: Well 4/4a South (Area 6); Mercury, NV
150,000 Gallon GST
September 24, 2018
Mr. Kevin Olsen
Scientist 1
(702) 295-0485
Job No. 318448-H**

**Mission Support and Test Services, LLC
Nevada National Security Site
Mercury, NV 89023
RE: C-1 North (Area 6); Mercury, NV
50,000 Gallon GST
September 21, 2018
Mr. Kevin Olsen
Scientist 1
(702) 295-0485
Job No. 318448-O**

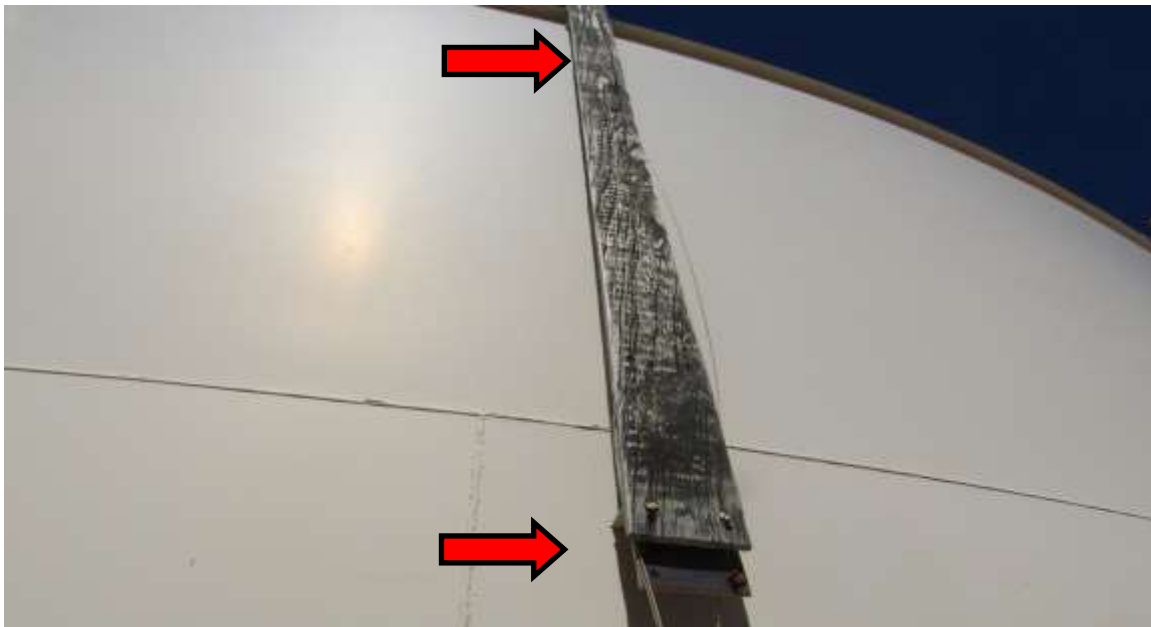
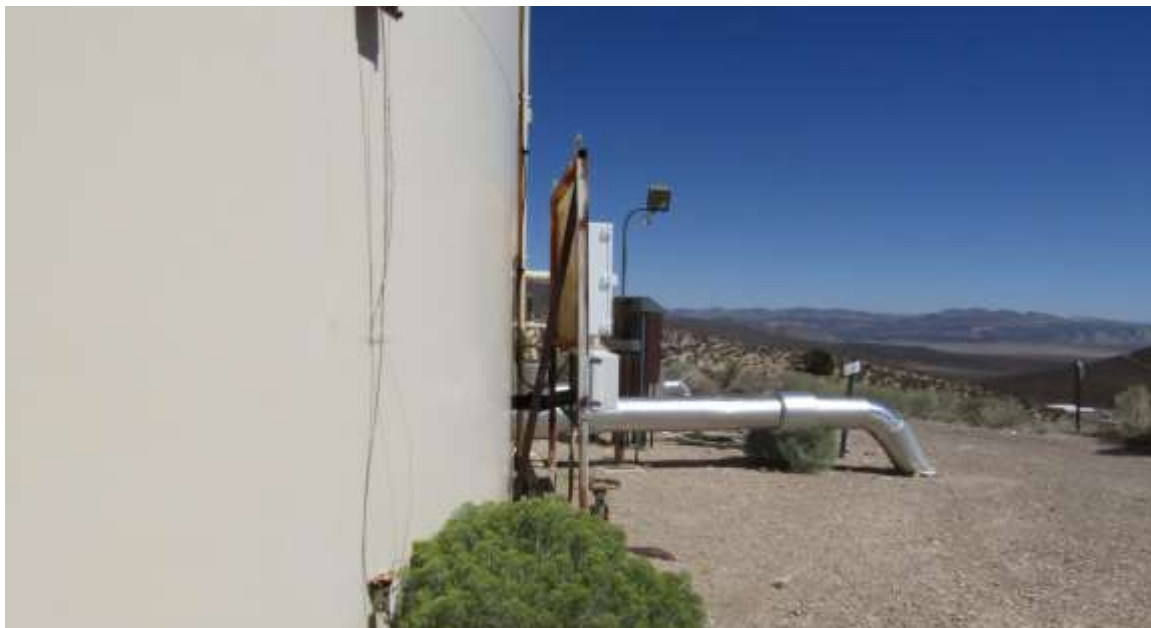
Photos show the condition of the liquid level indicator. Due to the condition of the indicator, we recommend replacing the existing liquid level indicator.

9	Replace the liquid level indicator.		X			
10	Install a compliant 42" high handrail system around the circumference of the tank roof, complete with intermediate rail, toeboard and a swing gate at the junction of the shell-to-roof access ladder and tank roof.			X		
11	Install 30" secondary roof hatch 180° from primary hatch.		X			
	Post Confined Space Entry sign on primary roof hatch.			X		
	Install a compliant interior access ladder complete with standoffs every 10' on center at the primary and suggested secondary roof hatch. <i>In cold climates it's up to the owner's discretion on placement of internal ladders.</i>			X		
	Install cable type ladder safety devices on primary and suggested secondary interior access ladders.			X		
12	Replace the existing roof vent with a vacuum-pressure, frost proof vent and screen. This work should be performed on an emergency basis.	X			X	
13	Re-evaluate the tank exterior at next inspection cycle.					X

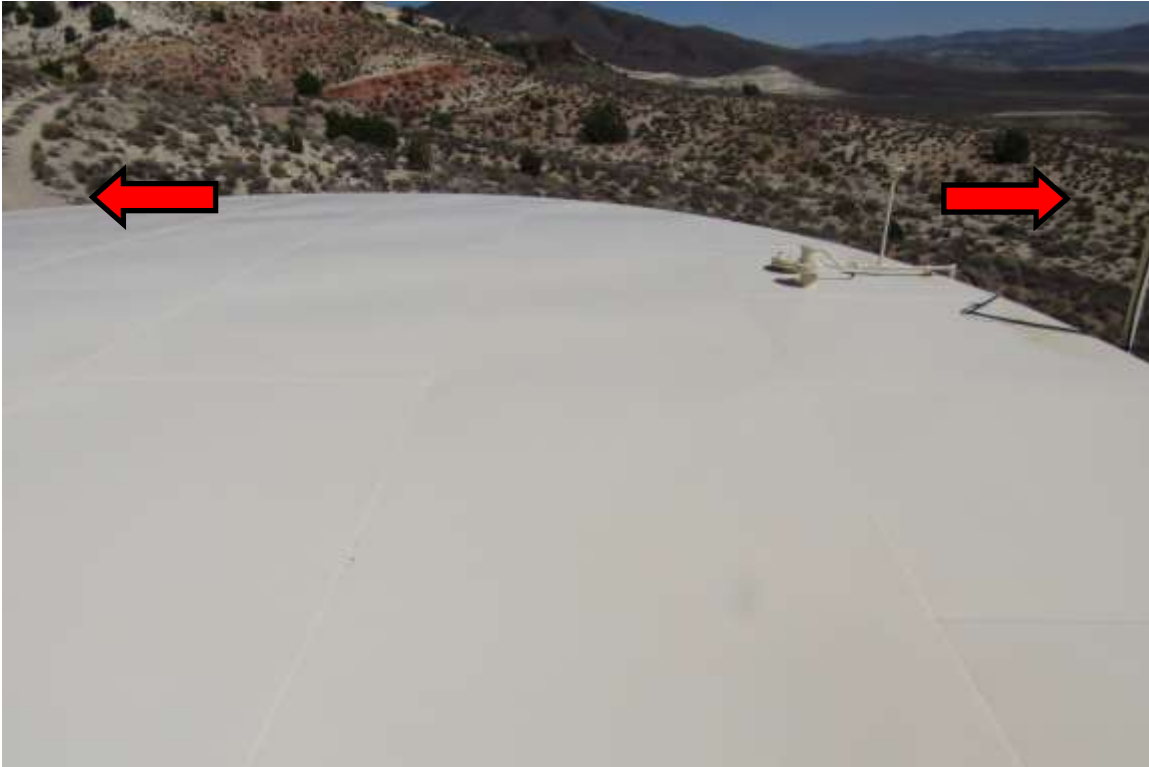
Photo shows the tank roof edge is not equipped with a required handrail system for fall protection. **OSHA 1910.28(b)(1)(i)** states, "...the employer must ensure that each employee on a walking-working surface with an unprotected side or edge that is 4 feet (1.2 m) or more above a lower level is protected from falling by one or more of the following: **1910.28(b)(1)(i)(A) Guardrail systems.**"

We recommend installing an **OSHA** compliant 42" high handrail system around the circumference of the tank roof, complete with intermediate rail, toeboard and a swing gate at the junction of the shell-to-roof access ladder and tank roof.

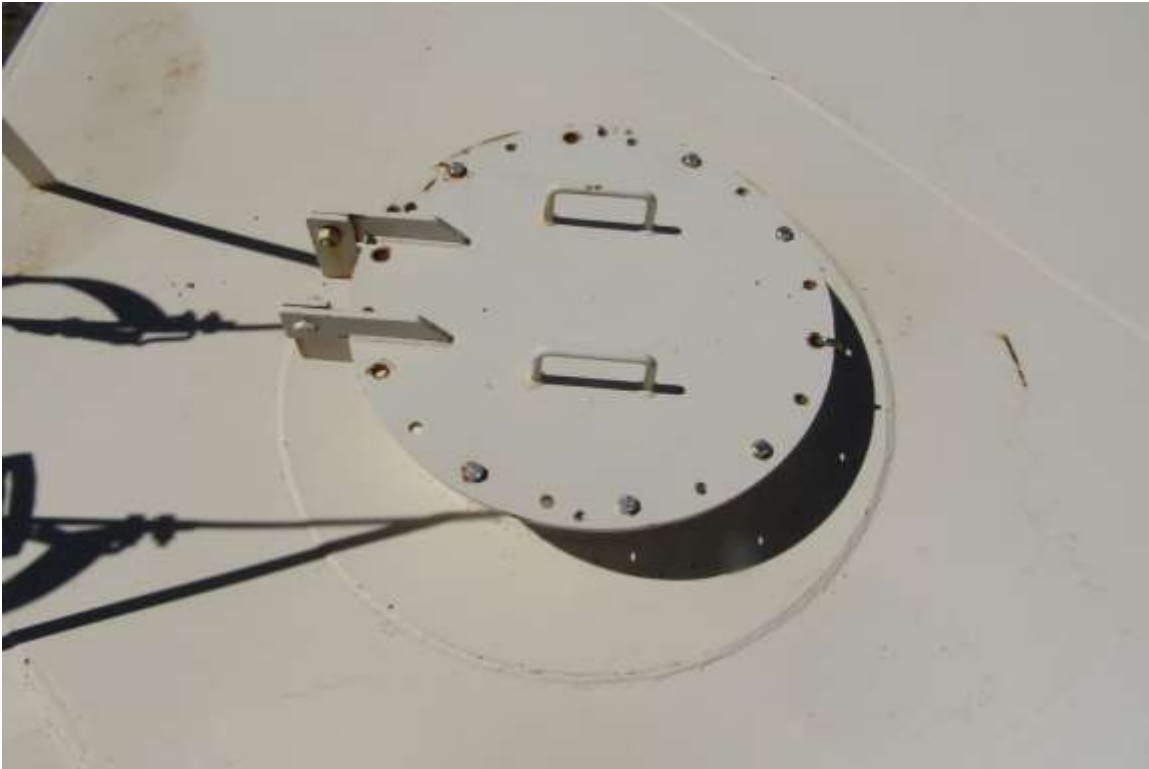
Photo shows the condition of the 24" primary roof hatch. Roof openings on this tank require the following to be in compliance with **AWWA D100-11; 7.4.3 Roof openings** and **OSHA 1910.146(c)(2) Confined spaces**.

We recommend:

We further recommend installing **OSHA** compliant interior access ladders complete with standoffs every 10' on center, and cable type ladder safety devices at the primary and suggested secondary roof hatches.

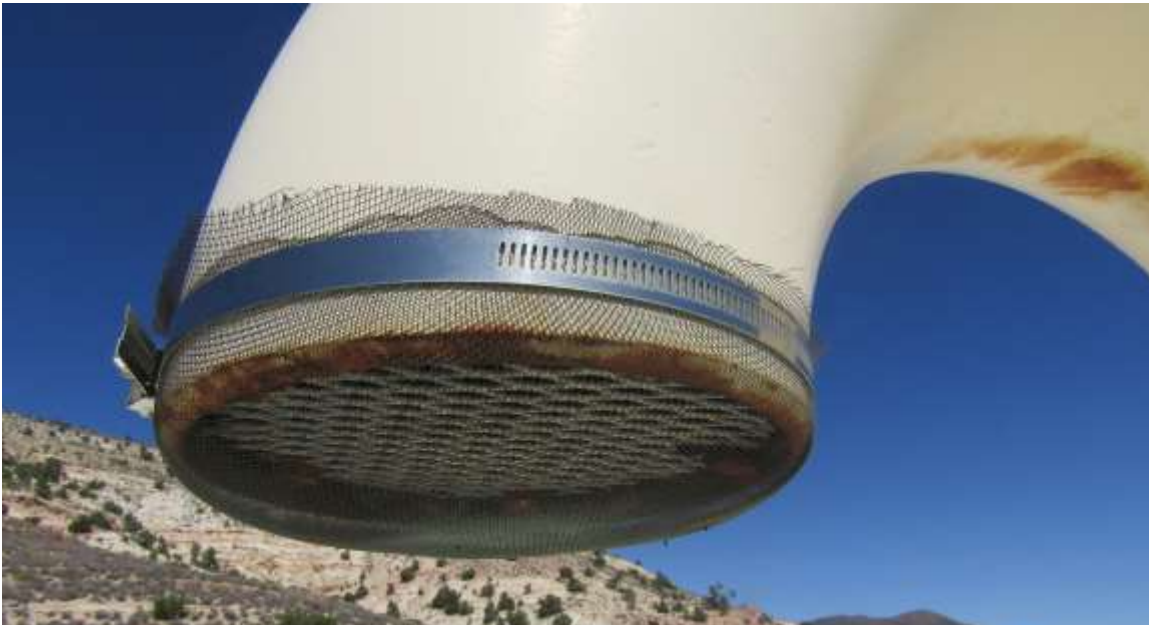
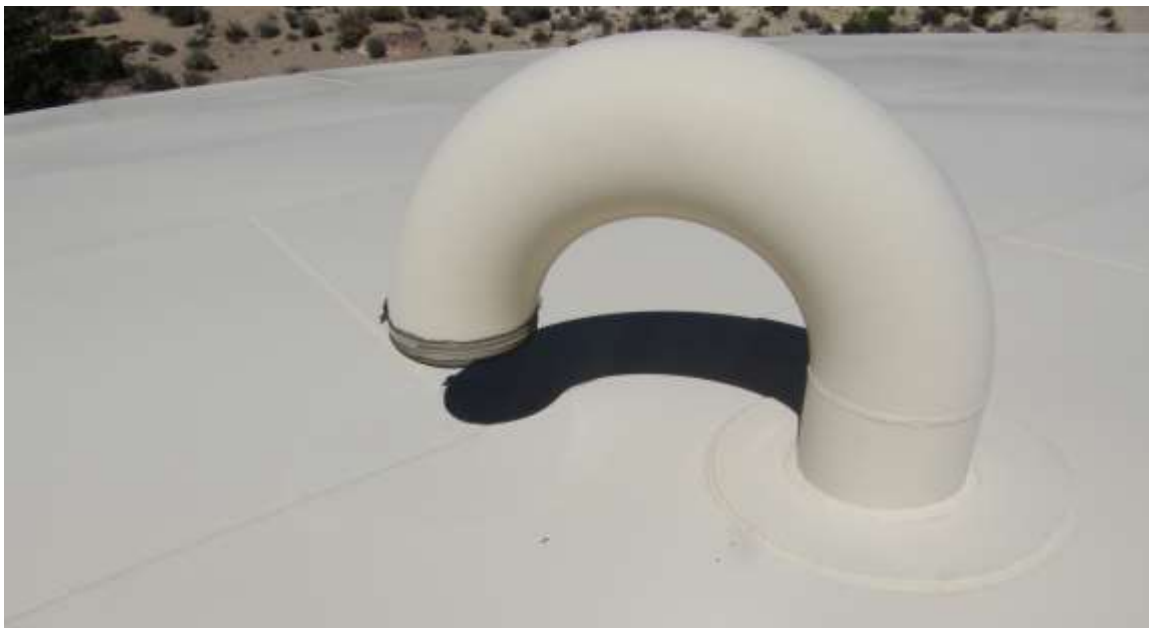
Photos show the condition of the existing 8" roof vent. **This vent is allowing the ingress of rain and wind-borne contaminants into the water system. An improperly vented tank may cause external pressure to act on the tank which can cause buckling even at low pressure differential.** We recommend replacing the existing roof vent with a vacuum-pressure, frost proof vent and screen.

This work should be performed on an emergency basis.

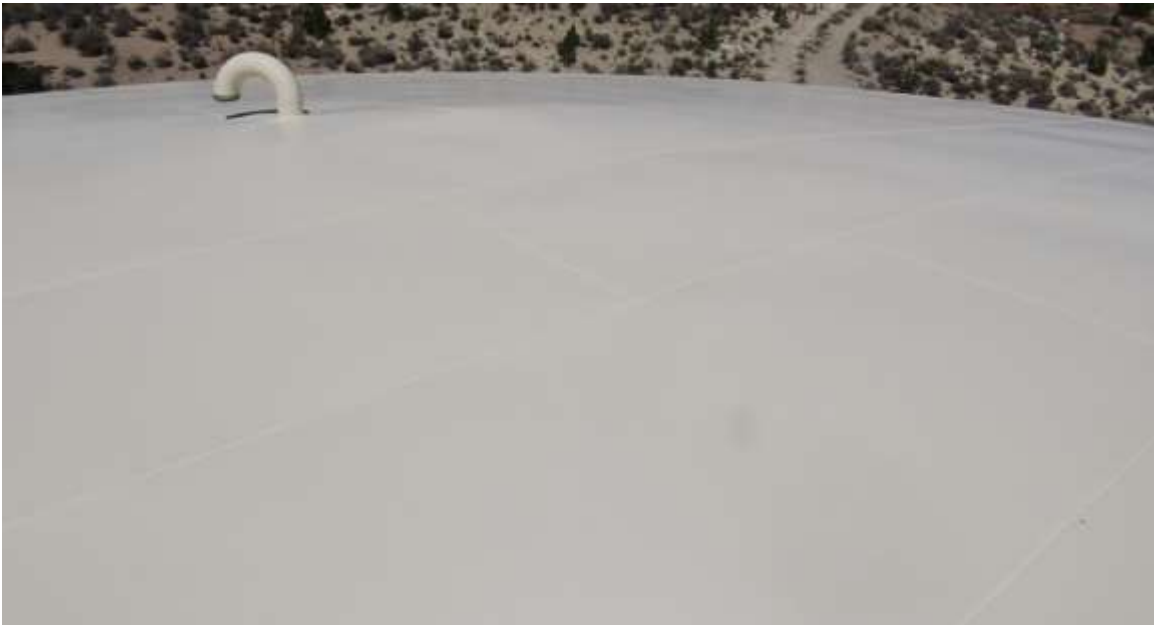
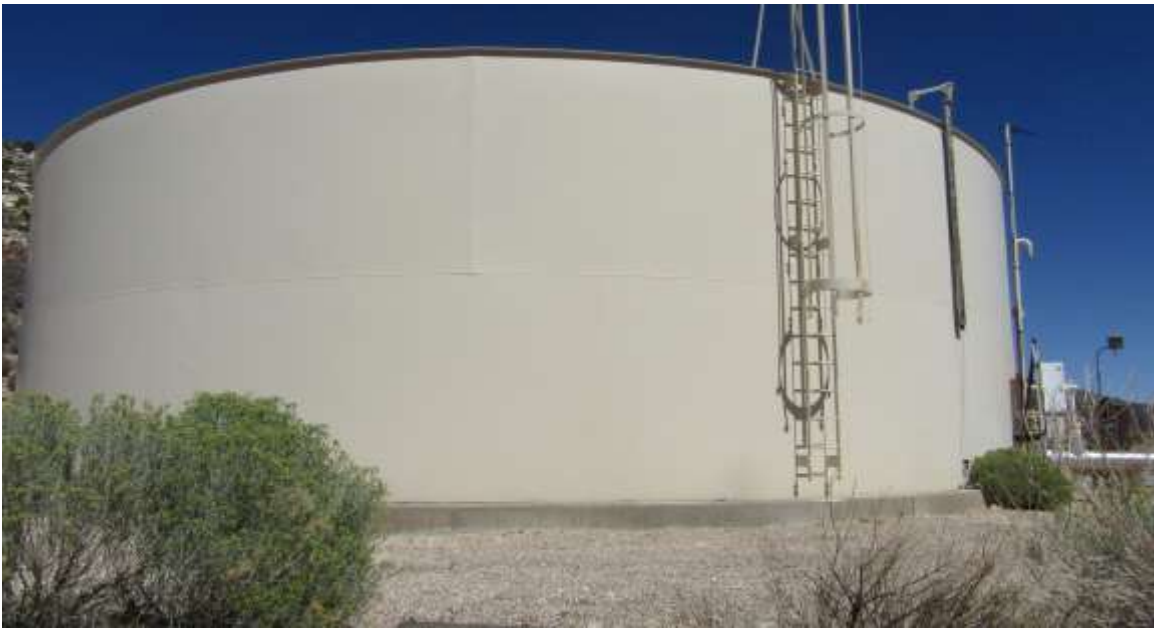
Photos show the tank exterior coating system. The overall exterior coating system appears to be in good condition. We recommend re-evaluating the tank exterior at next inspection cycle.

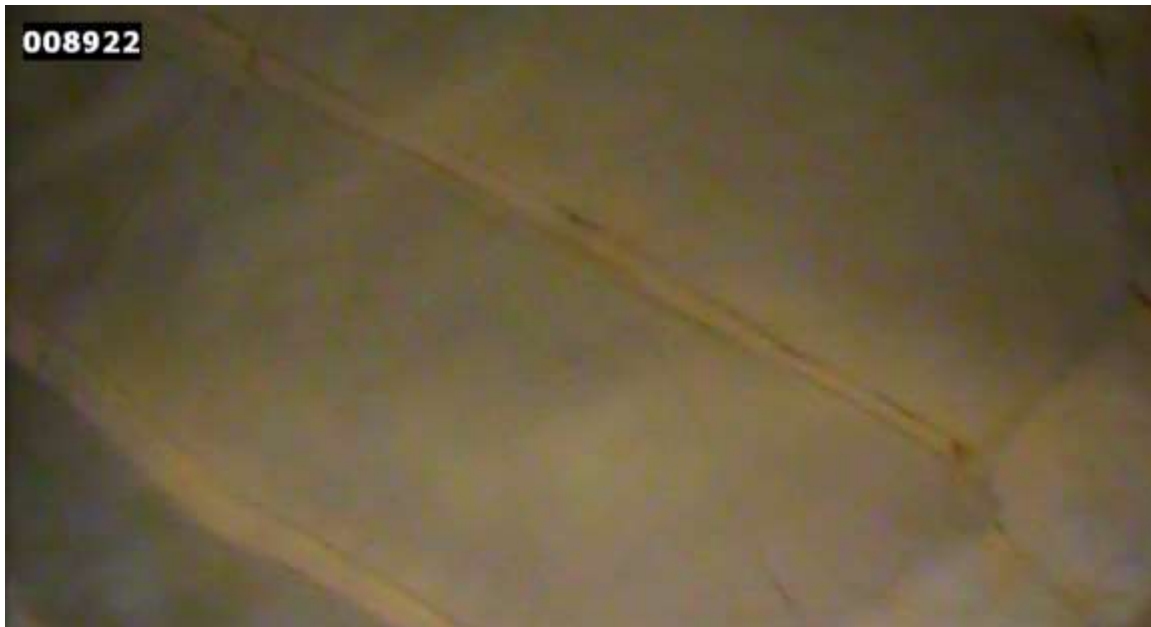
Top photo shows the interior roof lap seams, which appear to be in good condition.

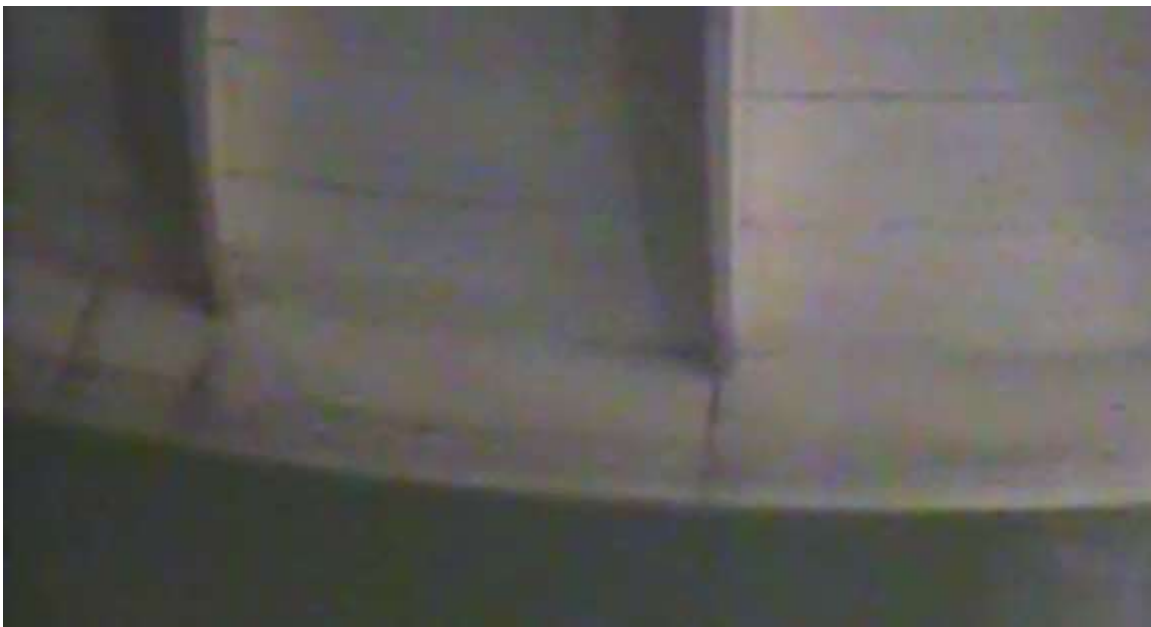
Bottom photo shows the interior roof-to-rim angle connection, which appears to be in good condition.

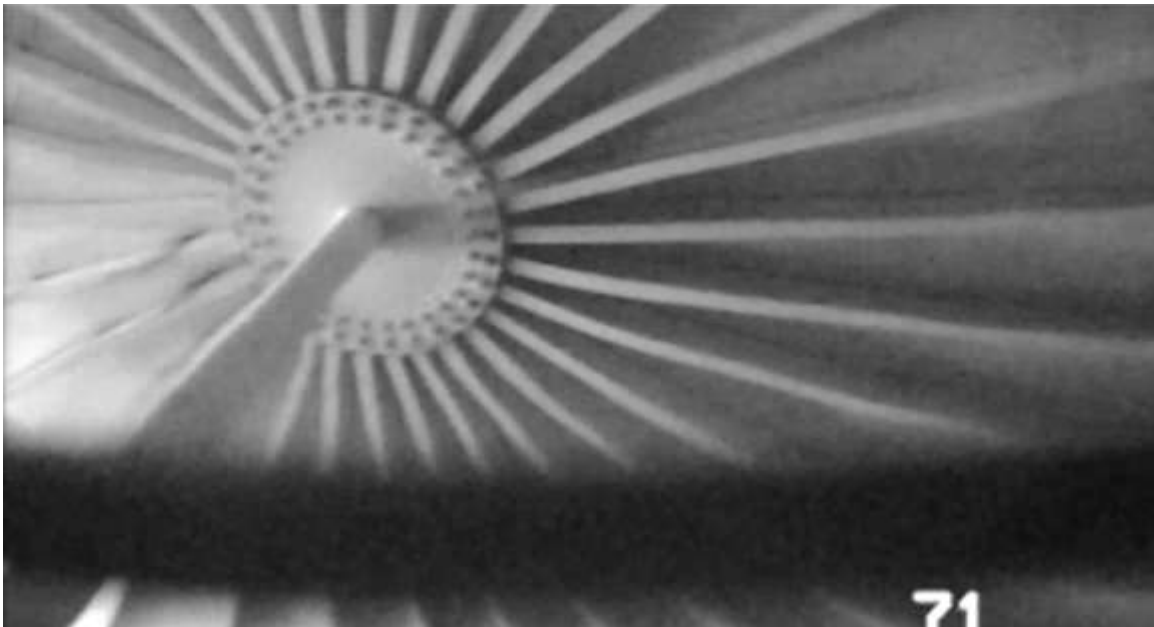
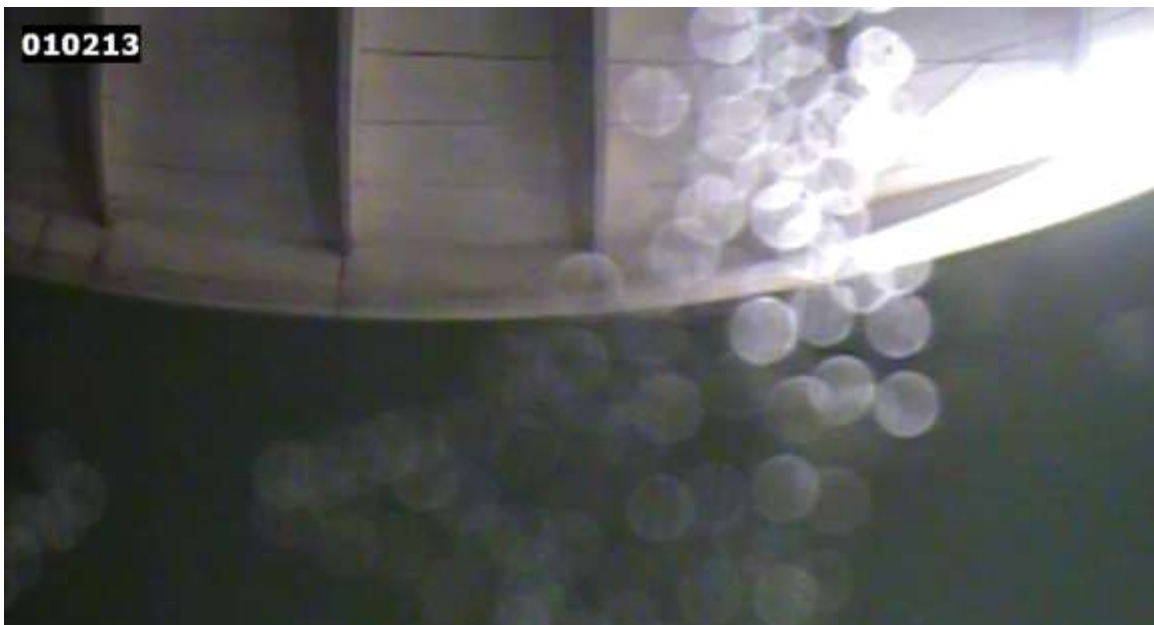
Photos show the rafter-to-support column and rafter-to-shell connections, which appear to be in good condition.

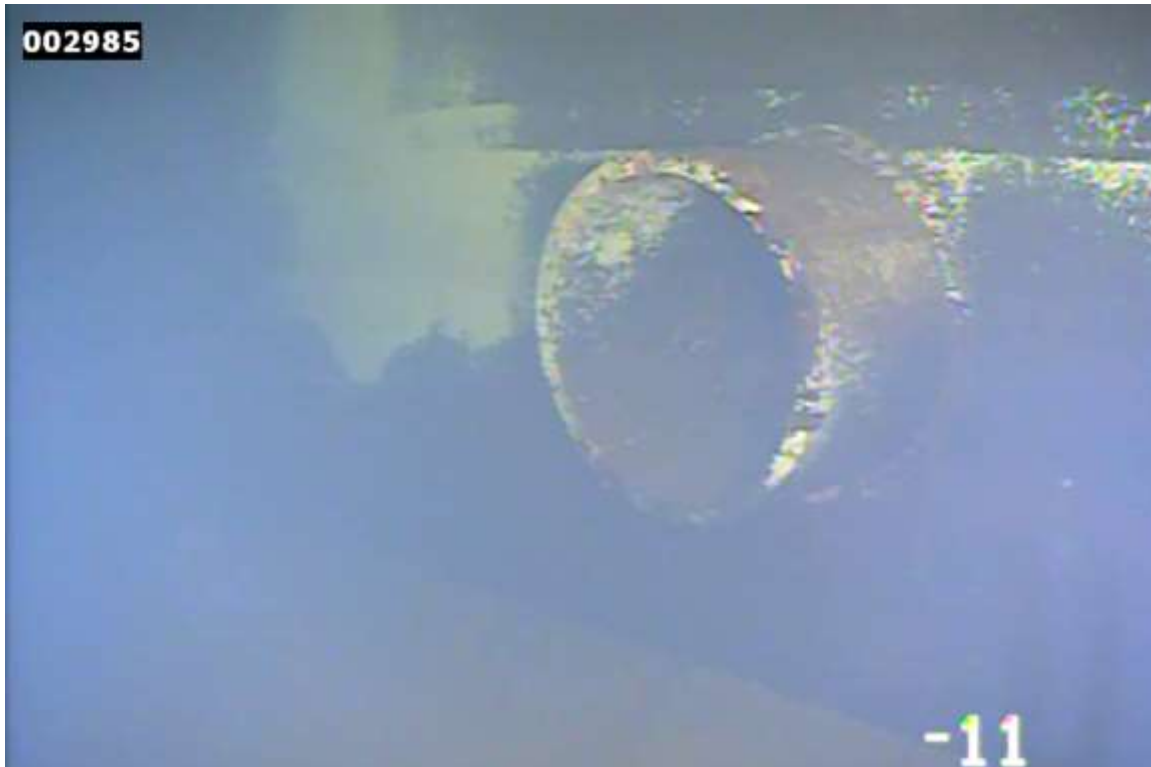
Photo shows a fill pipe on the tank interior. A temperature difference between the water in the top and bottom of a tank, even as little as 1-2 degrees Fahrenheit, is an indication of thermal stratification and the tank water not being completely mixed. Incomplete mixing would result in short-circuiting, and localized increase in water age would develop inside the tank. This typically leads to water quality problems, such as loss of residual, DBP spikes, HPC spikes, bacteria regrowth, formation of bio-film, changes in pH and dissolved oxygen. We recommend installing a mixing system. Electrical work to be done by others if required.

16	Install a mixing system. Electrical work to be done by others if required.		X			
17	Install a passive cathodic protection system.					X
19	Sandblast all rusted and abraded interior areas to SSPC-SP10 (near white), and brush blast all remaining interior areas to SSPC-SP7; then apply one (1) spot coat of epoxy primer to all areas sandblasted to #10, stripe coat all weld seams, and apply one (1) full coat of epoxy to the entire tank, to achieve 8 to 10 mils of total dry film thickness. Total mil thickness will include a combination of the existing and new coating.					X

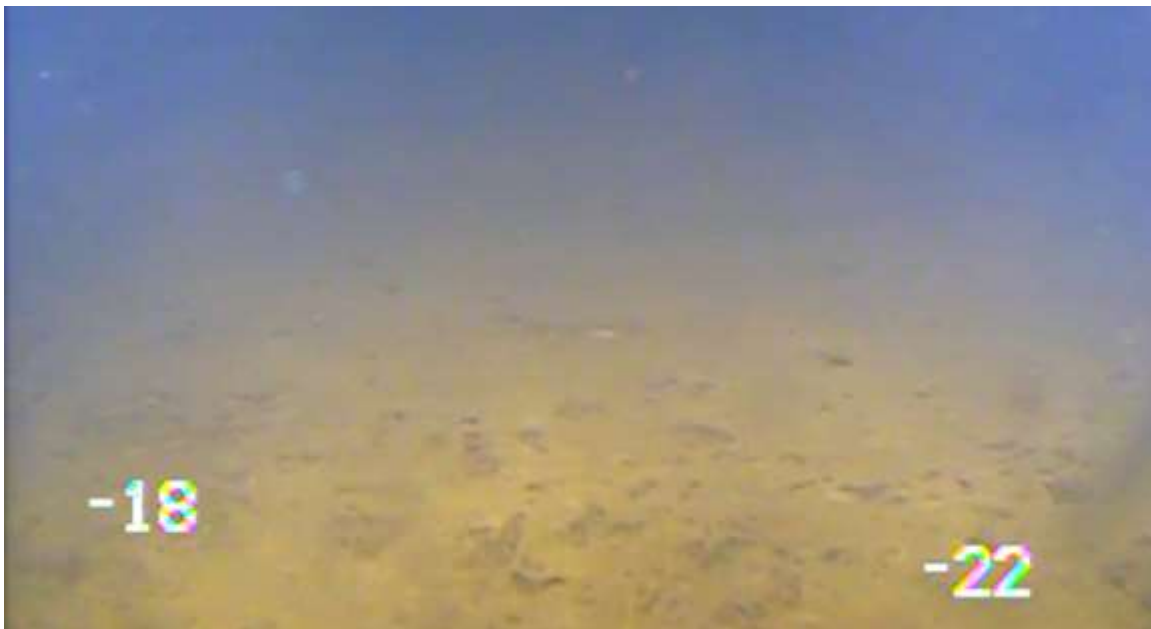
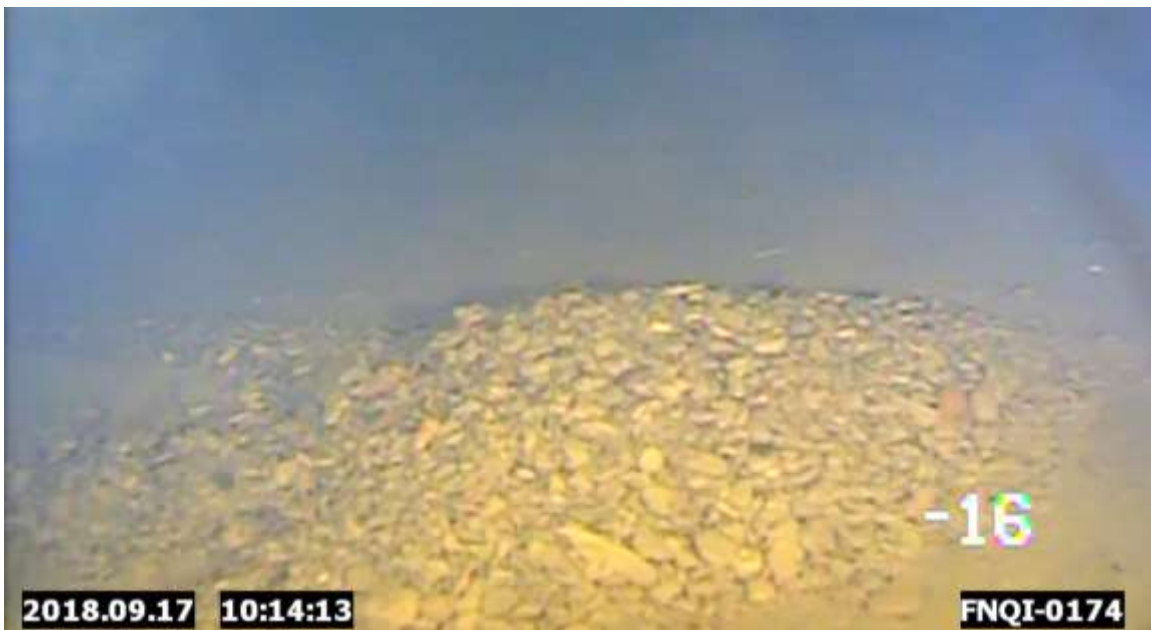
Photos show sediment and debris on the tank interior before a cleanout was performed.

We recommend installing a passive cathodic protection system.

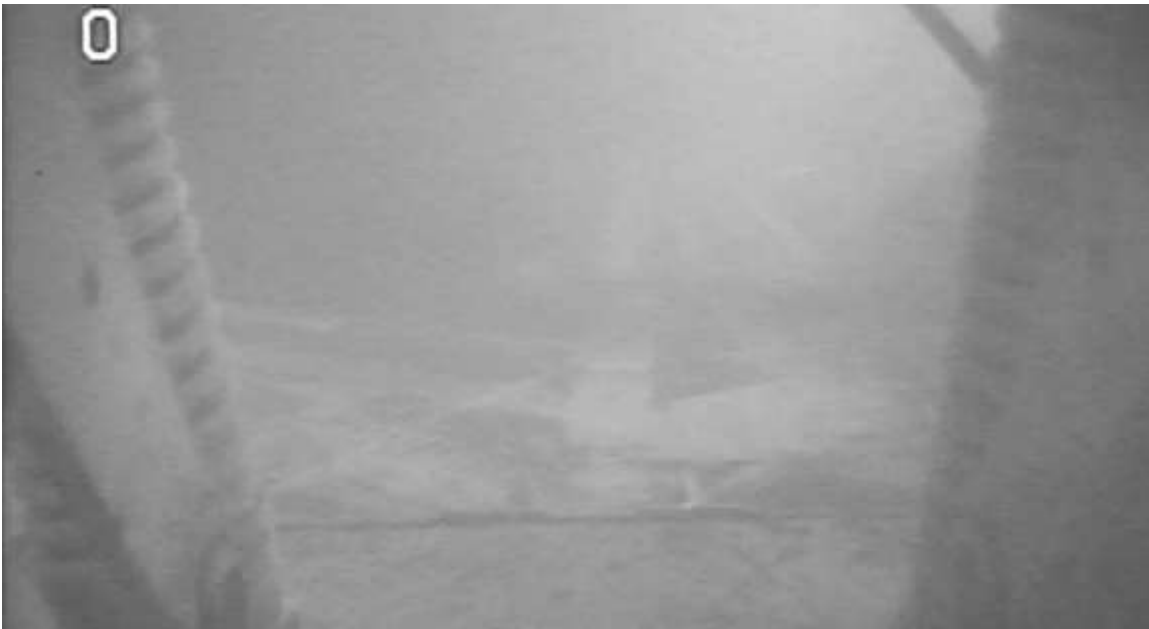
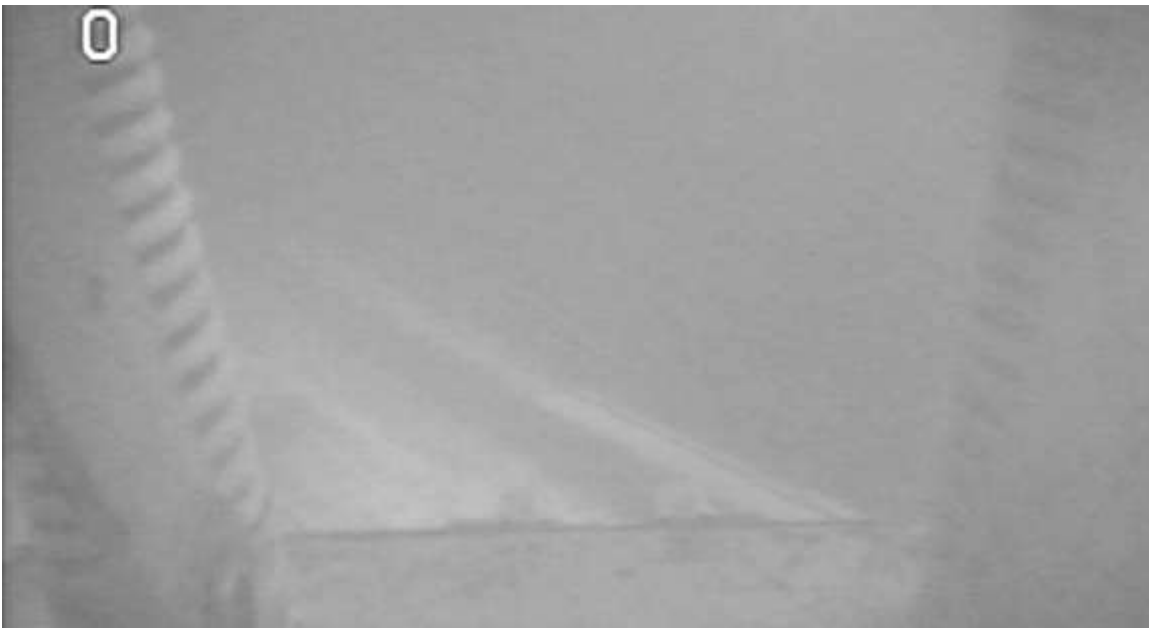
Photos show the tank interior during a cleanout.

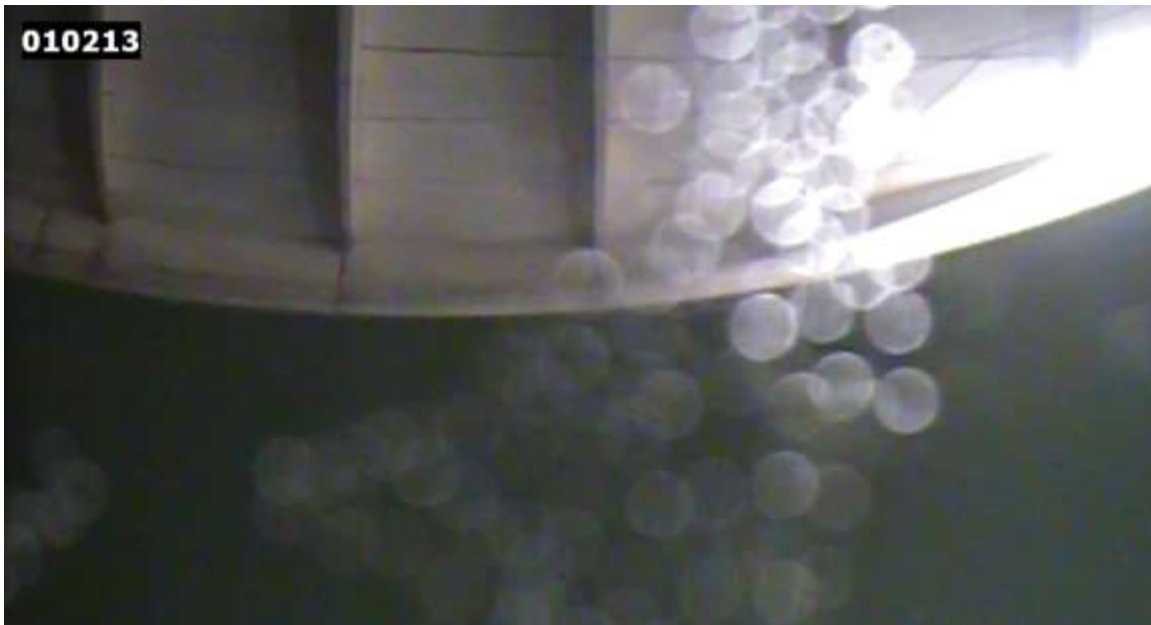
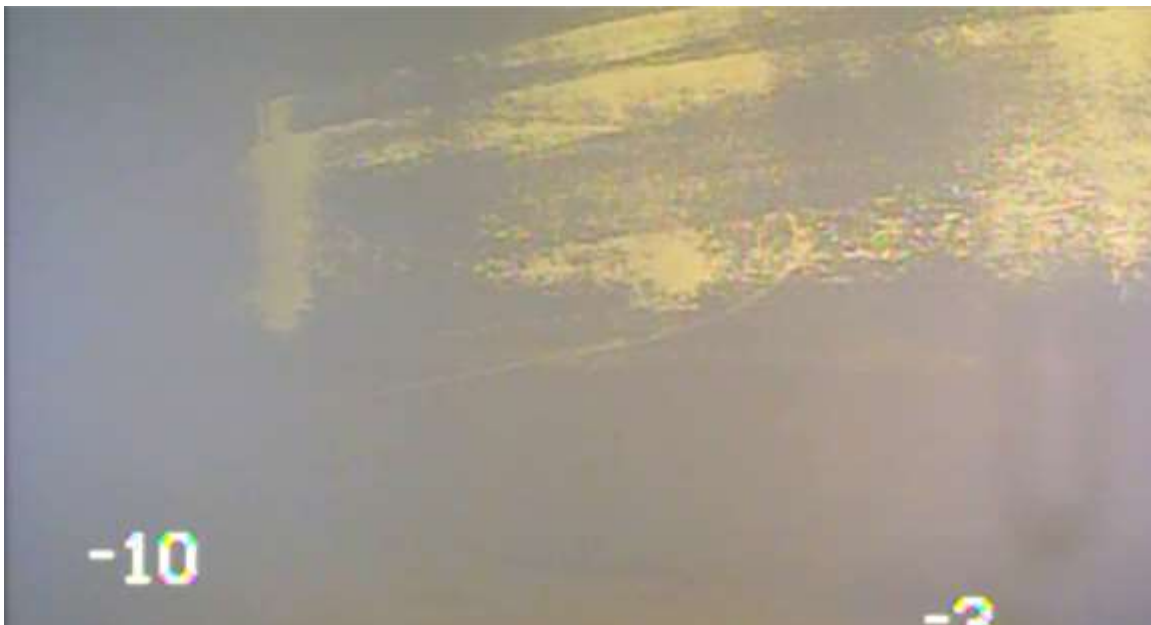
Photos show the condition of the interior coating system. We recommend sand-blasting all rusted and abraded interior areas to SSPC-SP10 (near white), and brush blasting all remaining interior areas to SSPC-SP7; then applying one (1) spot coat of epoxy primer to all areas sandblasted to #10, stripe coating all weld seams, and applying epoxy to the entire tank, to achieve 8 to 10 mils of total dry film thickness. Total mil thickness will include a combination of the existing and new coating.

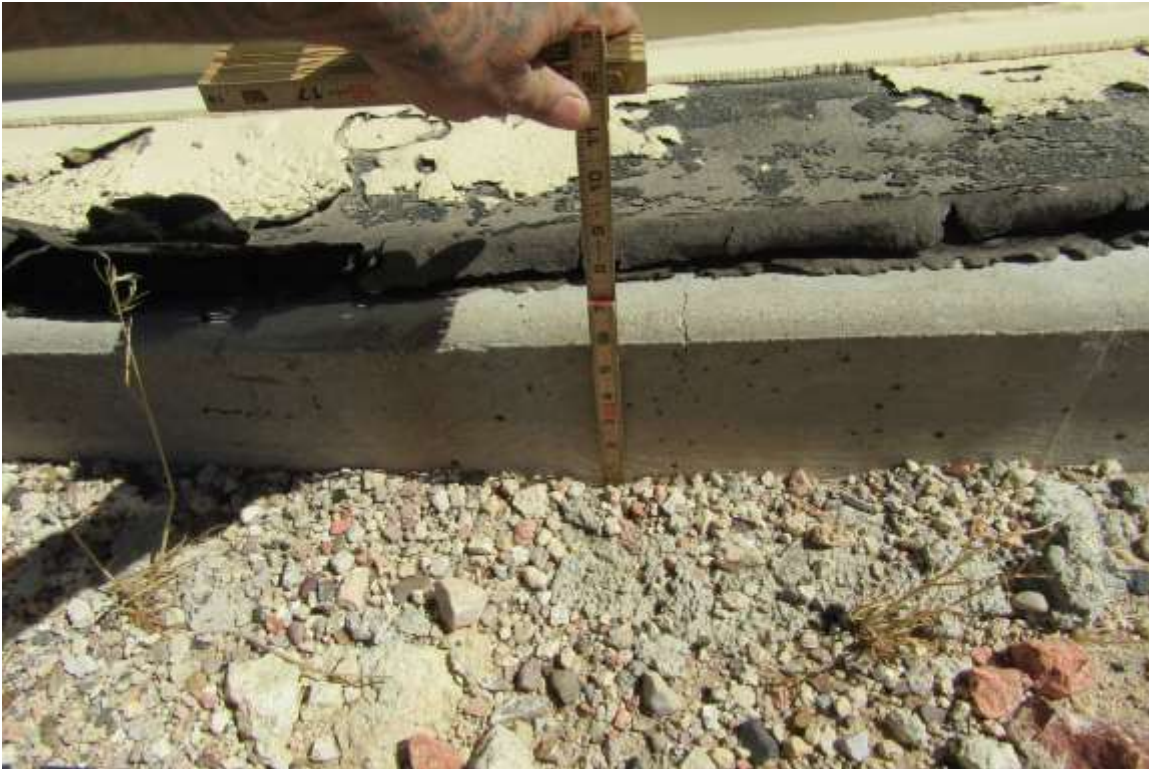
Photo shows the area around the tank foundation is properly graded and in compliance with **AWWA D100-11; 12.7.1 Height aboveground.**

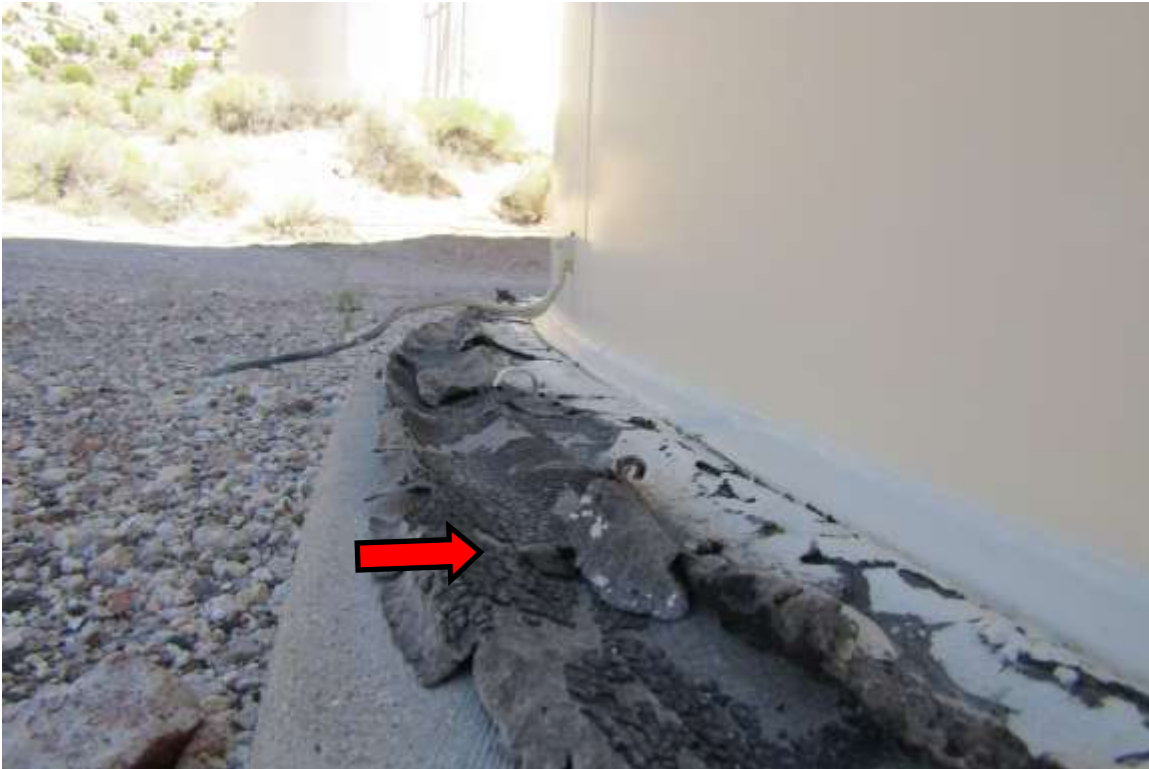
Photo shows the condition of the foundation. We recommend caulking/grouting around the base of the tank to foundation connection to prevent water from entering under the tank, then sealing the foundation with a sealant.

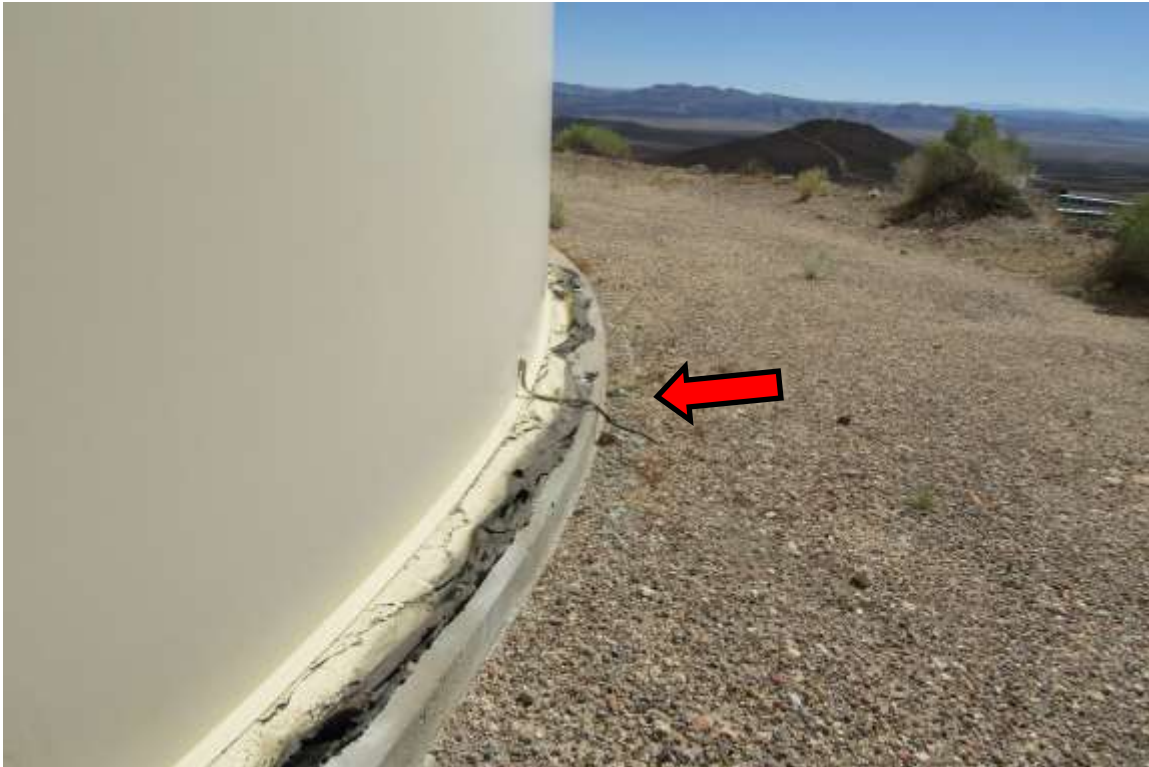
Photo shows the tank is electrically grounded for lightning protection as required by **OSH Act of 1970 Section 5** and appears to be in good condition.

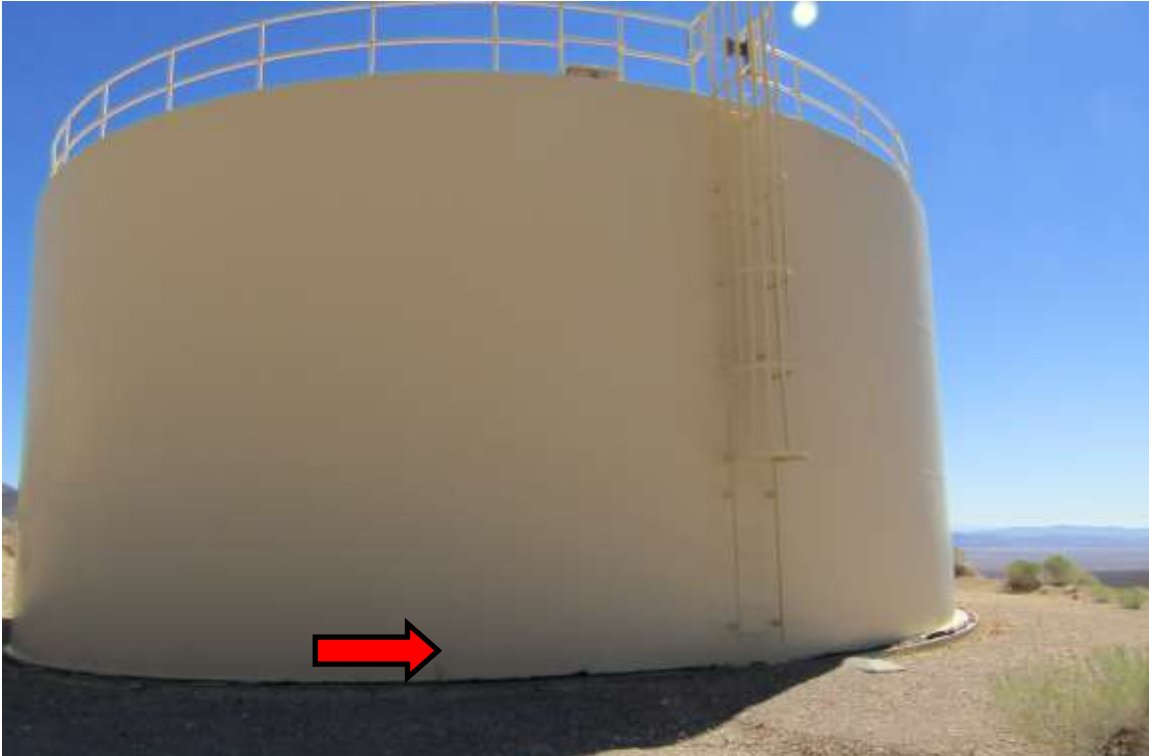
Photo shows the condition of the shell. Currently there is no drain valve. We recommend installing a frost proof drain valve near the shell-to-floor connection, complete with a locking device to prevent unauthorized draining of the tank and a splash pad to direct water away from the foundation.

**Splash pad to be installed by owner.*

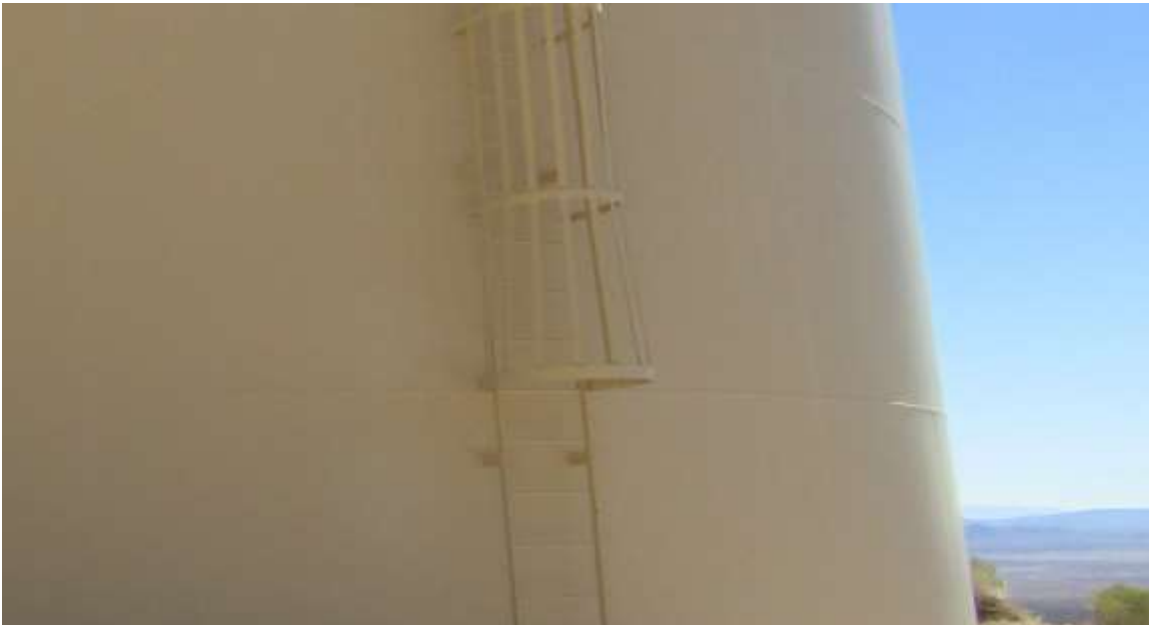
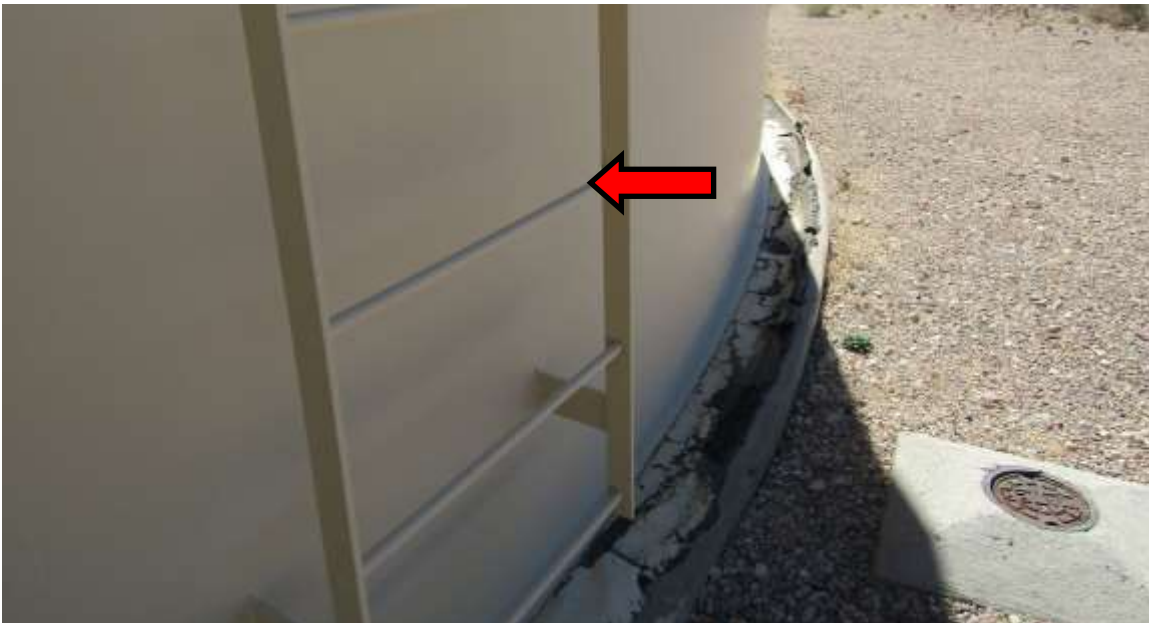
Shell access ladder in above photos is 24" wide, but is not equipped with anti-skid rungs. We recommend installing anti-skid rung covers, a cable type ladder safety device, a lockable ladder guard to prevent unauthorized access, and posting a **Fall Protection Required** sign at the base of the ladder.

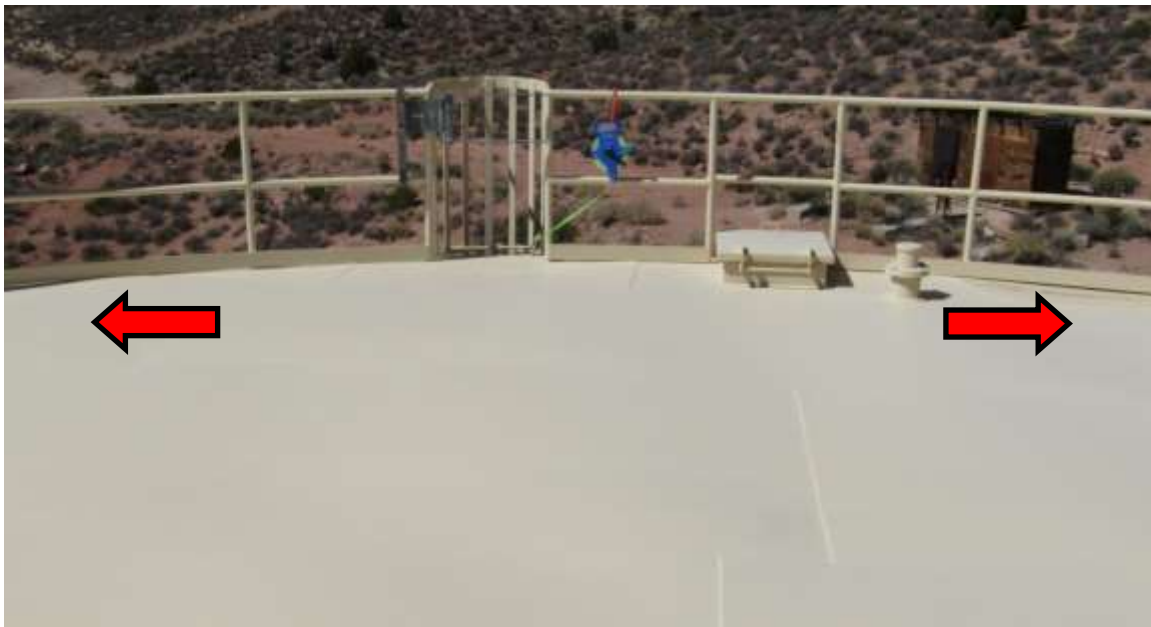
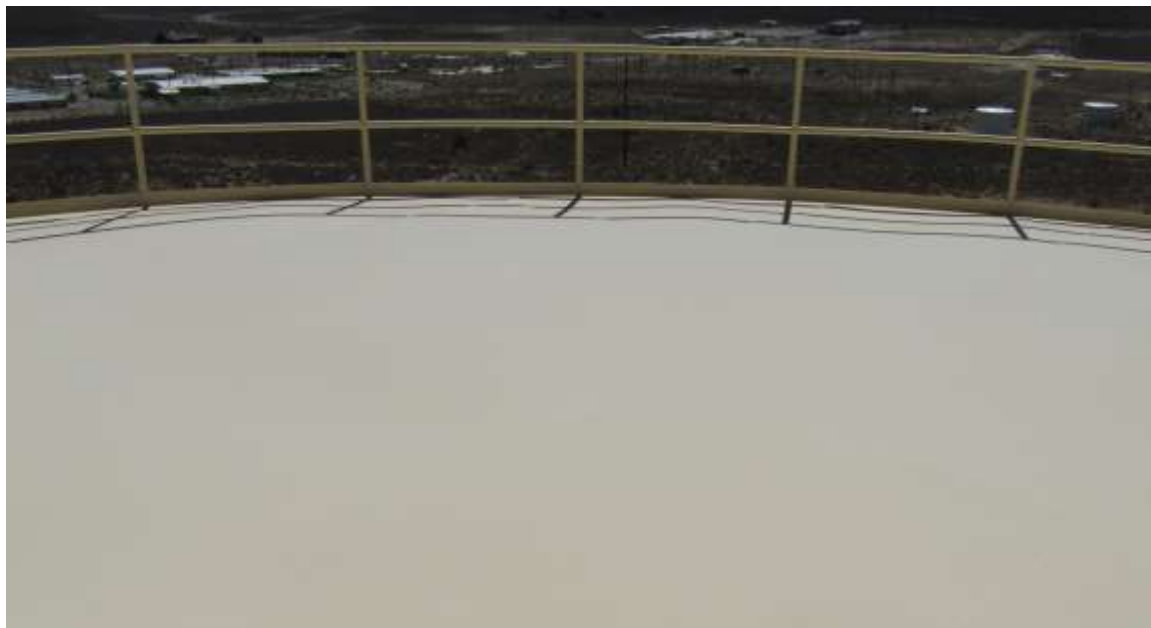
Photos show the tank roof edge is equipped with a 43" high compliant handrail system for fall protection as required by **OSHA 1910.28(b)(1)**. The handrail system is equipped with an intermediate rail and toeboard.
