**Mission Support and Test Services, LLC
Nevada National Security Site
Mercury, NV 89023
RE: Mercury North (Area 23); Mercury, NV
1,500,000 Gallon GST
September 16, 2018
Mr. Kevin Olsen
Scientist 1
(702) 295-0485
Job No. 318448-A**

**Mission Support and Test Services, LLC
Nevada National Security Site
Mercury, NV 89023
RE: Camp South (Area 12); Mercury, NV
500,000 Gallon GST
September 13, 2018
Mr. Kevin Olsen
Scientist 1
(702) 295-0485
Job No. 318448-D**

**Mission Support and Test Services, LLC
Nevada National Security Site
Mercury, NV 89023
RE: Well 4/4a South (Area 6); Mercury, NV
150,000 Gallon GST
September 24, 2018
Mr. Kevin Olsen
Scientist 1
(702) 295-0485
Job No. 318448-H**

**Mission Support and Test Services, LLC
Nevada National Security Site
Mercury, NV 89023
RE: C-1 North (Area 6); Mercury, NV
50,000 Gallon GST
September 21, 2018
Mr. Kevin Olsen
Scientist 1
(702) 295-0485
Job No. 318448-O**

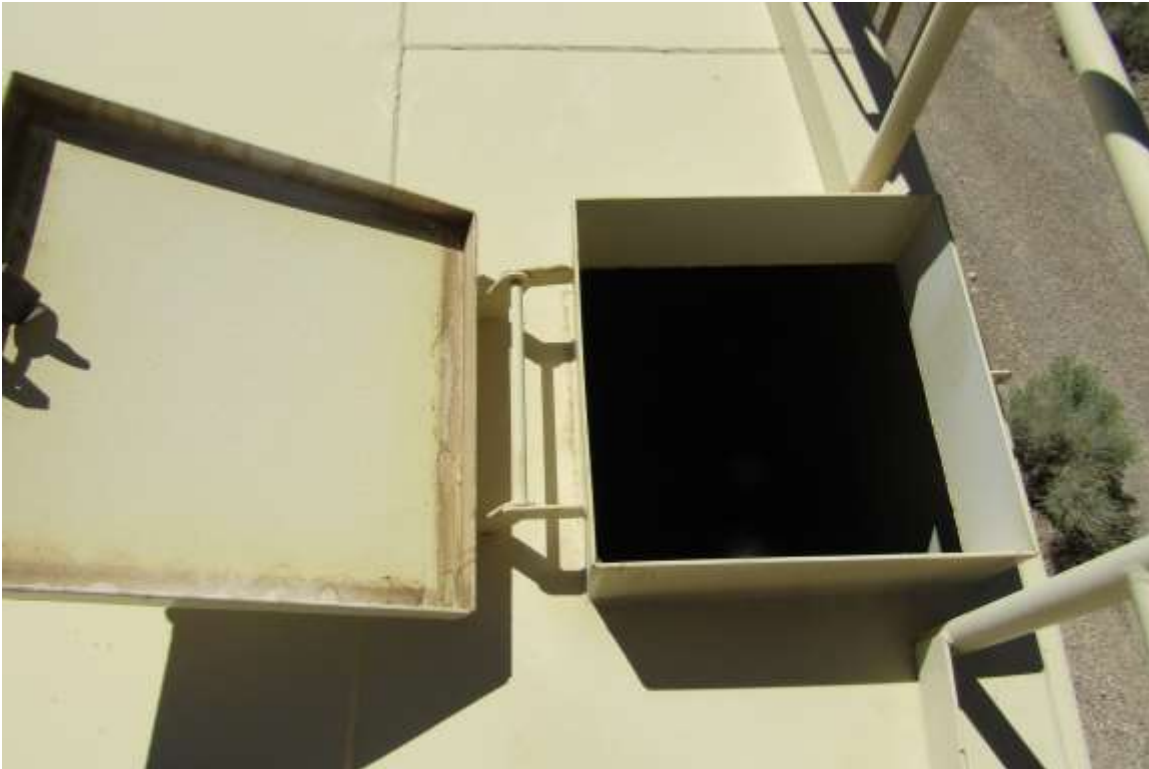
Photo shows the condition of the 24" primary roof hatch. Roof openings on this tank require the following to be in compliance with **AWWA D100-11; 7.4.3 Roof openings** and **OSHA 1910.146(c)(2) Confined spaces**.

We recommend:

We further recommend installing **OSHA** compliant interior access ladders complete with standoffs every 10' on center, and cable type ladder safety devices at the primary and suggested secondary roof hatches.

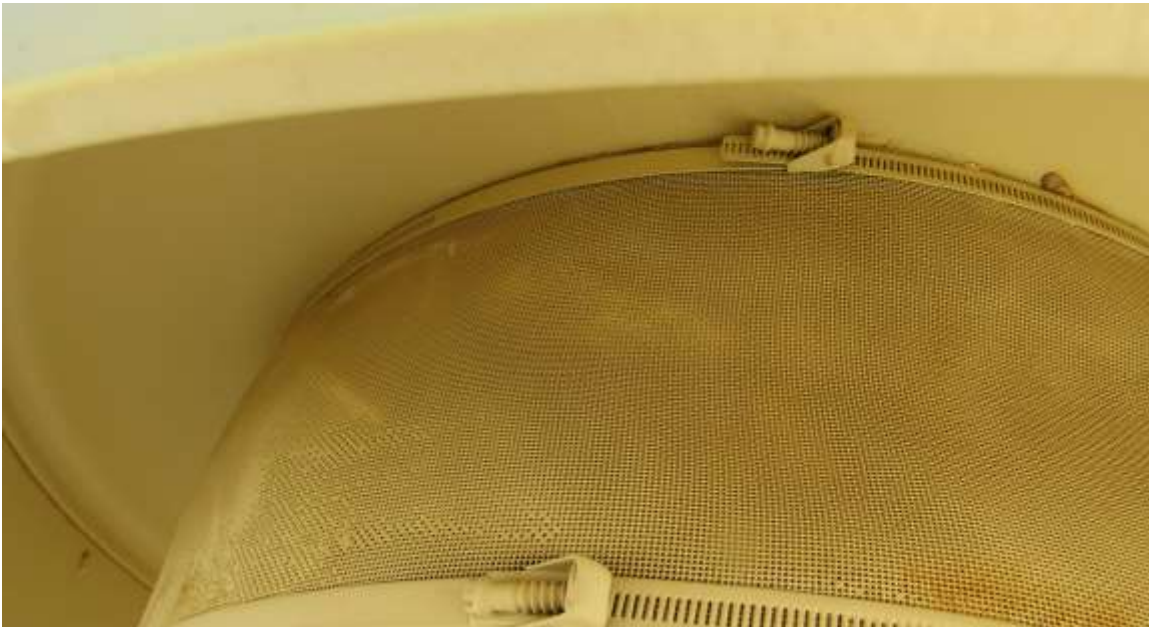
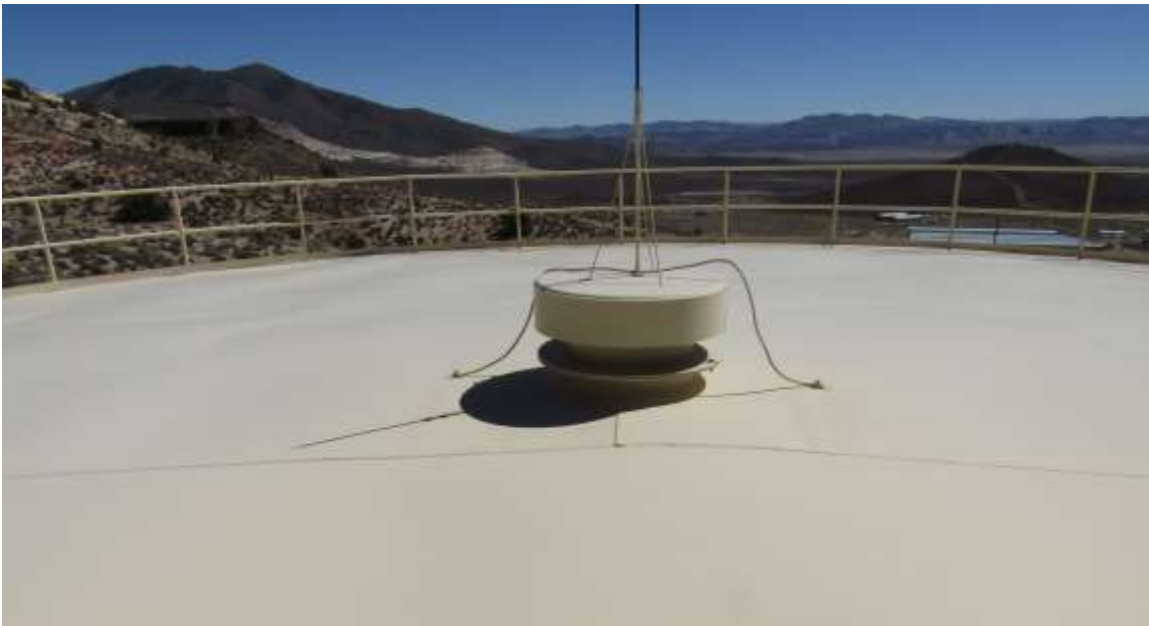
Photos show the existing roof vent, which appears to be in good condition.

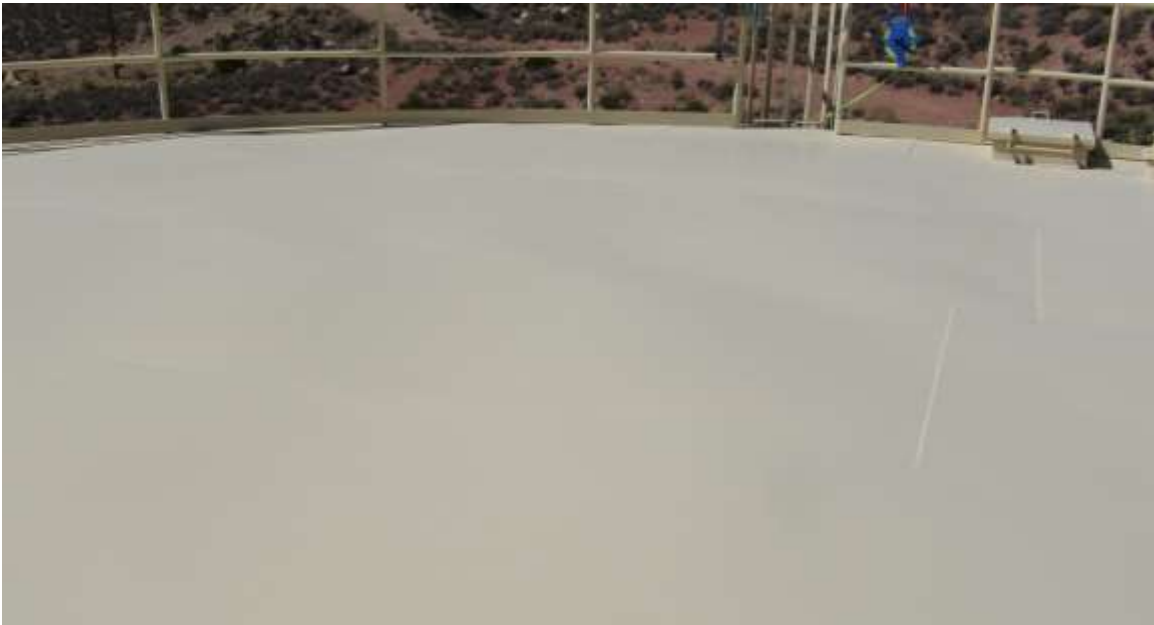
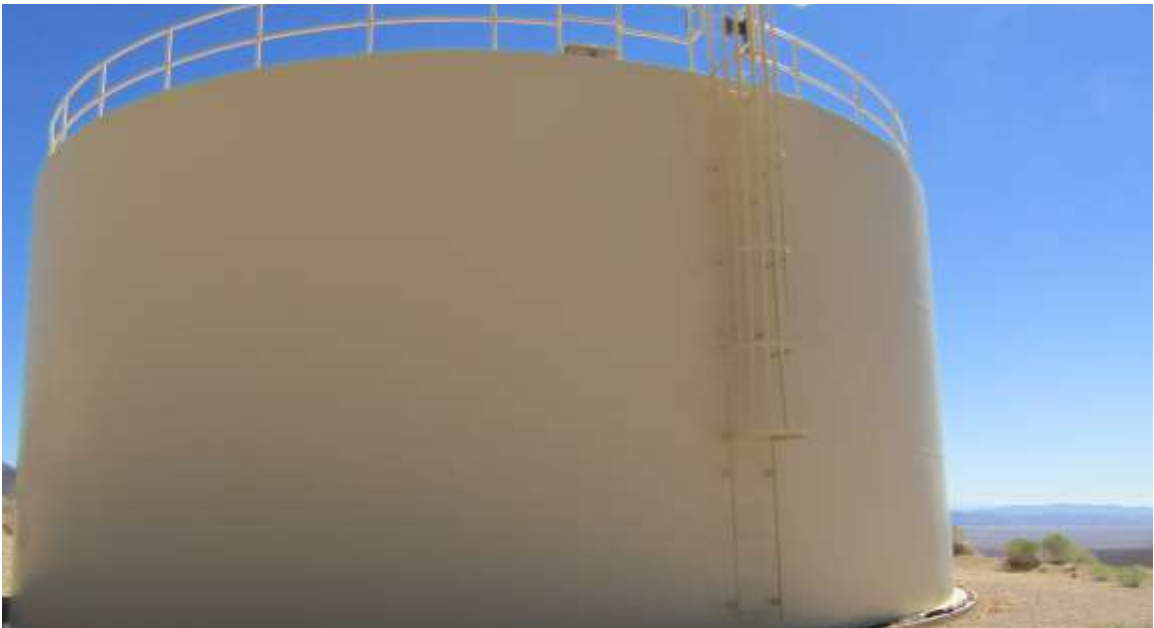
Photos show the tank exterior coating system. The overall exterior coating system appears to be in good condition. We recommend re-evaluating the tank exterior at next inspection cycle.

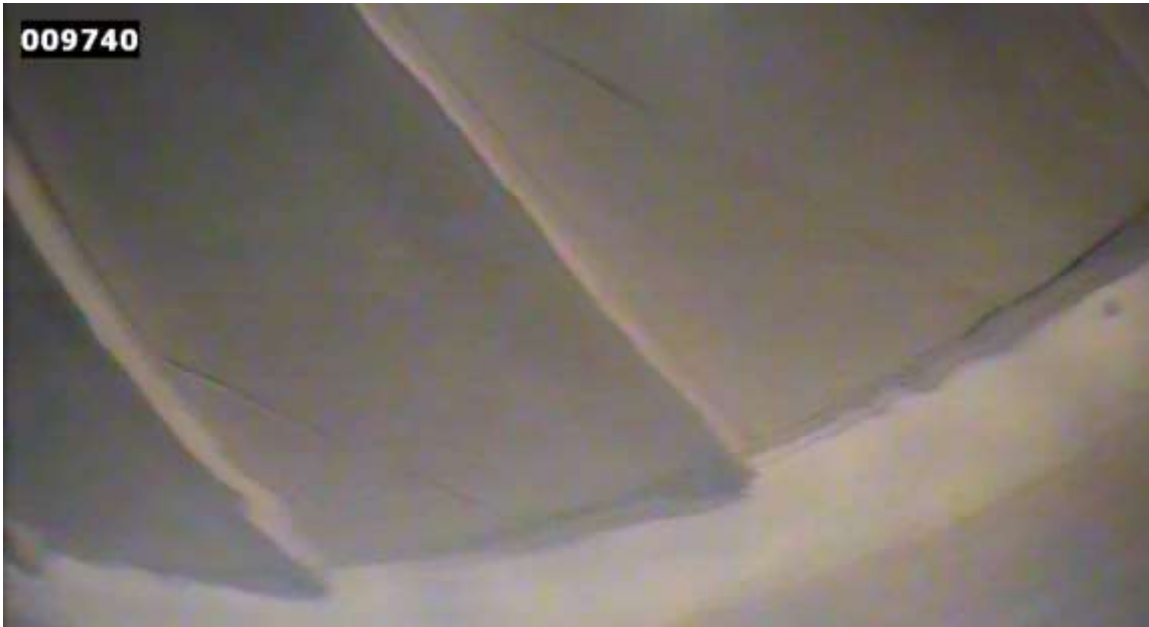
Top photo shows the interior roof lap seams, which appear to be in good condition.

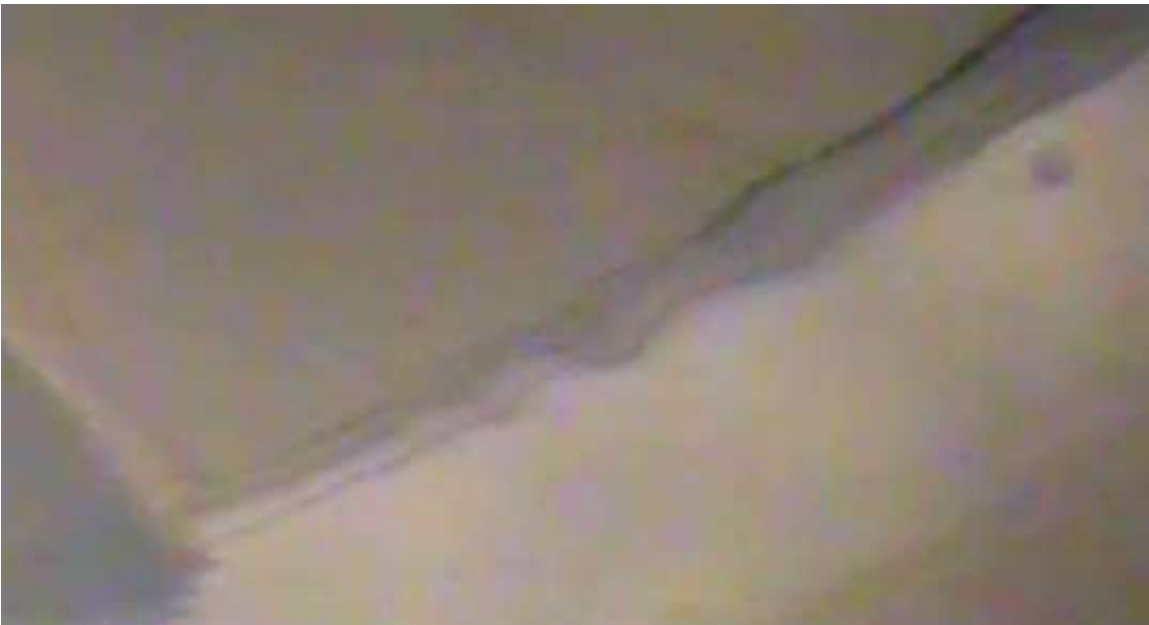
Bottom photo shows the interior roof-to-rim angle connection, which appears to be in good condition.

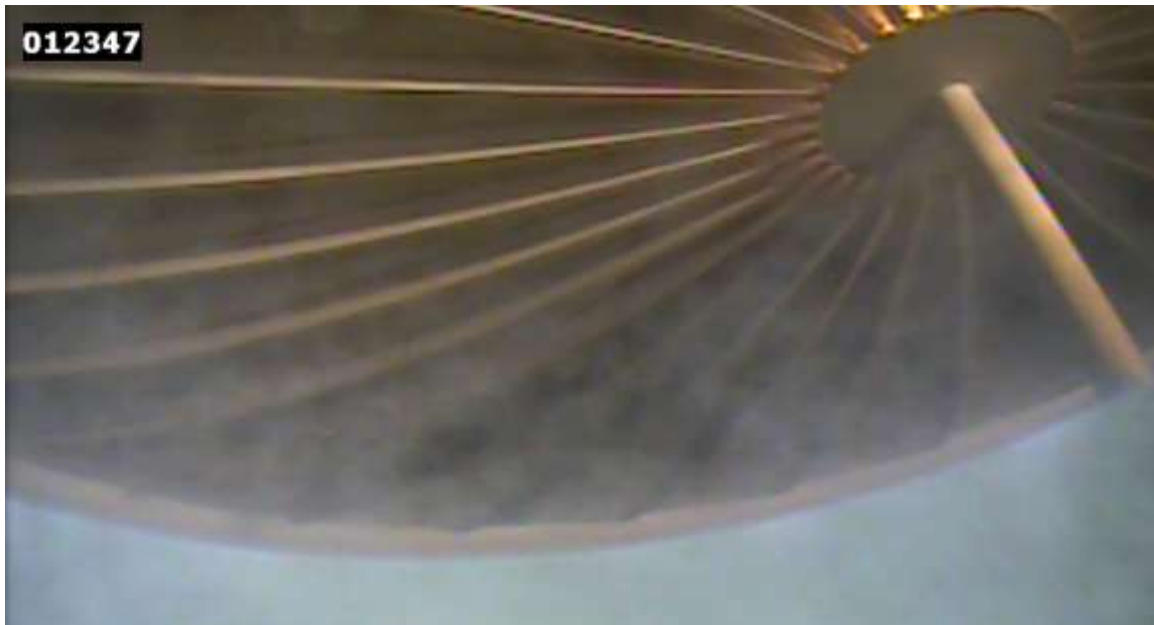
Photos show the rafter-to-support column and rafter-to-shell connections, which appear to be in good condition.

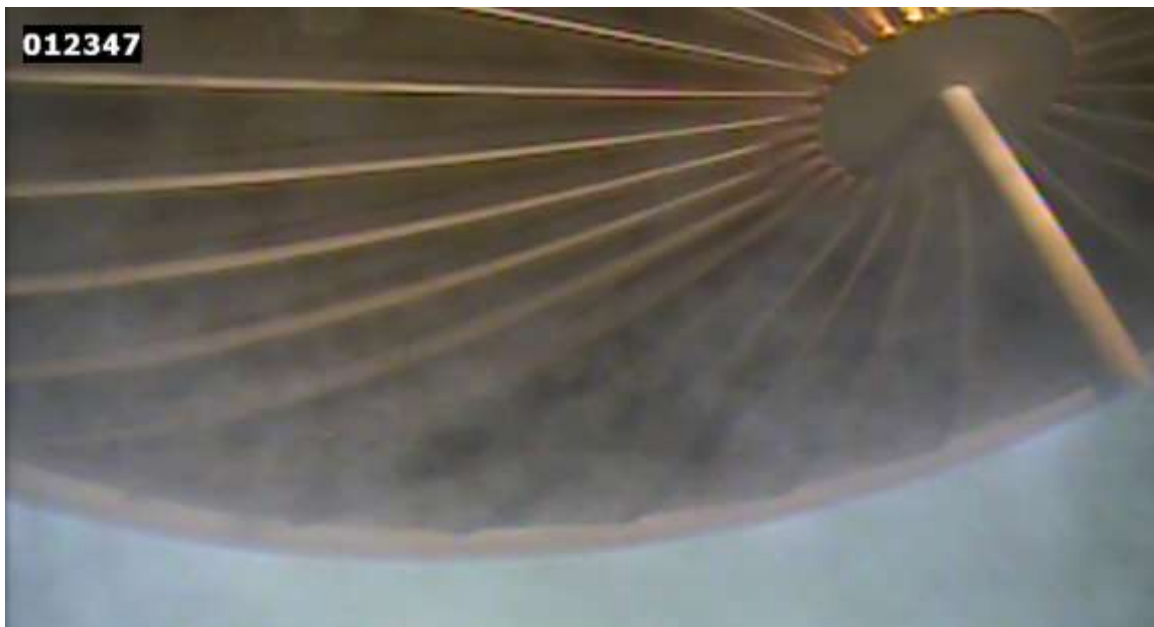
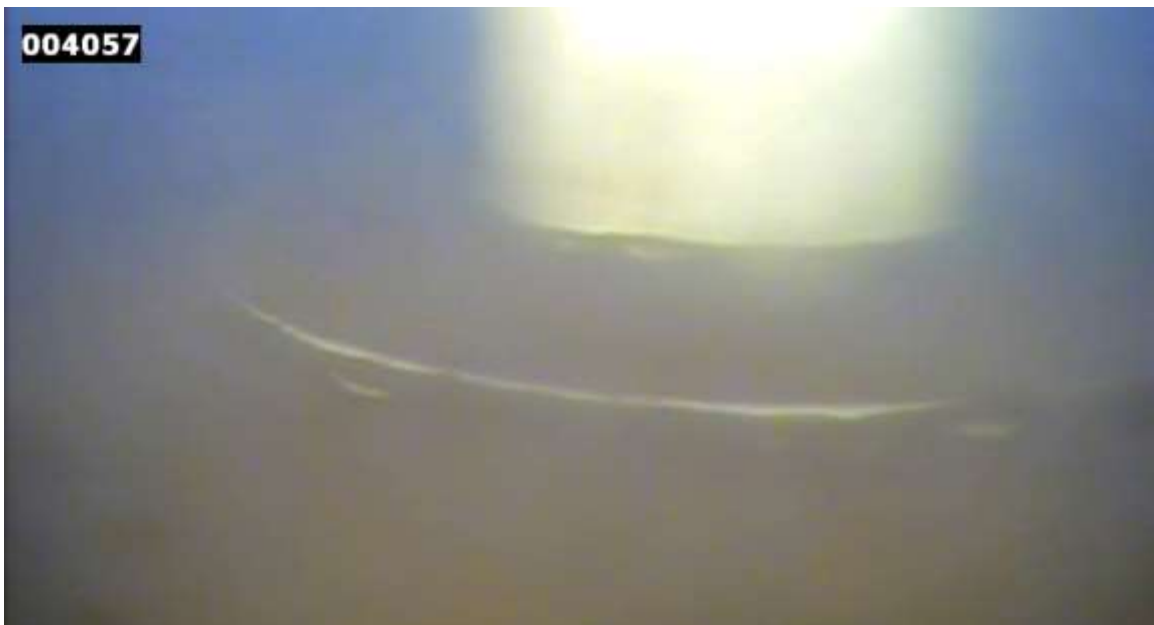
Top photo shows the center support column, which appears to be in good condition.

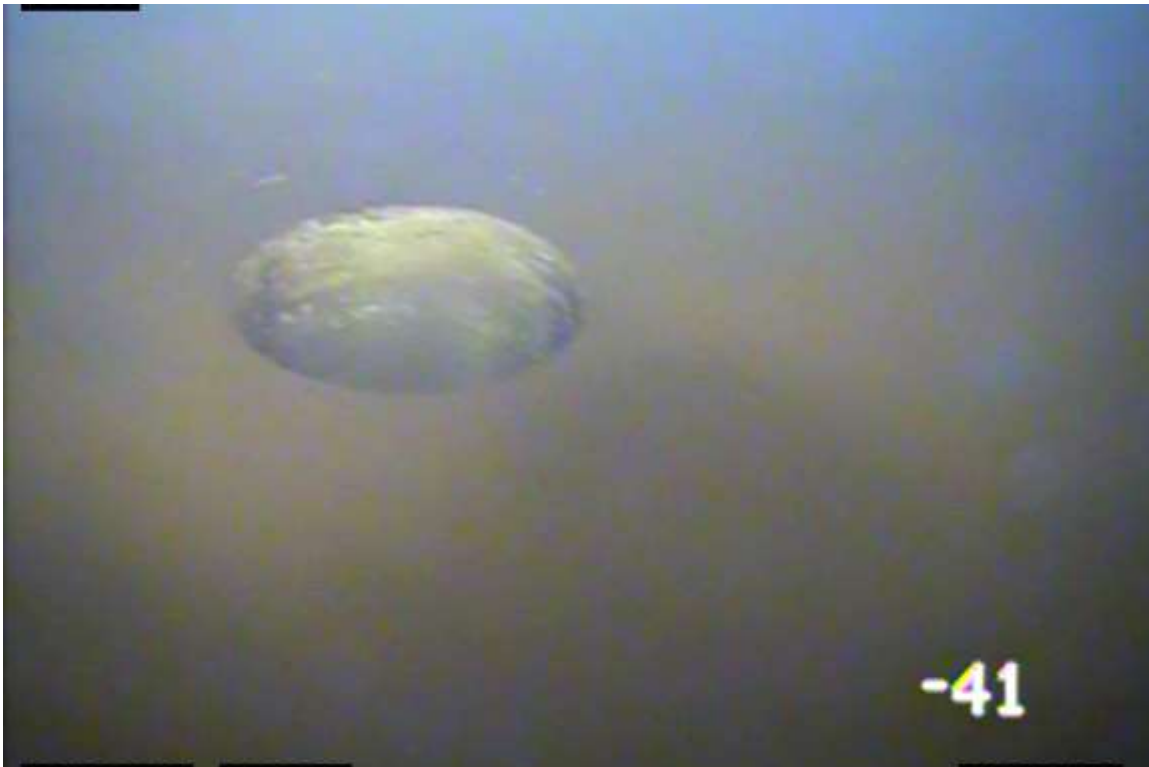
Photo shows a fill pipe on the tank interior. A temperature difference between the water in the top and bottom of a tank, even as little as 1-2 degrees Fahrenheit, is an indication of thermal stratification and the tank water not being completely mixed. Incomplete mixing would result in short-circuiting, and localized increase in water age would develop inside the tank. This typically leads to water quality problems, such as loss of residual, DBP spikes, HPC spikes, bacteria regrowth, formation of bio-film, changes in pH and dissolved oxygen. We recommend installing a mixing system. Electrical work to be done by others if required.

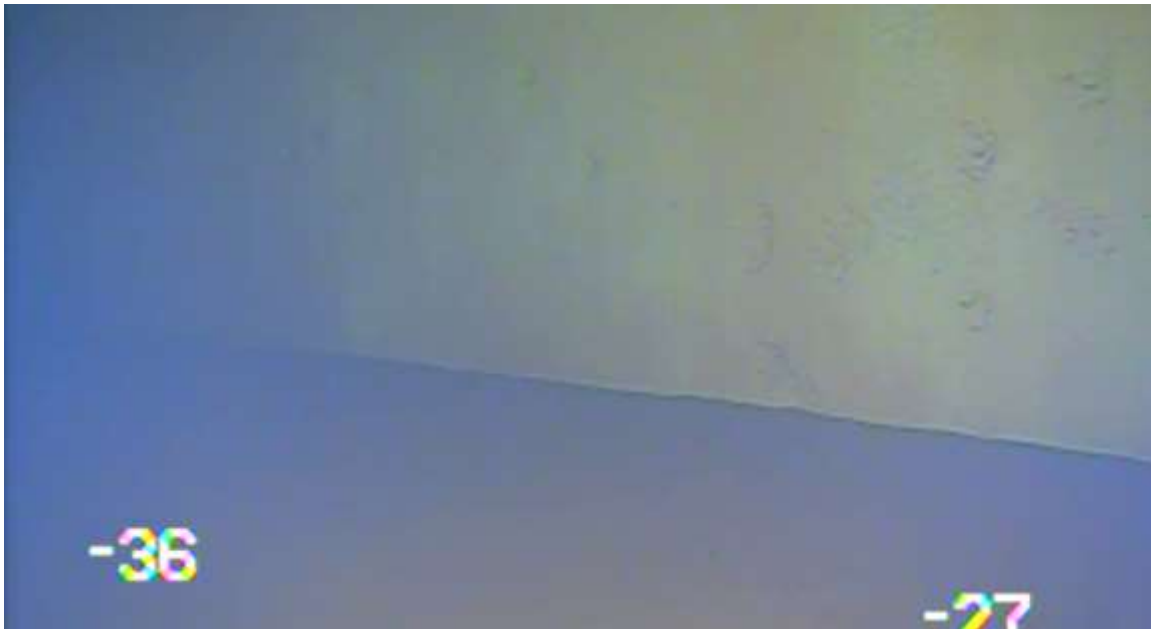
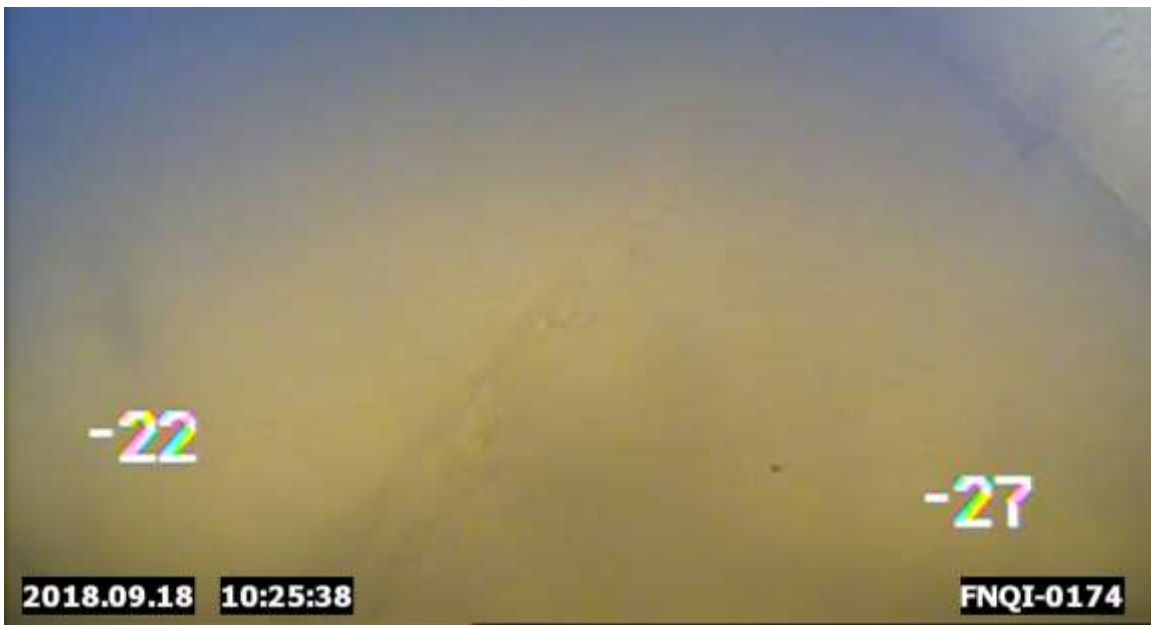
Photos show sediment and debris on the tank interior before a cleanout was performed.

We recommend installing a passive cathodic protection system.

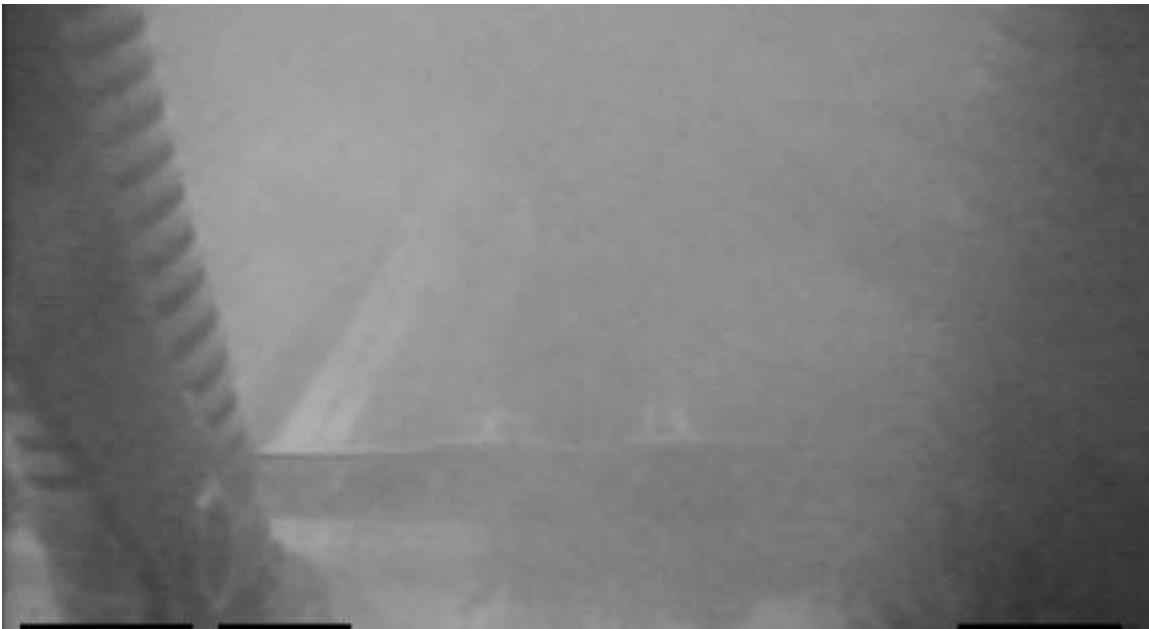
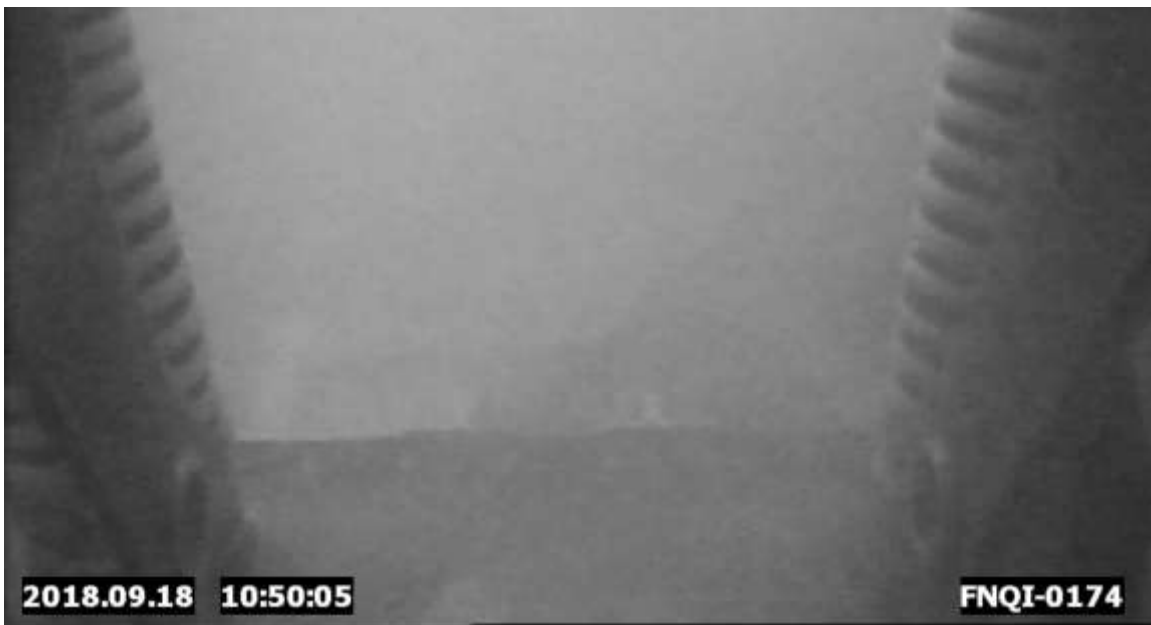
Photos show the tank interior during a cleanout.

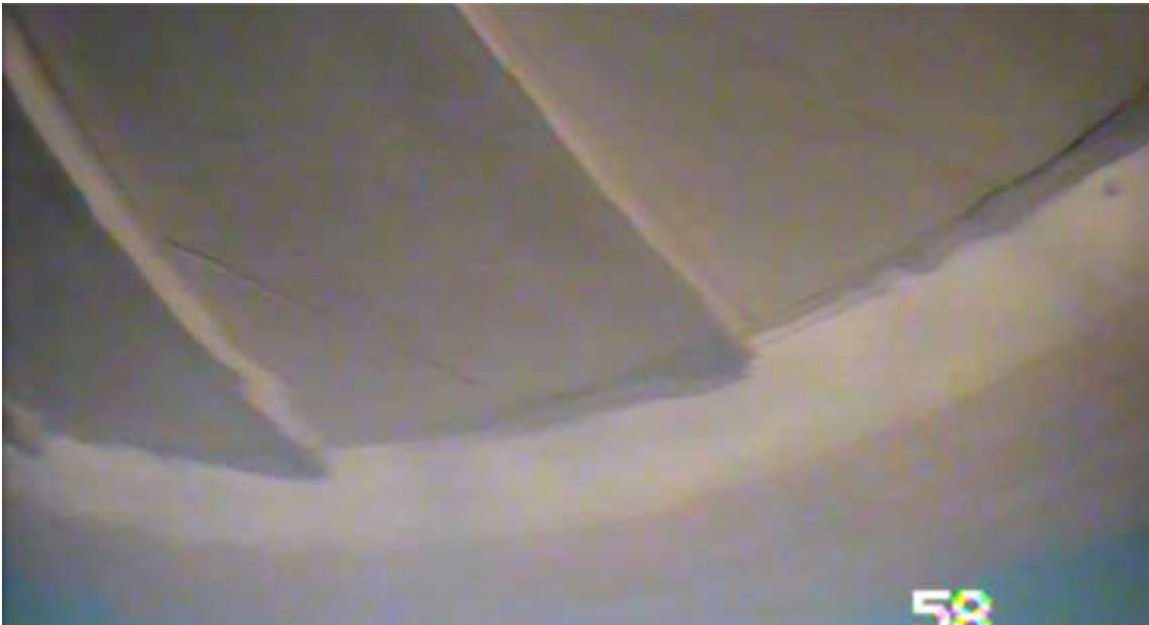
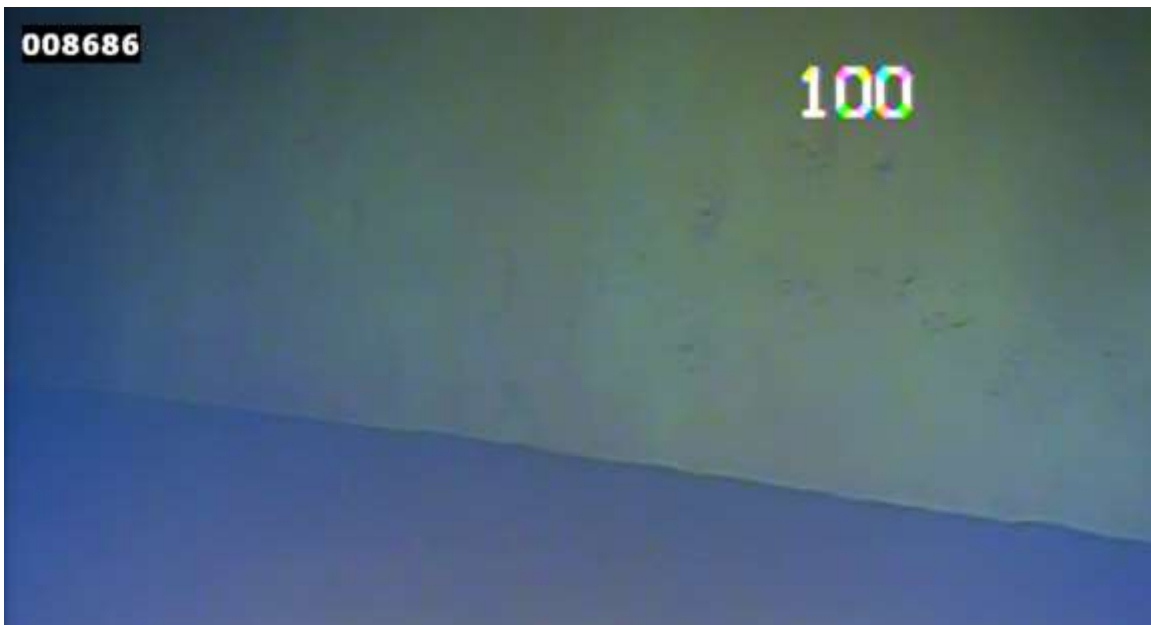
Photos show the tank interior coating system. The overall interior coating system appears to be in good condition. We recommend pressure washing the tank interior with biodegradable detergent injection (minimum 3,500 psi at 3.0 gpm), then re-evaluating the tank interior at next inspection cycle.

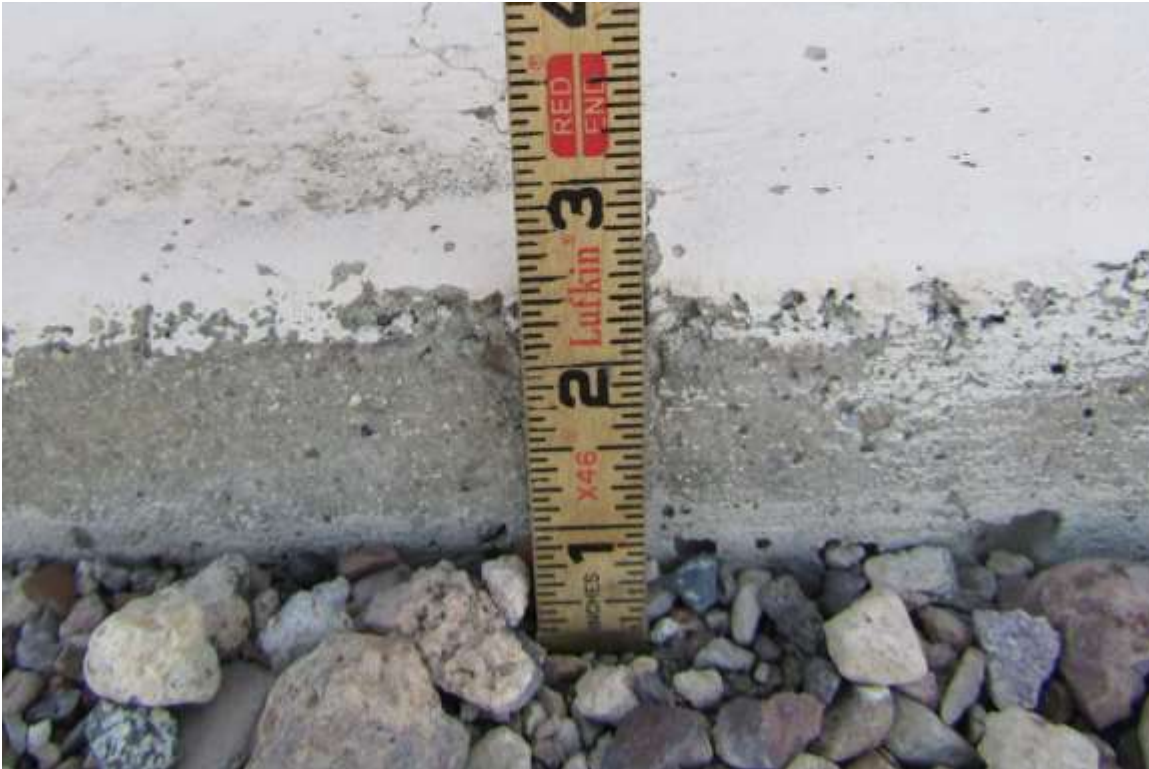
Photo shows the condition of the foundation. **AWWA D100-11; 12.7.1 Height aboveground** states, "The tops of the concrete foundations shall be a minimum of 6" above the finished grade, unless otherwise specified." We recommend clearing any dirt, debris and other loose gravel away from the tank foundation, down to a minimum 6" below top of foundation. This should be done by a local excavating company.

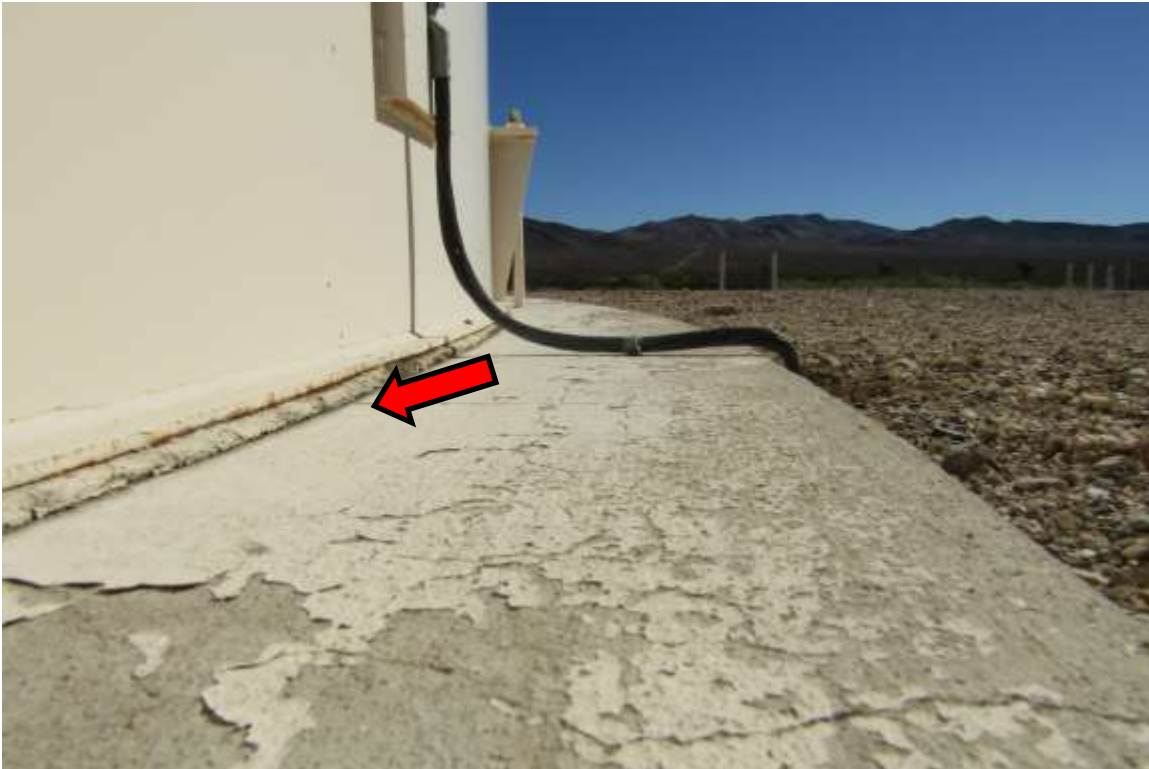
Photo shows the condition of the foundation. **NFPA 22-2018; 12.2.1.2** states, "... the junction of the tank bottom and the top of the concrete foundation shall be tightly sealed to prevent water from entering the base." We recommend repairing any cracks and spalling in the concrete with a commercial non-shrinking grout, caulking/grouting around the base of the tank to foundation connection to prevent water from entering under the tank, then sealing the foundation with a sealant.

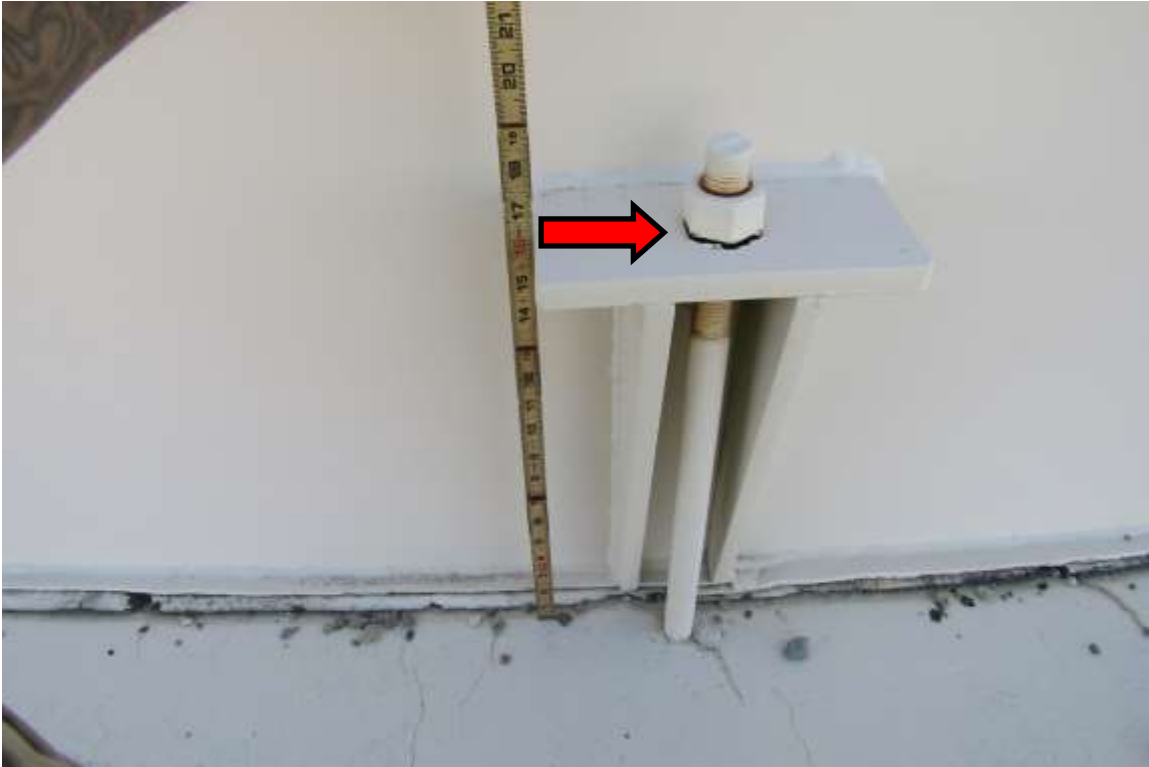
Photo shows the condition of the anchor bolts. **AWWA D100-11; 3.8.1.1 Required anchorage** states, "For ground-supported flat-bottom reservoirs and standpipes, mechanical anchorage shall be provided when the wind or seismic loads exceed the limits for self-anchored tanks." We recommend cleaning the area around the anchor bolts, tightening the anchor nuts, then tack welding the circumference of the nut-to-base plate connections and bolt-to-nut connections to reinforce.

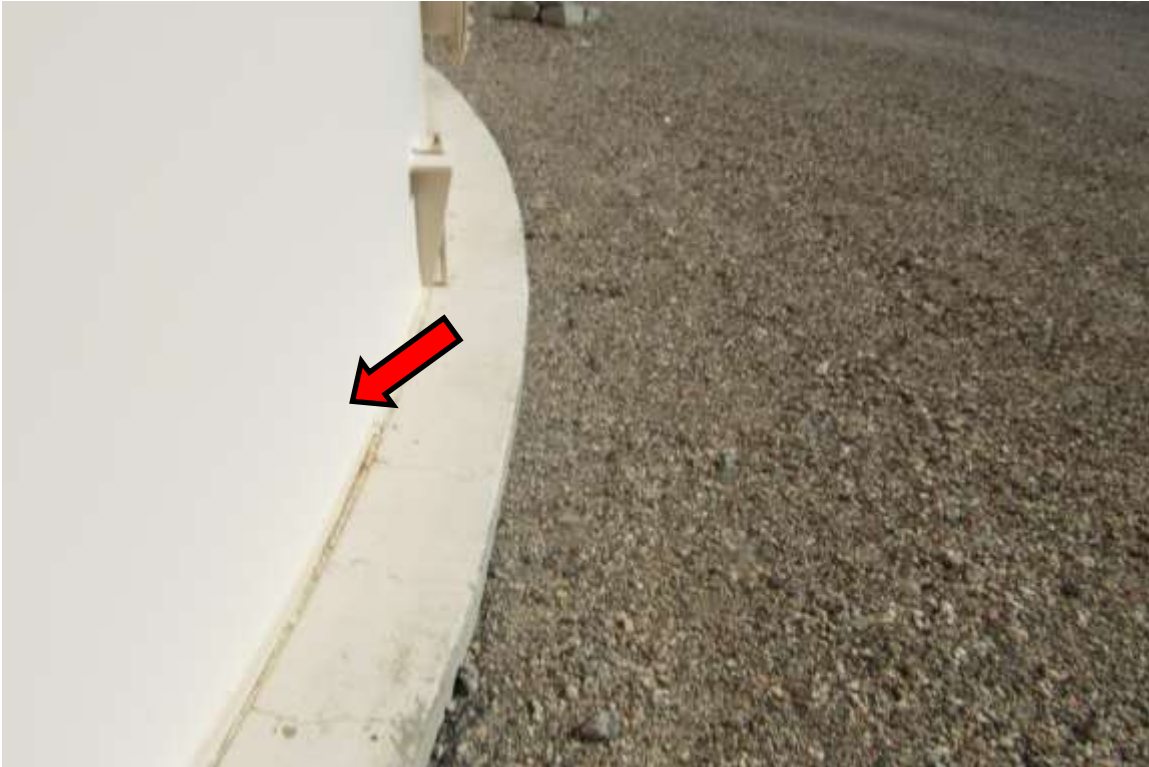
Photo shows the condition of the shell. Currently there is no drain valve. We recommend installing a frost proof drain valve near the shell-to-floor connection, complete with a locking device to prevent unauthorized draining of the tank and a splash pad to direct water away from the foundation.

**Splash pad to be installed by owner.*

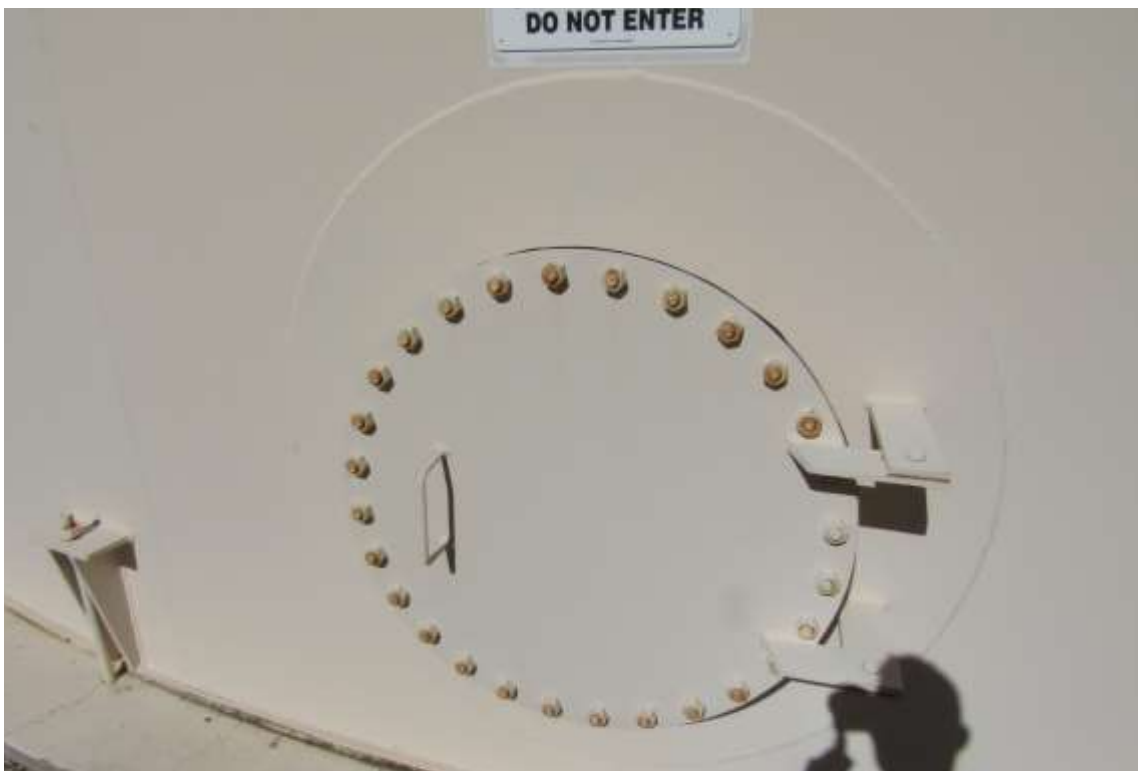
Photo shows the condition of the 24" secondary shell manway. The following is required for the tank to be in compliance with **AWWA D100-11; 7.4.4 Shell man-holes, NFPA 22-2018; 14.7.2.1.1** and **OSHA 1910.146(c)(2) Confined spaces**.

We recommend:

Replace 24" manway with 30" manway

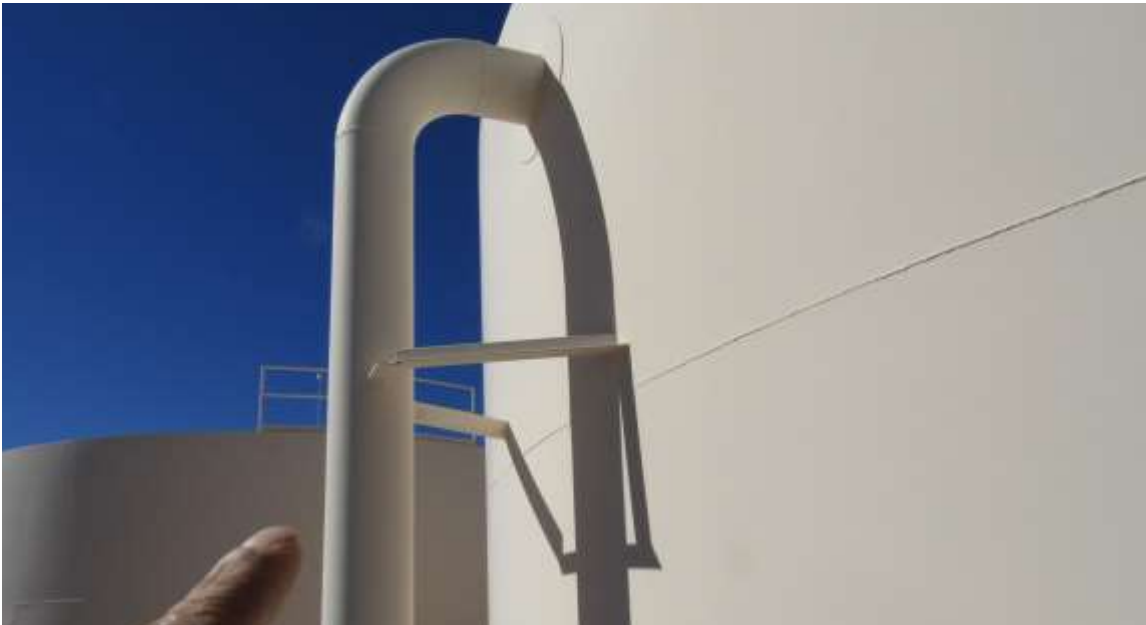
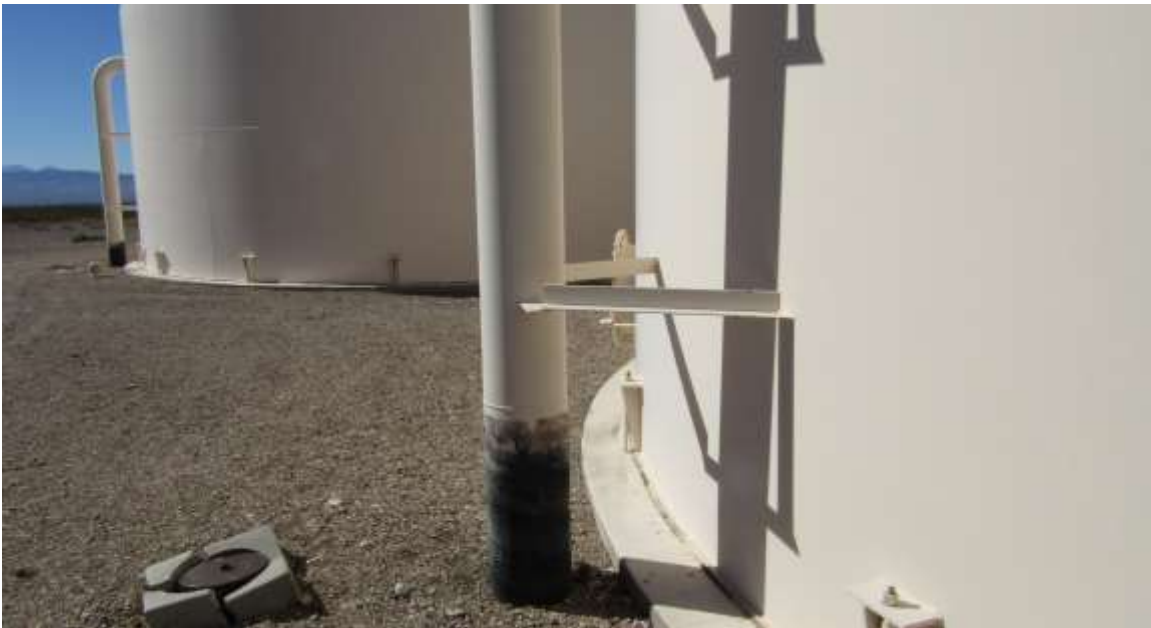
Photos show the condition of the 12" overflow pipe system. We recommend disconnecting the pipe from the underground drain then installing an air break complete with a flapper valve and screen to prevent the ingress of contaminants into the water supply.

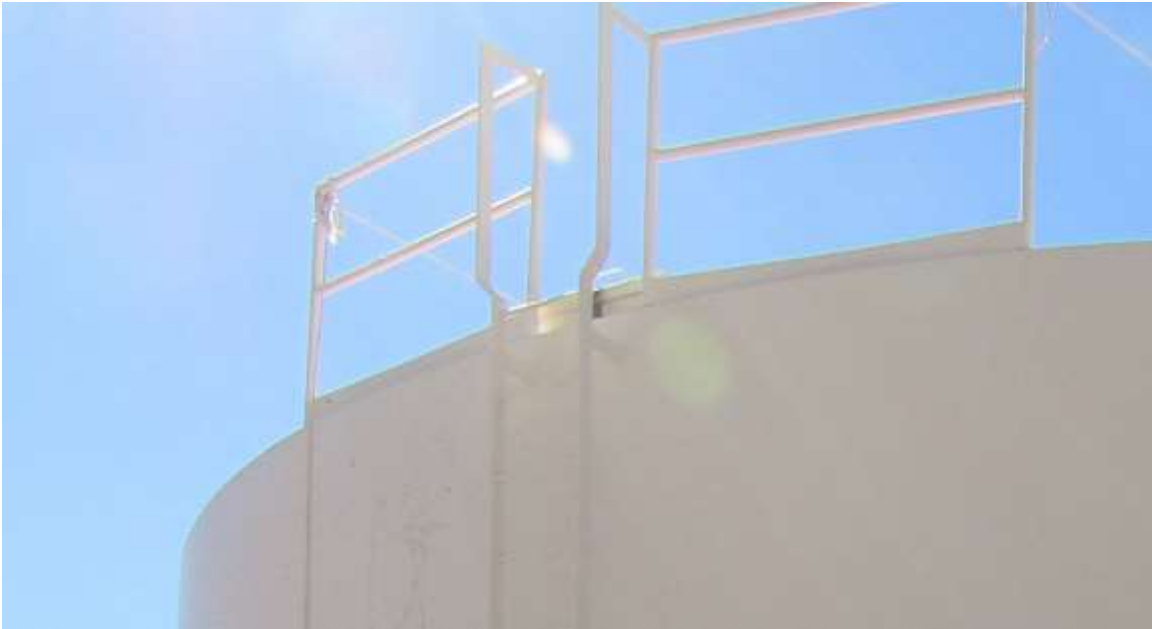
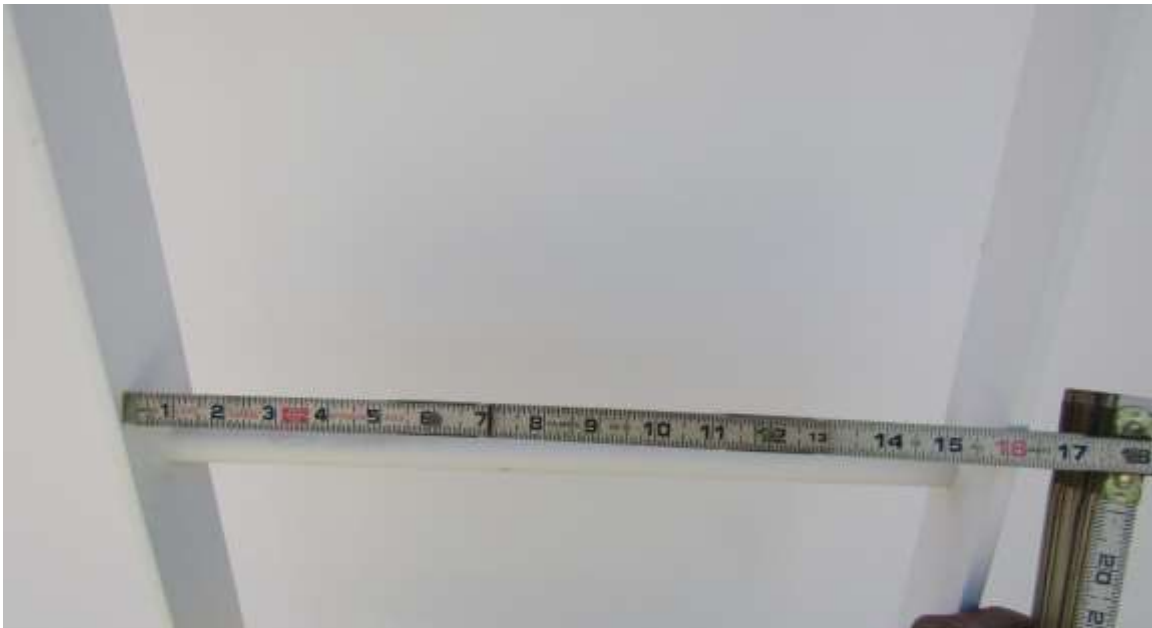
Shell access ladder in above photos is 16" wide, but is not equipped with anti-skid rungs. We recommend installing anti-skid rung covers, a cable type ladder safety device, a lockable ladder guard to prevent unauthorized access, and posting a **Fall Protection Required** sign at the base of the ladder.

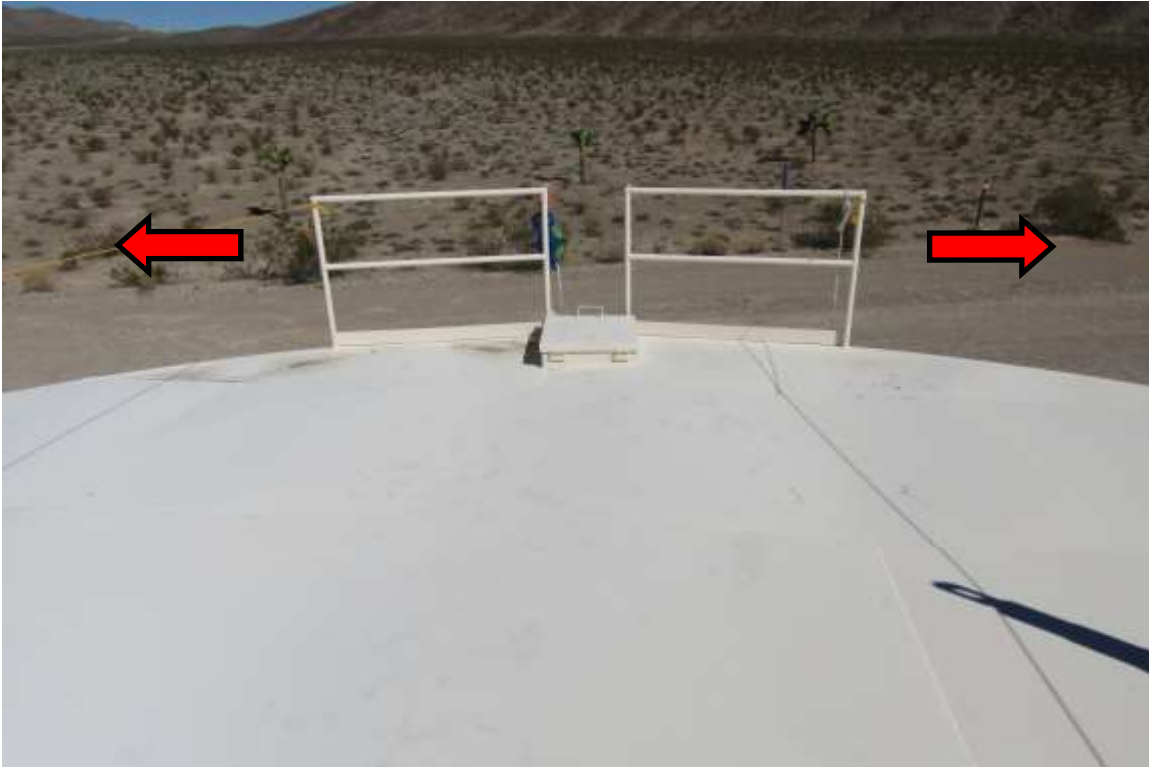
Photo shows the tank roof edge is not equipped with a required handrail system for fall protection. **OSHA 1910.28(b)(1)(i)** states, "...the employer must ensure that each employee on a walking-working surface with an unprotected side or edge that is 4 feet (1.2 m) or more above a lower level is protected from falling by one or more of the following: **1910.28(b)(1)(i)(A) Guardrail systems.**"

The tank is equipped with 42" high handrails to the left and right of the access ladder. We recommend extending the handrails around the circumference of the tank roof, complete with an intermediate rail, a toeboard, and a swing gate at the junction of the shell-to-roof access ladder and tank roof.
