**Mission Support and Test Services, LLC
Nevada National Security Site
Mercury, NV 89023
RE: Mercury North (Area 23); Mercury, NV
1,500,000 Gallon GST
September 16, 2018
Mr. Kevin Olsen
Scientist 1
(702) 295-0485
Job No. 318448-A**

**Mission Support and Test Services, LLC
Nevada National Security Site
Mercury, NV 89023
RE: Camp South (Area 12); Mercury, NV
500,000 Gallon GST
September 13, 2018
Mr. Kevin Olsen
Scientist 1
(702) 295-0485
Job No. 318448-D**

**Mission Support and Test Services, LLC
Nevada National Security Site
Mercury, NV 89023
RE: Well 4/4a South (Area 6); Mercury, NV
150,000 Gallon GST
September 24, 2018
Mr. Kevin Olsen
Scientist 1
(702) 295-0485
Job No. 318448-H**

**Mission Support and Test Services, LLC
Nevada National Security Site
Mercury, NV 89023
RE: C-1 North (Area 6); Mercury, NV
50,000 Gallon GST
September 21, 2018
Mr. Kevin Olsen
Scientist 1
(702) 295-0485
Job No. 318448-O**

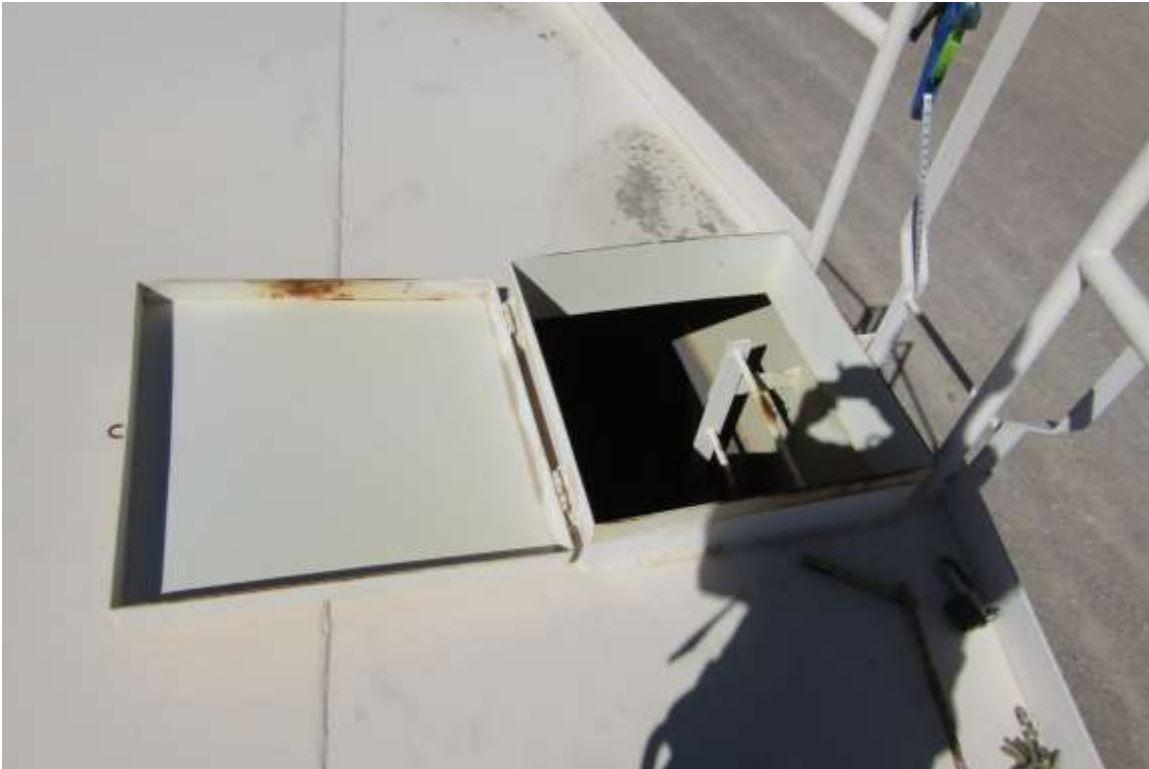
Photo shows the condition of the 24" primary roof hatch. Roof openings on this tank require the following to be in compliance with **AWWA D100-11; 7.4.3 Roof openings** and **OSHA 1910.146(c)(2) Confined spaces**.

We recommend:

Post **Confined Space Entry** sign

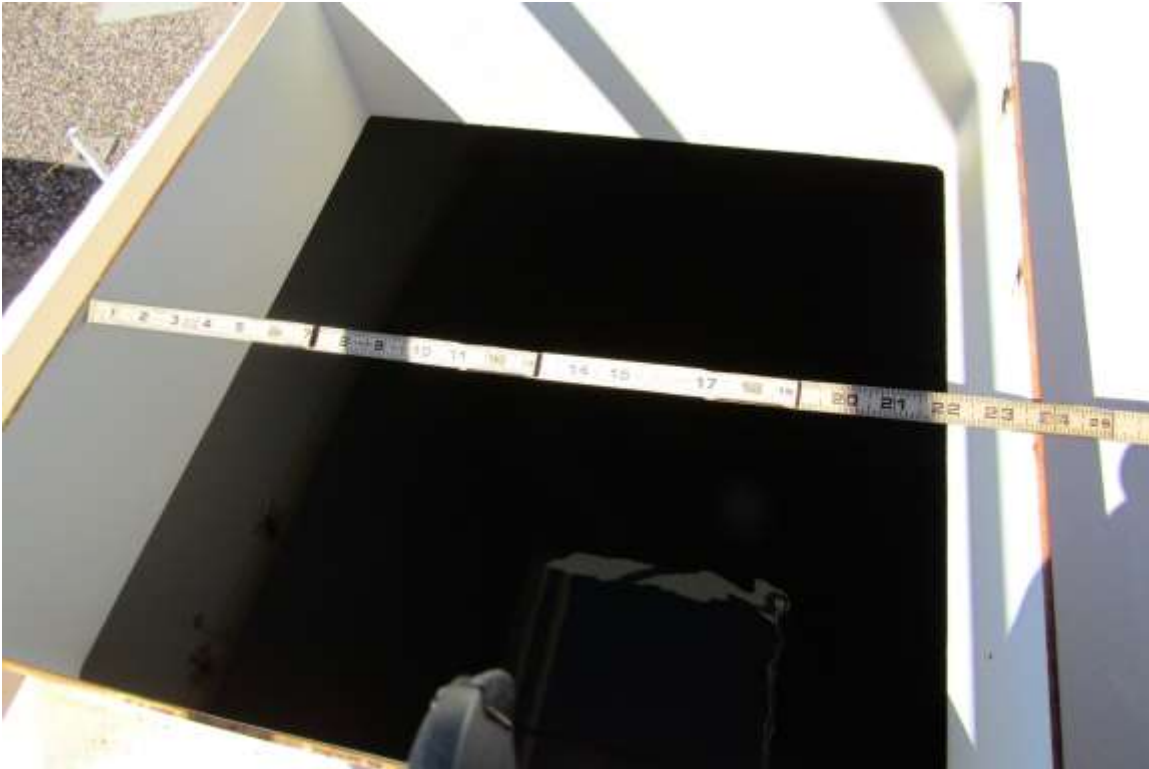
Photo shows the condition of the 24" secondary roof hatch. Roof openings on this tank require the following to be in compliance with **AWWA D100-11; 7.4.3 Roof openings** and **OSHA 1910.146(c)(2) Confined spaces**.

We recommend:

We further recommend installing an **OSHA** compliant interior access ladder complete with standoffs every 10' on center, and a cable type ladder safety device at the secondary roof hatch.

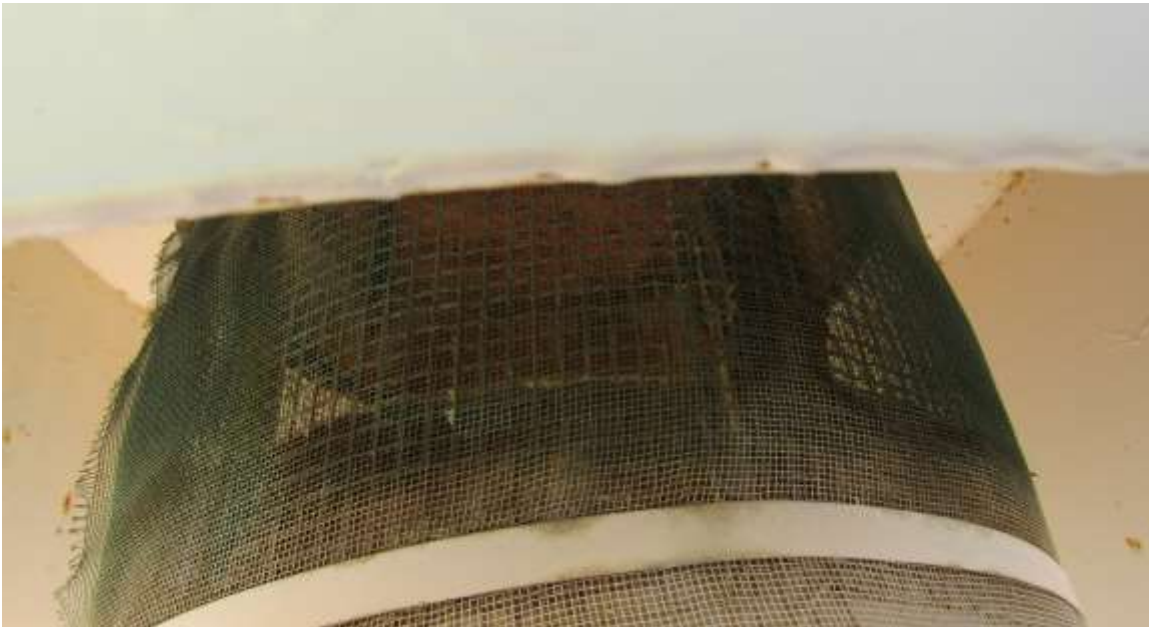
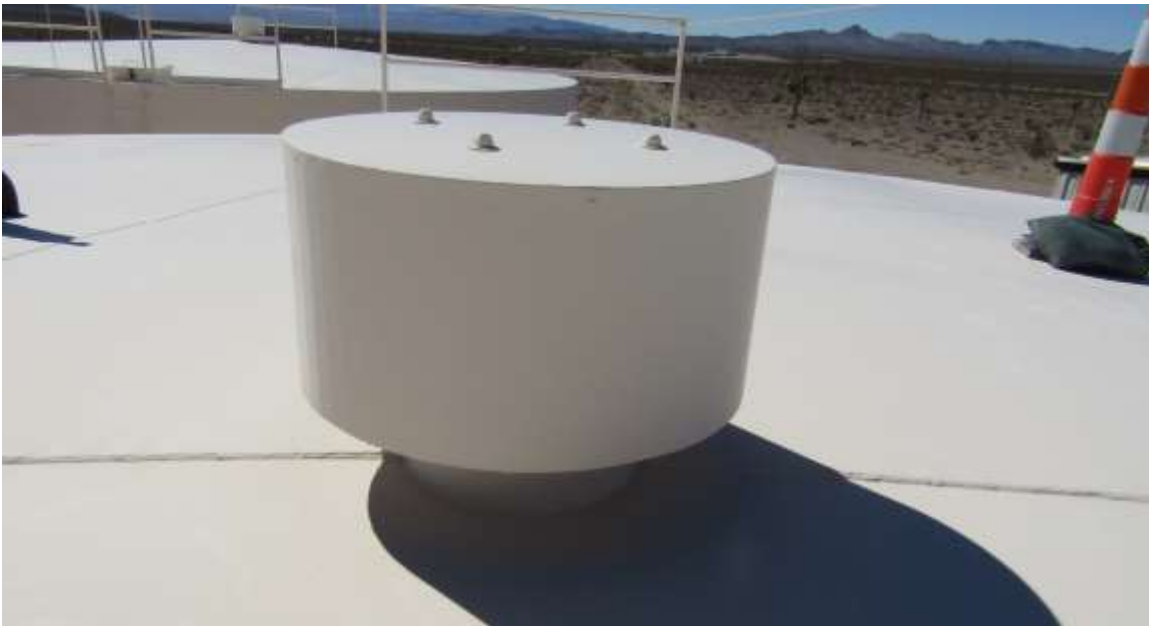
Photos show the existing 8" roof vent, which appears to be in good condition.

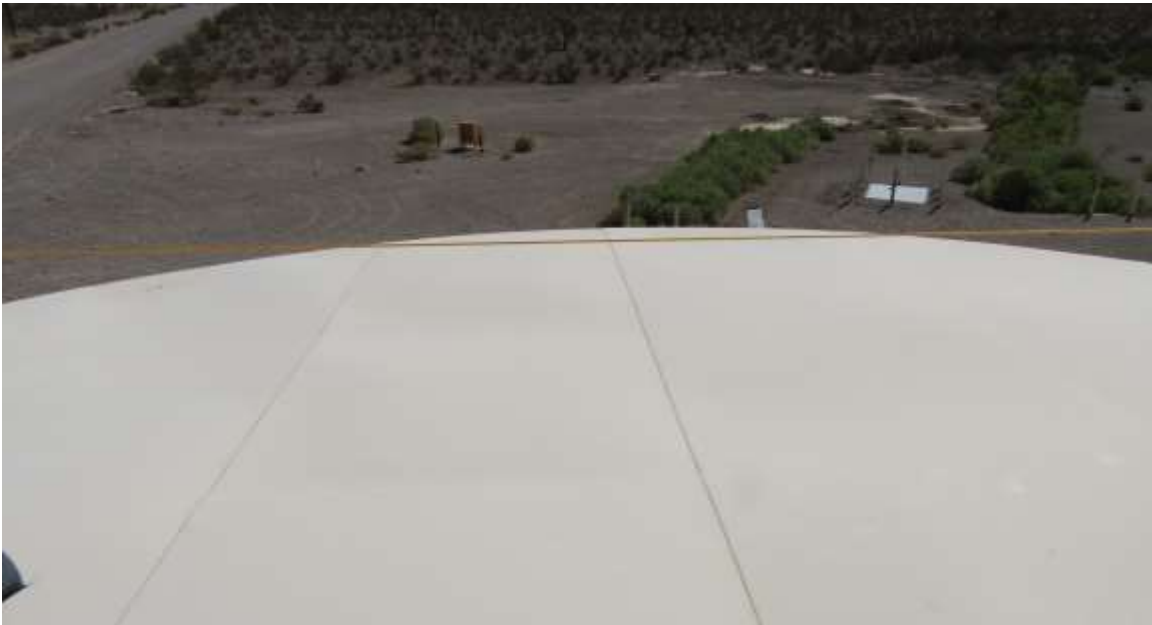
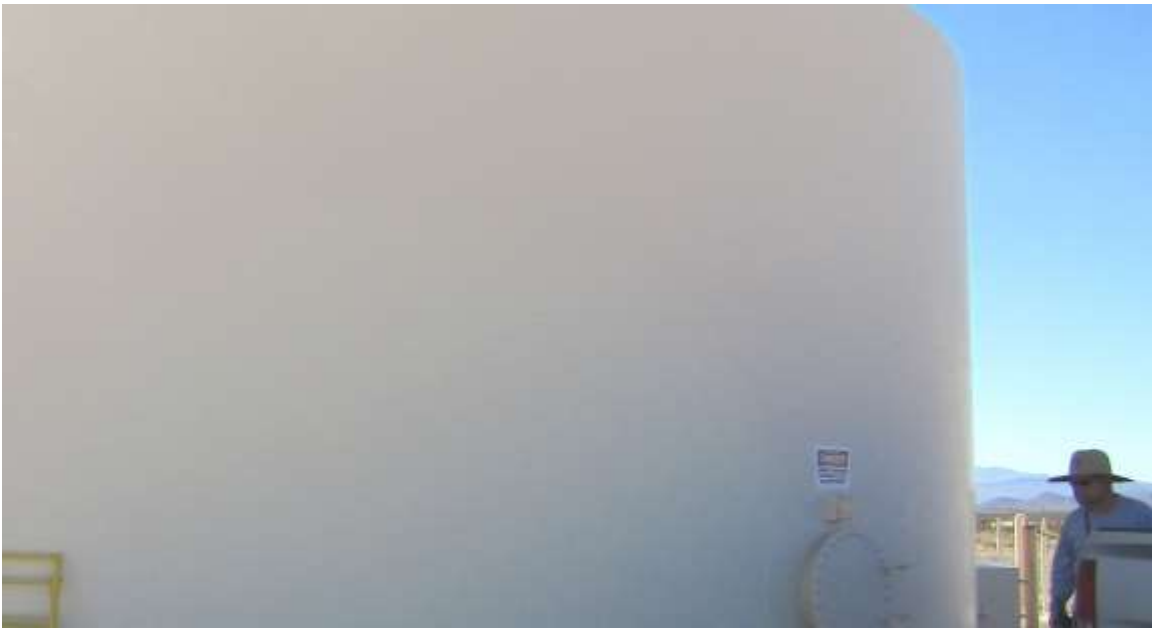
Photos show the tank exterior coating system. The overall exterior coating system appears to be in good condition. We recommend re-evaluating the tank exterior at next inspection cycle.

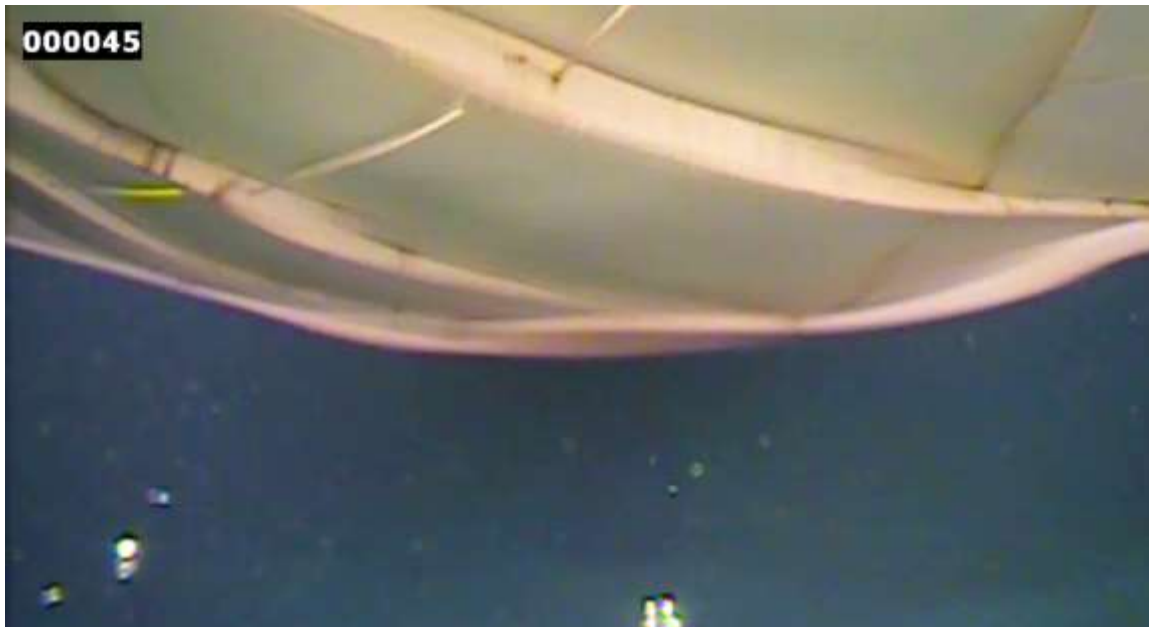
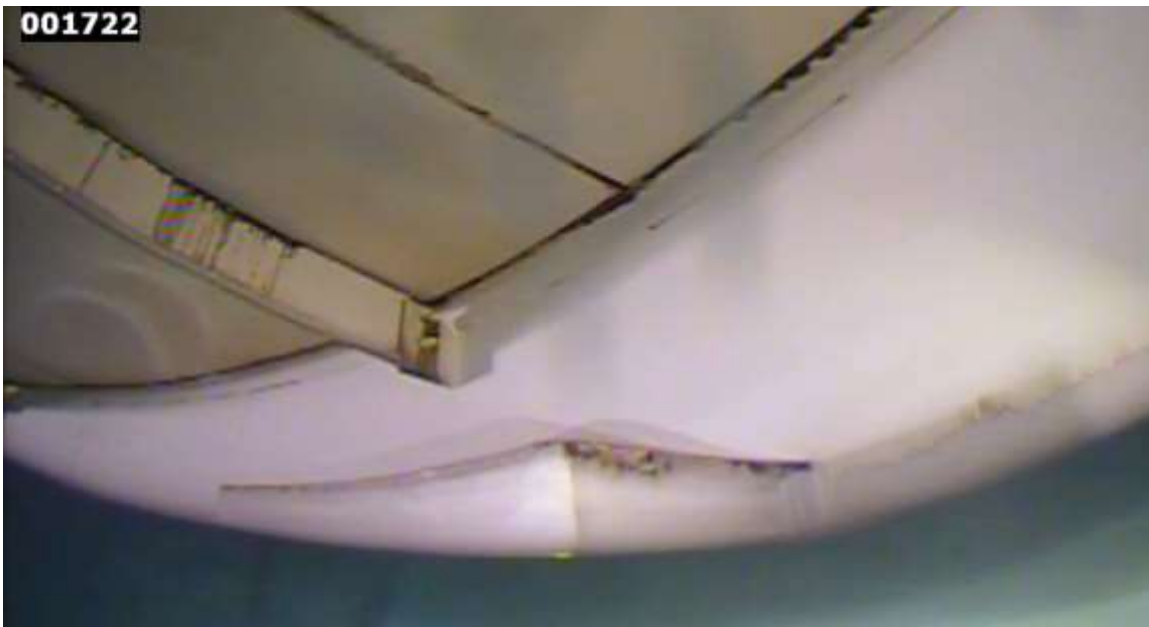
Top photo shows the interior roof lap seams, which appear to be in good condition.

Bottom photo shows the interior roof-to-rim angle connection, which appears to be in good condition.

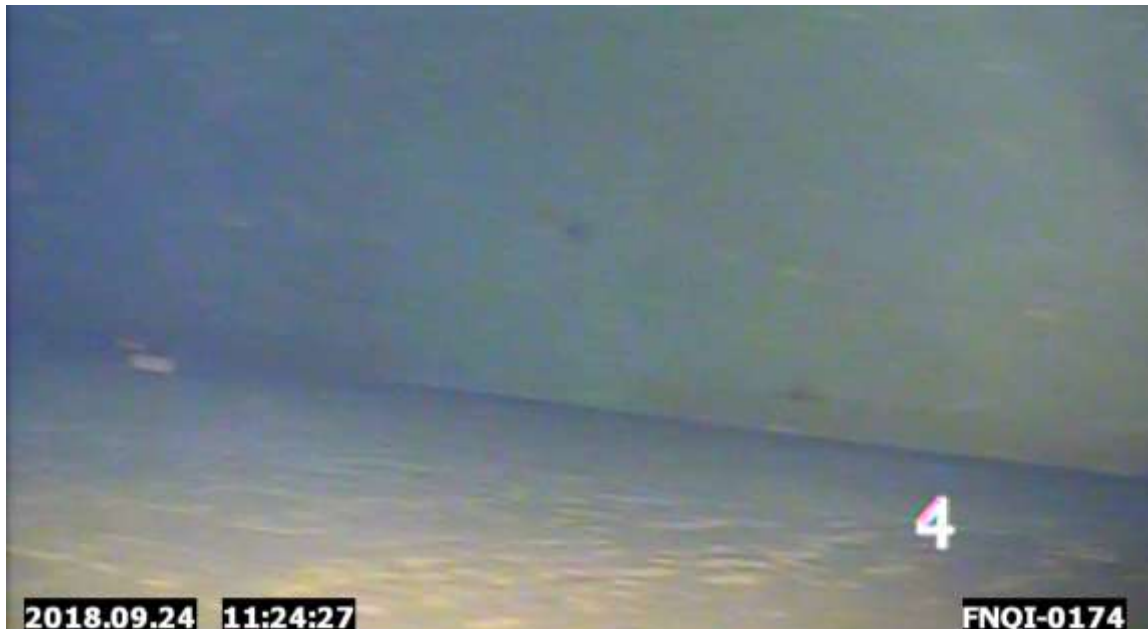
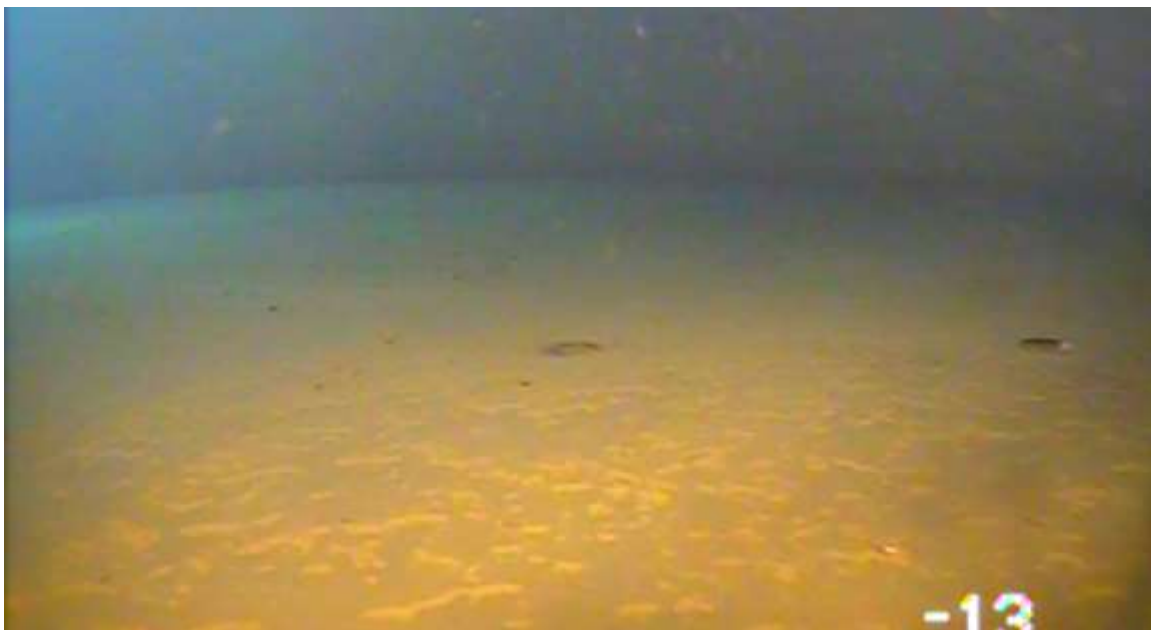
Photos show sediment and debris on the tank interior before a cleanout was performed.

We recommend installing a passive cathodic protection system.

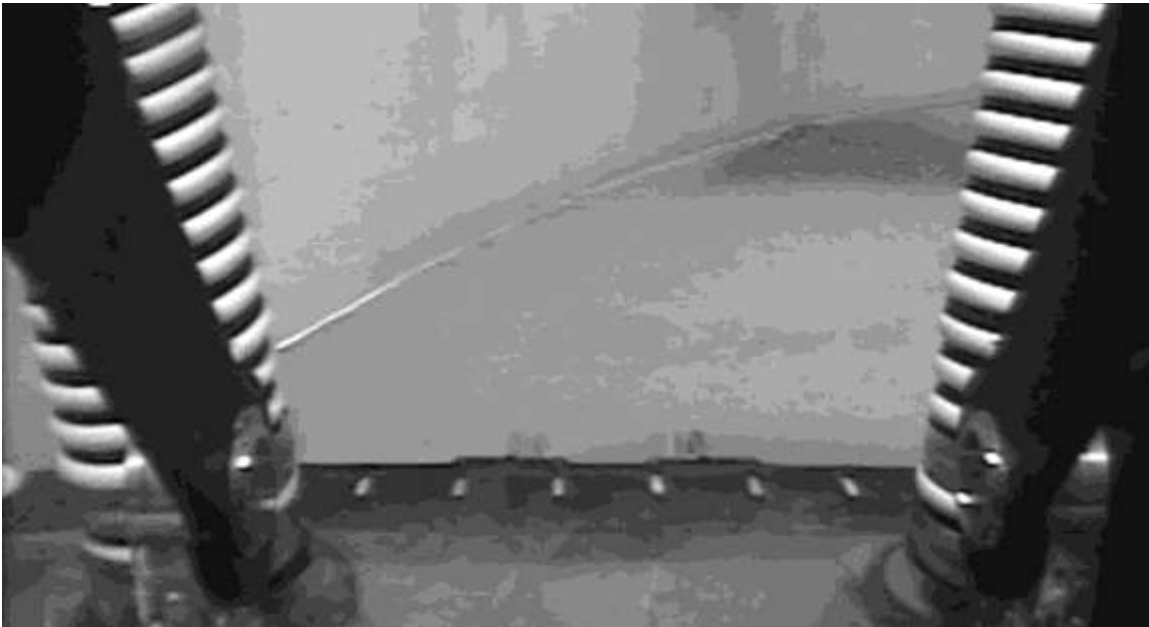
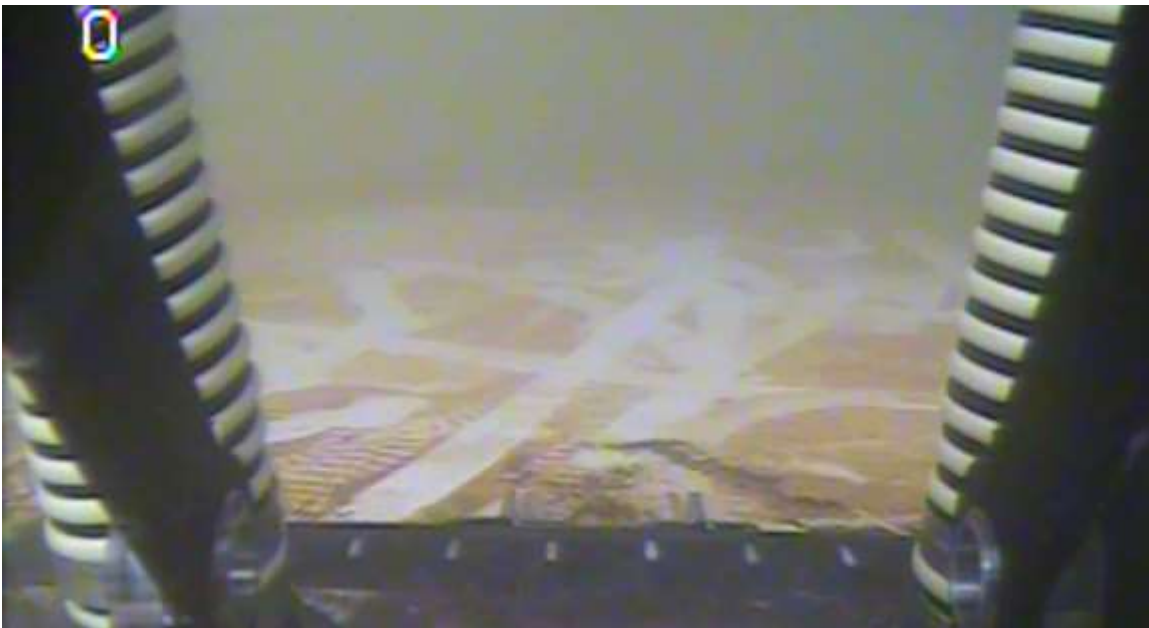
Photos show the tank interior during a cleanout.

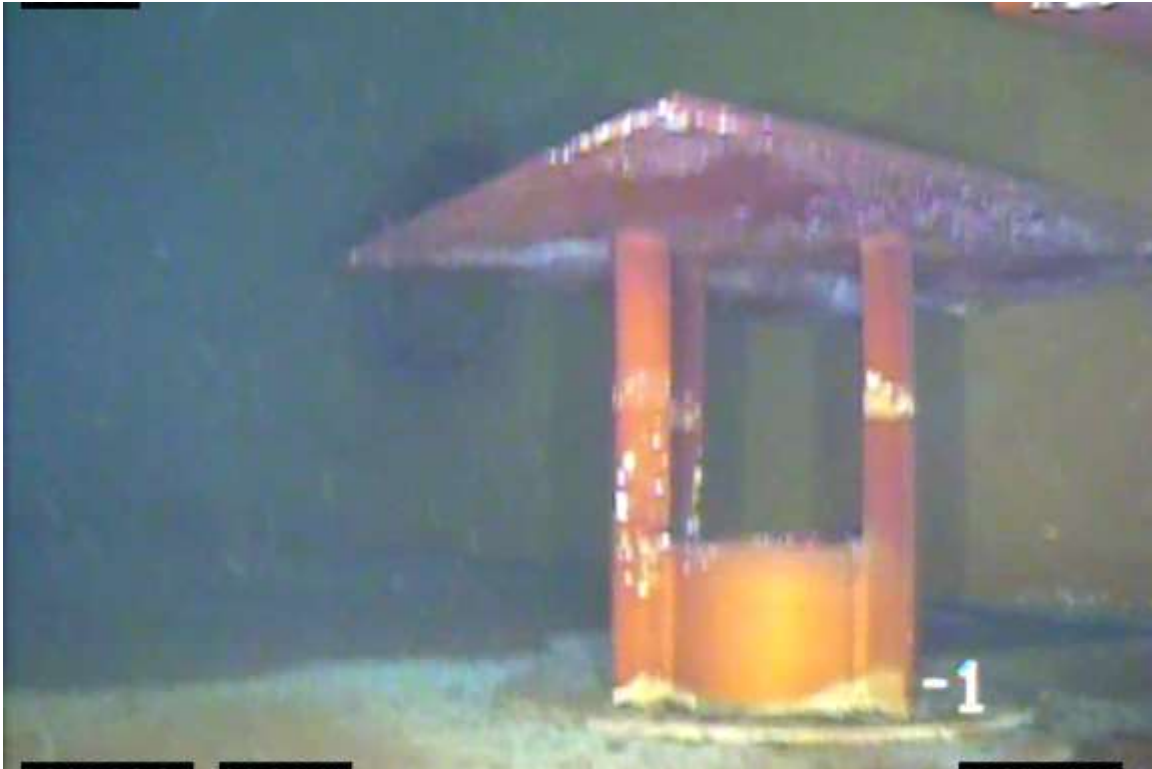
Photo shows a suction pipe on the interior of the tank, which is equipped with a properly sized anti-vortex plate to prevent formation of a vortex.

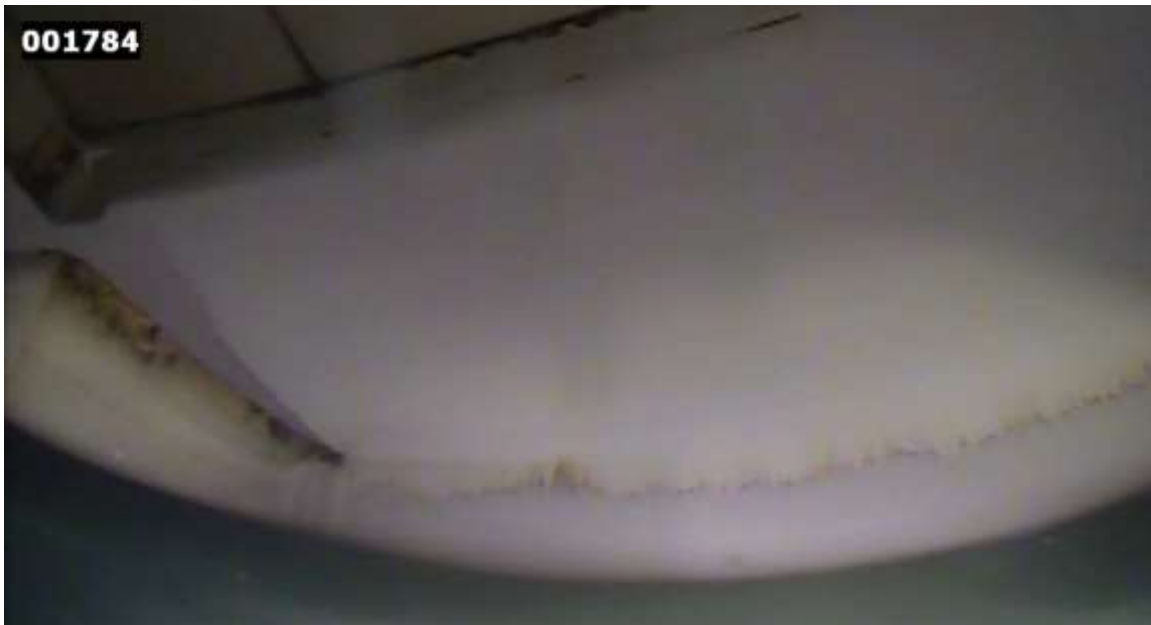
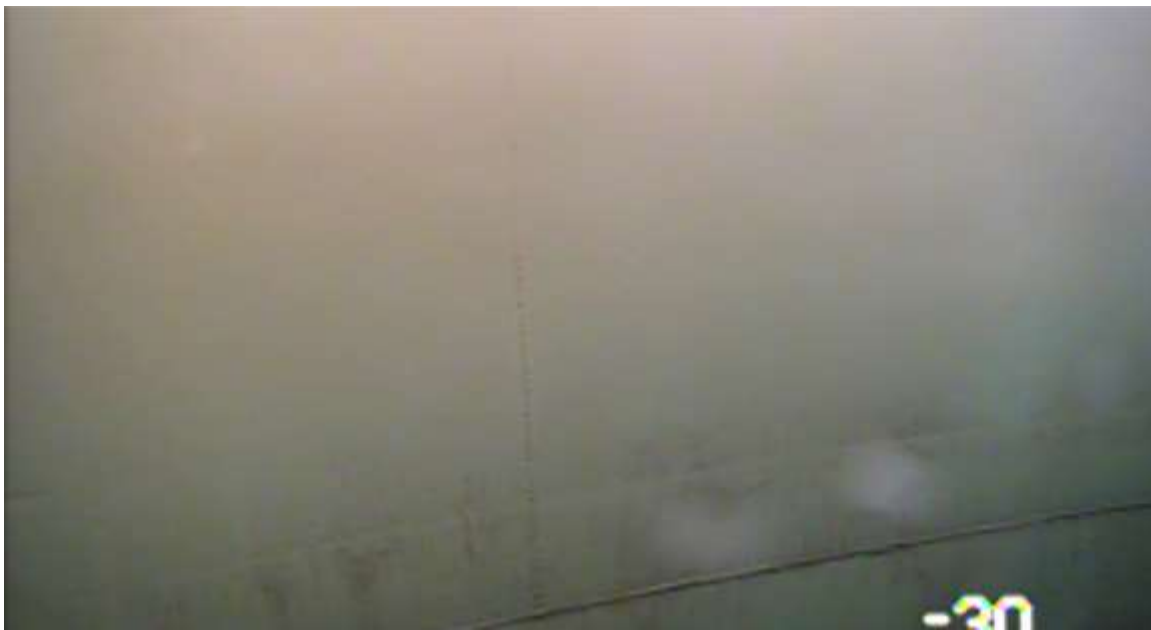
Photos show the tank interior coating system. The overall interior coating system appears to be in good condition. We recommend re-evaluating the tank interior at next inspection cycle.

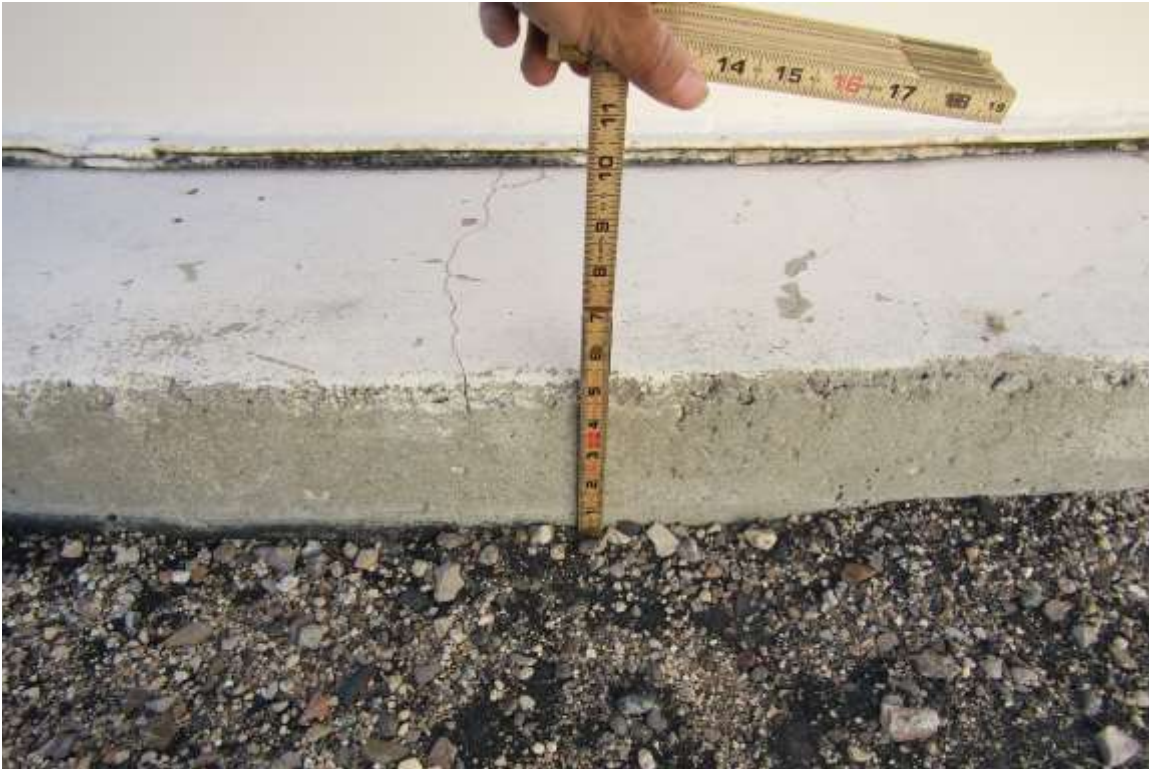
Photo shows the condition of the foundation. **AWWA D100-11; 12.7.1 Height aboveground** states, "The tops of the concrete foundations shall be a minimum of 6" above the finished grade, unless otherwise specified." We recommend clearing any dirt, debris and other loose gravel away from the tank foundation, down to a minimum 6" below top of foundation. This should be done by a local excavating company.

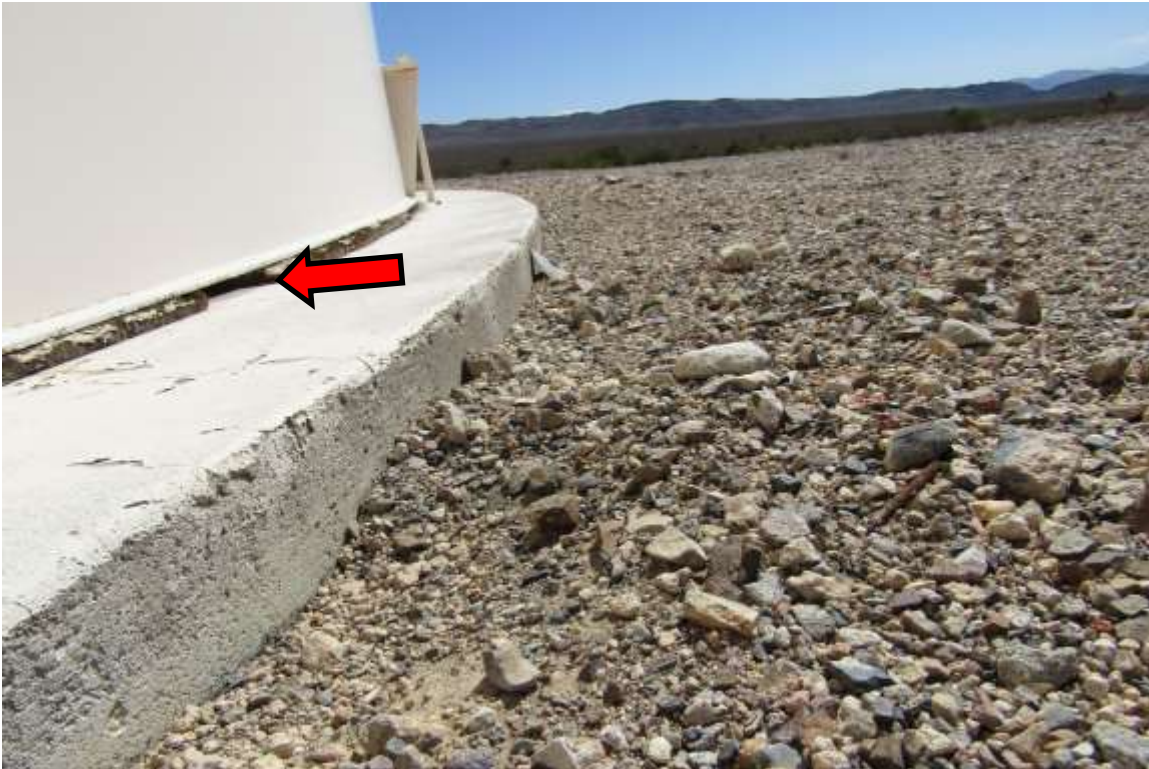
Photo shows the condition of the foundation. **NFPA 22-2018; 12.2.1.2** states, "... the junction of the tank bottom and the top of the concrete foundation shall be tightly sealed to prevent water from entering the base." We recommend repairing any cracks and spalling in the concrete with a commercial non-shrinking grout, caulking/grouting around the base of the tank to foundation connection to prevent water from entering under the tank, then sealing the foundation with a sealant.

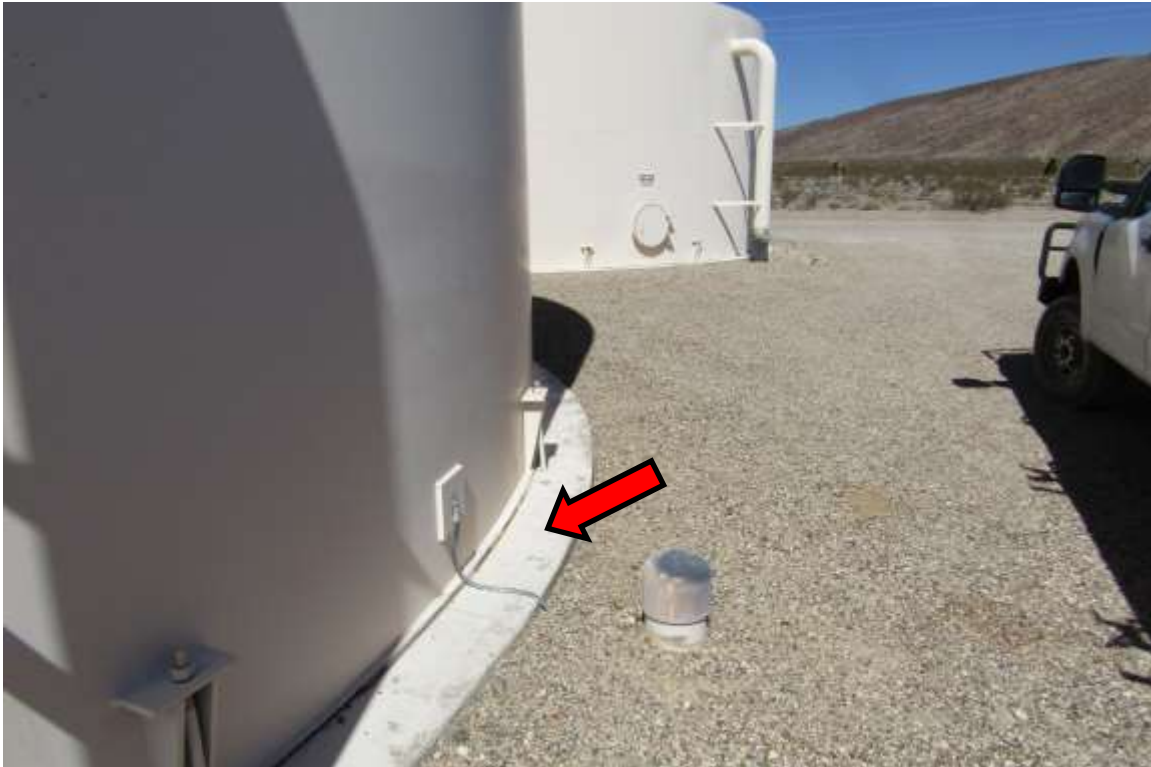
Photo shows the tank is electrically grounded for lightning protection as required by **OSH Act of 1970 Section 5** and **NFPA 780-2017; 5.4 Metal Towers and Tanks** and appears to be in good condition.

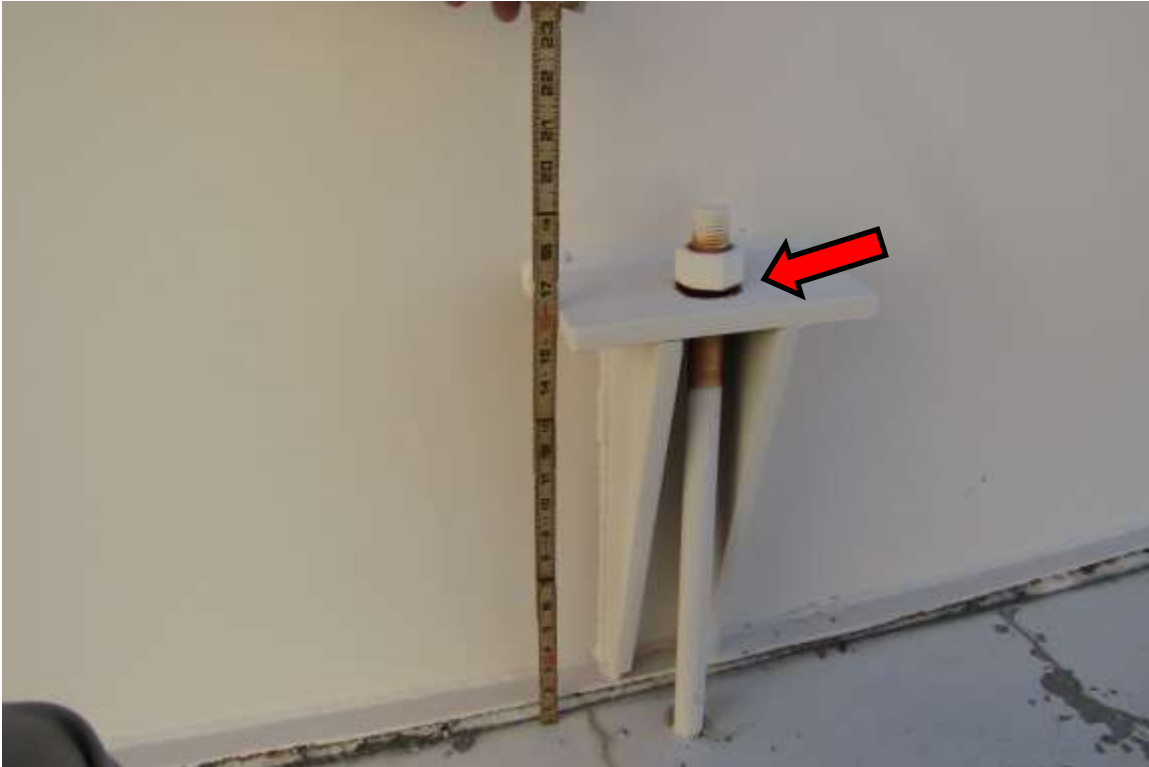
Photo shows the condition of one (1) of the sixteen (16) anchor bolts. **AWWA D100-11; 3.8.1.1 Required anchorage** states, "For ground-supported flat-bottom reservoirs and standpipes, mechanical anchorage shall be provided when the wind or seismic loads exceed the limits for self-anchored tanks." We recommend cleaning the area around the anchor bolts, tightening the anchor nuts, then tack welding the circumference of the nut-to-base plate connections and bolt-to-nut connections to reinforce.

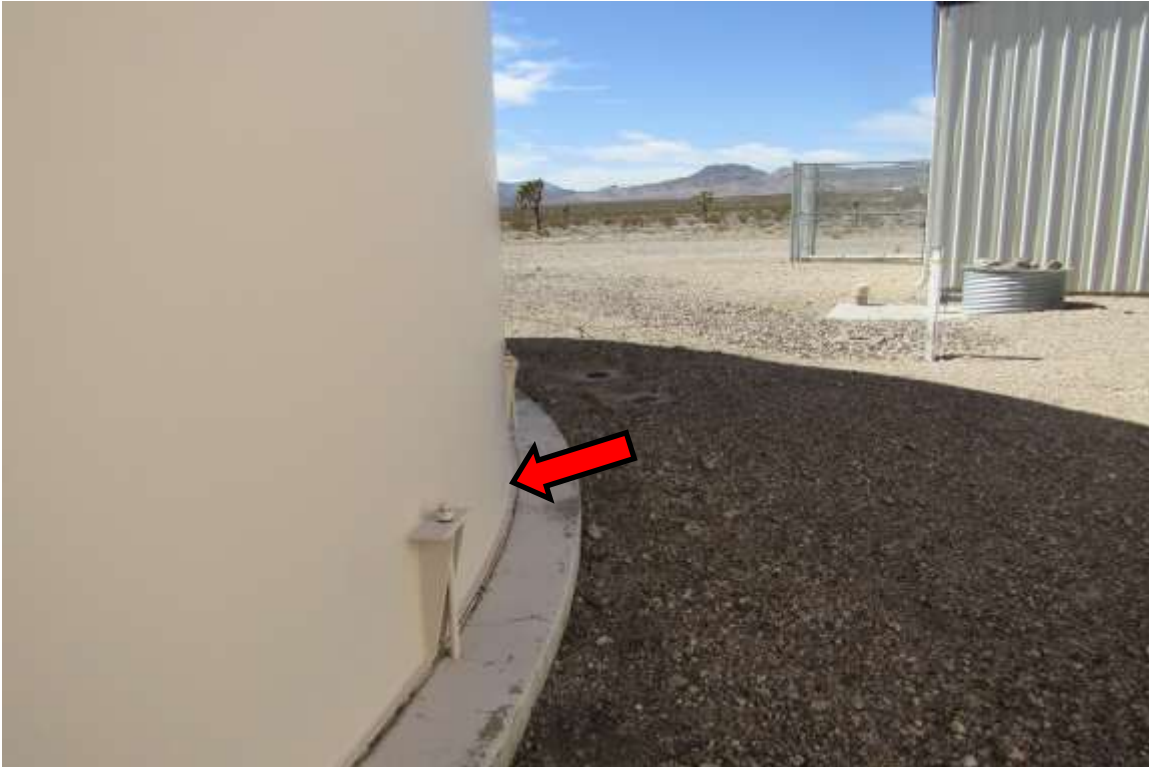
Photo shows the condition of the shell. Currently there is no drain valve. We recommend installing a frost proof drain valve near the shell-to-floor connection, complete with a locking device to prevent unauthorized draining of the tank and a splash pad to direct water away from the foundation.

**Splash pad to be installed by owner.*

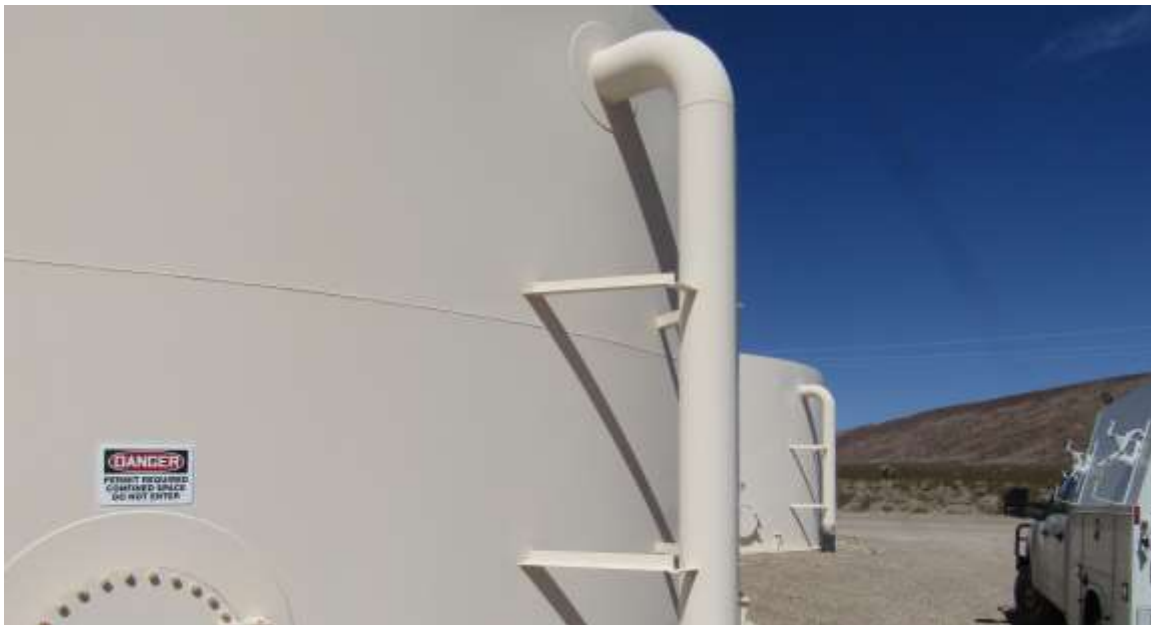
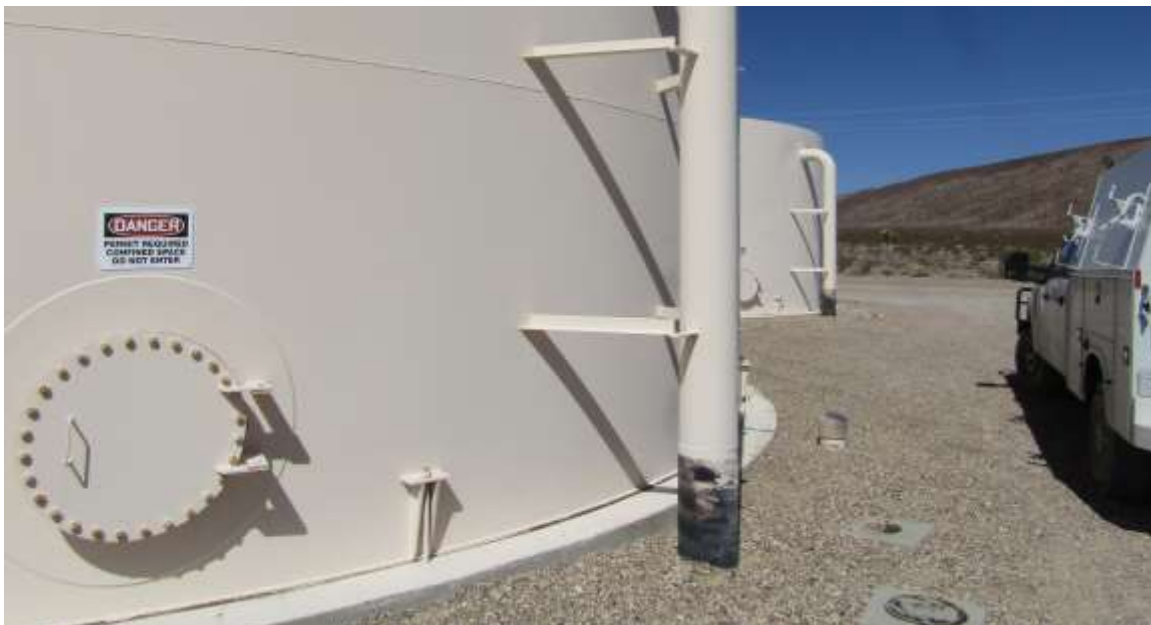
Photos show the condition of the 12" overflow pipe system. We recommend disconnecting the pipe from the underground drain then installing an air break complete with a flapper valve and screen to prevent the ingress of contaminants into the water supply.

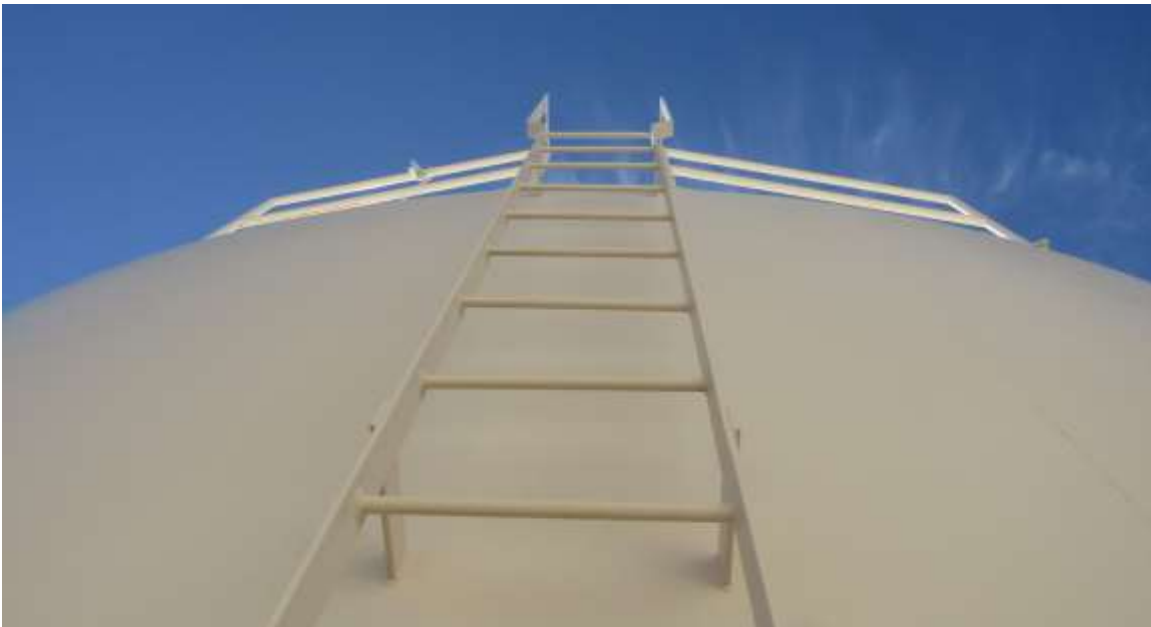
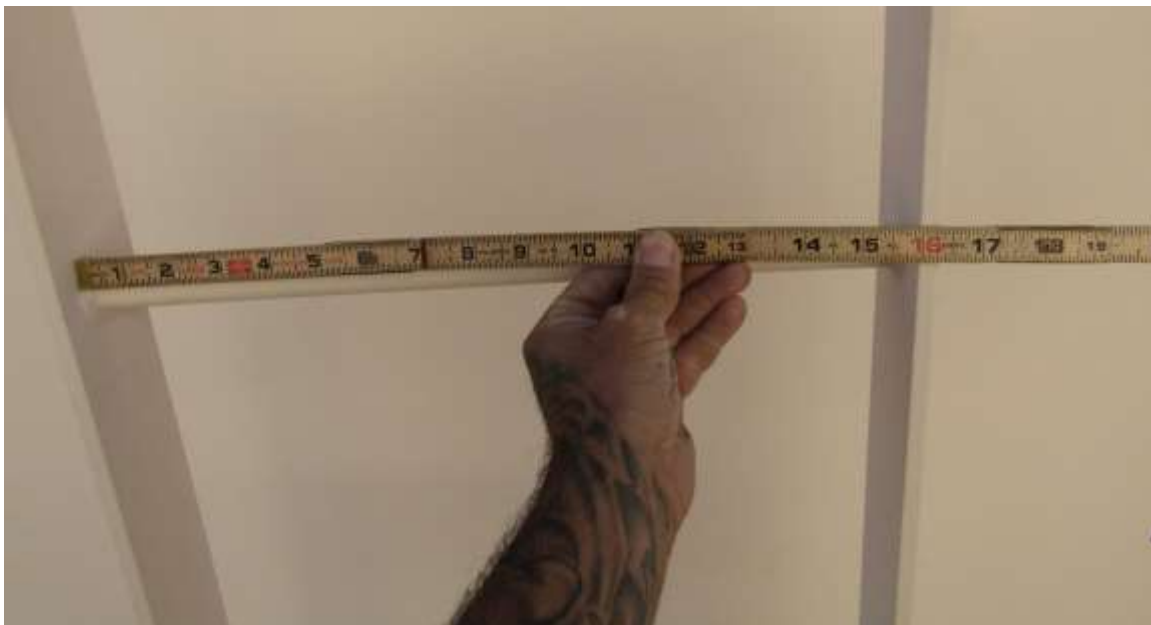
Shell access ladder in above photos is 16" wide, but is not equipped with anti-skid rungs. We recommend installing anti-skid rung covers, a cable type ladder safety device, a lockable ladder guard to prevent unauthorized access, and posting a **Fall Protection Required** sign at the base of the ladder.

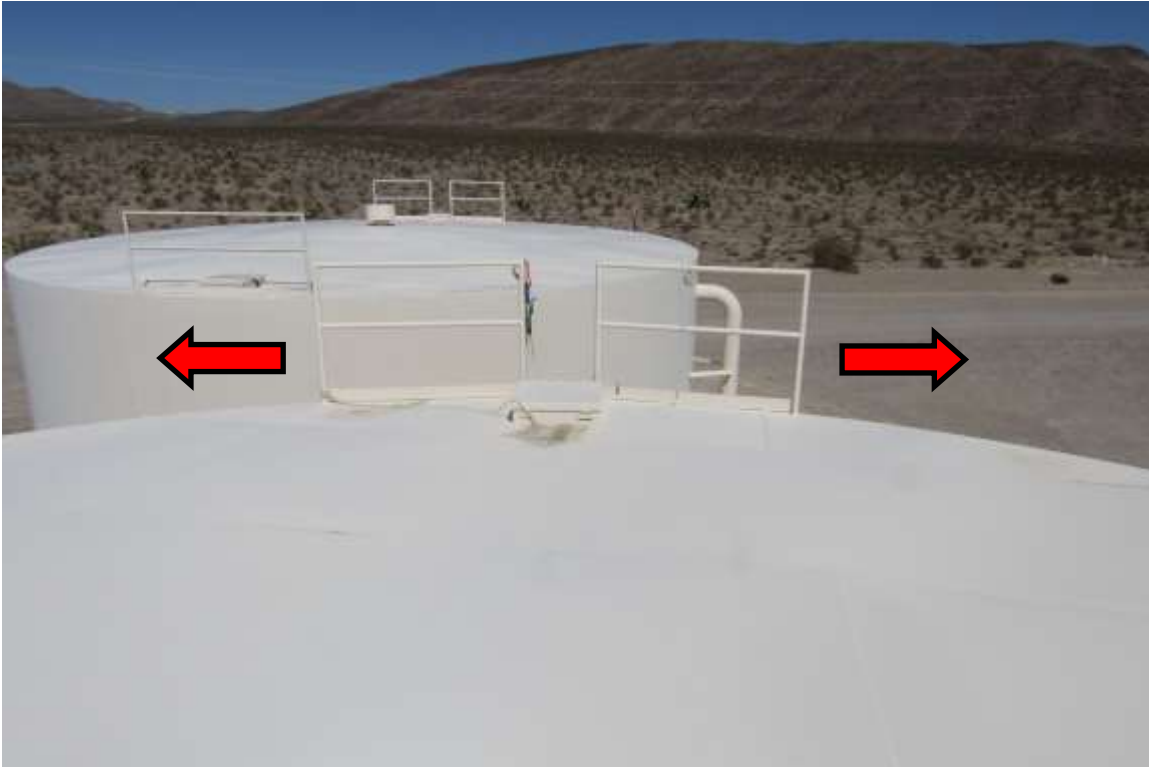
Photos show the tank roof edge is not equipped with a required handrail system for fall protection. **OSHA 1910.28(b)(1)(i)** states, "...the employer must ensure that each employee on a walking-working surface with an unprotected side or edge that is 4 feet (1.2 m) or more above a lower level is protected from falling by one or more of the following: **1910.28(b)(1)(i)(A) Guardrail systems.**" The tank is equipped with 42" high handrails to the left and right of the access ladder. We recommend extending the handrails around the circumference of the tank roof, complete with an intermediate rail, a toeboard, and a swing gate at the junction of the shell-to-roof access ladder and tank roof.

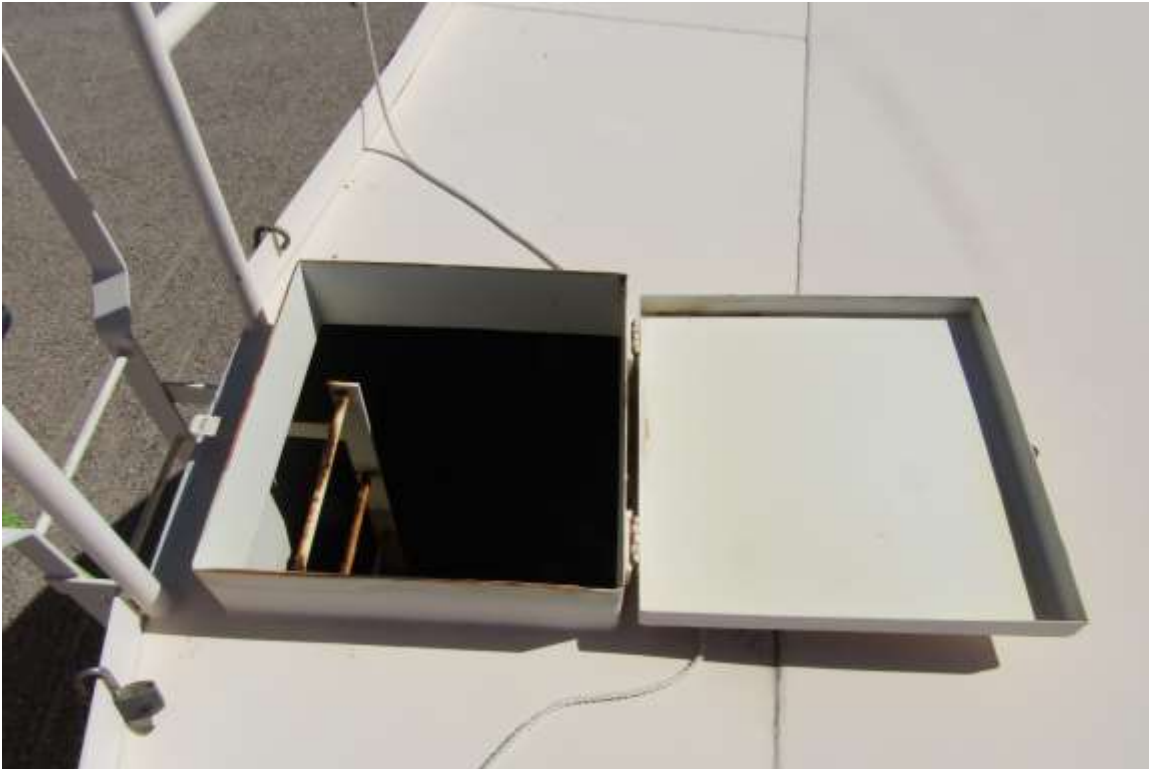
Photo shows the condition of the 24" primary roof hatch. Roof openings on this tank require the following to be in compliance with **AWWA D100-11; 7.4.3 Roof openings** and **OSHA 1910.146(c)(2) Confined spaces**.

We recommend:

Post **Confined Space Entry** sign

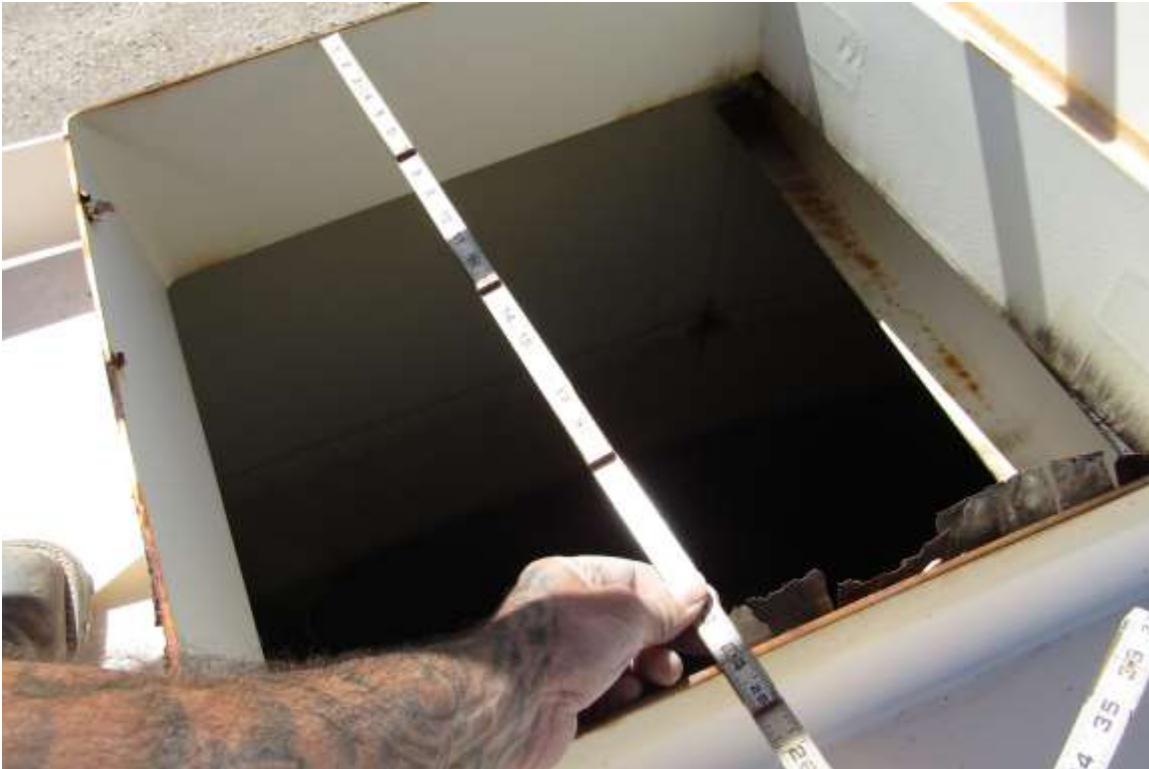
Photo shows the condition of the 24" secondary roof hatch. Roof openings on this tank require the following to be in compliance with **AWWA D100-11; 7.4.3 Roof openings** and **OSHA 1910.146(c)(2) Confined spaces**.

We recommend:

We further recommend installing an **OSHA** compliant interior access ladder complete with standoffs every 10' on center, and a cable type ladder safety device at the secondary roof hatch.
