**Mission Support and Test Services, LLC
Nevada National Security Site
Mercury, NV 89023
RE: Mercury North (Area 23); Mercury, NV
1,500,000 Gallon GST
September 16, 2018
Mr. Kevin Olsen
Scientist 1
(702) 295-0485
Job No. 318448-A**

**Mission Support and Test Services, LLC
Nevada National Security Site
Mercury, NV 89023
RE: Camp South (Area 12); Mercury, NV
500,000 Gallon GST
September 13, 2018
Mr. Kevin Olsen
Scientist 1
(702) 295-0485
Job No. 318448-D**

**Mission Support and Test Services, LLC
Nevada National Security Site
Mercury, NV 89023
RE: Well 4/4a South (Area 6); Mercury, NV
150,000 Gallon GST
September 24, 2018
Mr. Kevin Olsen
Scientist 1
(702) 295-0485
Job No. 318448-H**

**Mission Support and Test Services, LLC
Nevada National Security Site
Mercury, NV 89023
RE: C-1 North (Area 6); Mercury, NV
50,000 Gallon GST
September 21, 2018
Mr. Kevin Olsen
Scientist 1
(702) 295-0485
Job No. 318448-O**

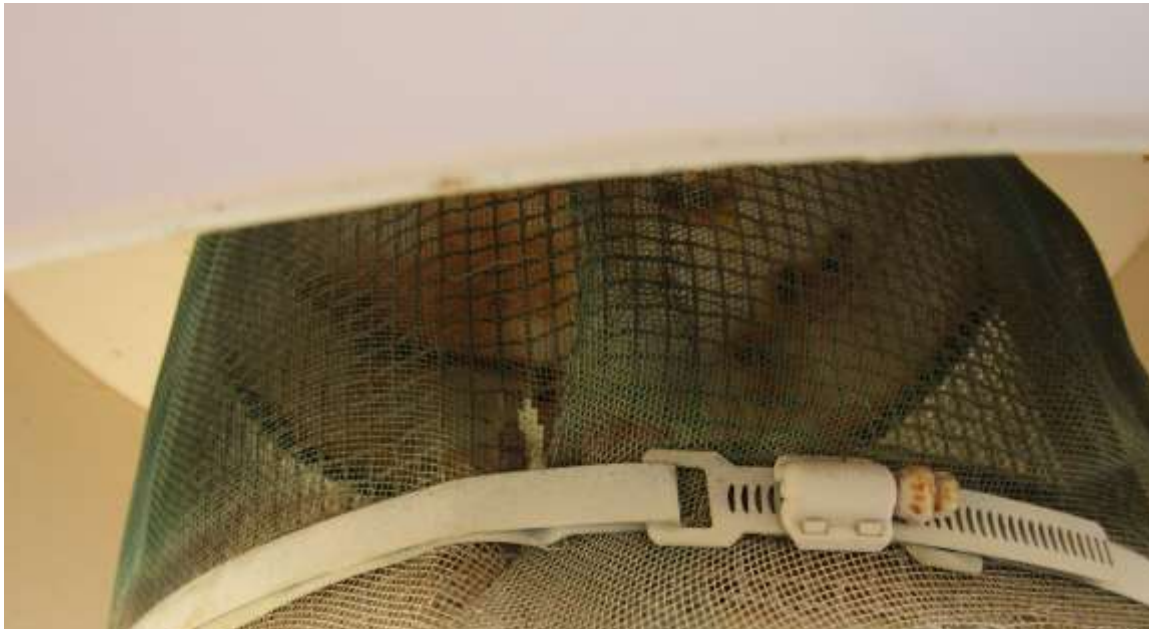
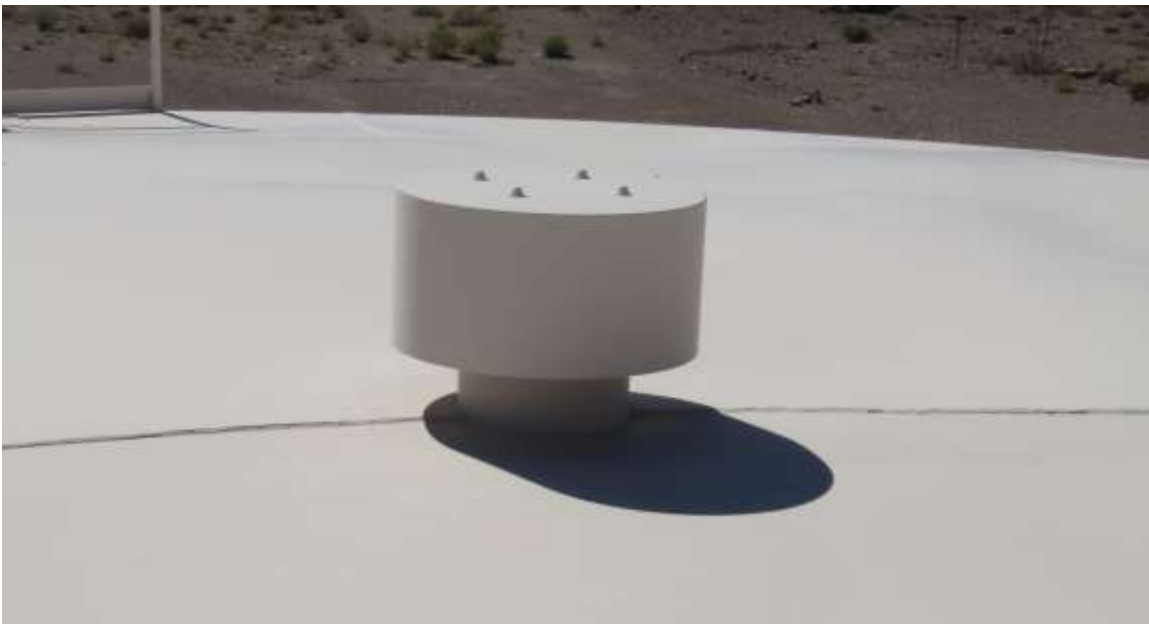
Photos show the existing 12" roof vent, which appears to be in good condition.

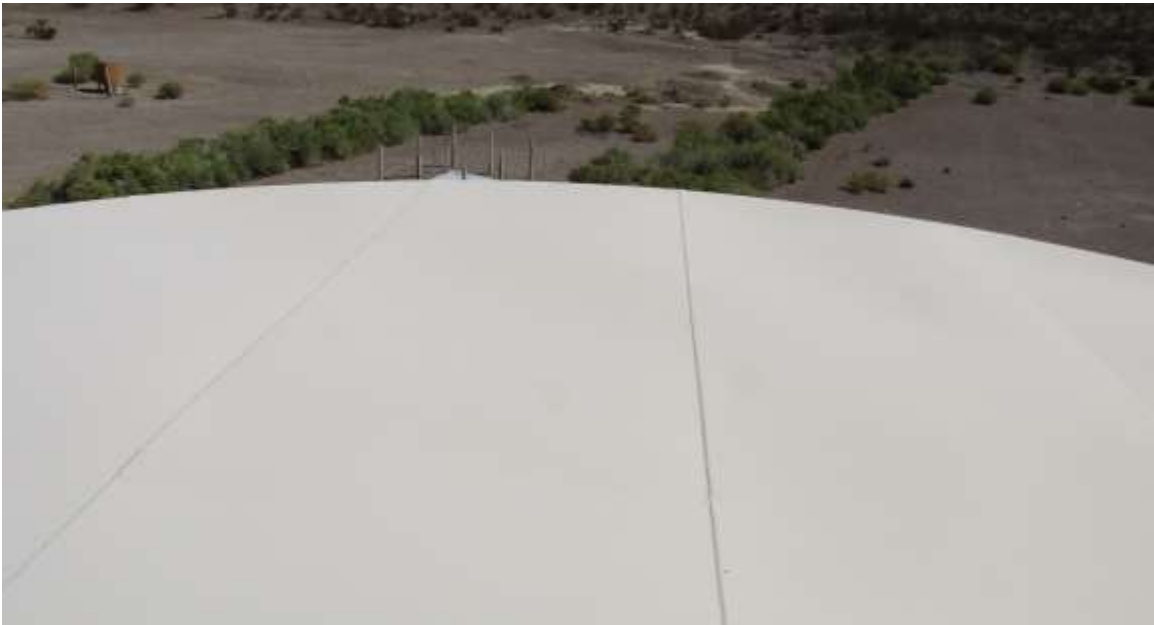
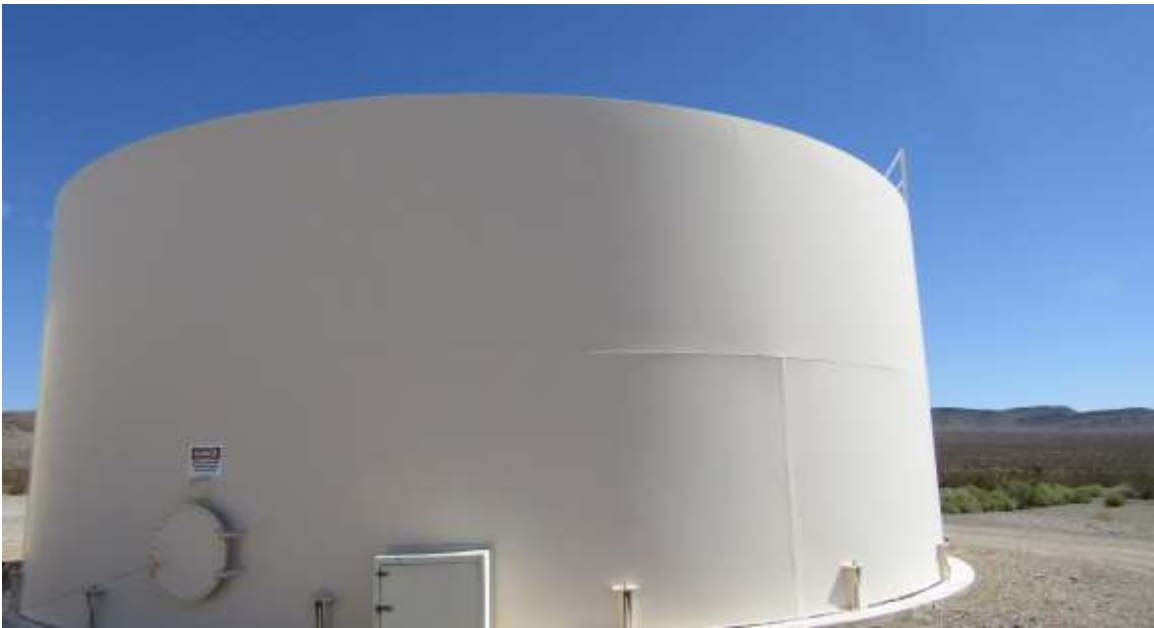
Photos show the tank exterior coating system. The overall exterior coating system appears to be in good condition. We recommend re-evaluating the tank exterior at next inspection cycle.

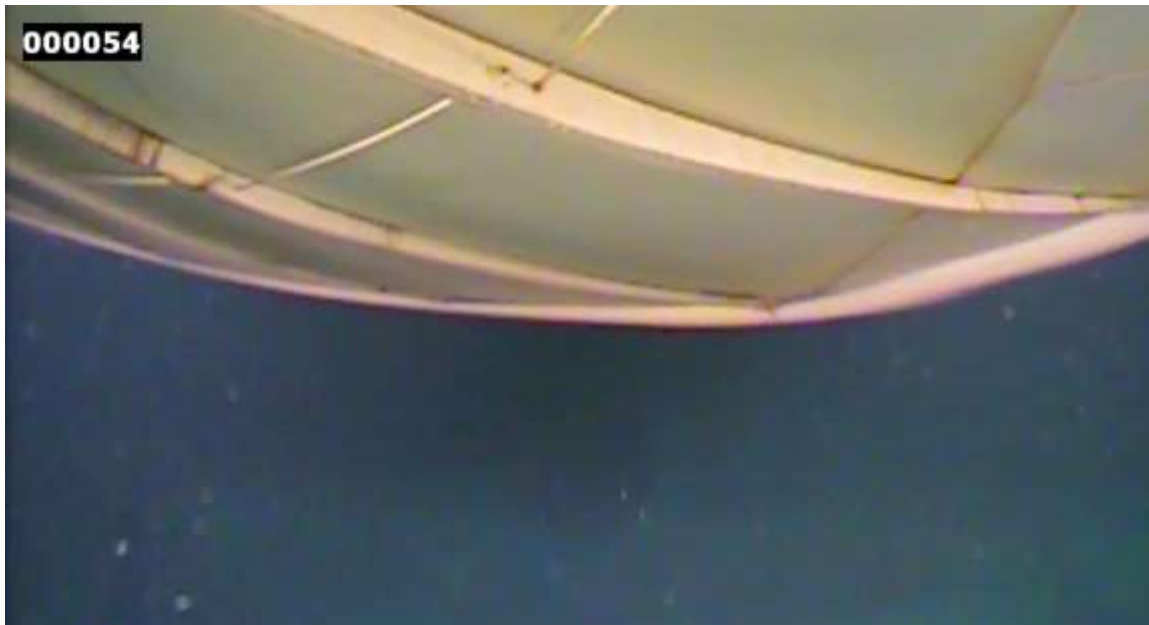
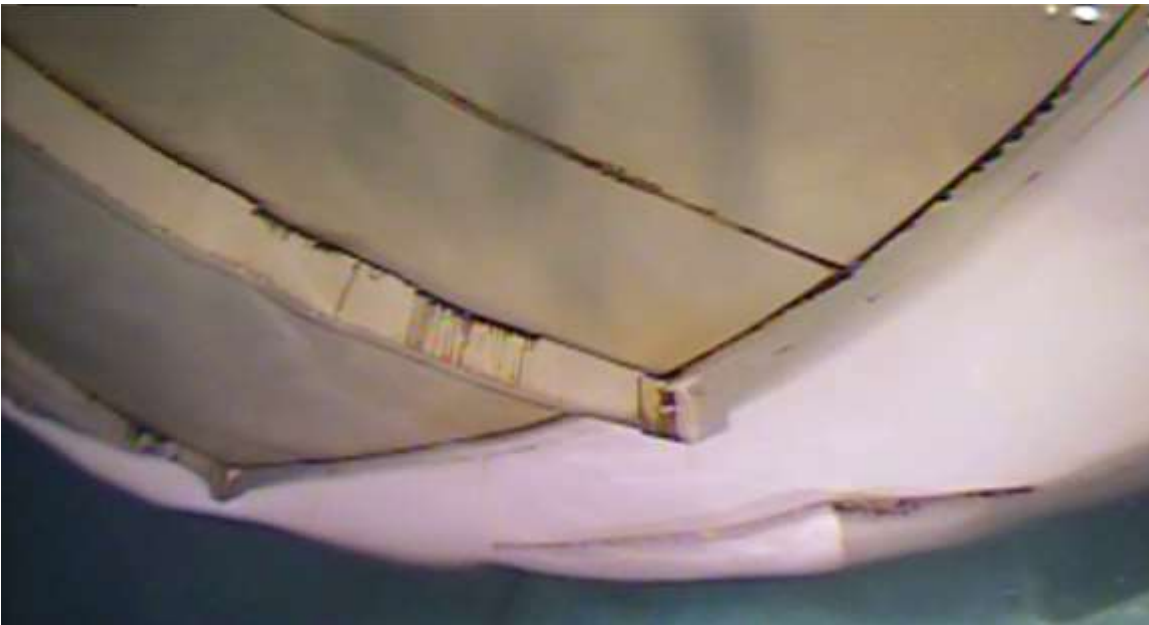
Top photo shows the interior roof lap seams, which appear to be in good condition.

Bottom photo shows the interior roof-to-rim angle connection, which appears to be in good condition.

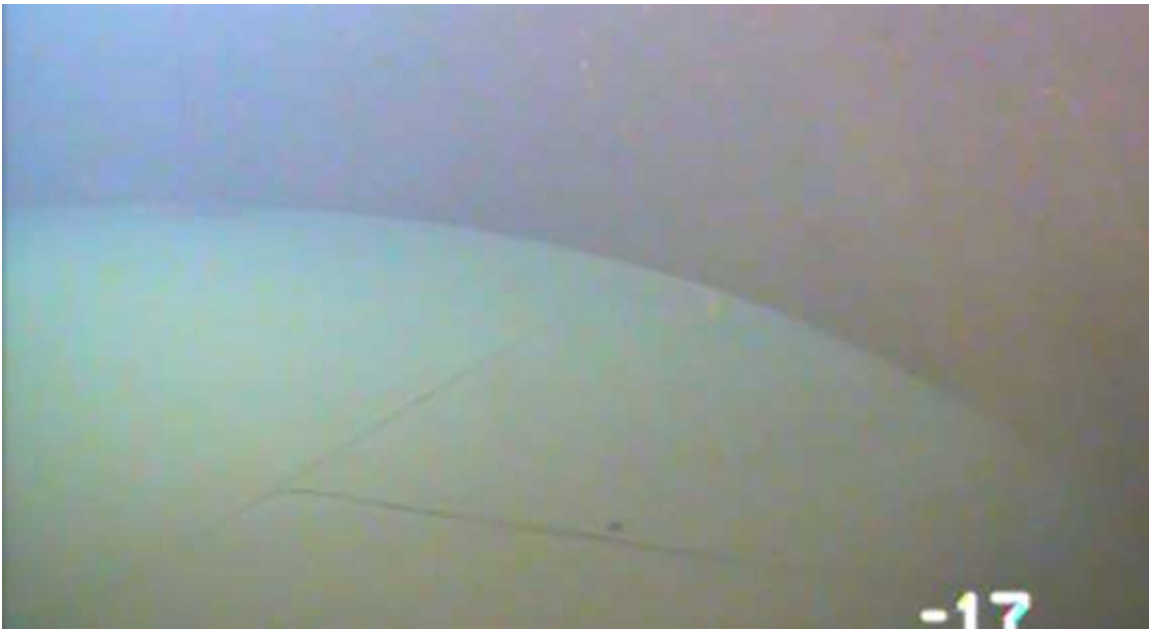
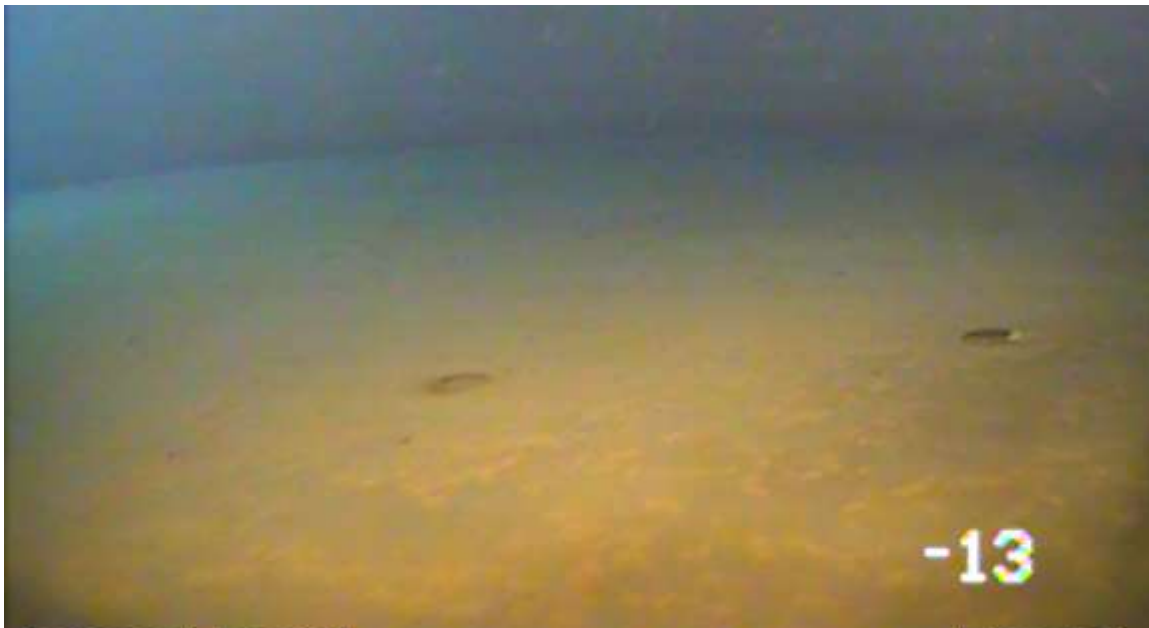
Photos show sediment and debris on the tank interior before a cleanout was performed.

We recommend installing a passive cathodic protection system.

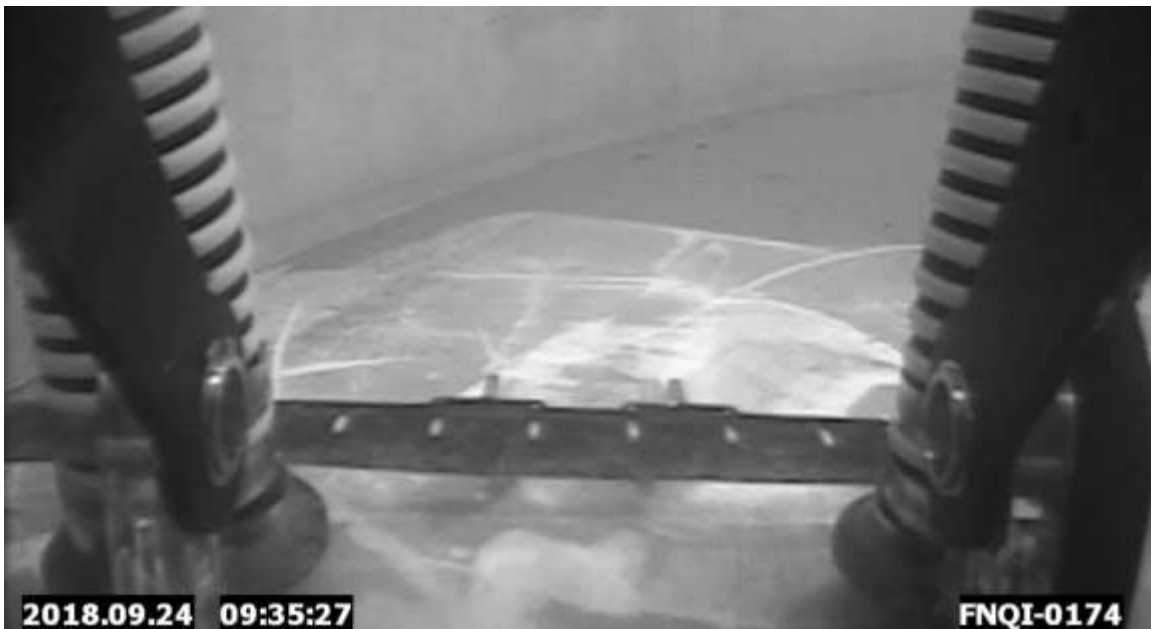
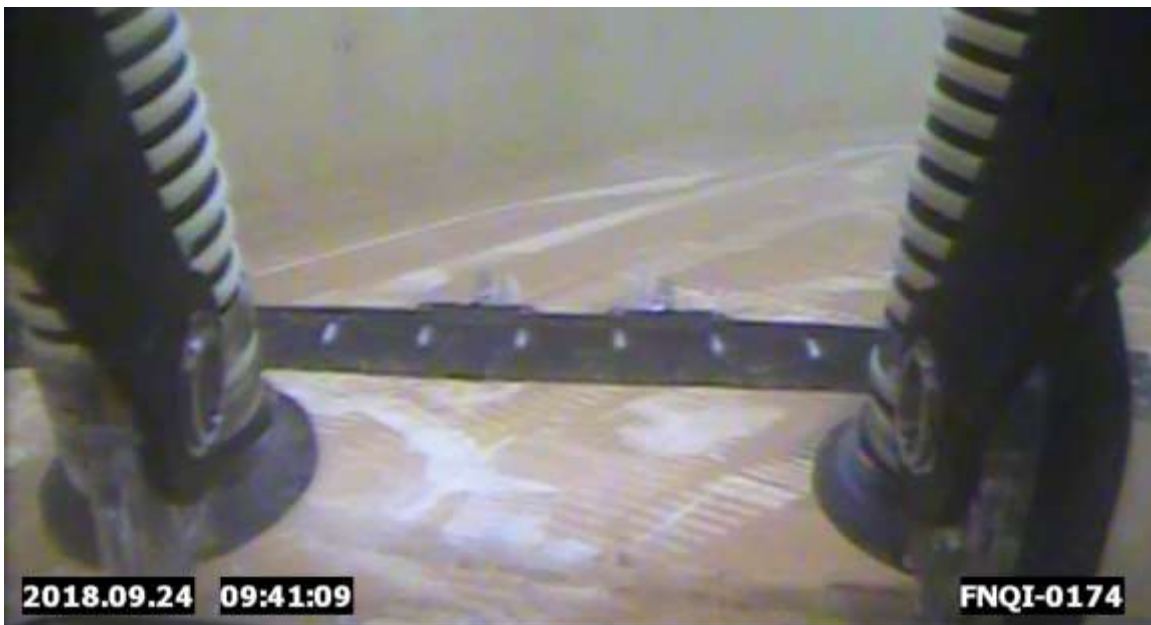
Photos show the tank interior during a cleanout.

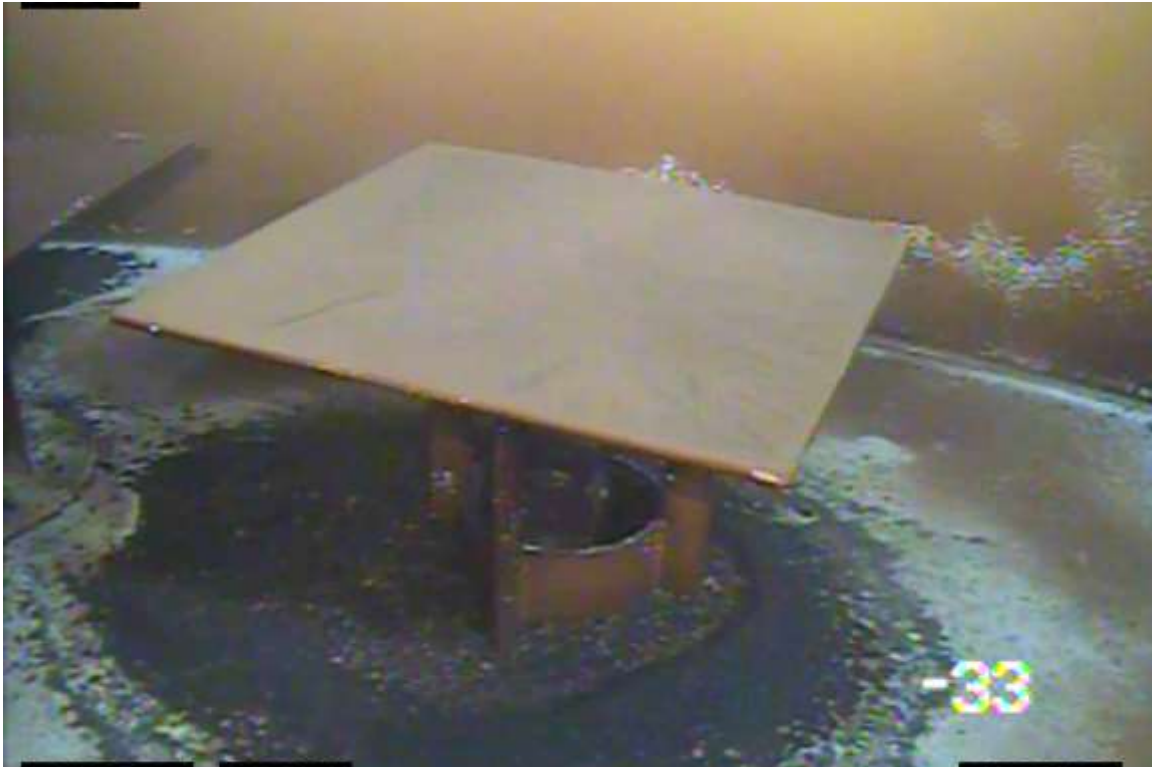
Photo shows a suction pipe on the interior of the tank, which is equipped with a properly sized anti-vortex plate to prevent formation of a vortex.

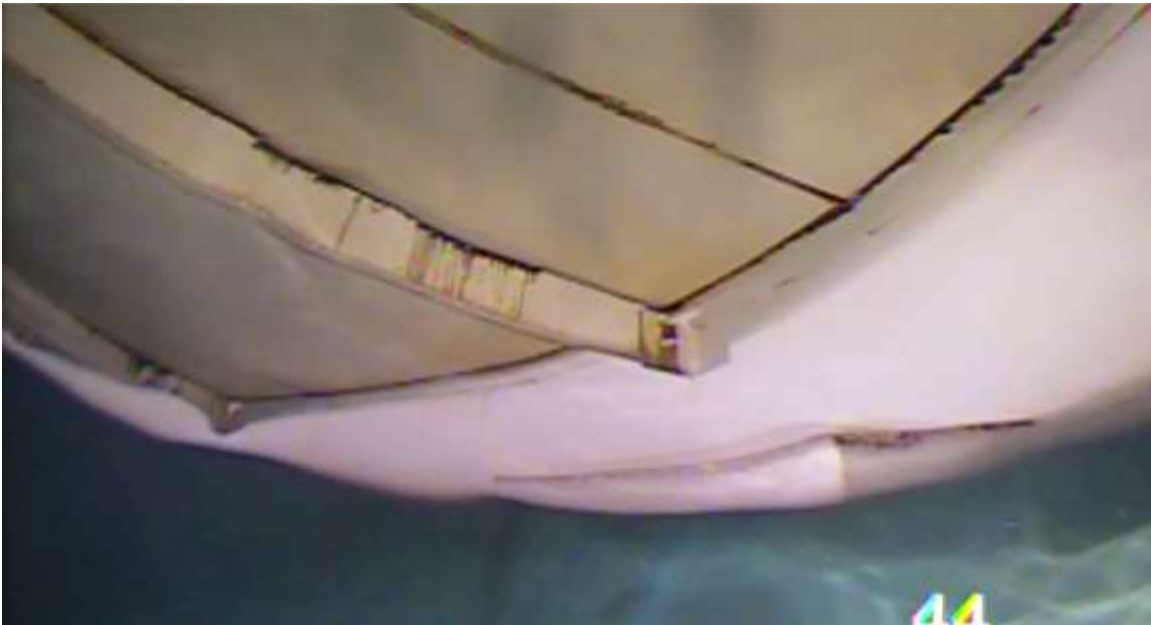
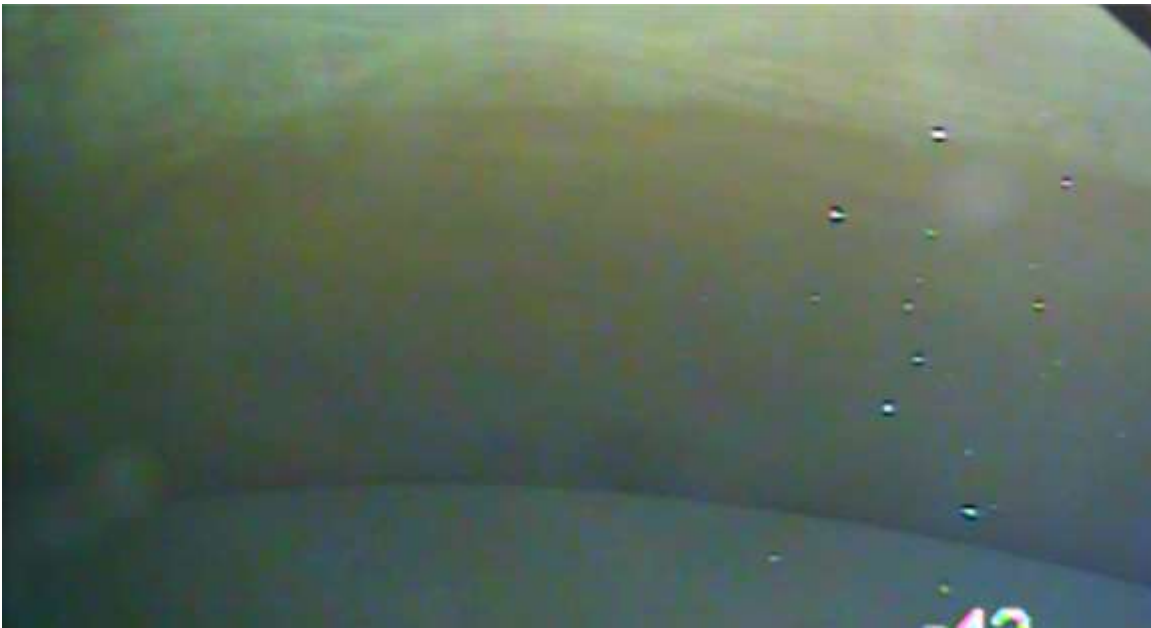
Photos show the tank interior coating system. The overall interior coating system appears to be in good condition. We recommend pressure washing the tank interior with biodegradable detergent injection (minimum 3,500 psi at 3.0 gpm), then re-evaluating the tank interior at next inspection cycle.

22	Pressure wash the tank interior with biodegradable detergent injection (minimum 3,500 psi at 3.0 gpm), then re-evaluate the tank interior at next inspection cycle.					X

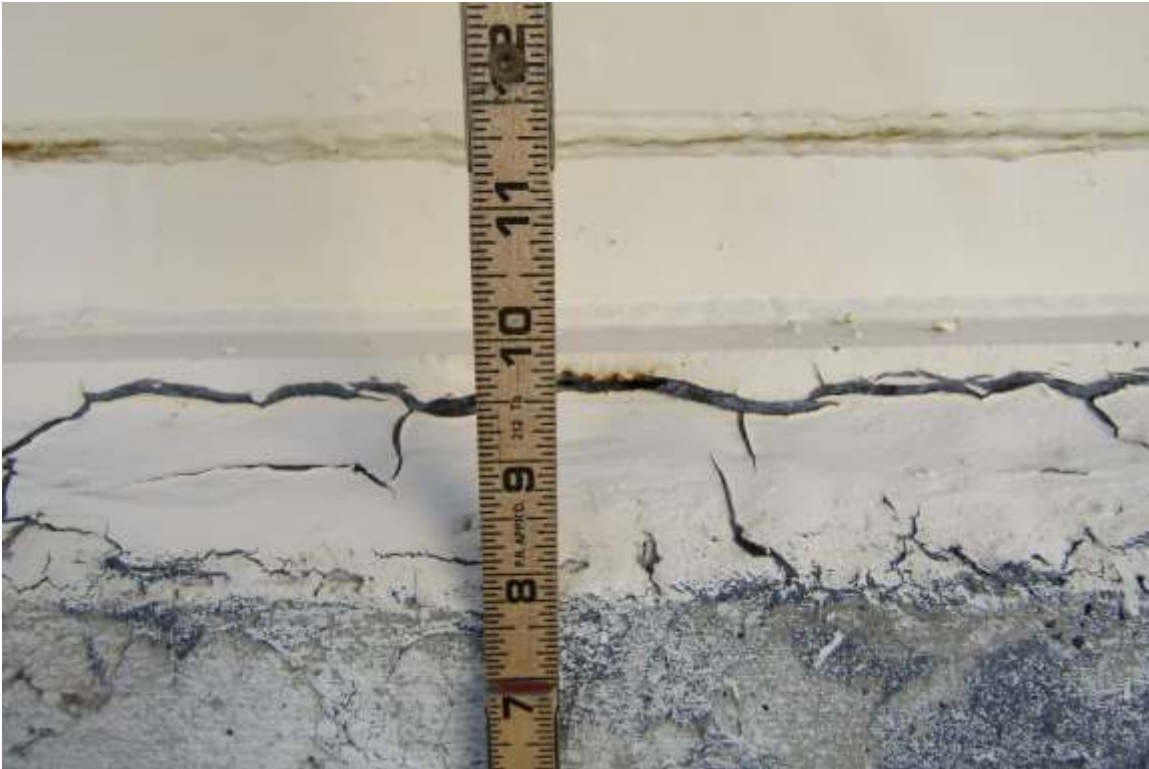
Photo shows the area around the tank foundation is properly graded and in compliance with **AWWA D100-11; 12.7.1 Height aboveground.**

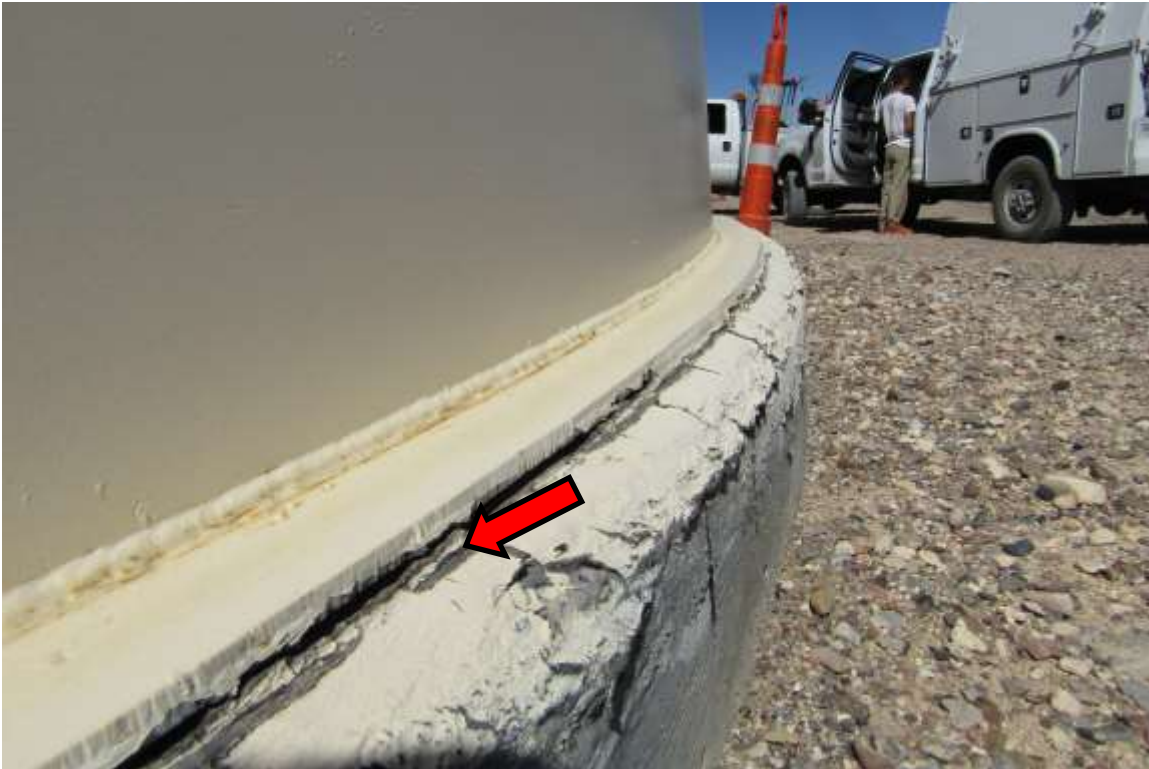
Photo shows the condition of the foundation. We recommend repairing any cracks and spalling in the concrete with a commercial non-shrinking grout, caulking/grouting around the base of the tank to foundation connection to prevent water from entering under the tank, then sealing the foundation with a sealant.

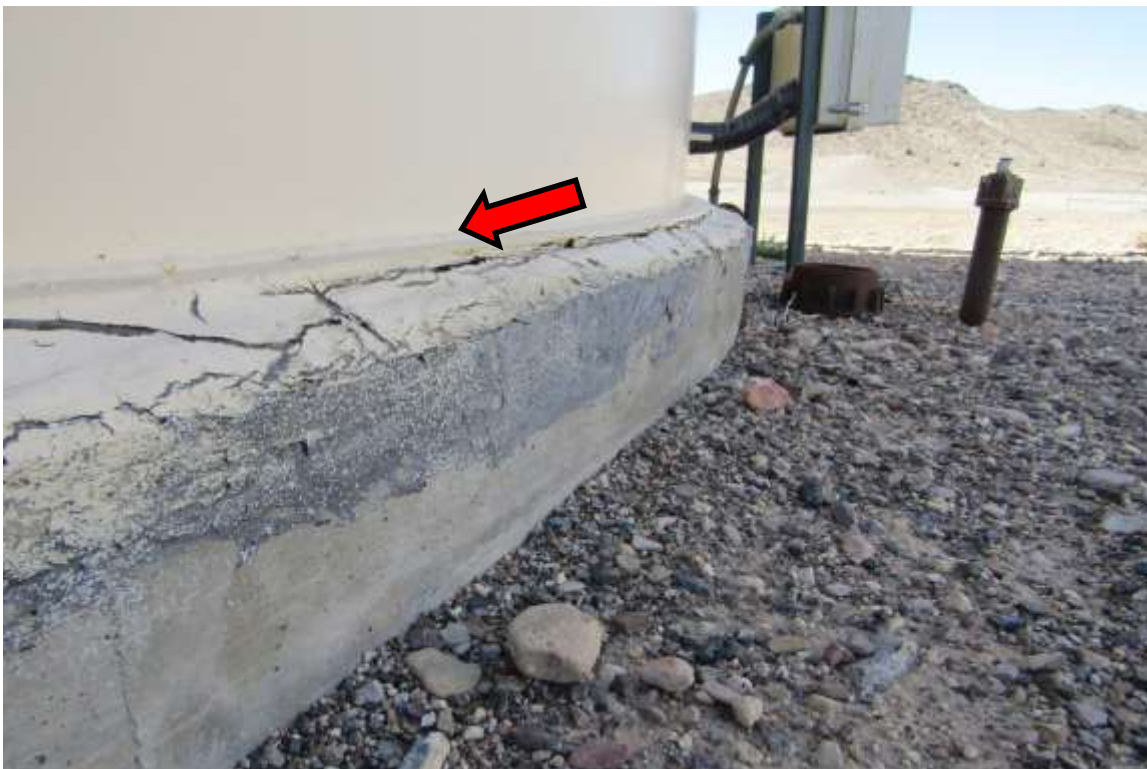
Photo shows the tank has no grounding system. We recommend electrically grounding the tank for lightning protection as required by **OSH Act of 1970 Section 5**.

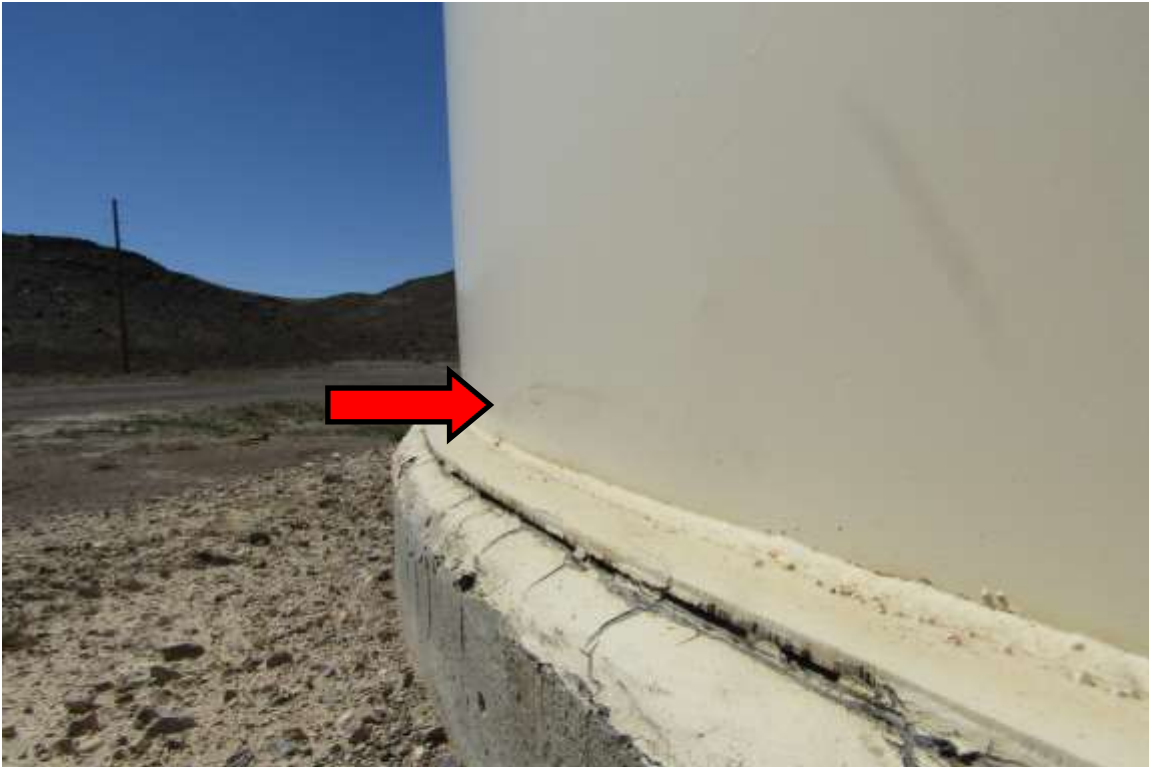
Photo shows the condition of the shell. Currently there is no drain valve. We recommend installing a frost proof drain valve near the shell-to-floor connection, complete with a locking device to prevent unauthorized draining of the tank and a splash pad to direct water away from the foundation.

**Splash pad to be installed by owner.*

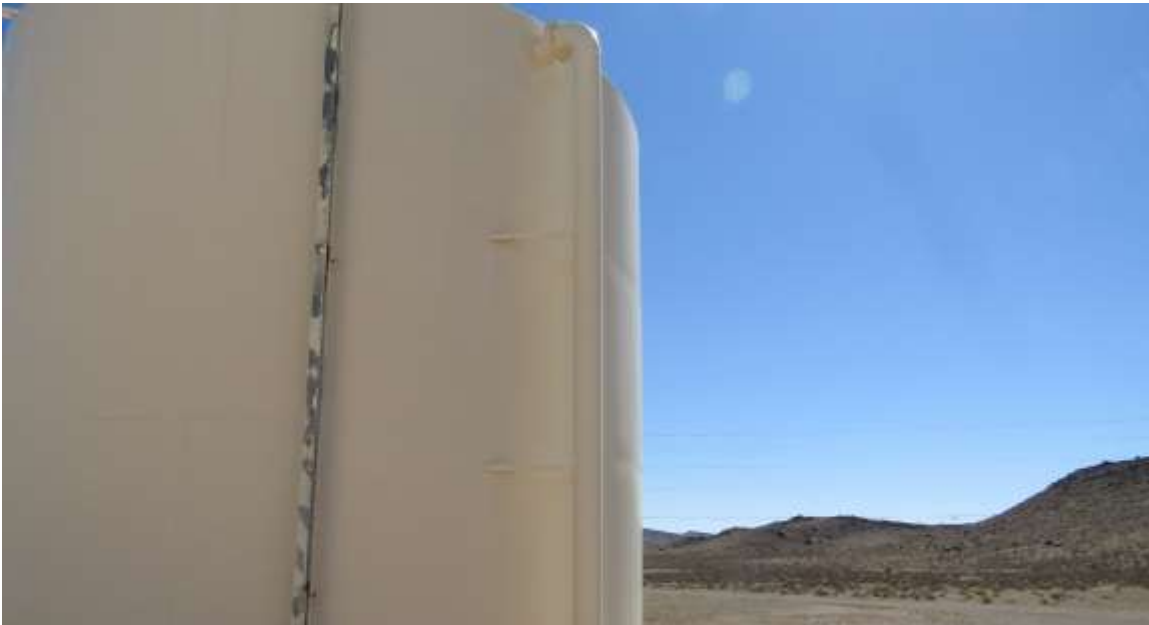
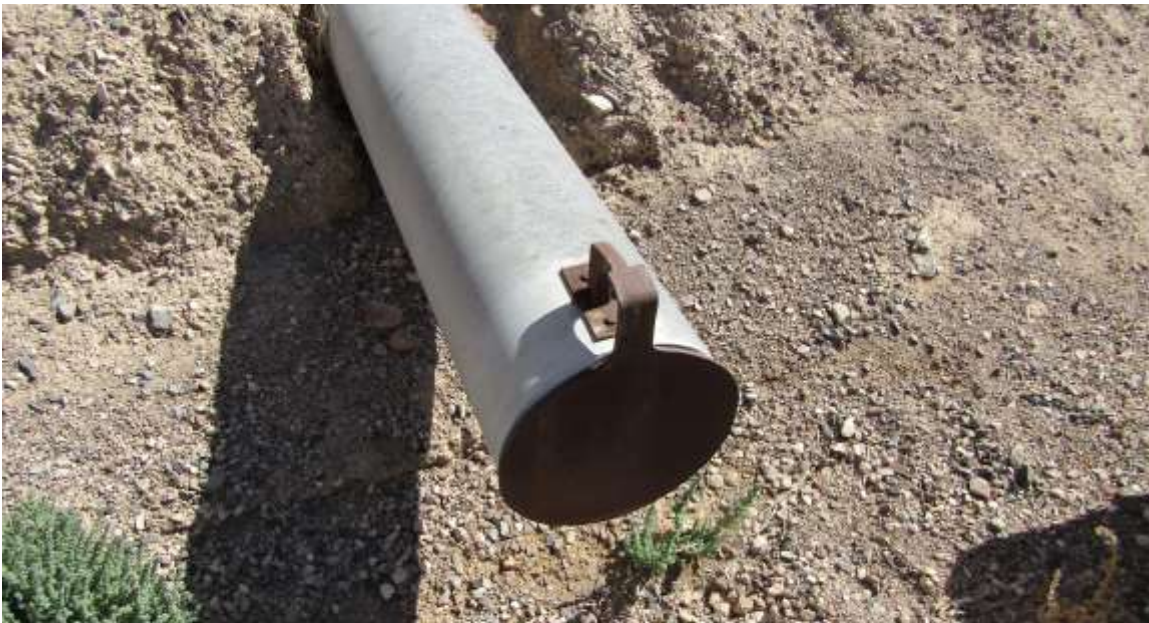
Photos show the 8" overflow pipe system, which is equipped with a flapper valve as required by **AWWA D100-11; 7.3 Overflow**. We recommend installing a screen on the existing overflow pipe elbow.

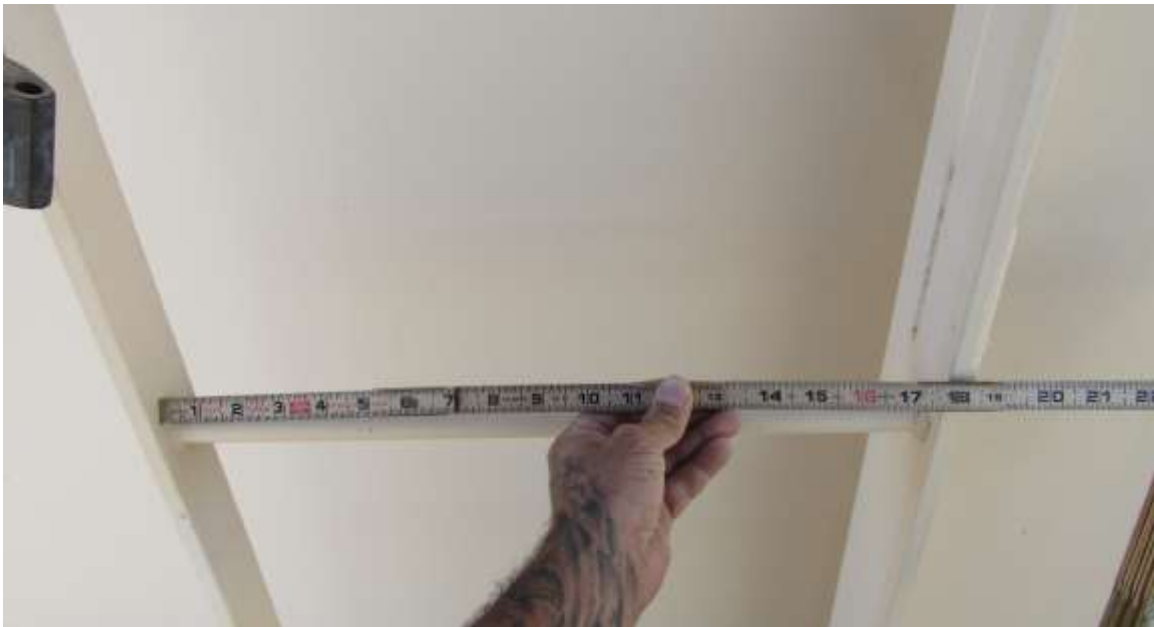
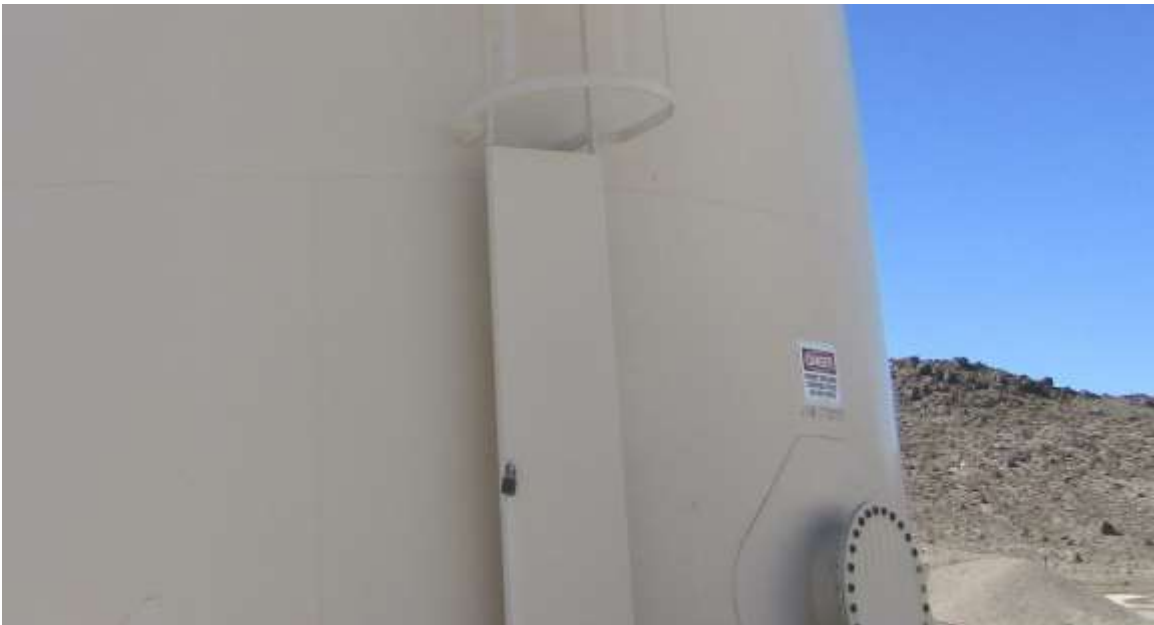
Shell access ladder in above photos is 18" wide, but is not equipped with anti-skid rungs. We recommend installing anti-skid rung covers, a cable type ladder safety device, and posting a **Fall Protection Required** sign at the base of the ladder.

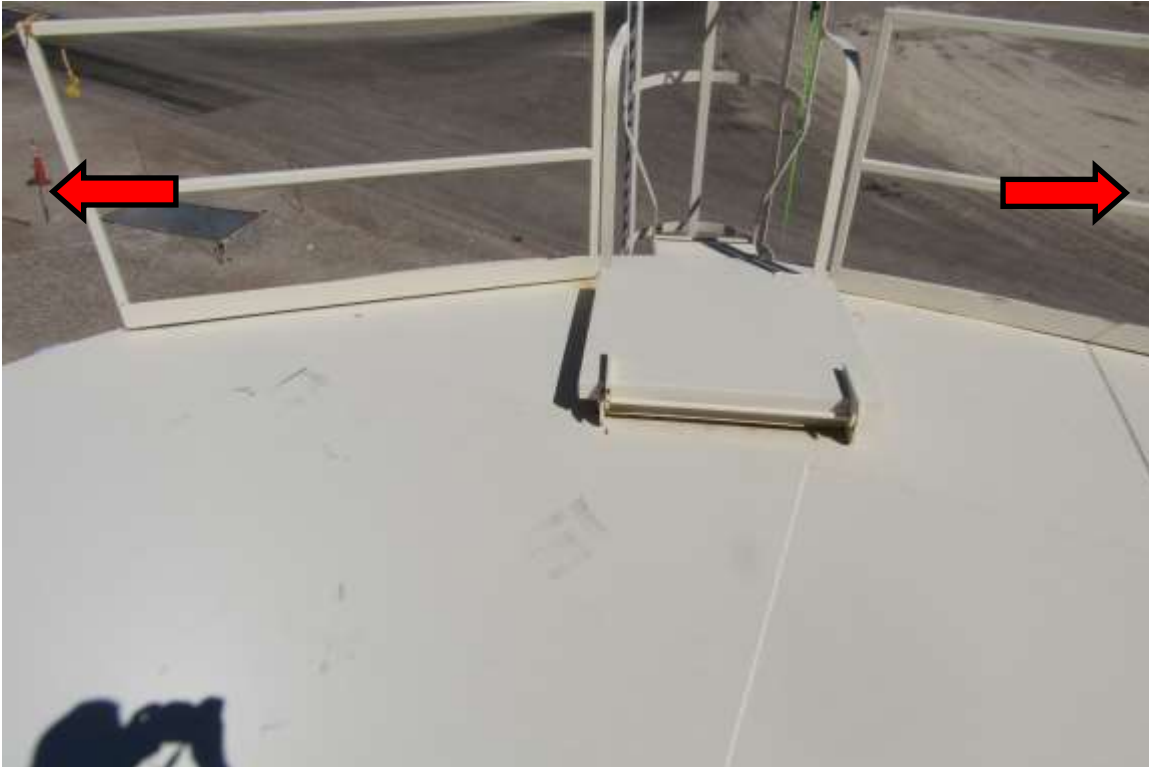
Photo shows the tank roof edge is not equipped with a required handrail system for fall protection. **OSHA 1910.28(b)(1)(i)** states, "...the employer must ensure that each employee on a walking-working surface with an unprotected side or edge that is 4 feet (1.2 m) or more above a lower level is protected from falling by one or more of the following: **1910.28(b)(1)(i)(A) Guardrail systems.**"

The tank is equipped with 42" high handrails to the left and right of the access ladder. We recommend extending the handrails around the circumference of the tank roof, complete with an intermediate rail, a toeboard, and a swing gate at the junction of the shell-to-roof access ladder and tank roof.

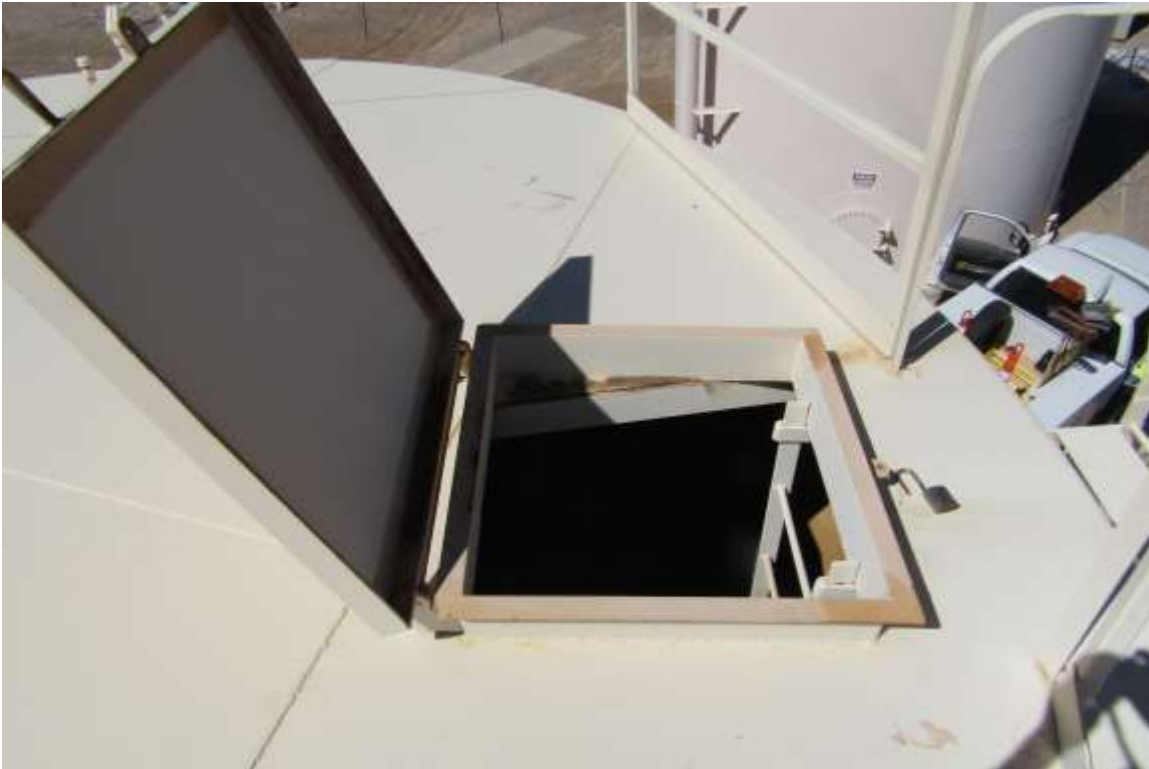
Photo shows the condition of the 30" primary roof hatch. Roof openings on this tank require the following to be in compliance with **AWWA D100-11; 7.4.3 Roof openings** and **OSHA 1910.146(c)(2) Confined spaces**.

We further recommend installing an **OSHA** compliant interior access ladder complete with standoffs every 10' on center, and a cable type ladder safety device at the suggested secondary roof hatch.

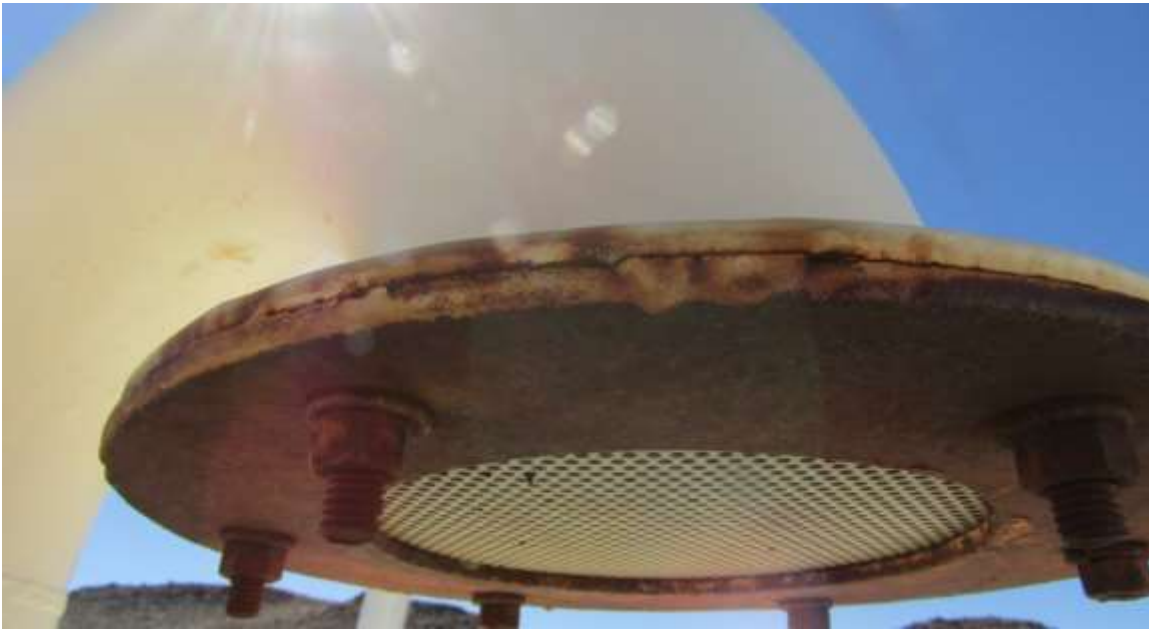
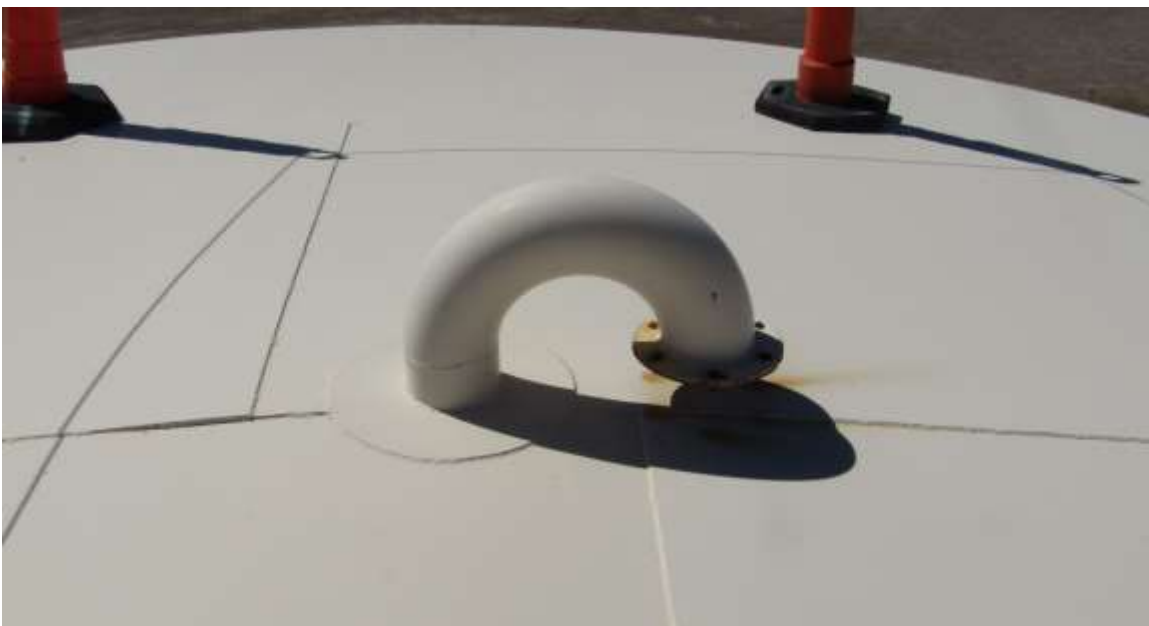
Photos show the condition of the existing 6" roof vent. **This vent is allowing the ingress of rain and wind-borne contaminants into the water system. An improperly vented tank may cause external pressure to act on the tank which can cause buckling even at low pressure differential.** We recommend replacing the existing roof vent with a vacuum-pressure, frost proof vent and screen.

This work should be performed on an emergency basis.

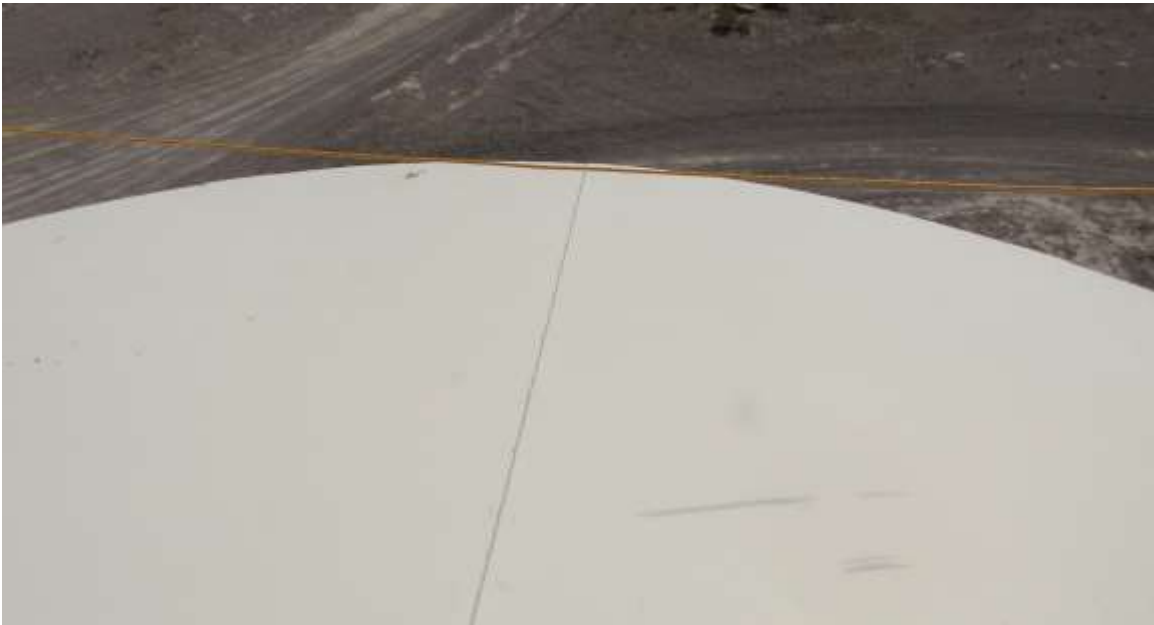
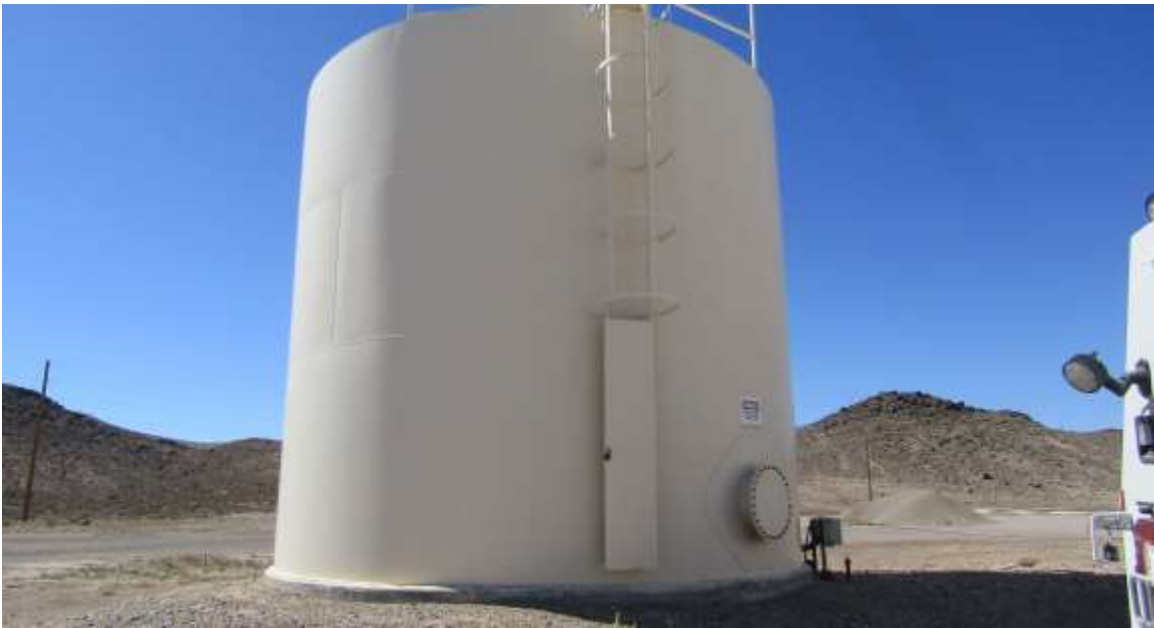
Photos show the tank exterior coating system. The overall exterior coating system appears to be in good condition. We recommend re-evaluating the tank exterior at next inspection cycle.

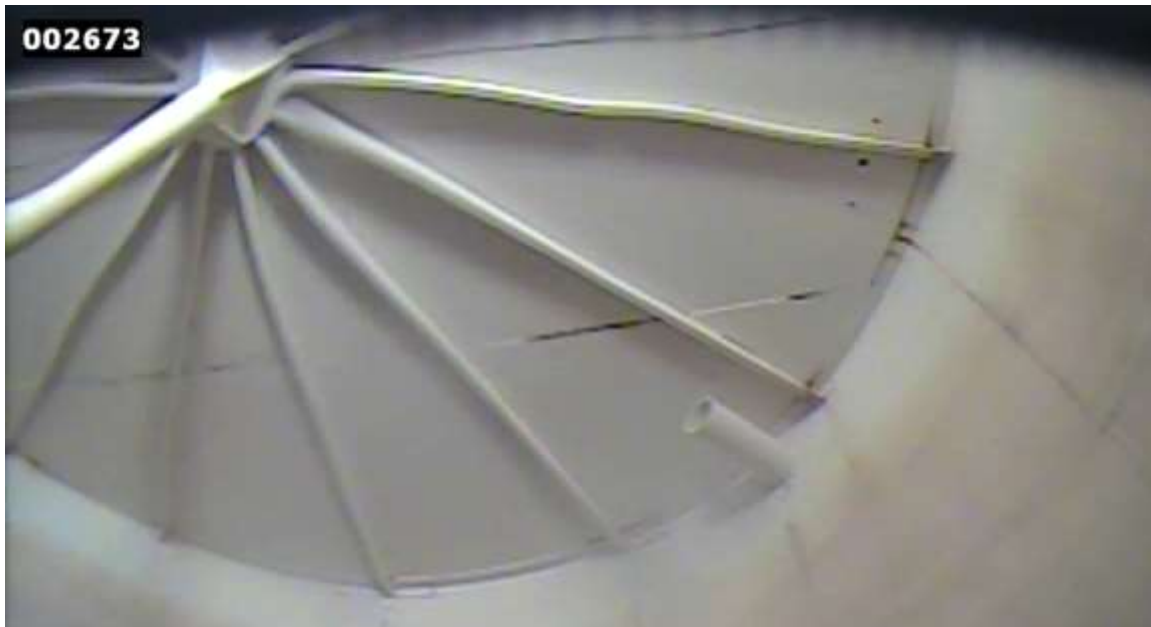
Top photo shows the interior roof lap seams, which appear to be in good condition.
