**Mission Support and Test Services, LLC
Nevada National Security Site
Mercury, NV 89023
RE: Mercury North (Area 23); Mercury, NV
1,500,000 Gallon GST
September 16, 2018
Mr. Kevin Olsen
Scientist 1
(702) 295-0485
Job No. 318448-A**

**Mission Support and Test Services, LLC
Nevada National Security Site
Mercury, NV 89023
RE: Camp South (Area 12); Mercury, NV
500,000 Gallon GST
September 13, 2018
Mr. Kevin Olsen
Scientist 1
(702) 295-0485
Job No. 318448-D**

**Mission Support and Test Services, LLC
Nevada National Security Site
Mercury, NV 89023
RE: Well 4/4a South (Area 6); Mercury, NV
150,000 Gallon GST
September 24, 2018
Mr. Kevin Olsen
Scientist 1
(702) 295-0485
Job No. 318448-H**

**Mission Support and Test Services, LLC
Nevada National Security Site
Mercury, NV 89023
RE: C-1 North (Area 6); Mercury, NV
50,000 Gallon GST
September 21, 2018
Mr. Kevin Olsen
Scientist 1
(702) 295-0485
Job No. 318448-O**

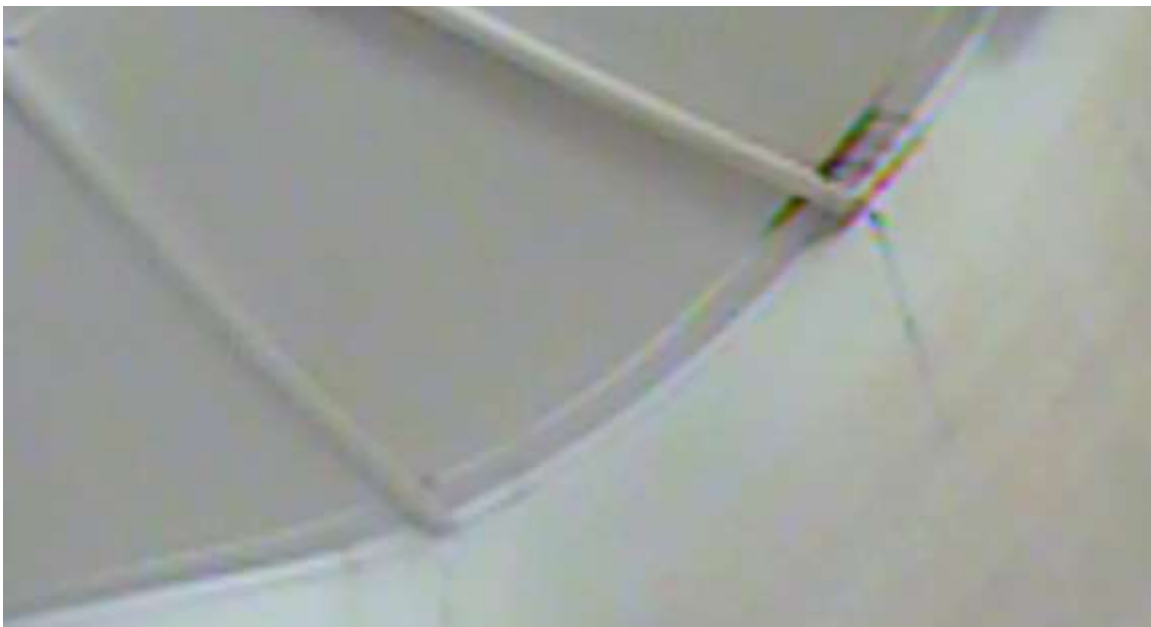
Bottom photo shows the interior roof-to-rim angle connection, which appears to be in good condition.

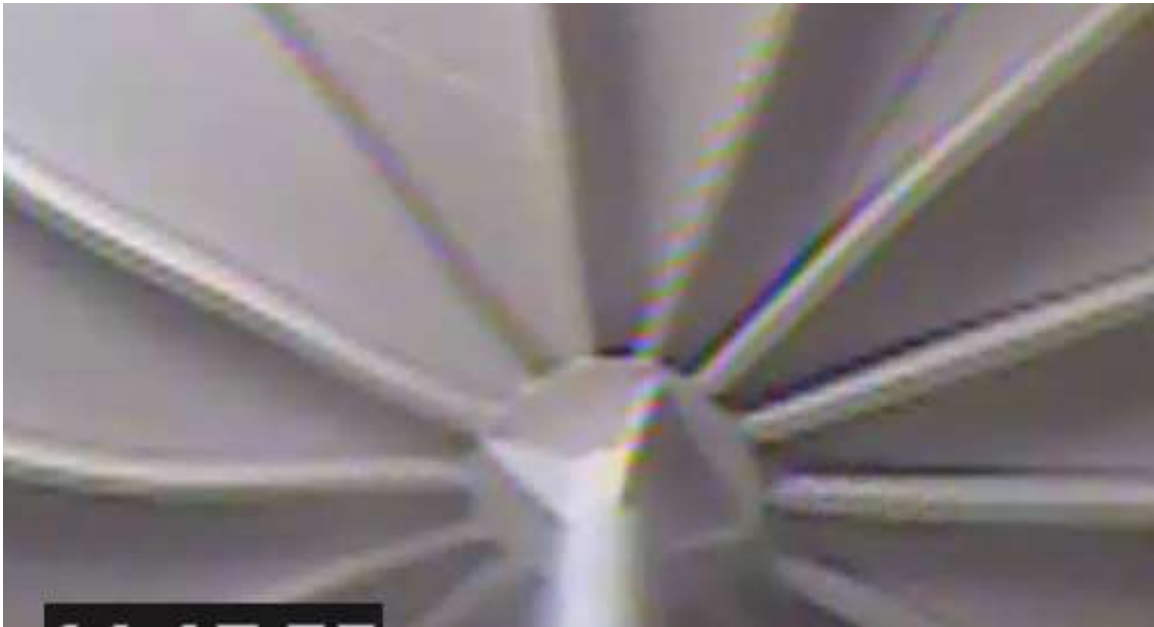
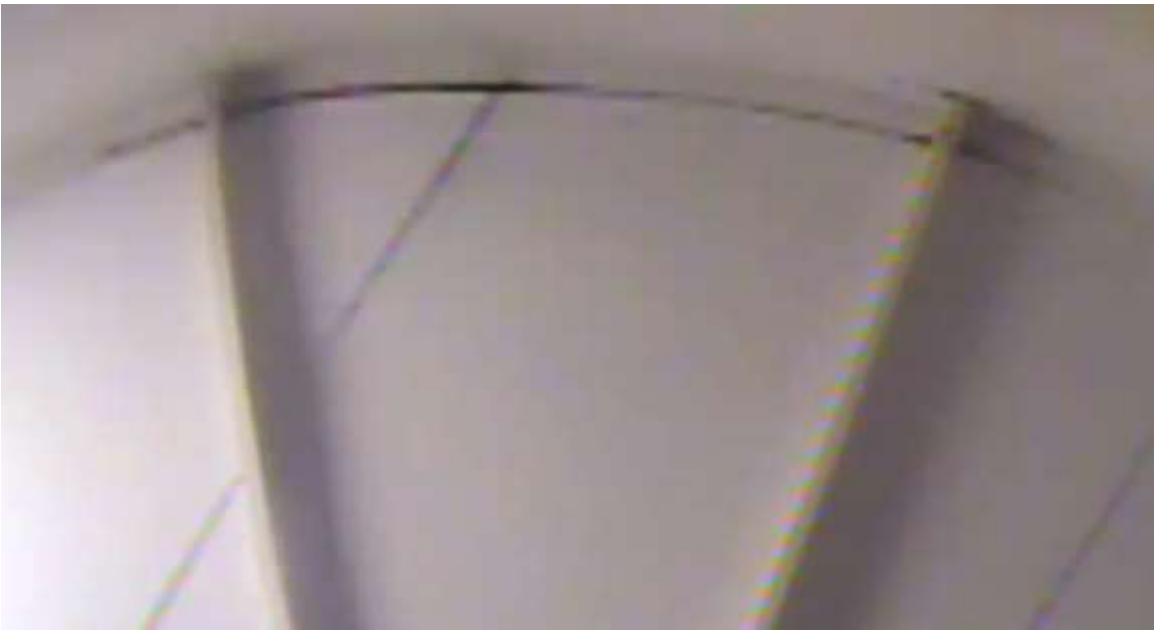
Photos show the rafter-to-support column and rafter-to-shell connections, which appear to be in good condition.

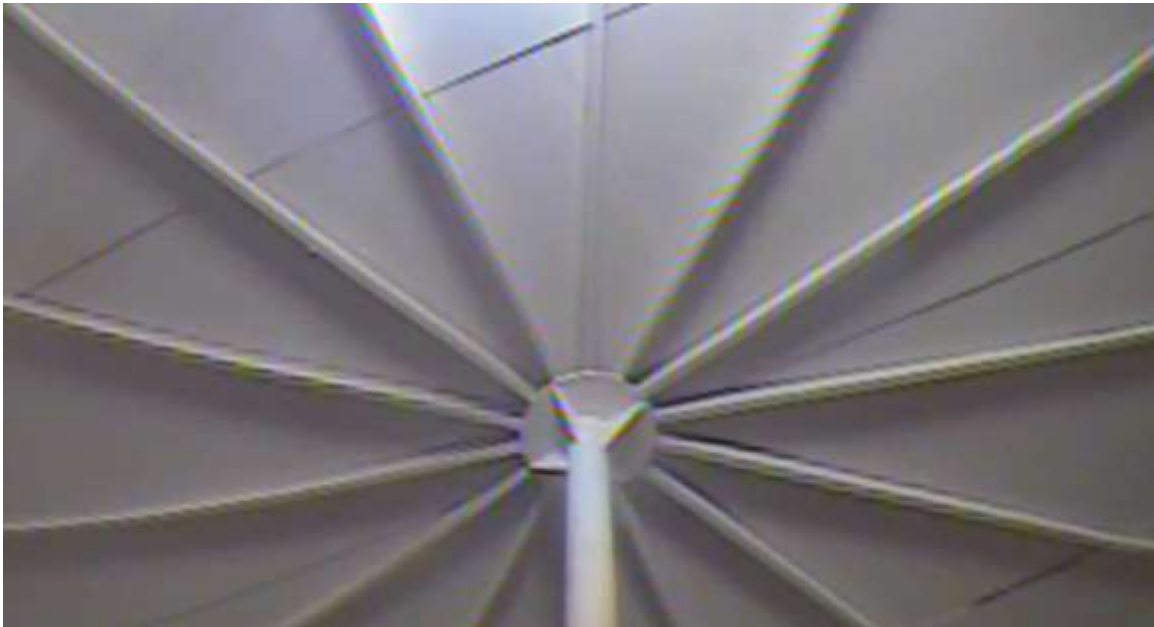
Top photo shows the center support column, which appears to be in good condition.

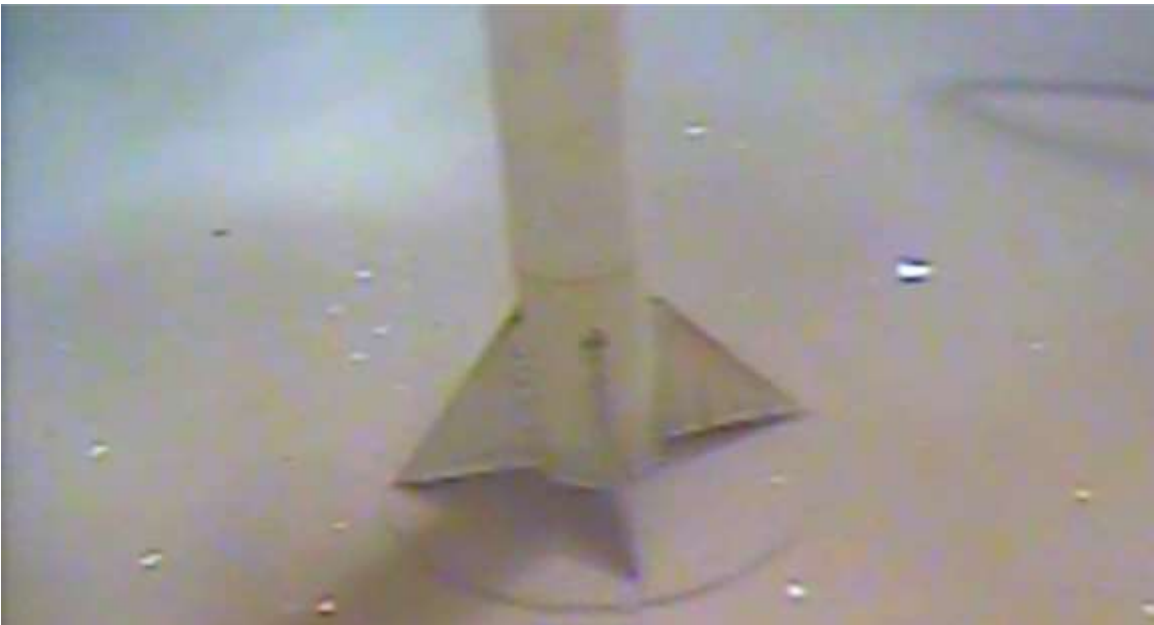
Bottom photo shows the support column baseplate-to-floor connection. Notice the baseplate is welded to the floor. Should the floor settle, the roof and structure could be damaged. We recommend disconnecting the support column baseplate from the floor and installing guides on the sides of the plate to ensure it stays in place.

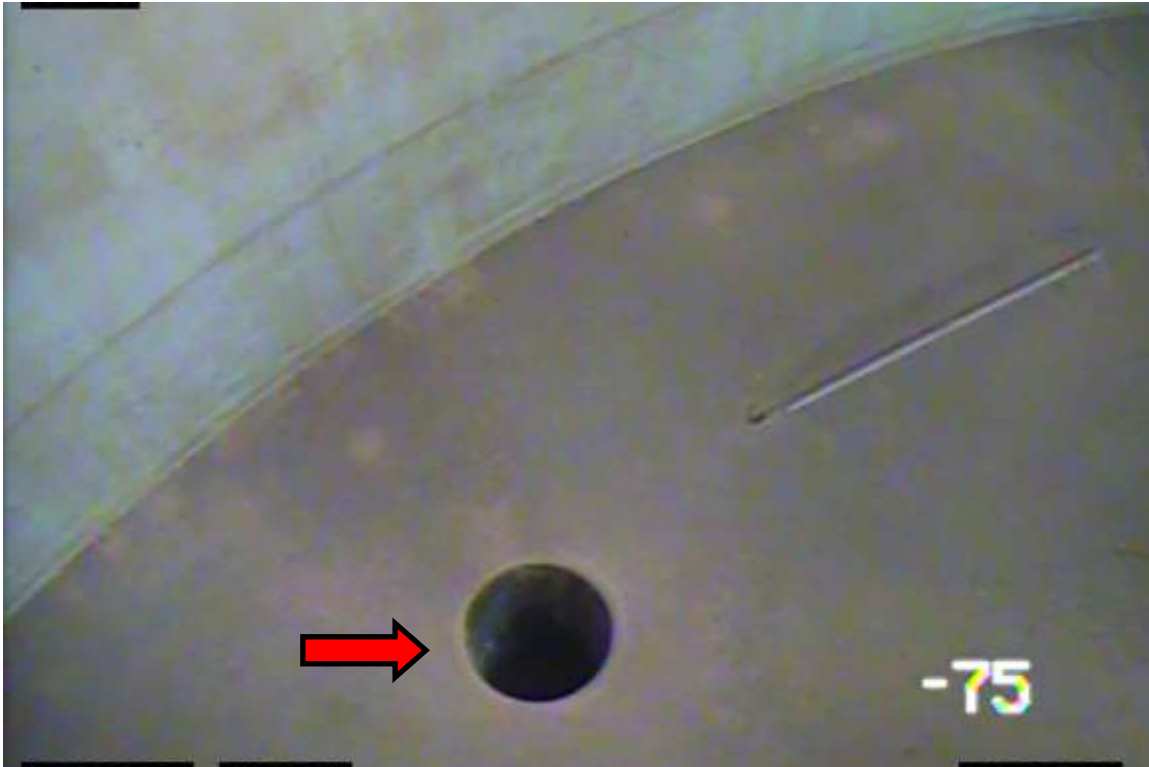
Photo shows a fill pipe on the tank interior. A temperature difference between the water in the top and bottom of a tank, even as little as 1-2 degrees Fahrenheit, is an indication of thermal stratification and the tank water not being completely mixed. Incomplete mixing would result in short-circuiting, and localized increase in water age would develop inside the tank. This typically leads to water quality problems, such as loss of residual, DBP spikes, HPC spikes, bacteria regrowth, formation of bio-film, changes in pH and dissolved oxygen. We recommend installing a mixing system. Electrical work to be done by others if required.

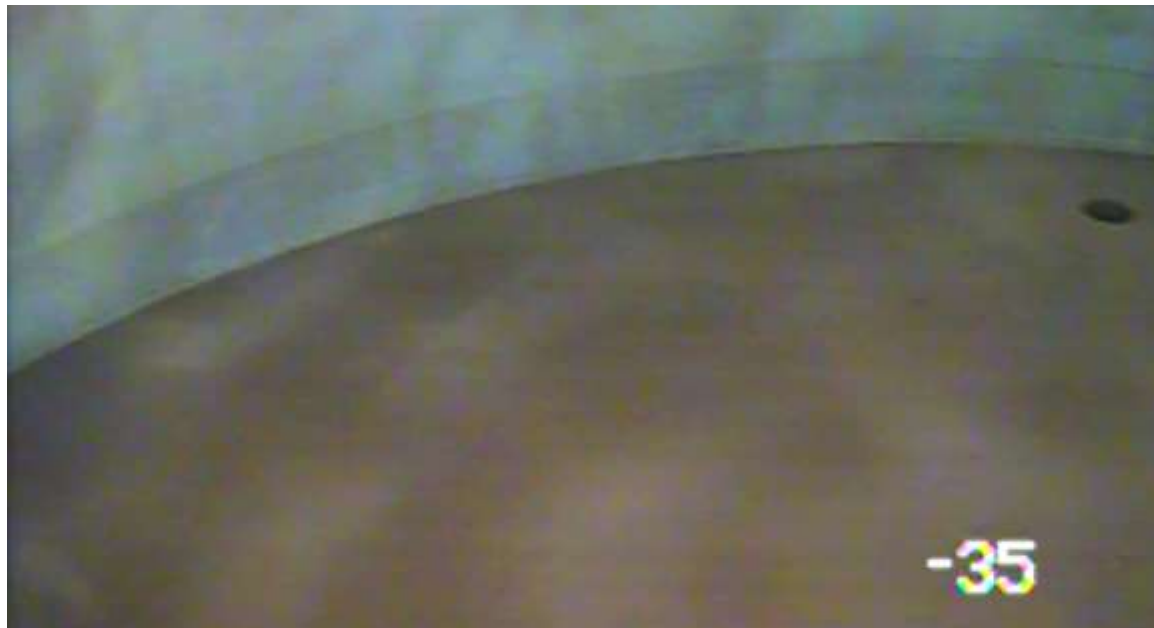
Photos show sediment and debris on the tank interior before a cleanout was performed.

We recommend installing a passive cathodic protection system.

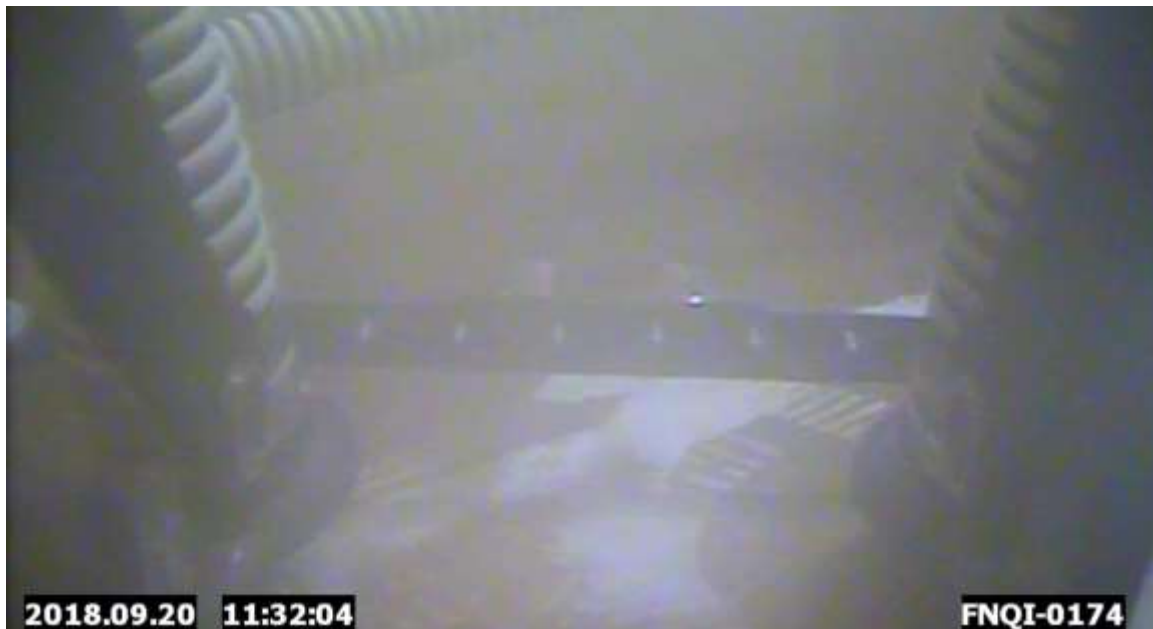
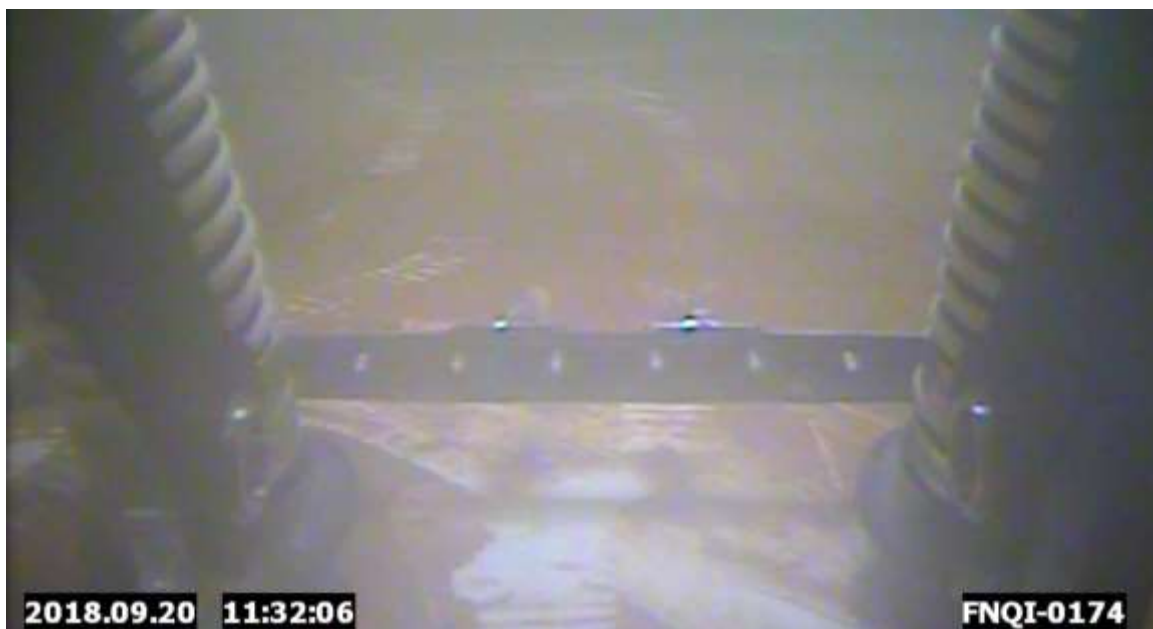
Photos show the tank interior during a cleanout.

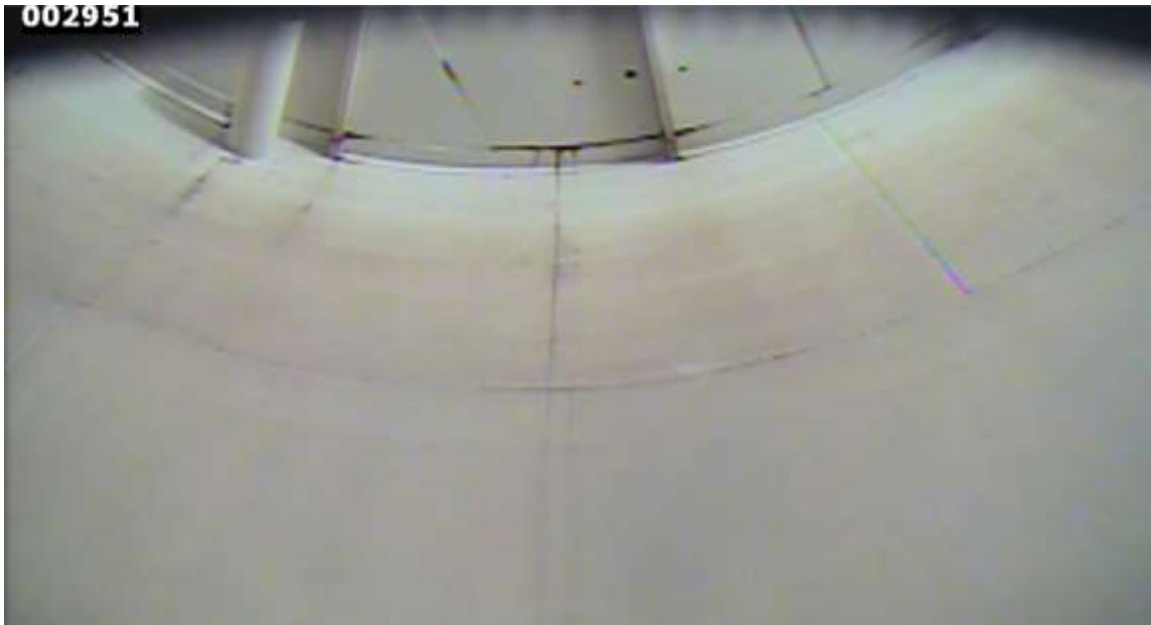
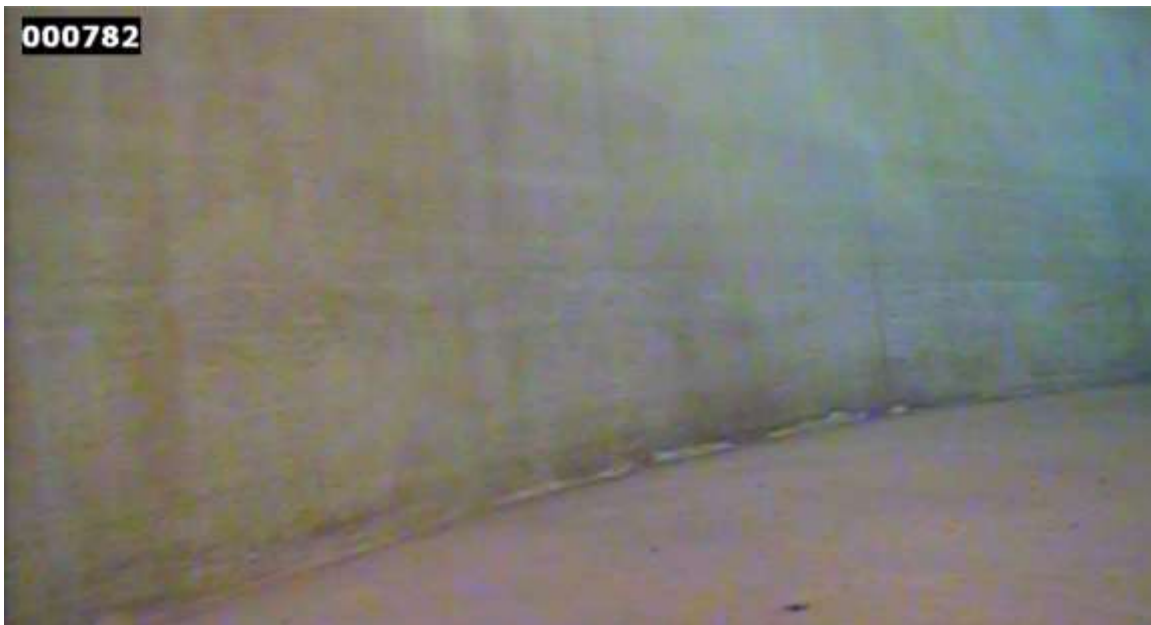
Photos show the tank interior coating system. The overall interior coating system appears to be in good condition. We recommend re-evaluating the tank interior at next inspection cycle.

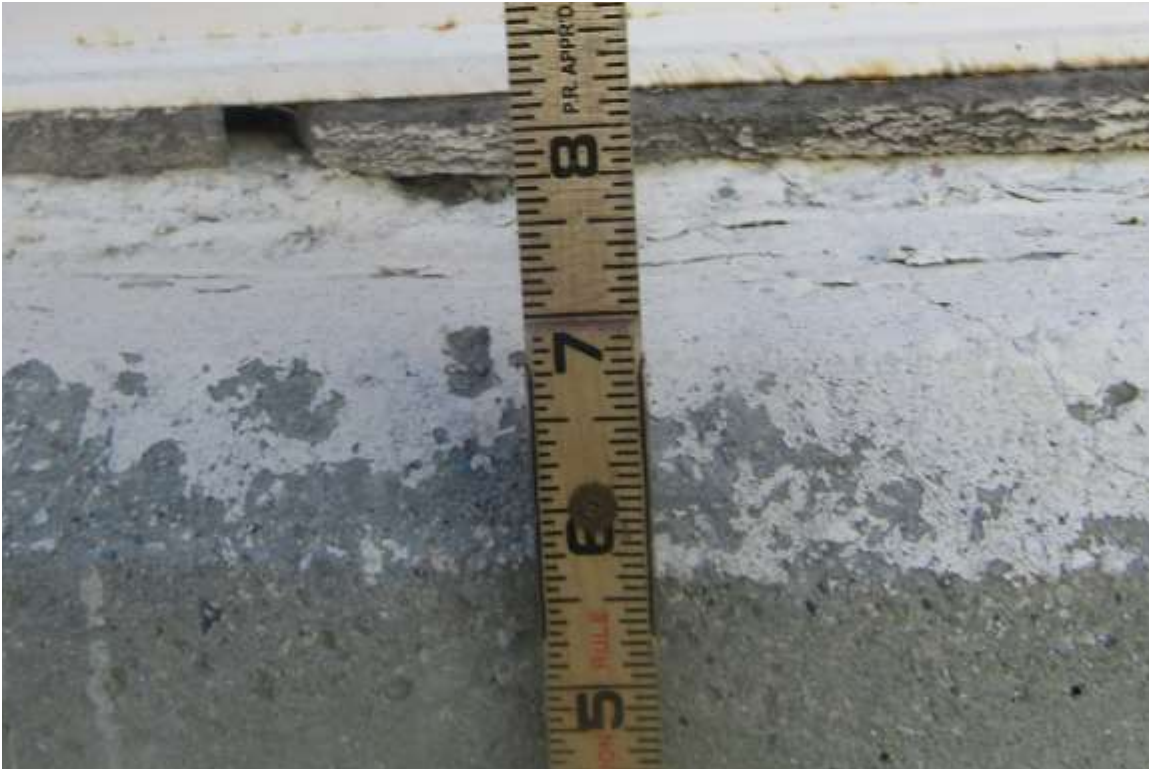
Photo shows the area around the tank foundation is properly graded and in compliance with **AWWA D100-11; 12.7.1 Height aboveground.**

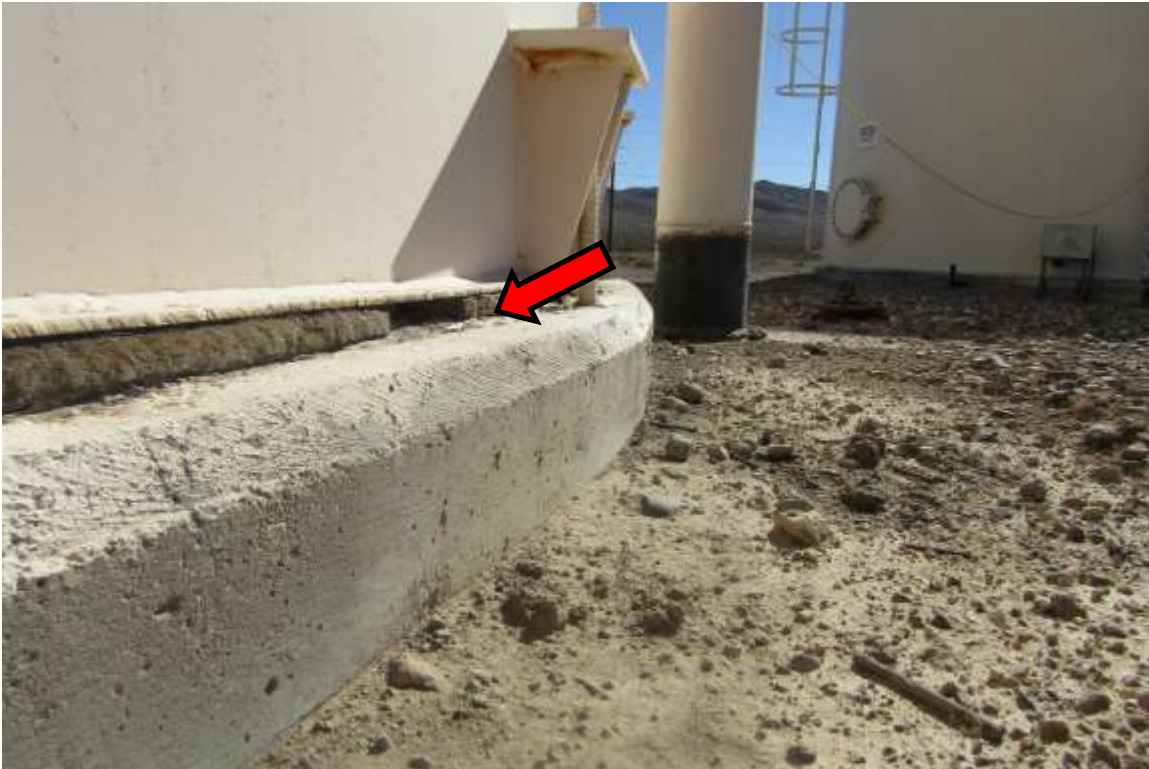
Photo shows the condition of the foundation. **NFPA 22-2018; 12.2.1.2** states, "... the junction of the tank bottom and the top of the concrete foundation shall be tightly sealed to prevent water from entering the base." We recommend repairing any cracks and spalling in the concrete with a commercial non-shrinking grout, caulking/grouting around the base of the tank to foundation connection to prevent water from entering under the tank, then sealing the foundation with a sealant.

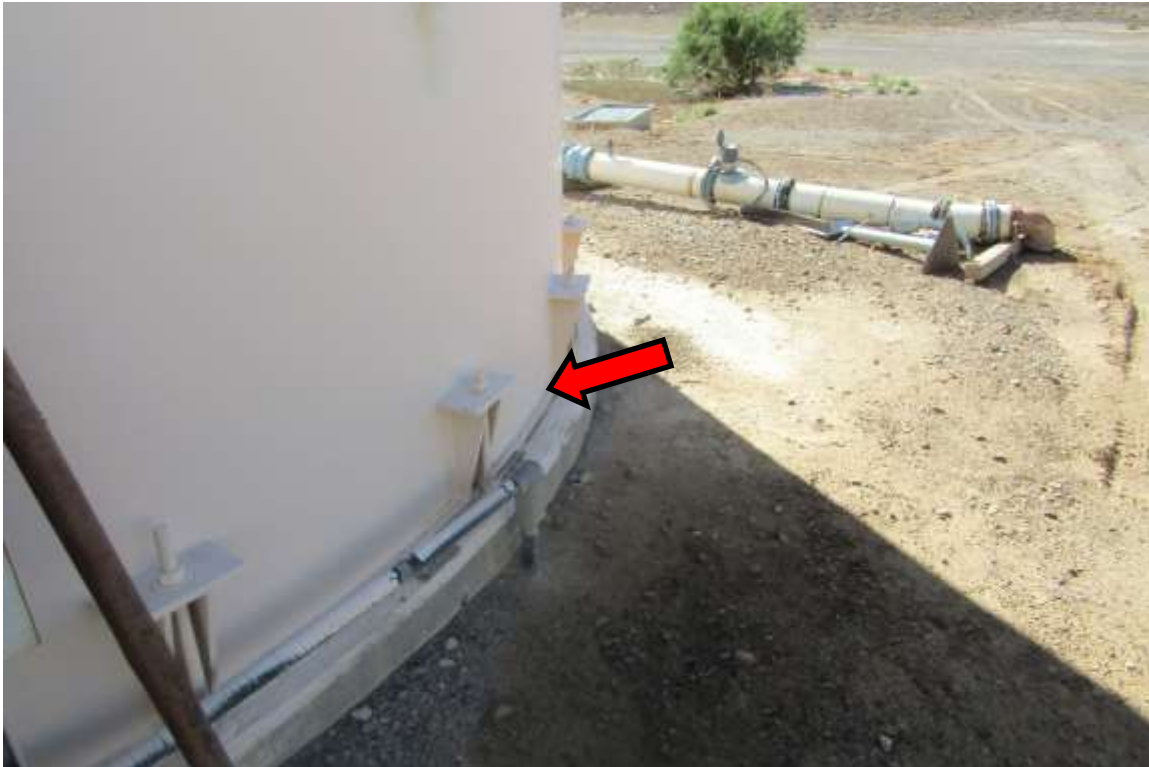
Photo shows the tank has no grounding system. We recommend electrically grounding the tank for lightning protection as required by **OSH Act of 1970 Section 5** and **NFPA 780-2017; 5.4 Metal Towers and Tanks**.

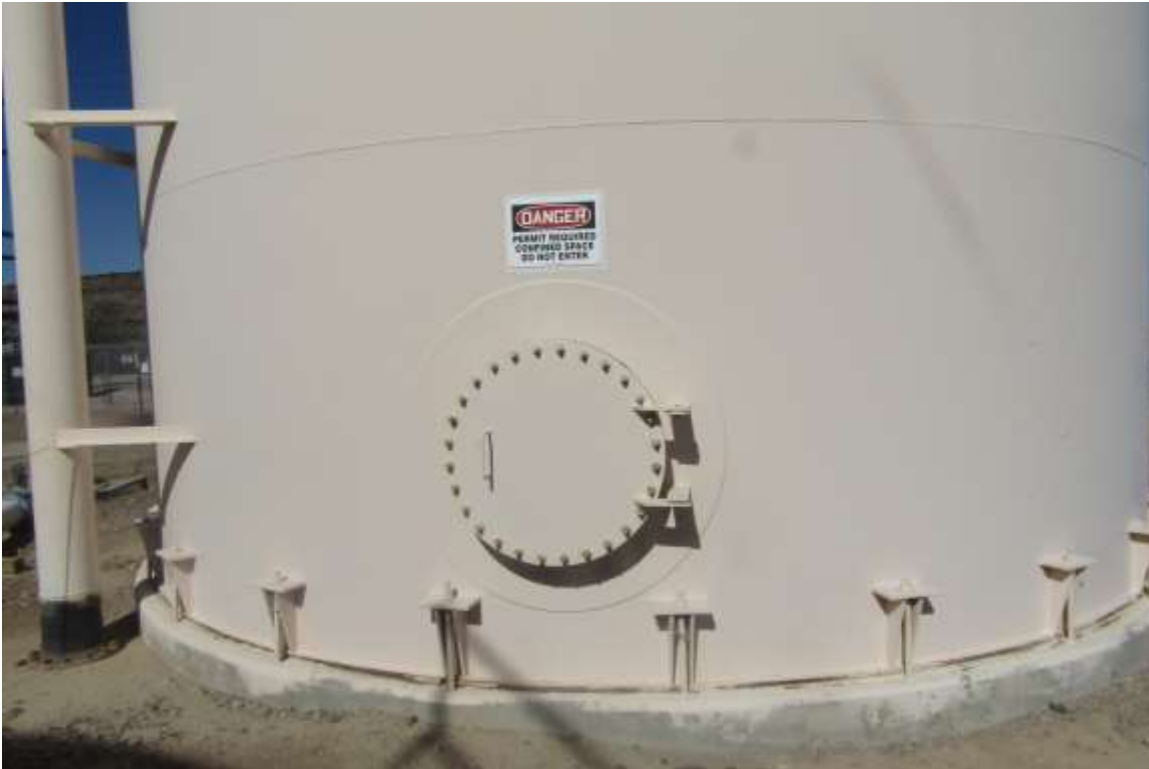
Photo shows the condition of the 24" secondary shell manway. The following is required for the tank to be in compliance with **AWWA D100-11; 7.4.4 Shell man-holes**, **NFPA 22-2018; 14.7.2.1.1** and **OSHA 1910.146(c)(2) Confined spaces**.

Replace 24" manway with 30" manway
Install maintenance free galvanized steel bolts

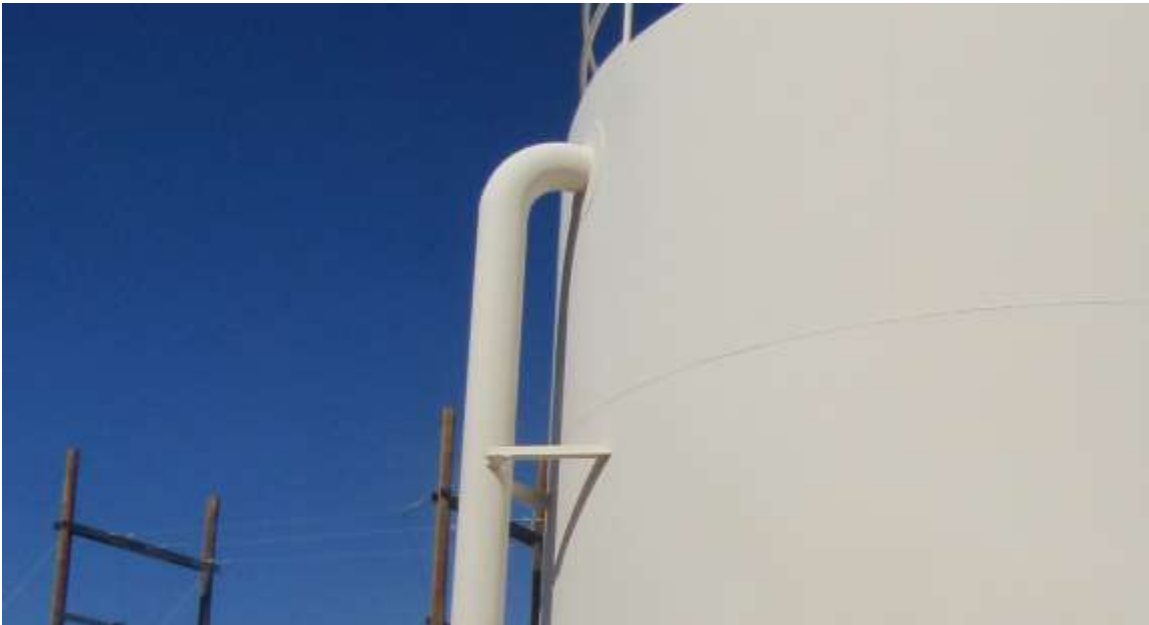
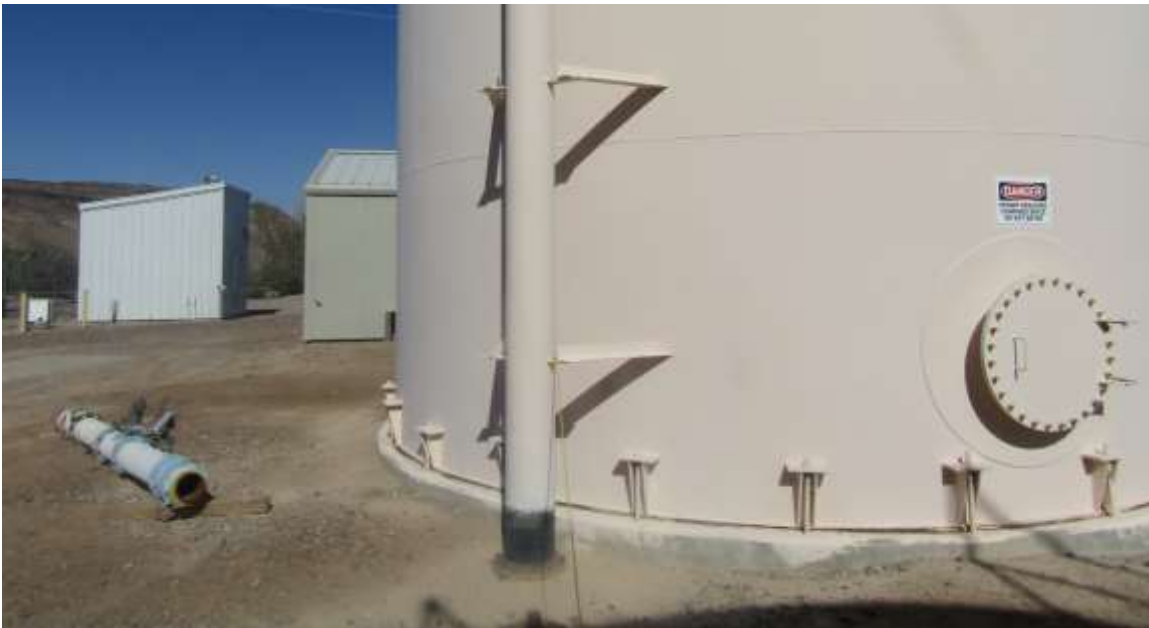
Photos show the condition of the 10" overflow pipe system. We recommend disconnecting the pipe from the underground drain then installing an air break complete with a flapper valve and screen to prevent the ingress of contaminants into the water supply.

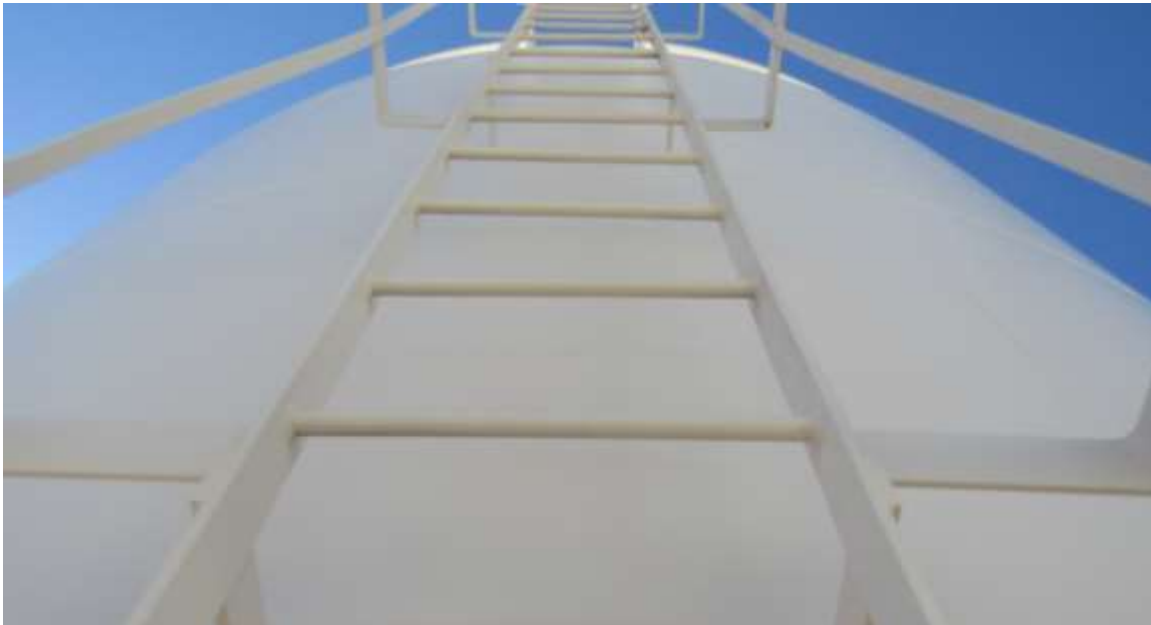
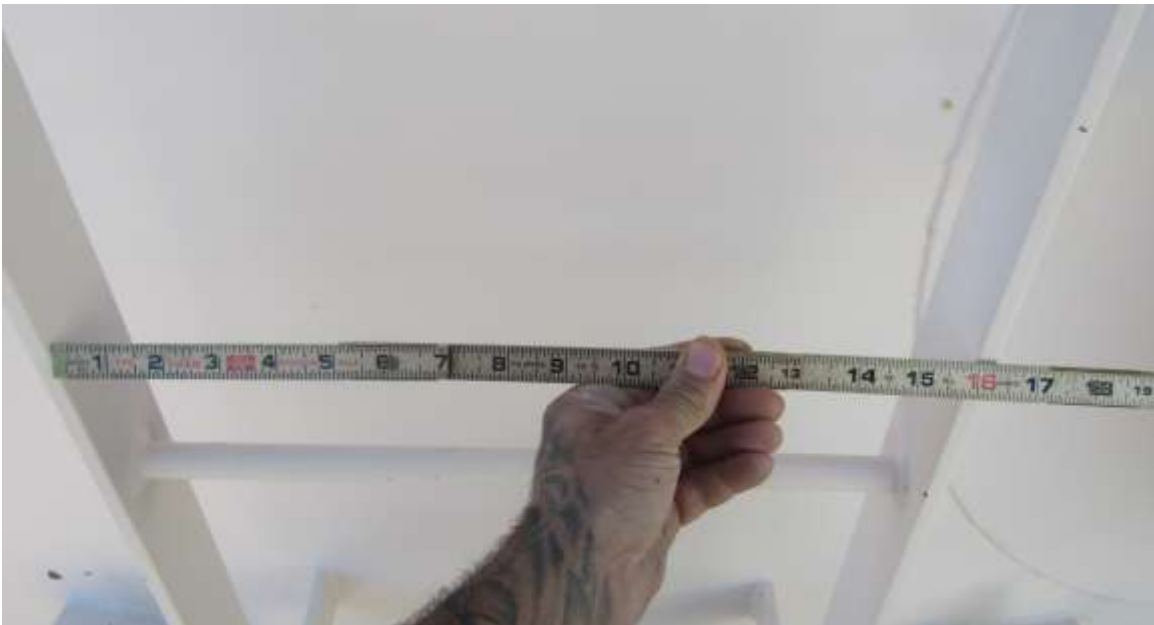
Shell access ladder in above photos is 18" wide, but is not equipped with anti-skid rungs. We recommend installing anti-skid rung covers, a cable type ladder safety device, a lockable ladder guard to prevent unauthorized access, and posting a **Fall Protection Required** sign at the base of the ladder.

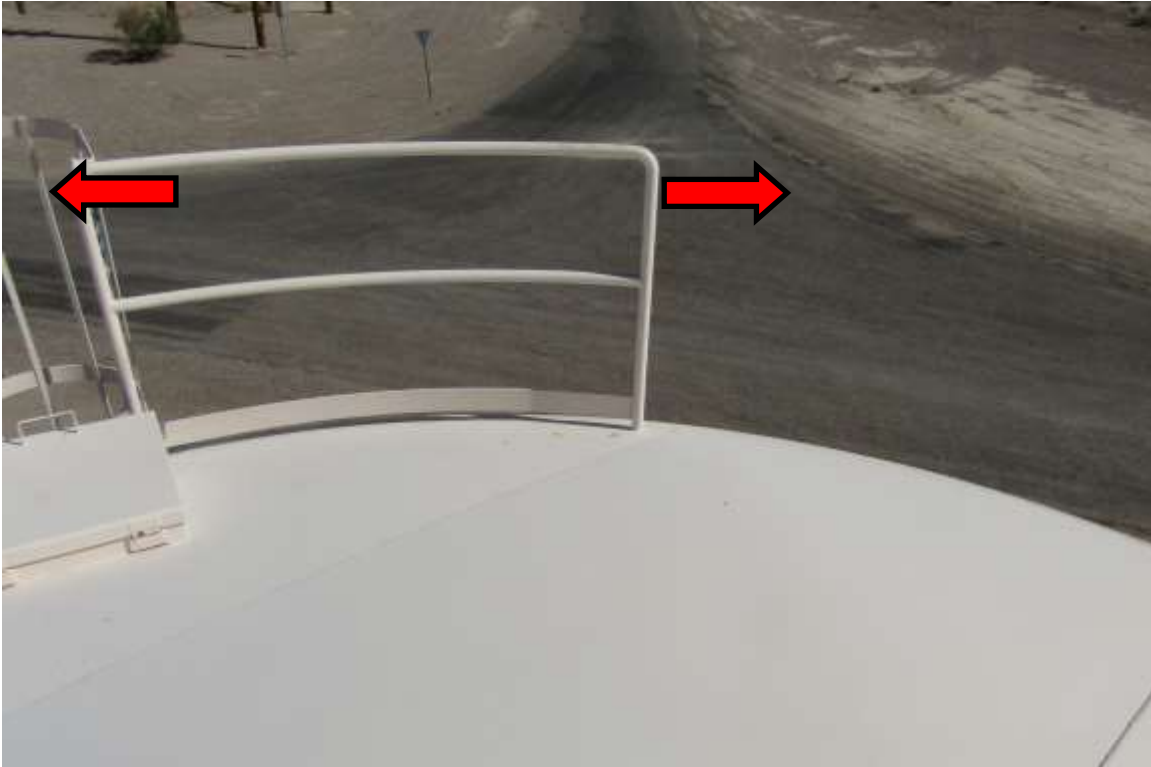
Photo shows the tank roof edge is not equipped with a required handrail system for fall protection. **OSHA 1910.28(b)(1)(i)** states, "...the employer must ensure that each employee on a walking-working surface with an unprotected side or edge that is 4 feet (1.2 m) or more above a lower level is protected from falling by one or more of the following: **1910.28(b)(1)(i)(A) Guardrail systems.**"

The tank is equipped with 43" high handrails to the left and right of the access ladder. We recommend extending the handrails around the circumference of the tank roof, complete with an intermediate rail, a toeboard, and a swing gate at the junction of the shell-to-roof access ladder and tank roof.

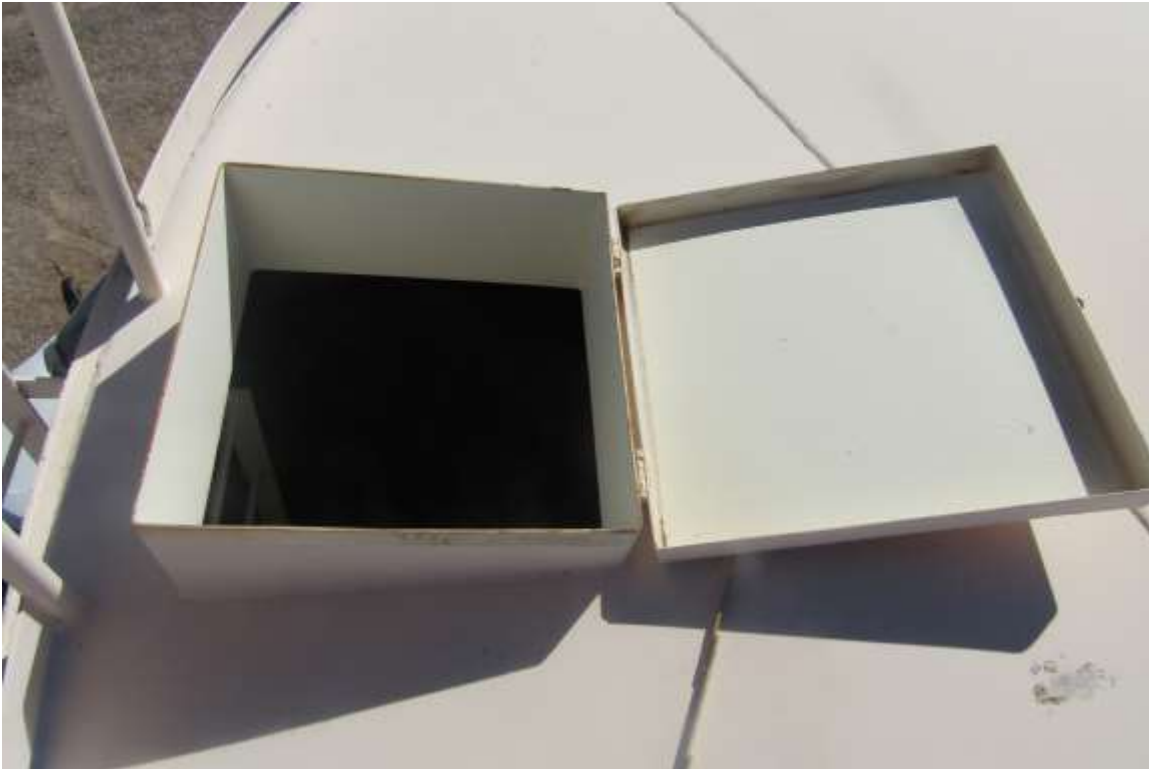
Photo shows the condition of the 24" primary roof hatch. Roof openings on this tank require the following to be in compliance with **AWWA D100-11; 7.4.3 Roof openings** and **OSHA 1910.146(c)(2) Confined spaces**.

Post **Confined Space Entry** sign

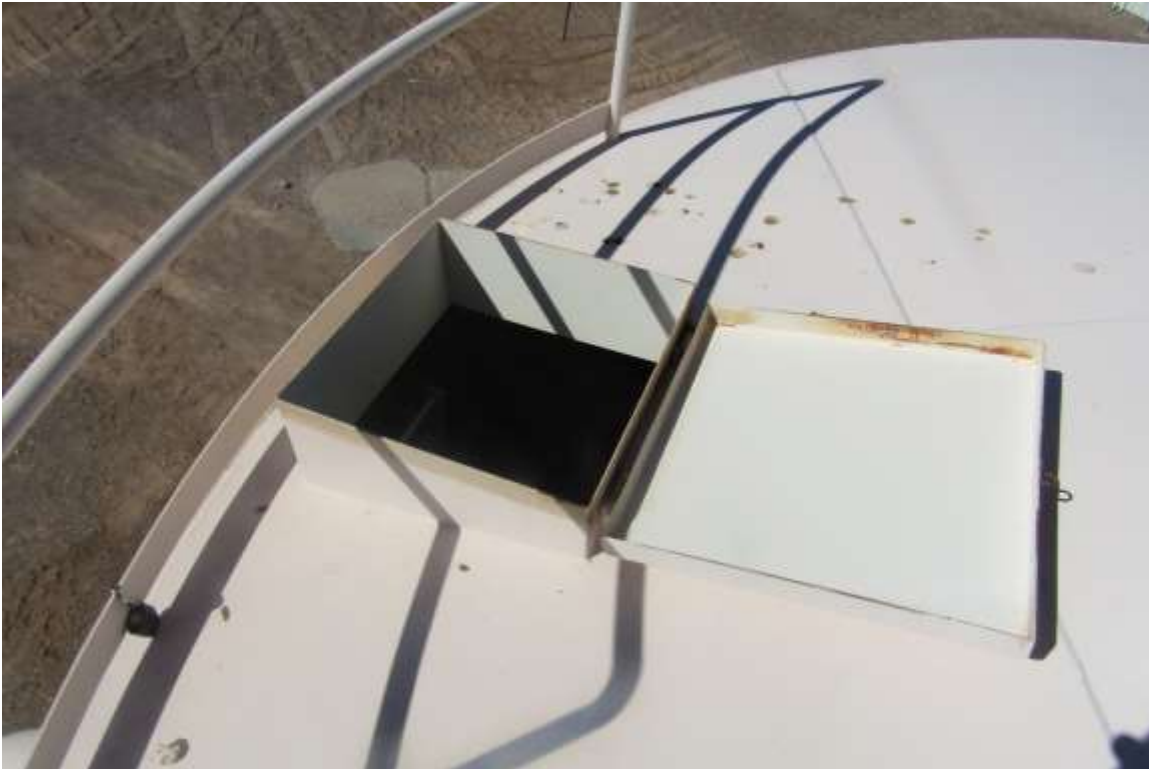
Photo shows the condition of the 24" secondary roof hatch. Roof openings on this tank require the following to be in compliance with **AWWA D100-11; 7.4.3 Roof openings** and **OSHA 1910.146(c)(2) Confined spaces**.

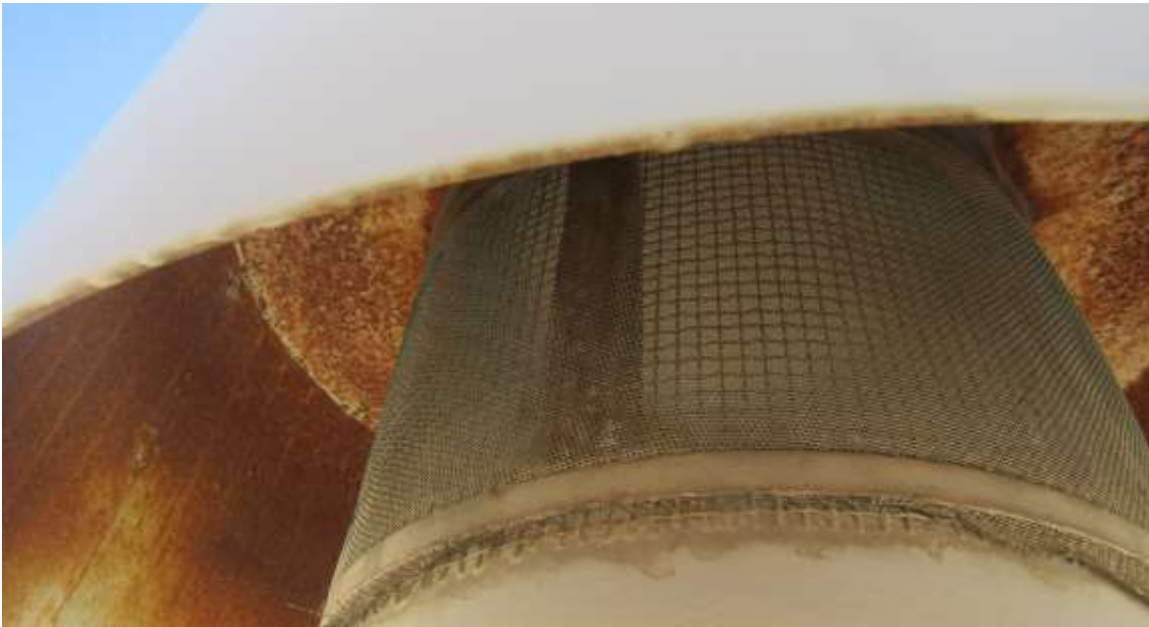
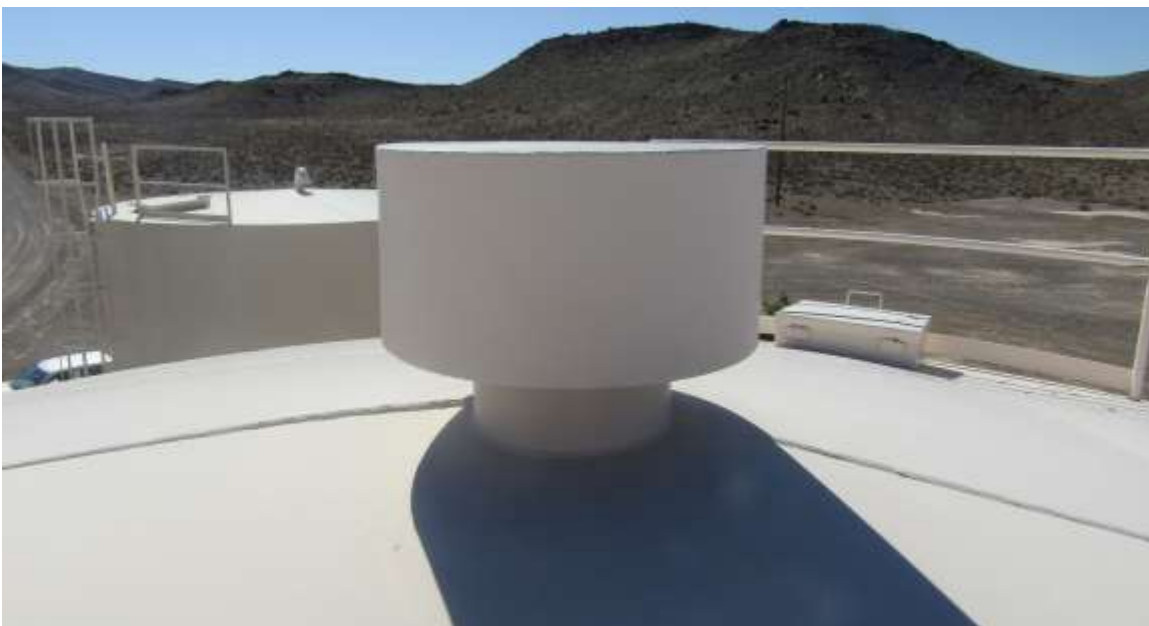
Photos show the existing 12" roof vent, which appears to be in good condition.

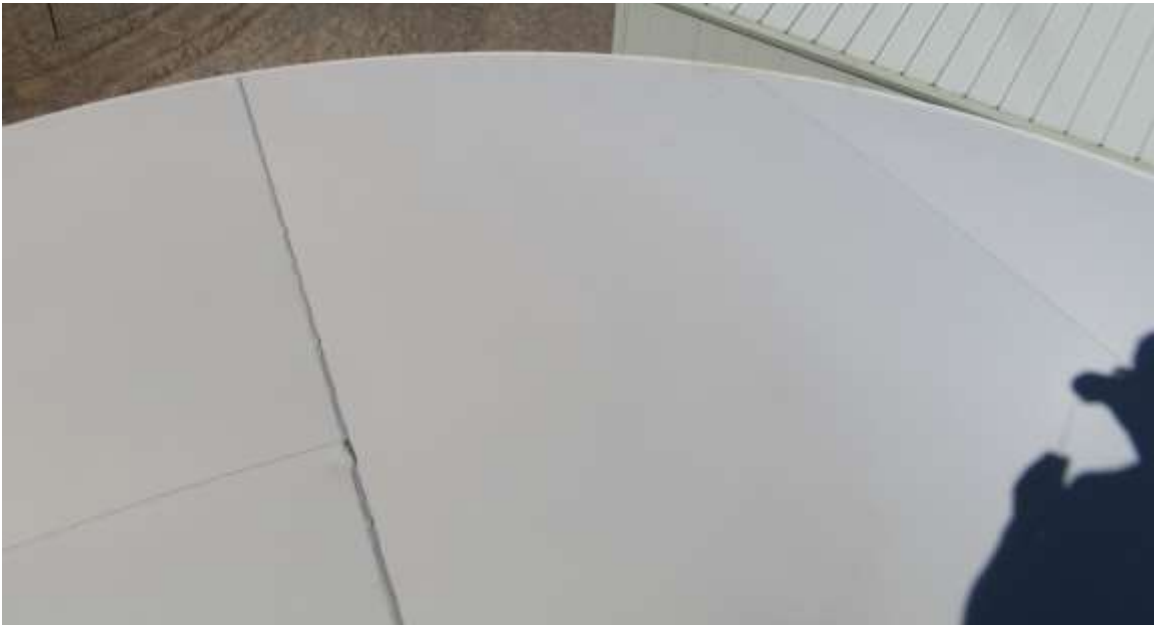
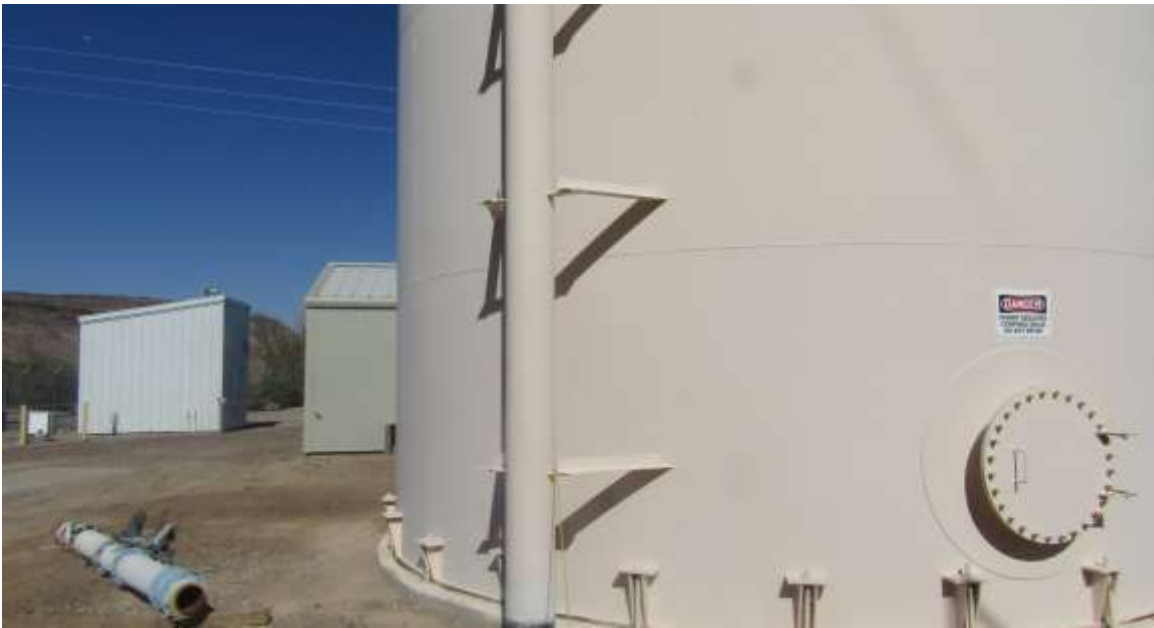
Photos show the tank exterior coating system. The overall exterior coating system appears to be in good condition. We recommend re-evaluating the tank exterior at next inspection cycle.

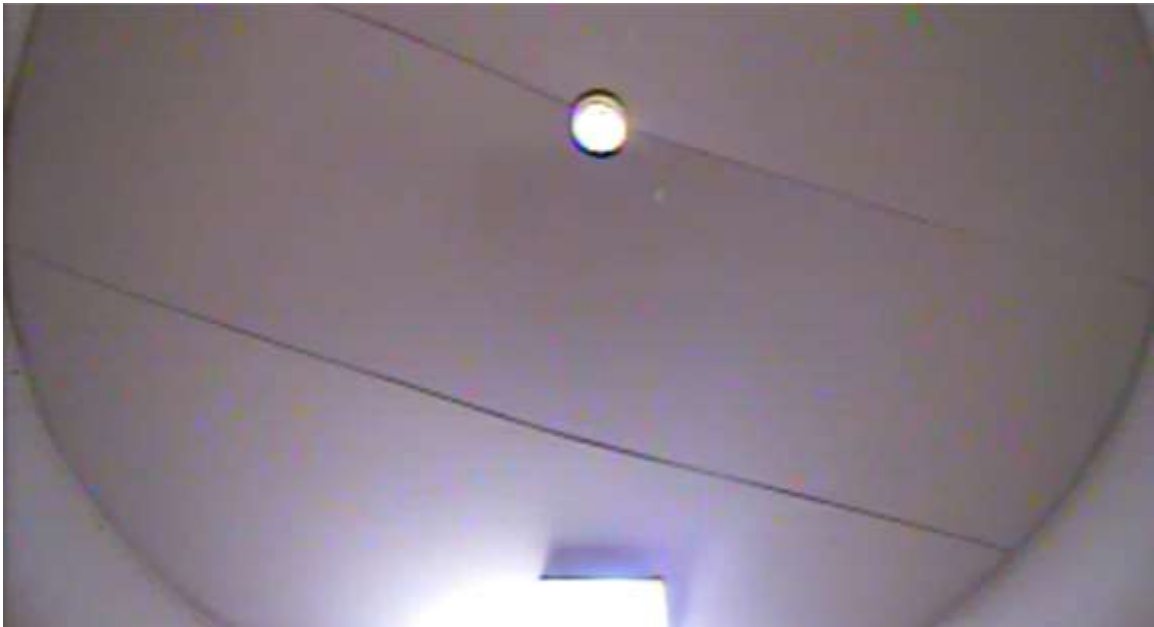
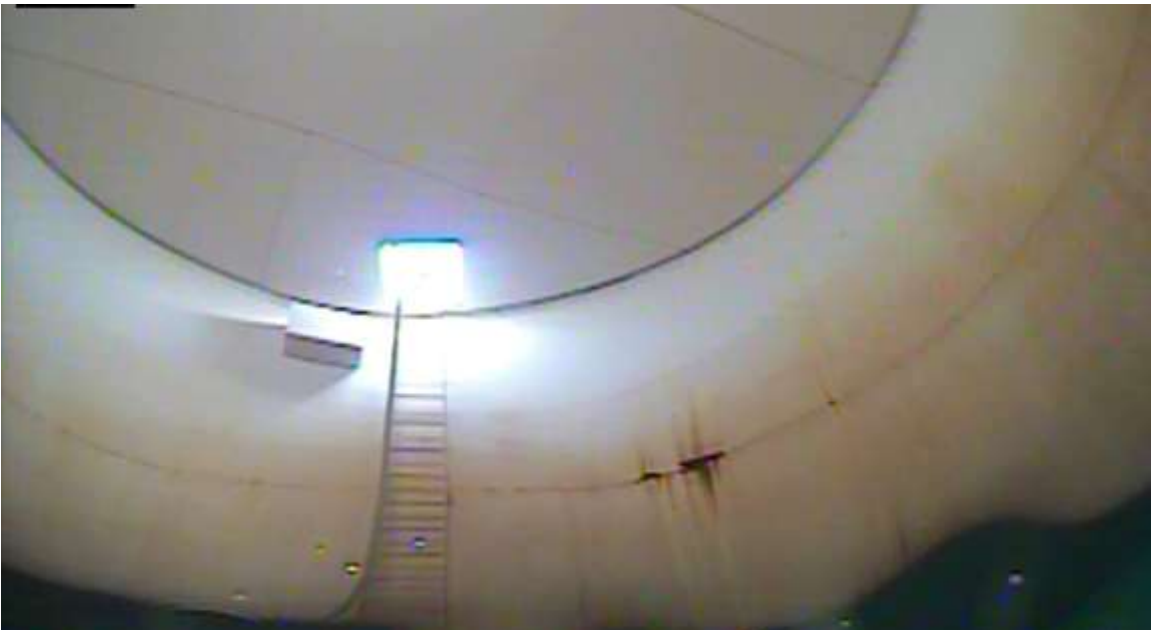
Top photo shows the interior roof lap seams, which appear to be in good condition.

Bottom photo shows the interior roof-to-rim angle connection, which appears to be in good condition.
