**Mission Support and Test Services, LLC
Nevada National Security Site
Mercury, NV 89023
RE: Mercury North (Area 23); Mercury, NV
1,500,000 Gallon GST
September 16, 2018
Mr. Kevin Olsen
Scientist 1
(702) 295-0485
Job No. 318448-A**

**Mission Support and Test Services, LLC
Nevada National Security Site
Mercury, NV 89023
RE: Camp South (Area 12); Mercury, NV
500,000 Gallon GST
September 13, 2018
Mr. Kevin Olsen
Scientist 1
(702) 295-0485
Job No. 318448-D**

**Mission Support and Test Services, LLC
Nevada National Security Site
Mercury, NV 89023
RE: Well 4/4a South (Area 6); Mercury, NV
150,000 Gallon GST
September 24, 2018
Mr. Kevin Olsen
Scientist 1
(702) 295-0485
Job No. 318448-H**

**Mission Support and Test Services, LLC
Nevada National Security Site
Mercury, NV 89023
RE: C-1 North (Area 6); Mercury, NV
50,000 Gallon GST
September 21, 2018
Mr. Kevin Olsen
Scientist 1
(702) 295-0485
Job No. 318448-O**

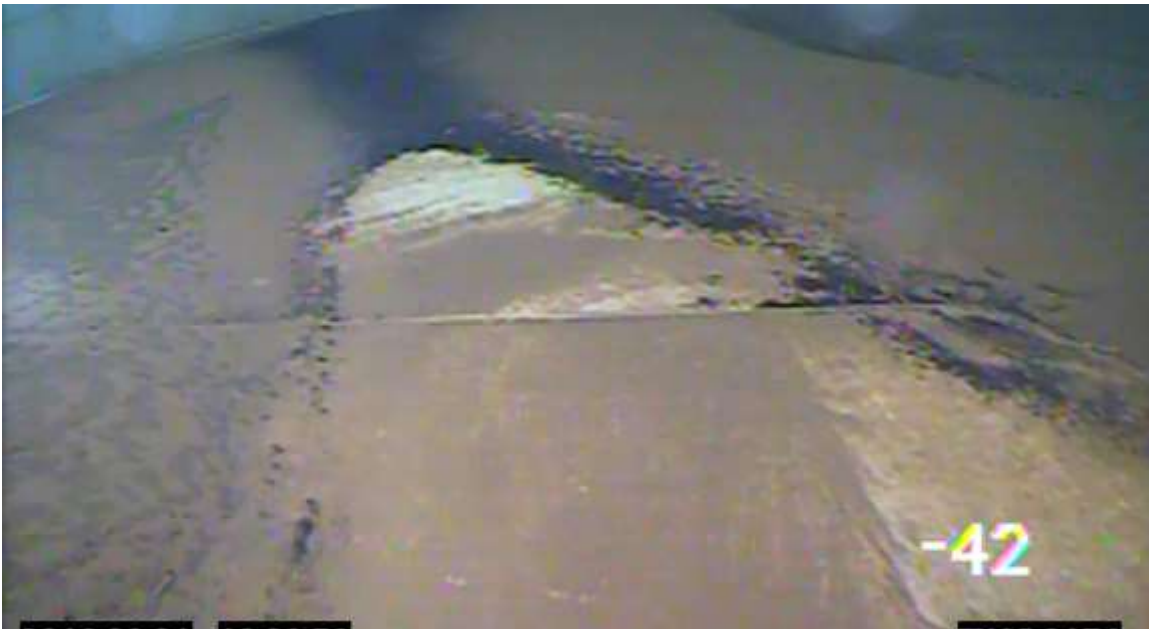
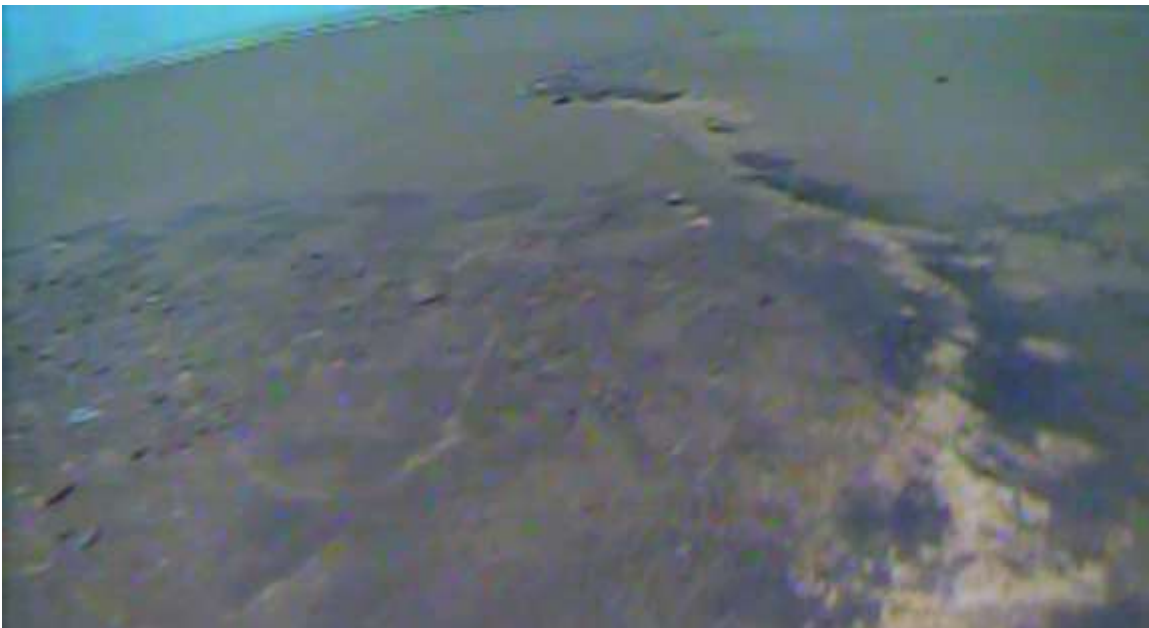
Photos show sediment and debris on the tank interior before a cleanout was performed.

We recommend installing a passive cathodic protection system.

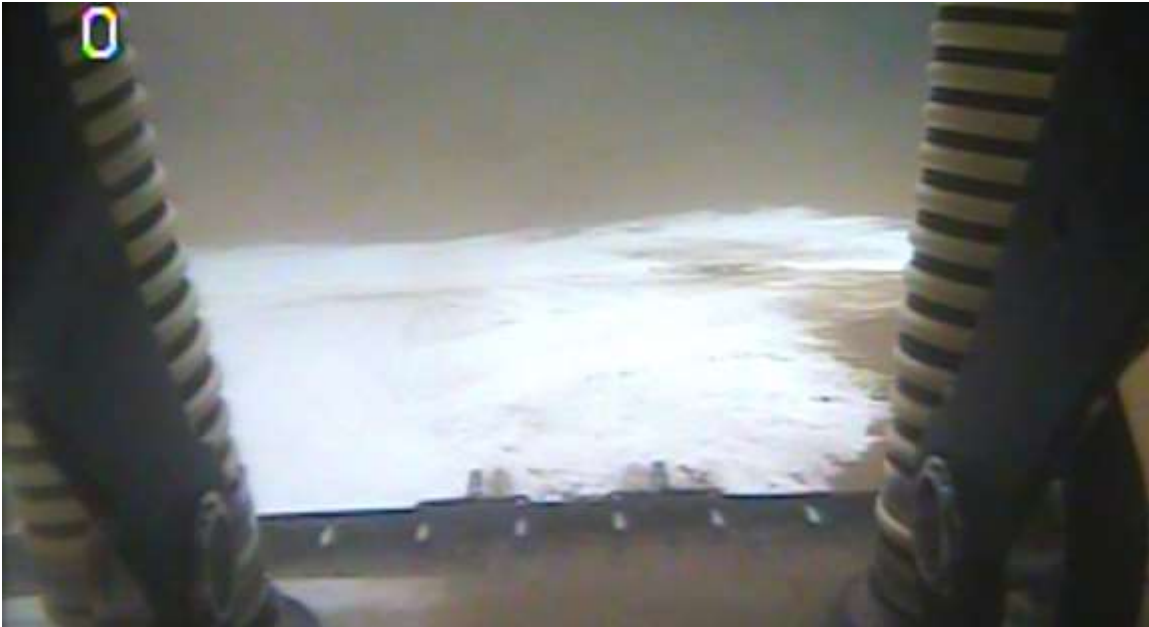
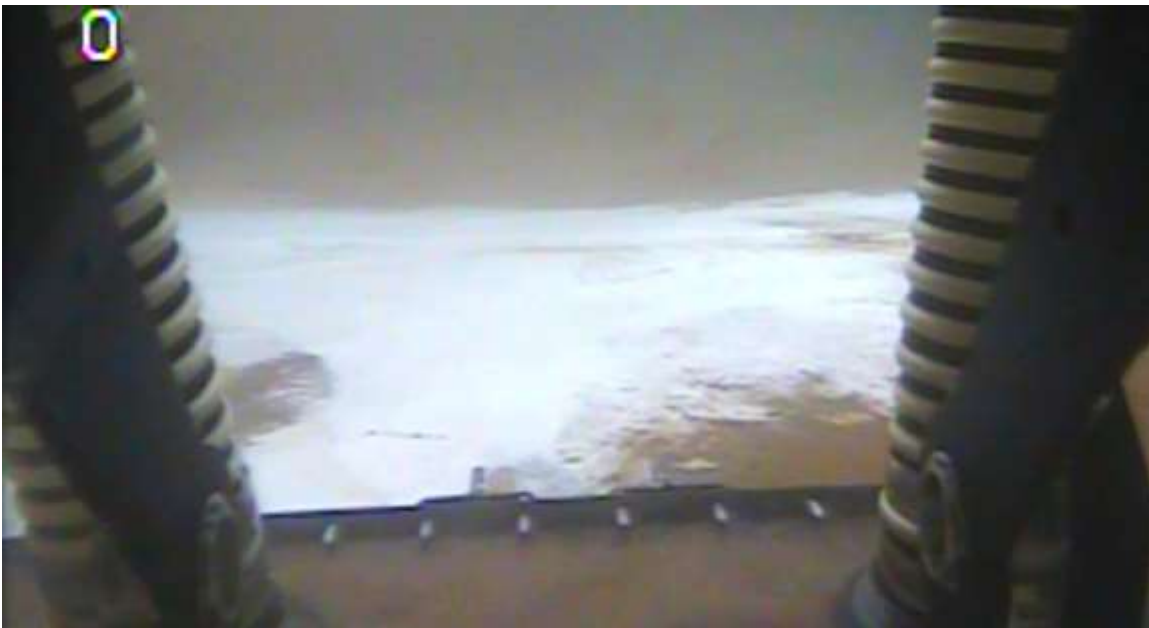
Photos show the tank interior during a cleanout.

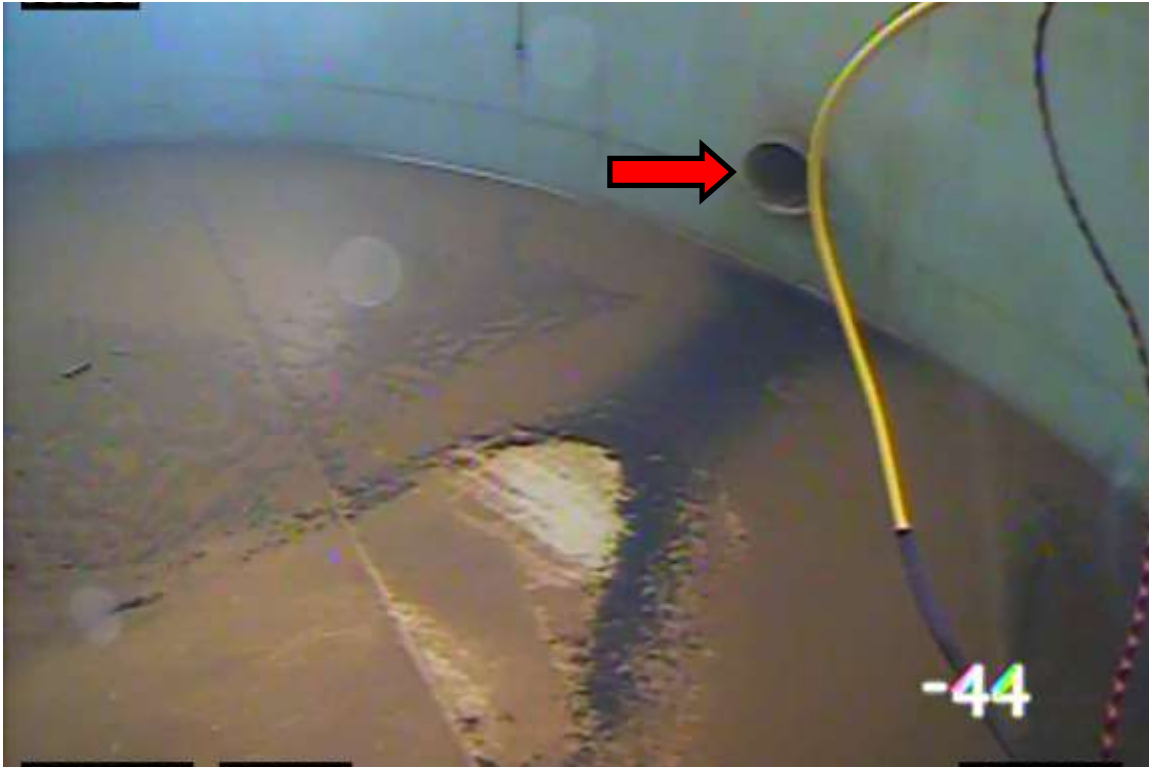
Photo shows a suction pipe on the interior of the tank. **NFPA 22-2018; 14.2.13.1** states, “ The discharge outlet for every suction tank shall be equipped with an anti-vortex plate assembly.” We recommend installing an elbow be added to the existing suction pipe in the down direction and installing a properly sized anti-vortex plate on the elbow to prevent formation of a vortex.

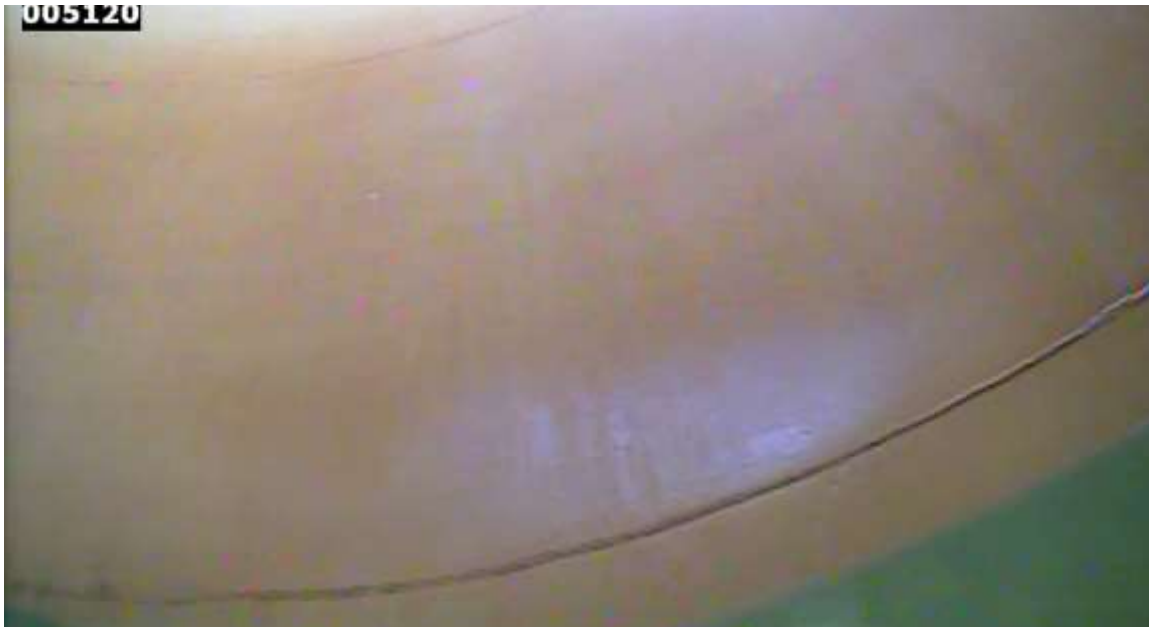
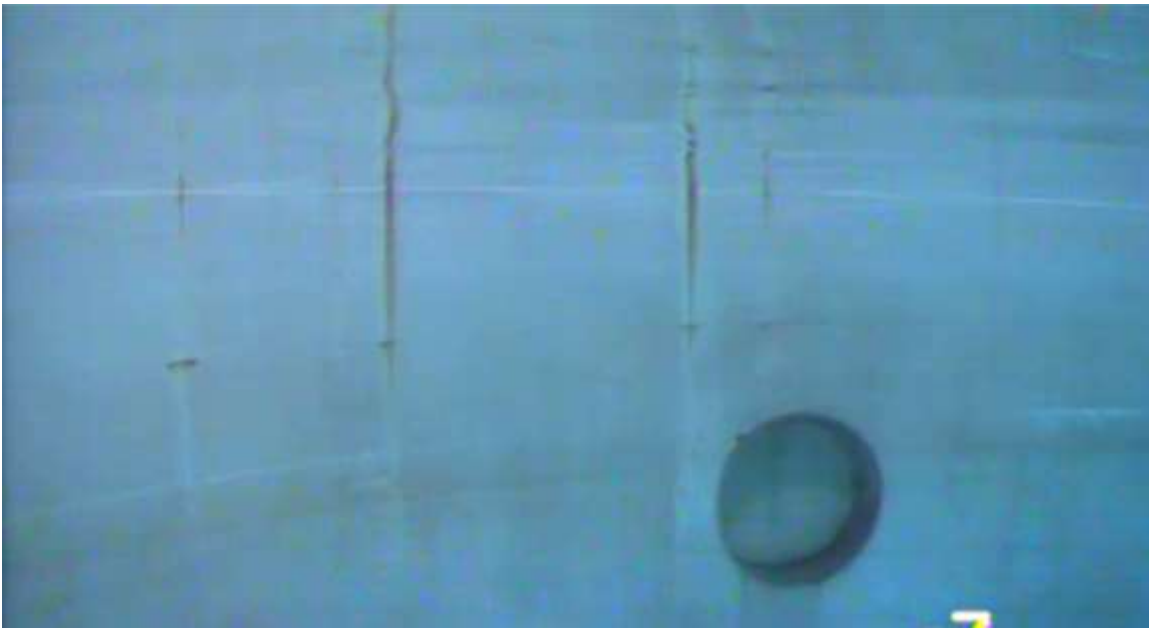
Photos show the tank interior coating system. The overall interior coating system appears to be in good condition. We recommend re-evaluating the tank interior at next inspection cycle.

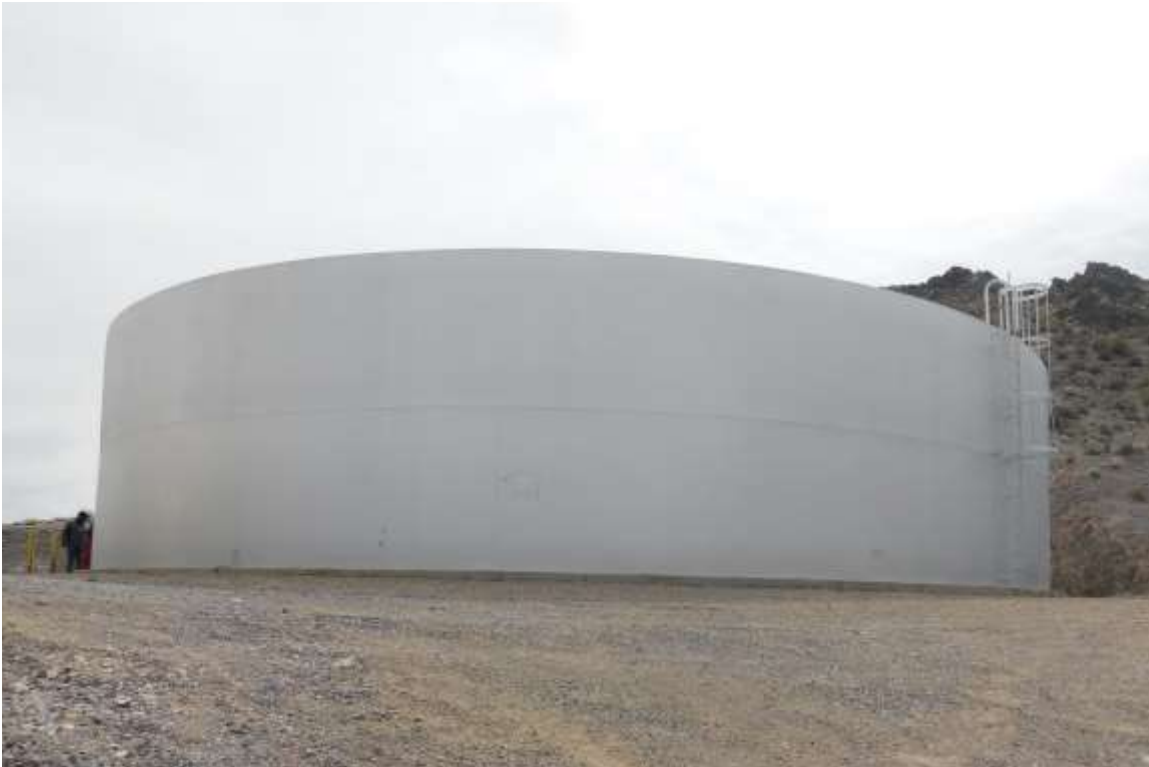
Photo shows the tank is not secured with fencing. We recommend fencing the area around the tank. We further recommend posting a **No Trespassing** sign and a **Warning, Tampering With This Facility is a Federal Offense (US code title 42, section 300i-1)** sign. Fence installation to be done by others.

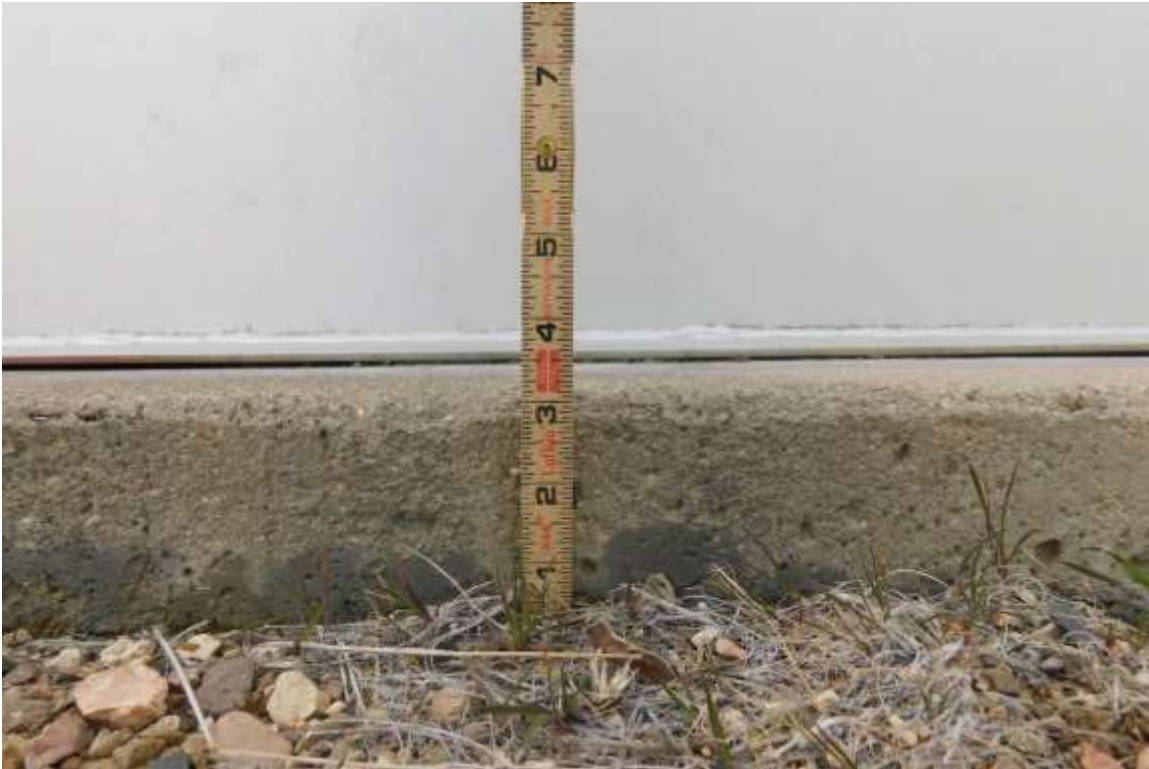
Photo shows the condition of the foundation. **AWWA D100-11; 12.7.1 Height aboveground** states, "The tops of the concrete foundations shall be a minimum of 6" above the finished grade, unless otherwise specified." We recommend clearing any dirt, debris and other loose gravel away from the tank foundation, down to a minimum 6" below top of foundation. This should be done by a local excavating company.

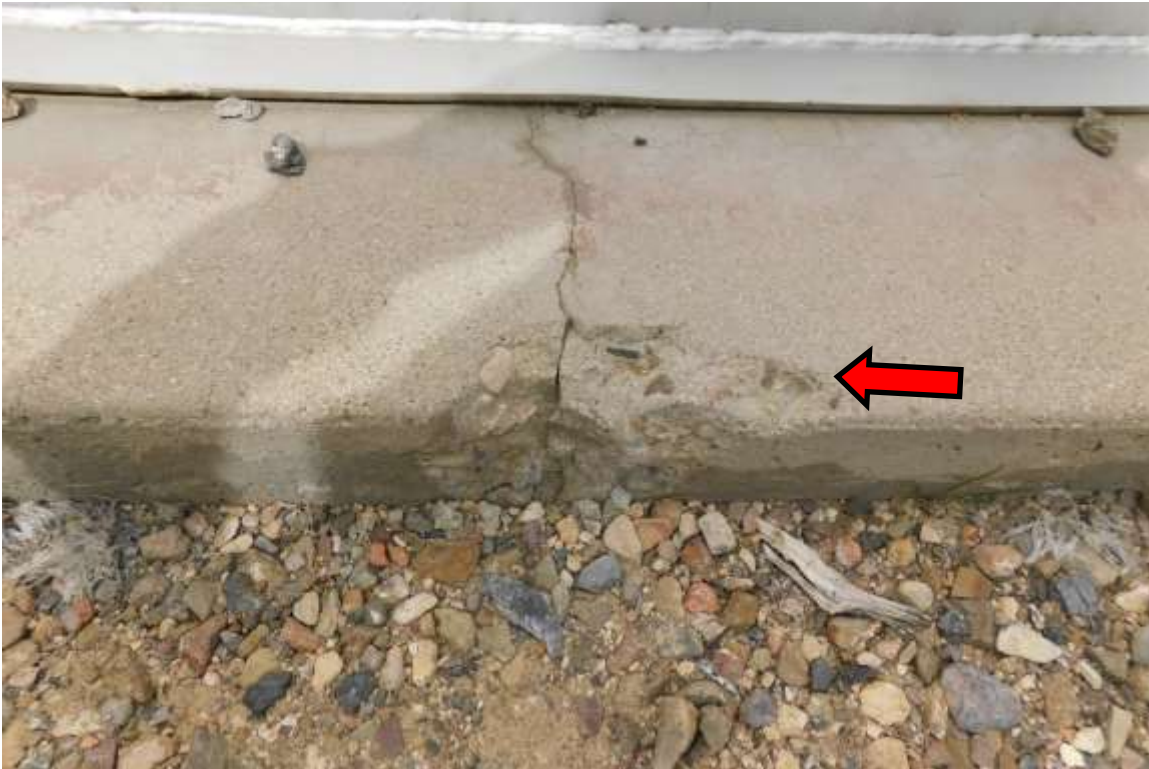
Photo shows the condition of the foundation. We recommend repairing any cracks and spalling in the concrete with a commercial non-shrinking grout, caulking/grouting around the base of the tank to foundation connection to prevent water from entering under the tank, then sealing the foundation with a sealant.

We further recommend inserting sacrificial cathodic protection rods radially every 15' beneath the floor of the tank.

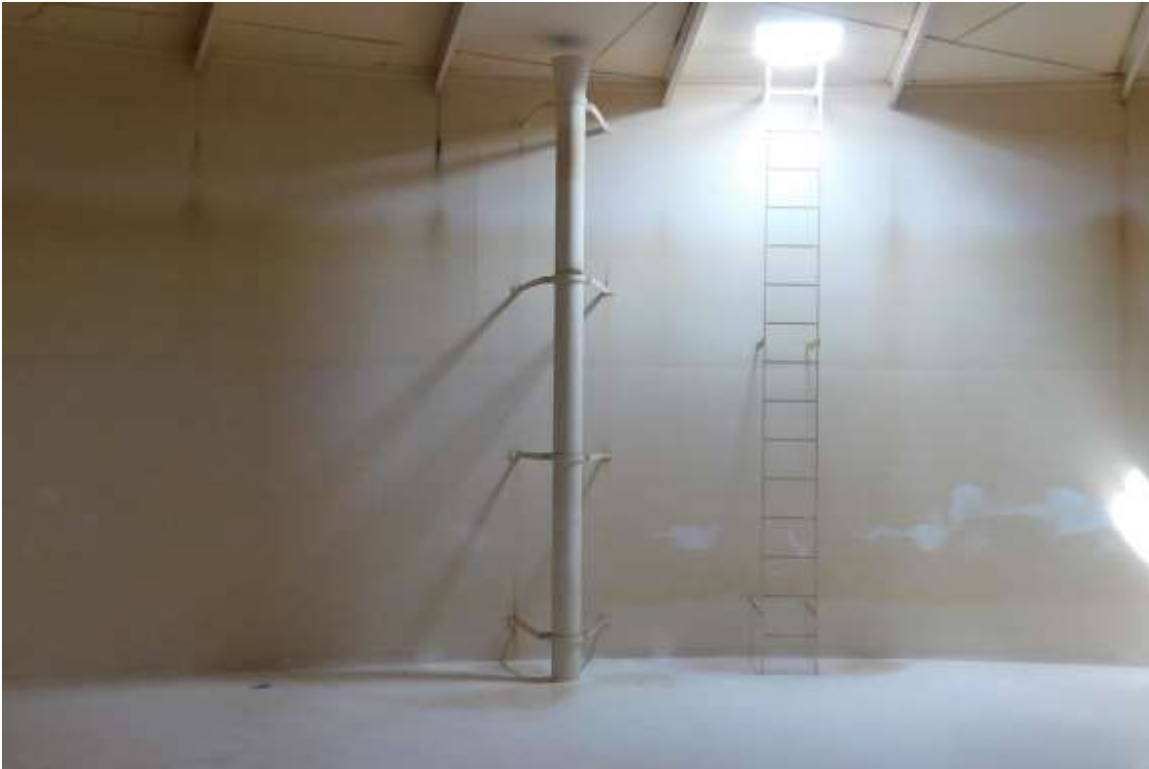
Photo shows the condition of the 8" overflow pipe system. **AWWA D100-11; 7.3 Overflow** states, "An internal overflow is defined as an overflow with piping inside the tank container. The consequences of an overflow failure, which can empty the tank contents, shall be considered when an internal overflow is provided." We recommend replacing the internal overflow system with a properly sized exterior overflow system, which will be complete with a weir box on the interior, standoffs every 10' on center extended to grade, an elbow fitted with a flapper valve and screen to prevent the ingress of contaminants, and a splash pad to direct the water away from the tank foundation.

**Splash pad to be installed by owner.*

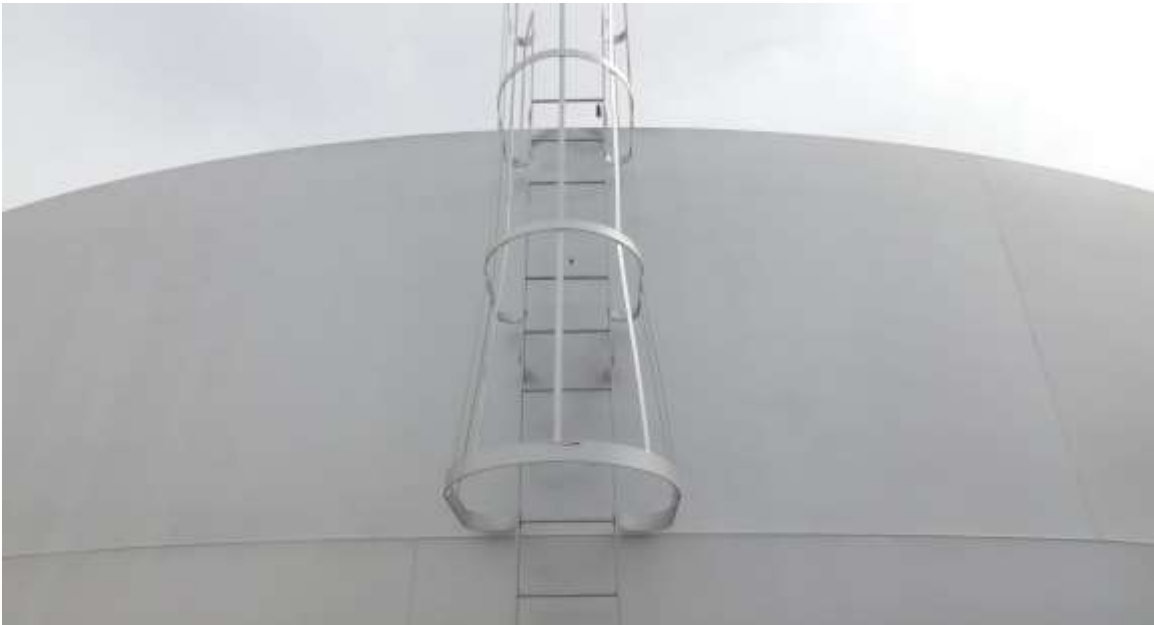
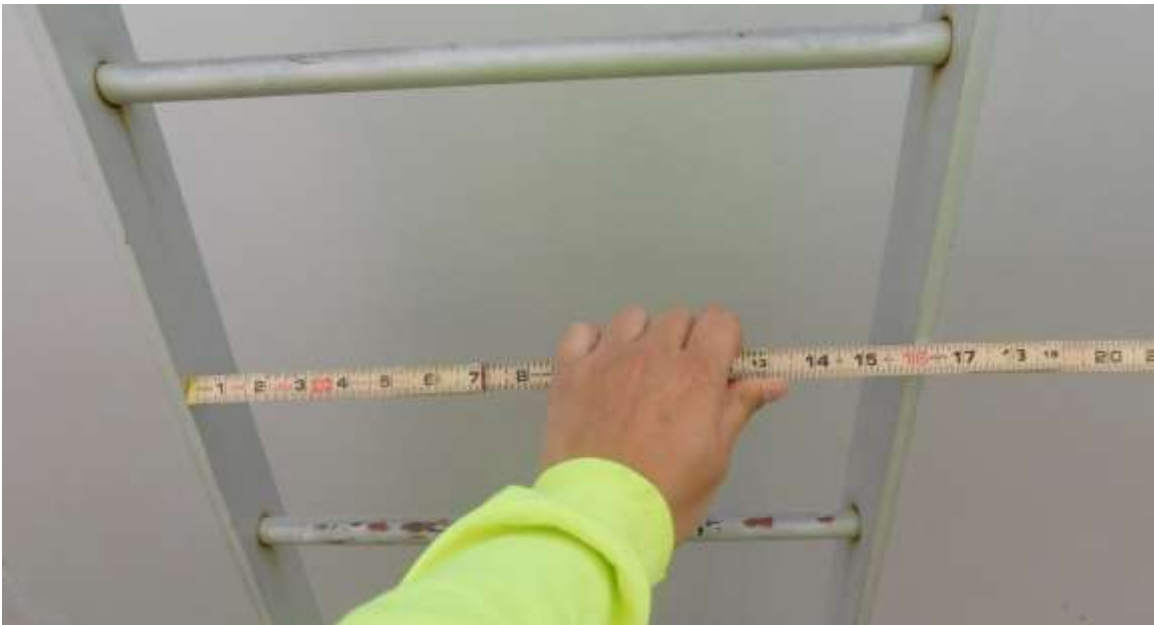
Shell access ladder in above photos is 16" wide, but is not equipped with anti-skid rungs. We recommend installing anti-skid rung covers, a cable type ladder safety device, a lockable ladder guard to prevent unauthorized access, and posting a **Fall Protection Required** sign at the base of the ladder.

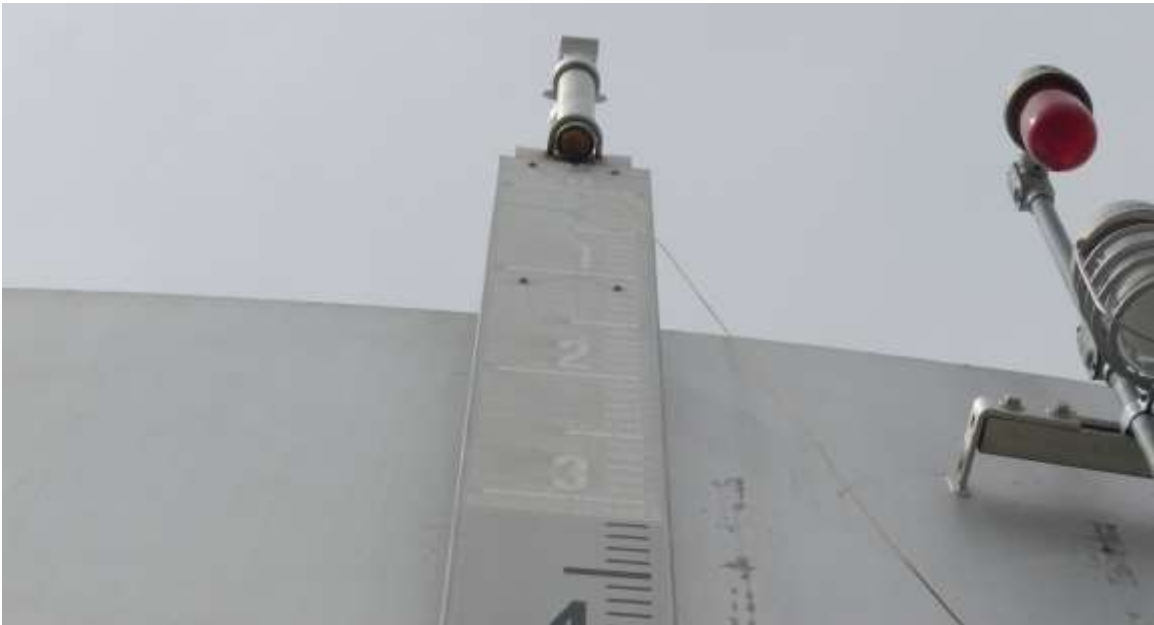
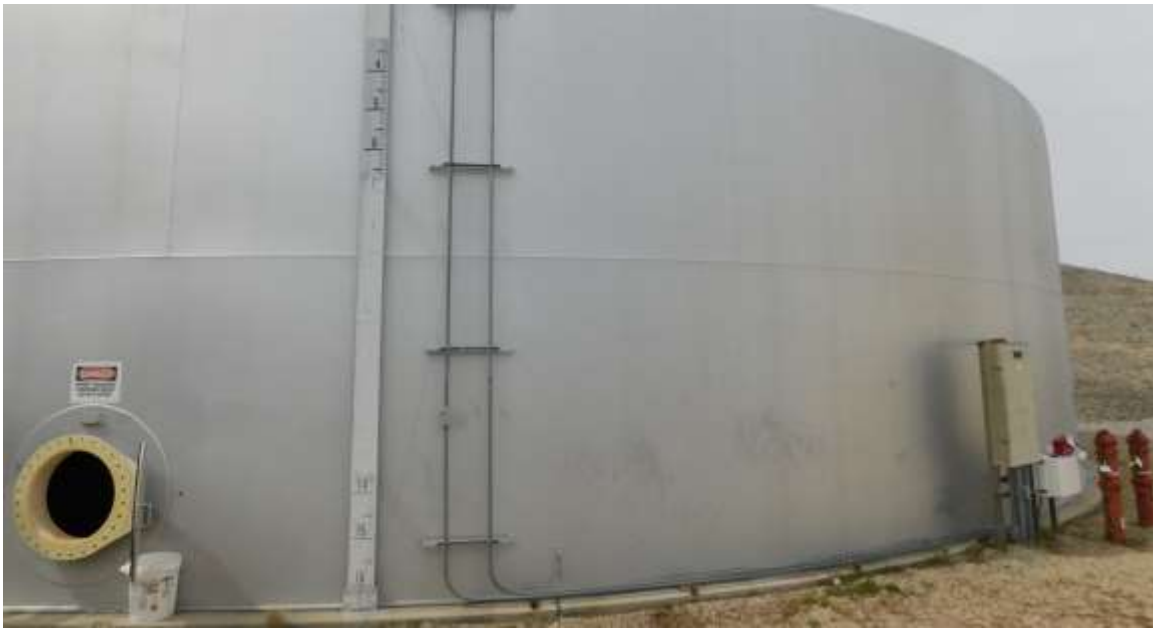
Photos show the condition of the liquid level indicator. We recommend repairing the existing liquid level indicator, replacing damaged parts as needed, then adjusting and calibrating the unit. We further recommend replacing sticker on target board.

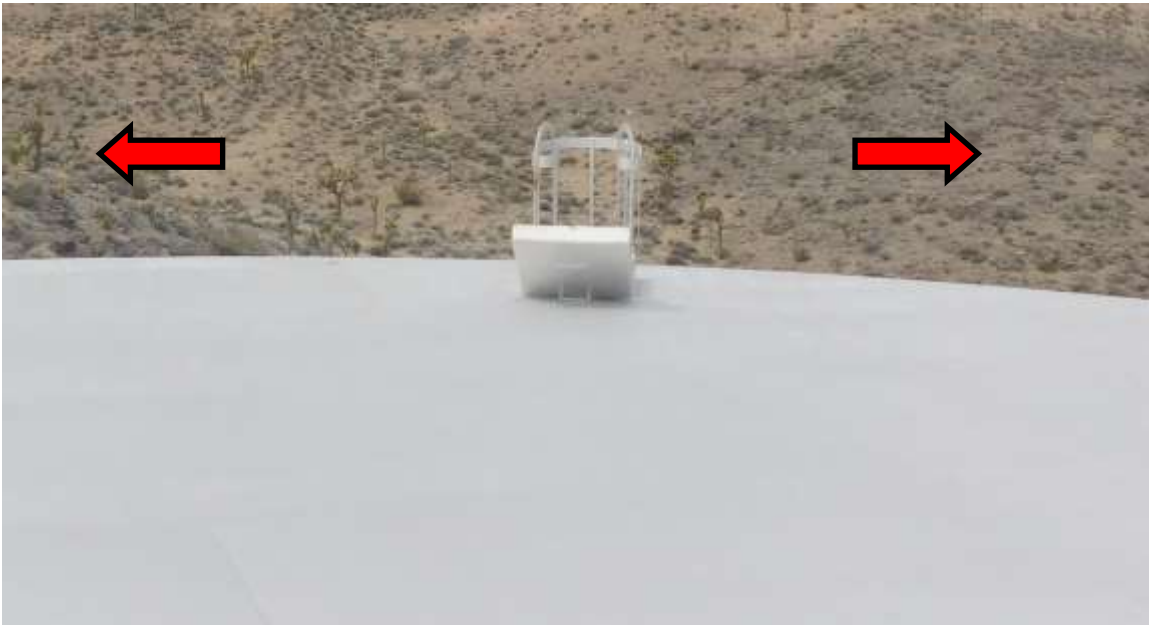
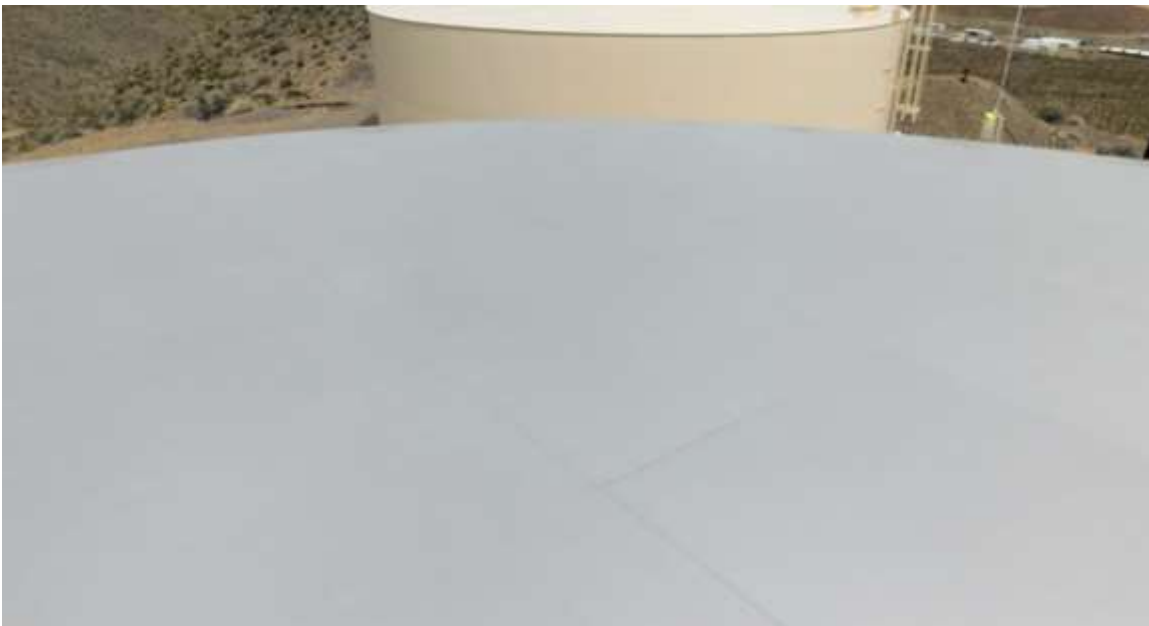
Photos show the tank roof edge is not equipped with a required handrail system for fall protection. **OSHA 1910.28(b)(1)(i)** states, "...the employer must ensure that each employee on a walking-working surface with an unprotected side or edge that is 4 feet (1.2 m) or more above a lower level is protected from falling by one or more of the following: **1910.28(b)(1)(i)(A) Guardrail systems.**" We recommend installing an **OSHA** compliant 42" high handrail system around the circumference of the tank roof, complete with intermediate rail, toeboard and a swing gate at the junction of the shell-to-roof access ladder and tank roof.

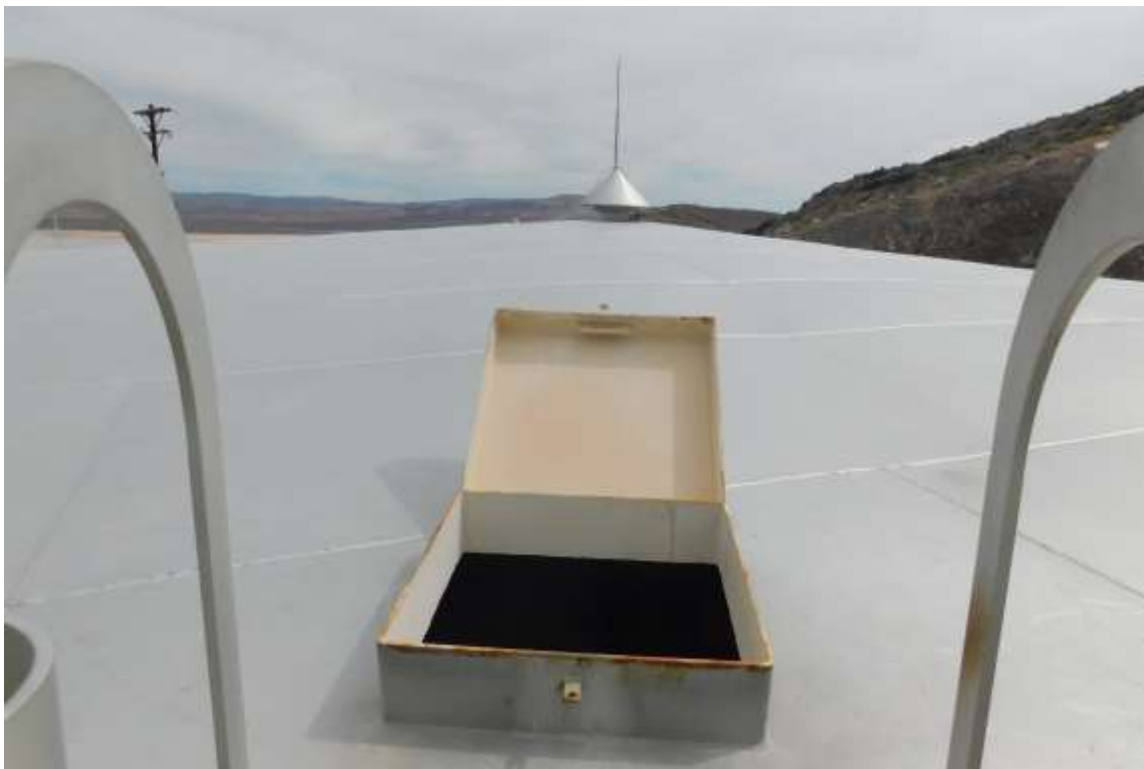
Photo shows the condition of the 24" primary roof hatch. Roof openings on this tank require the following to be in compliance with **AWWA D100-11; 7.4.3 Roof openings** and **OSHA 1910.146(c)(2) Confined spaces**.

Post **Confined Space Entry** sign
Install lock on primary hatch

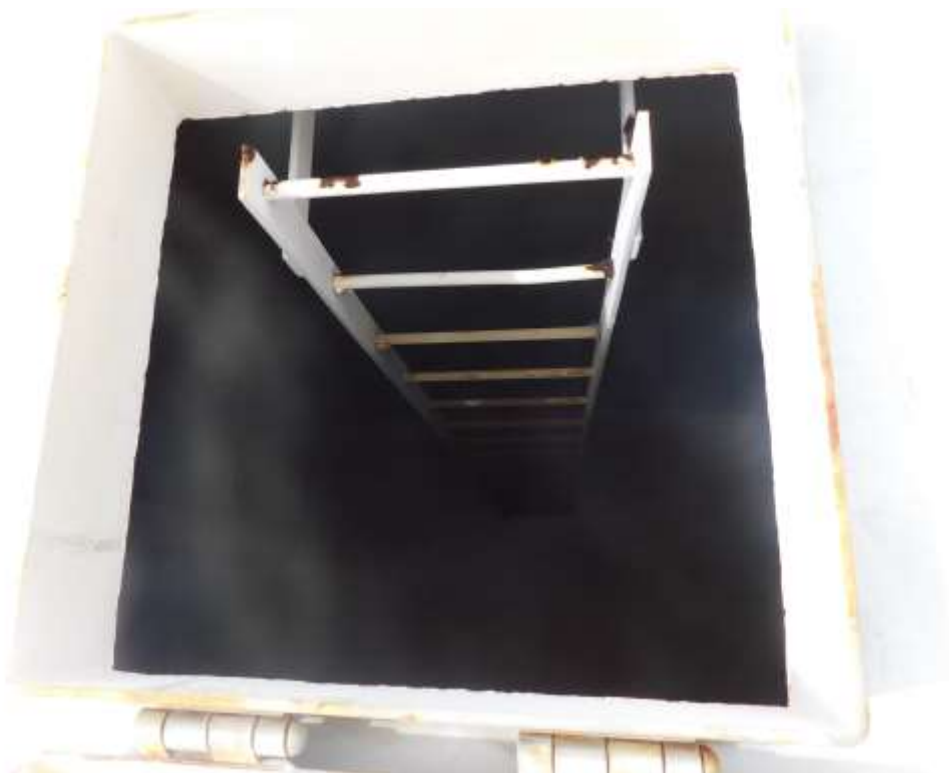
Primary interior access ladder in above photo is 16" wide, but is not equipped with anti-skid rungs. We recommend installing anti-skid rung covers and a cable type ladder safety device on the primary interior access ladder.

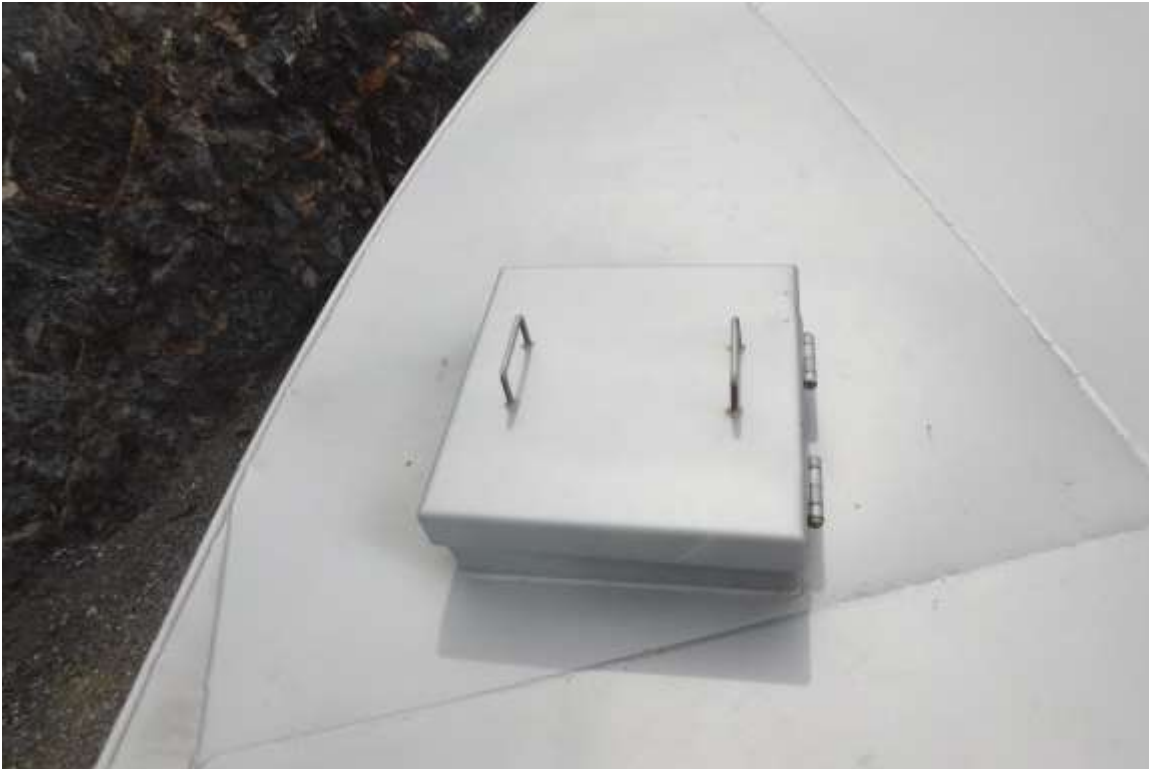
Photo shows the condition of the 24" secondary roof hatch. Roof openings on this tank require the following to be in compliance with **AWWA D100-11; 7.4.3 Roof openings** and **OSHA 1910.146(c)(2) Confined spaces**.

We further recommend installing an **OSHA** compliant interior access ladder complete with standoffs every 10' on center, and a cable type ladder safety device at the secondary roof hatch.

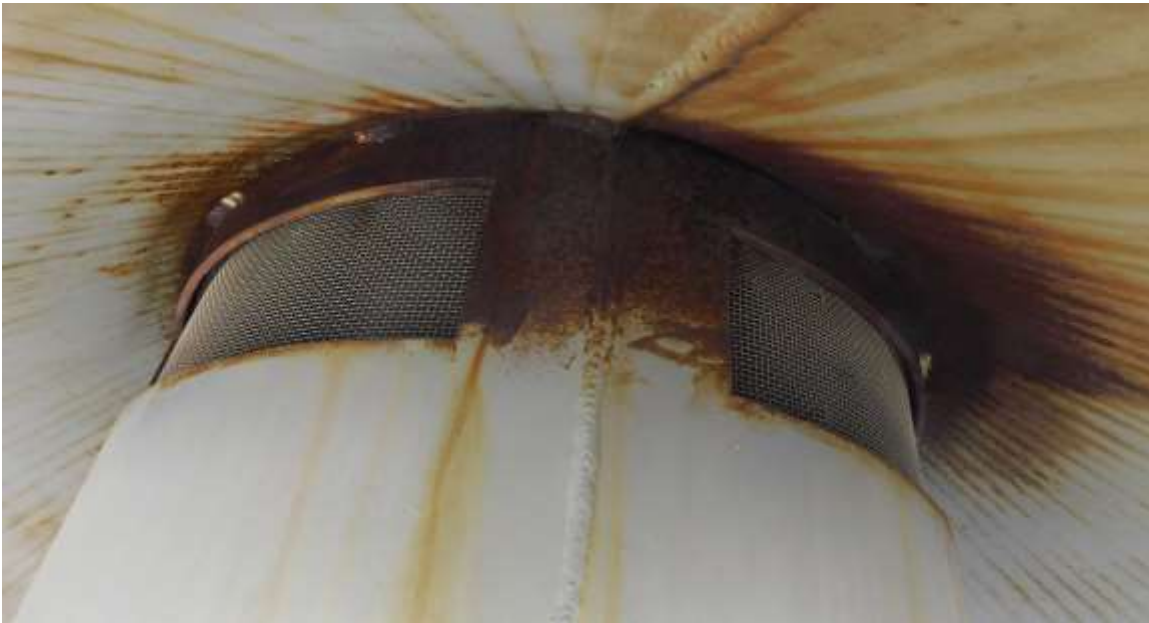
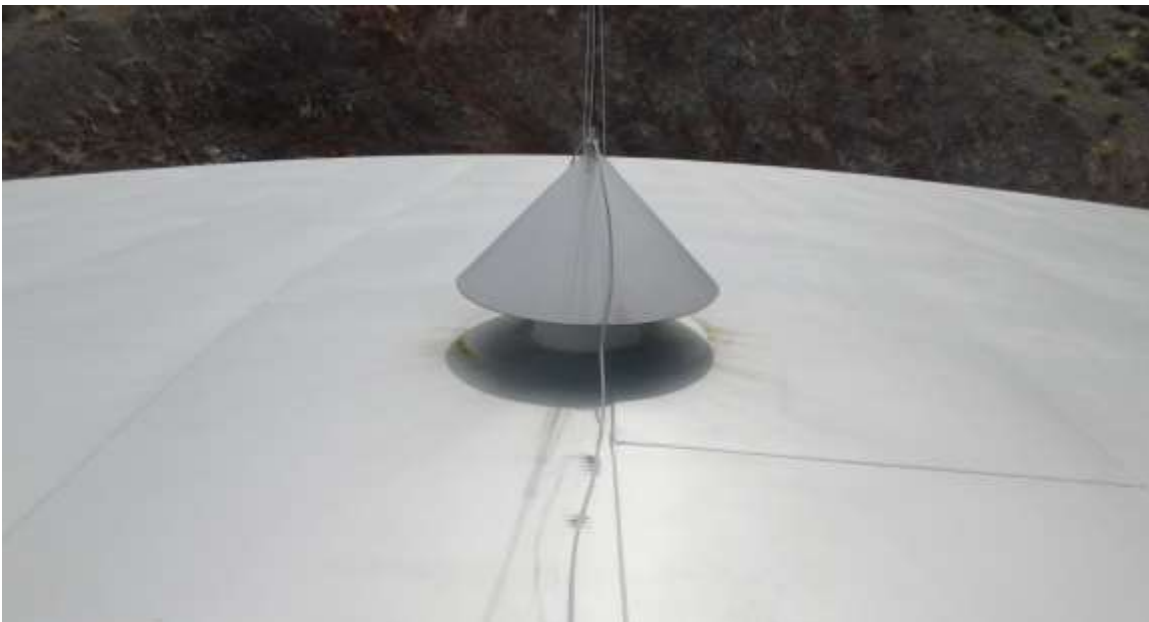
Photos show the condition of the existing 18" roof vent. **This vent is allowing the ingress of rain and wind-borne contaminants into the water system. An improperly vented tank may cause external pressure to act on the tank which can cause buckling even at low pressure differential.** We recommend replacing the existing roof vent with a vacuum-pressure, frost proof vent and screen.

This work should be performed on an emergency basis.

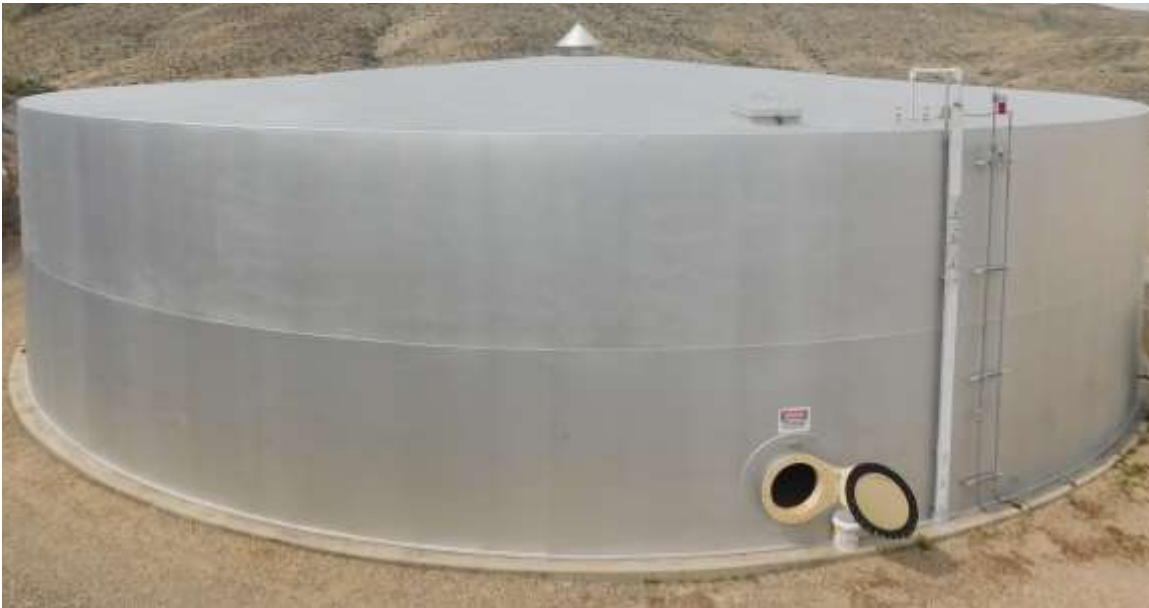
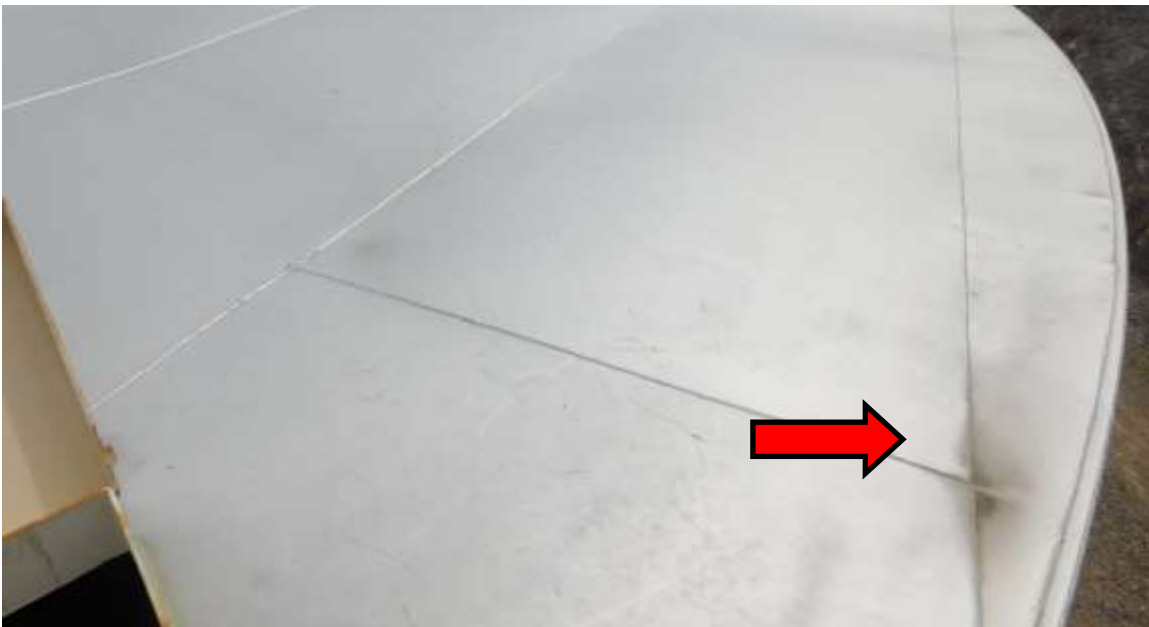
Top photo shows the tank exterior coating system. The overall exterior coating system appears to be in good condition. We recommend re-evaluating the tank exterior at next inspection cycle.

However, bottom photo shows water is ponding on the roof, causing deterioration of the paint and metal. We recommend hand tool cleaning of all ponding areas, then applying a commercial epoxy adhesive filler, as needed, to prevent ponding of water.

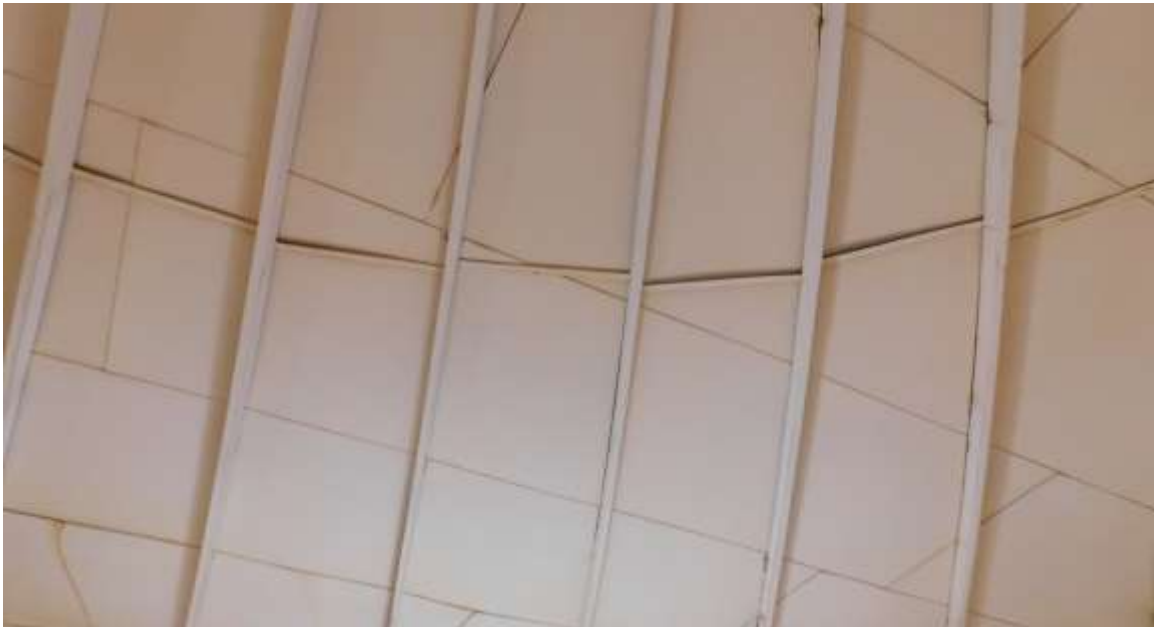
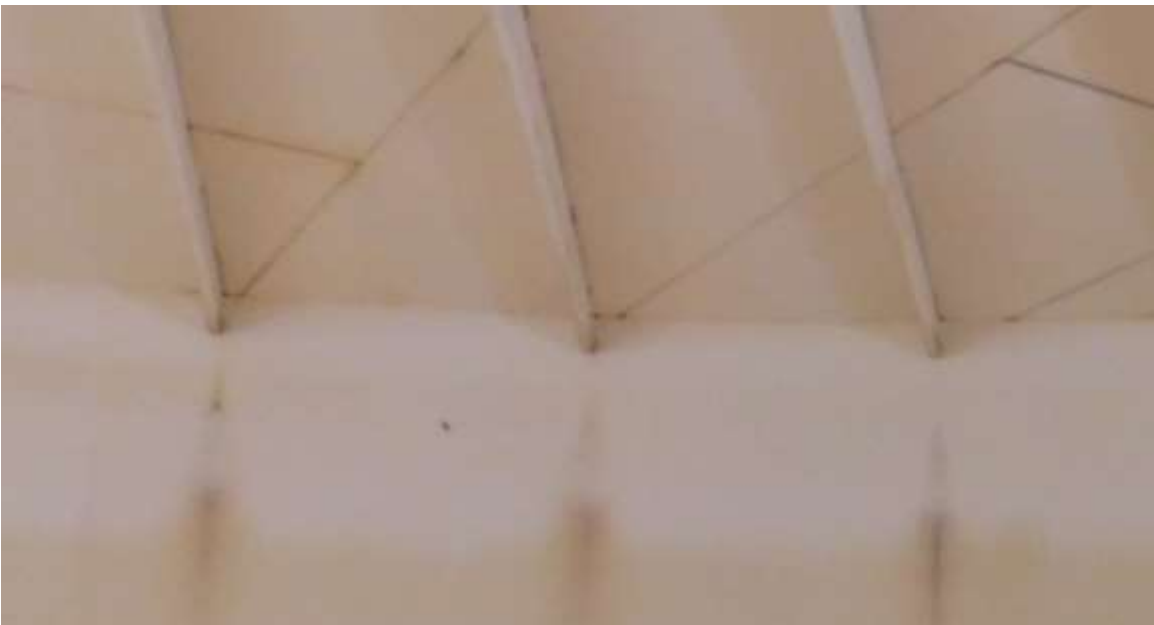
Top photo shows the interior roof lap seams, which appear to be in good condition.

Bottom photo shows the interior roof-to-rim angle connection, which appears to be in good condition.

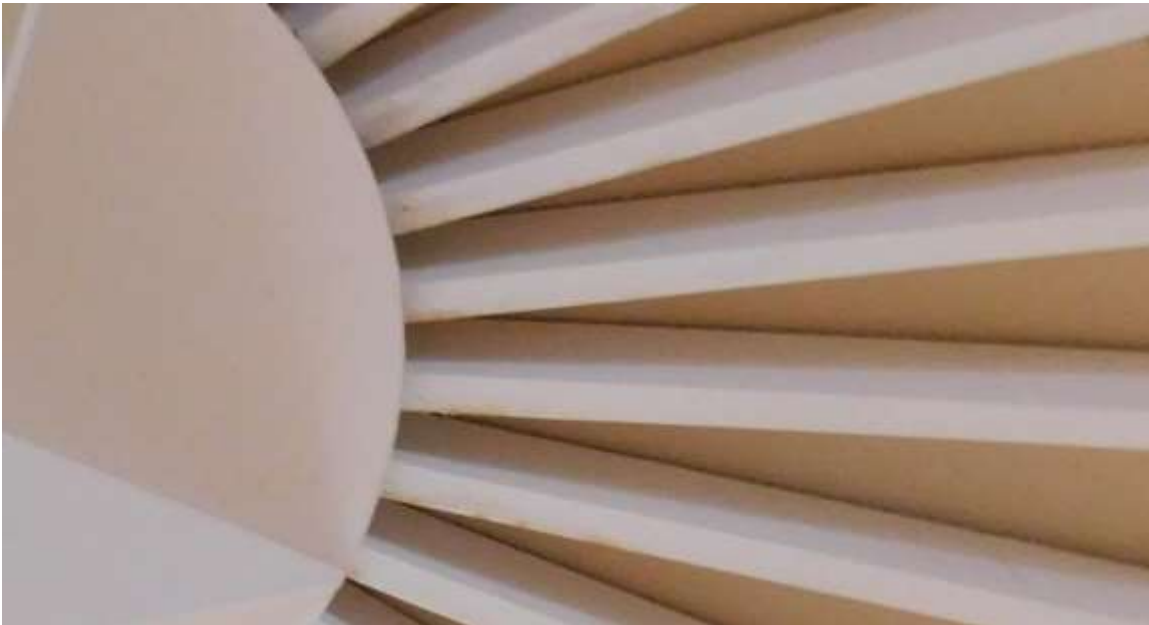
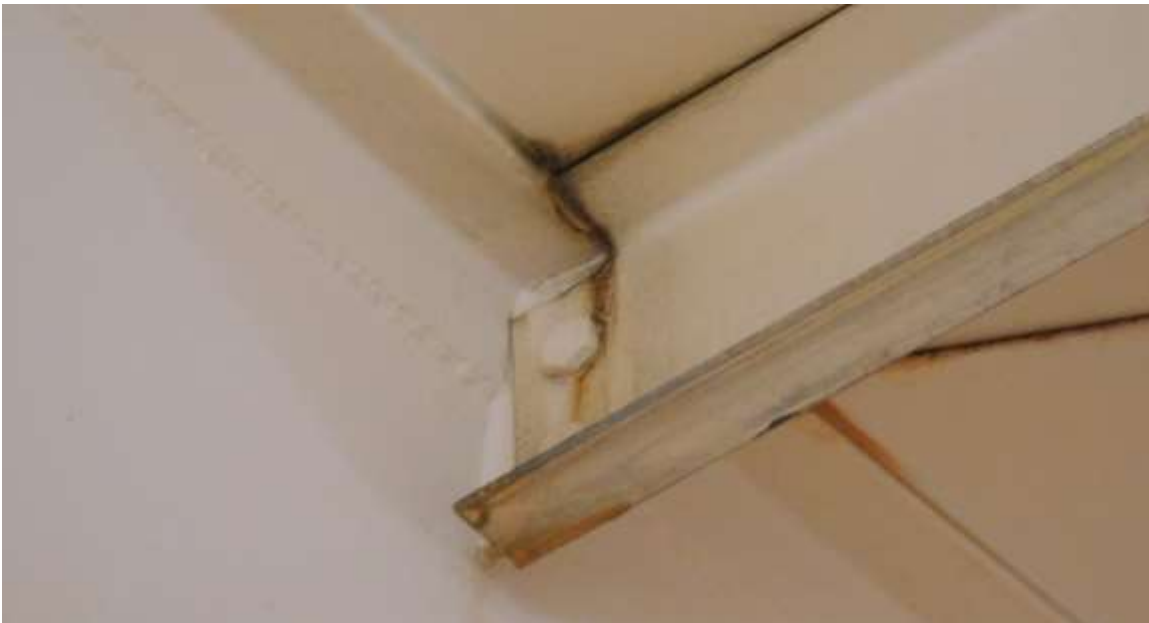
Photos show the rafter-to-support column and rafter-to-shell connections, which appear to be in good condition.
