**Mission Support and Test Services, LLC
Nevada National Security Site
Mercury, NV 89023
RE: Mercury North (Area 23); Mercury, NV
1,500,000 Gallon GST
September 16, 2018
Mr. Kevin Olsen
Scientist 1
(702) 295-0485
Job No. 318448-A**

**Mission Support and Test Services, LLC
Nevada National Security Site
Mercury, NV 89023
RE: Camp South (Area 12); Mercury, NV
500,000 Gallon GST
September 13, 2018
Mr. Kevin Olsen
Scientist 1
(702) 295-0485
Job No. 318448-D**

**Mission Support and Test Services, LLC
Nevada National Security Site
Mercury, NV 89023
RE: Well 4/4a South (Area 6); Mercury, NV
150,000 Gallon GST
September 24, 2018
Mr. Kevin Olsen
Scientist 1
(702) 295-0485
Job No. 318448-H**

**Mission Support and Test Services, LLC
Nevada National Security Site
Mercury, NV 89023
RE: C-1 North (Area 6); Mercury, NV
50,000 Gallon GST
September 21, 2018
Mr. Kevin Olsen
Scientist 1
(702) 295-0485
Job No. 318448-O**

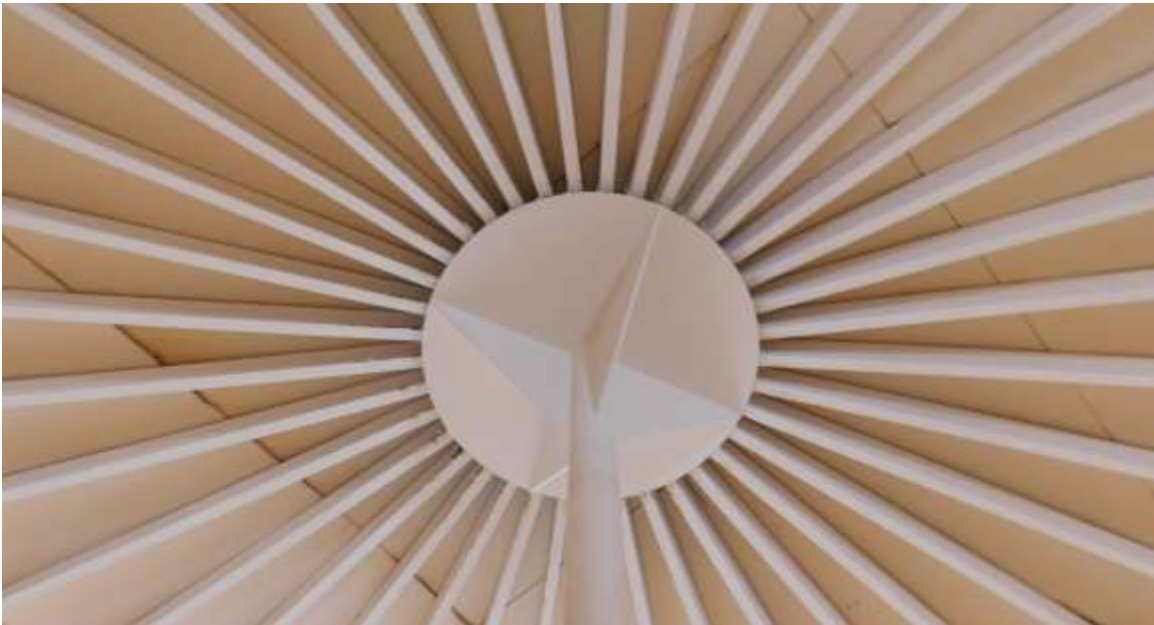
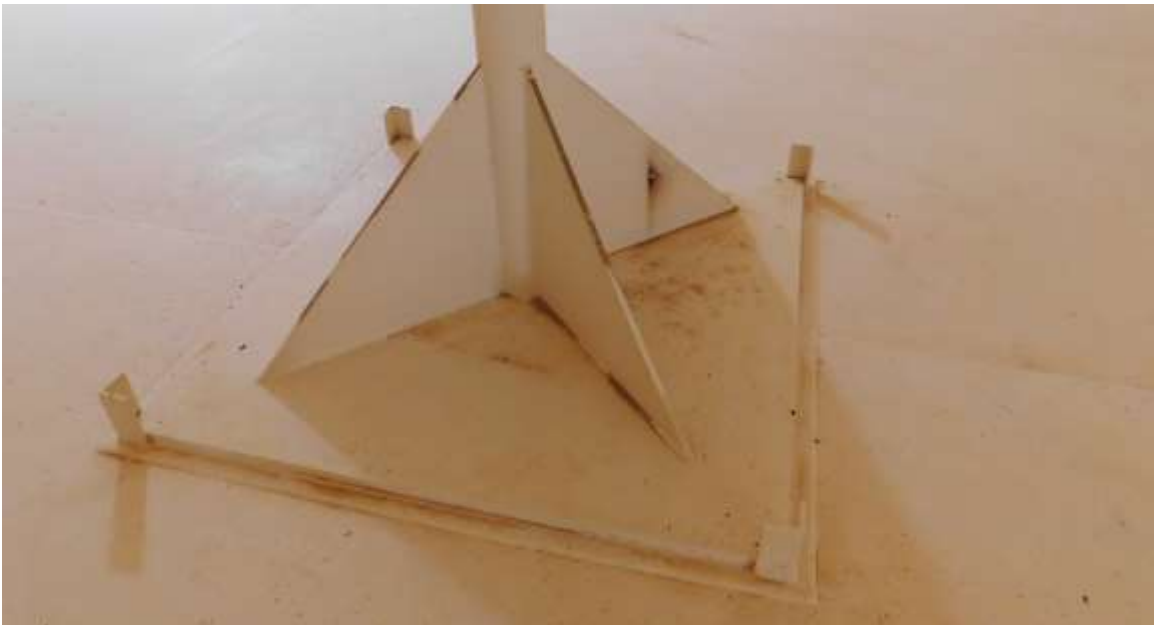
Top photo shows the center support column, which appears to be in good condition.

Bottom photo shows the support column baseplate-to-floor connection, which is disconnected from the floor and equipped with guides on the sides of the plate to ensure it stays in place, and appears to be in good condition.

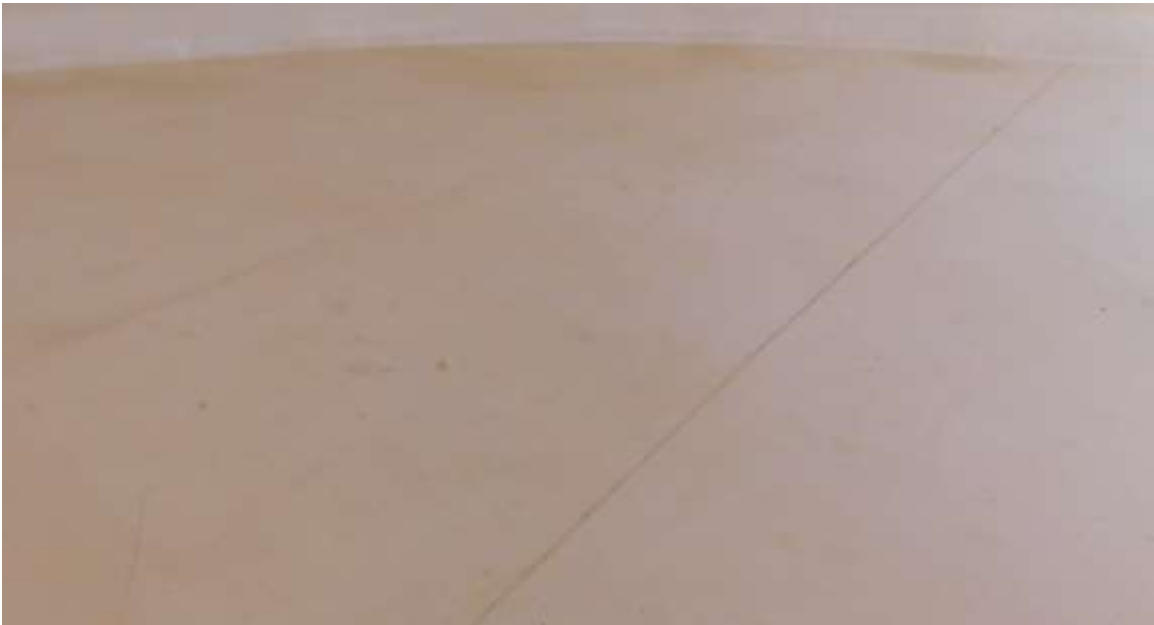
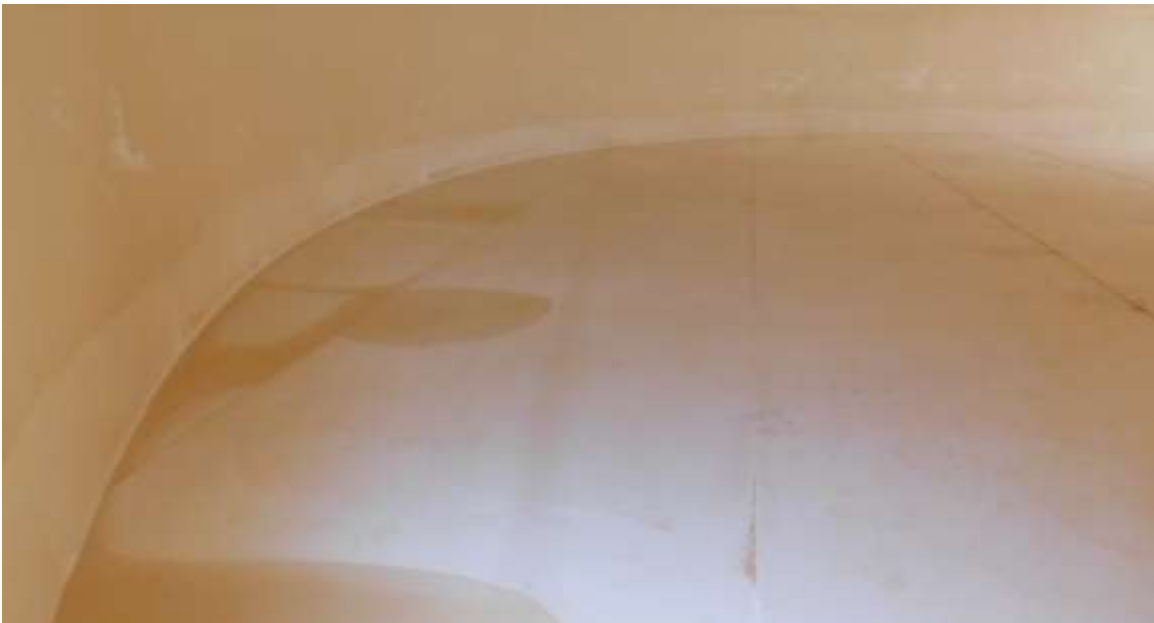
Photos show no sediment in the tank.

We recommend installing a passive cathodic protection system.

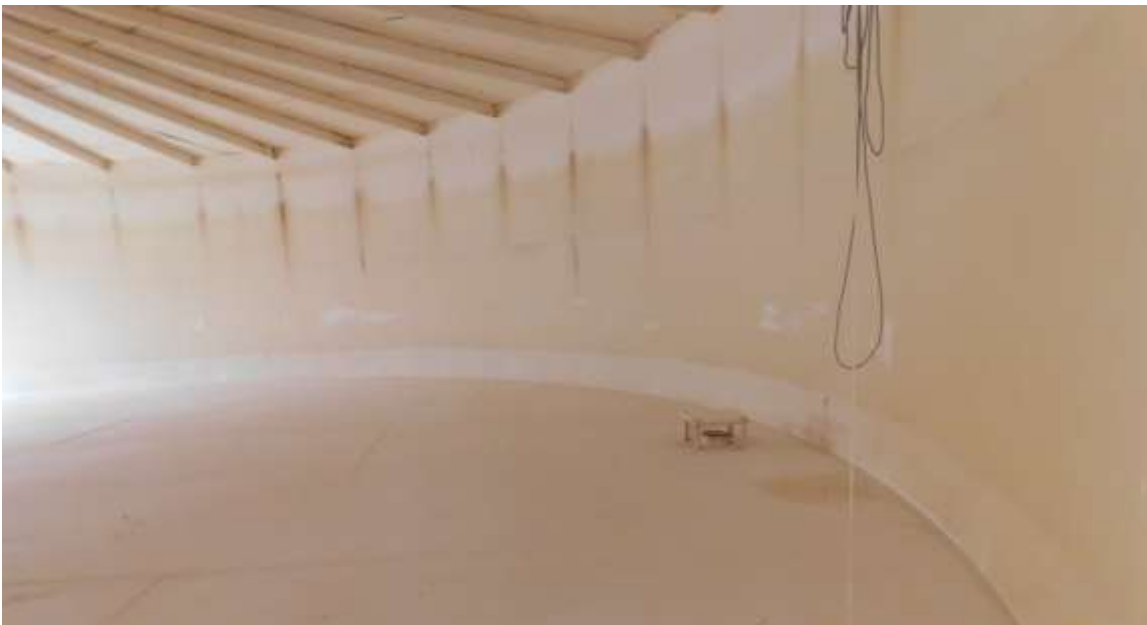
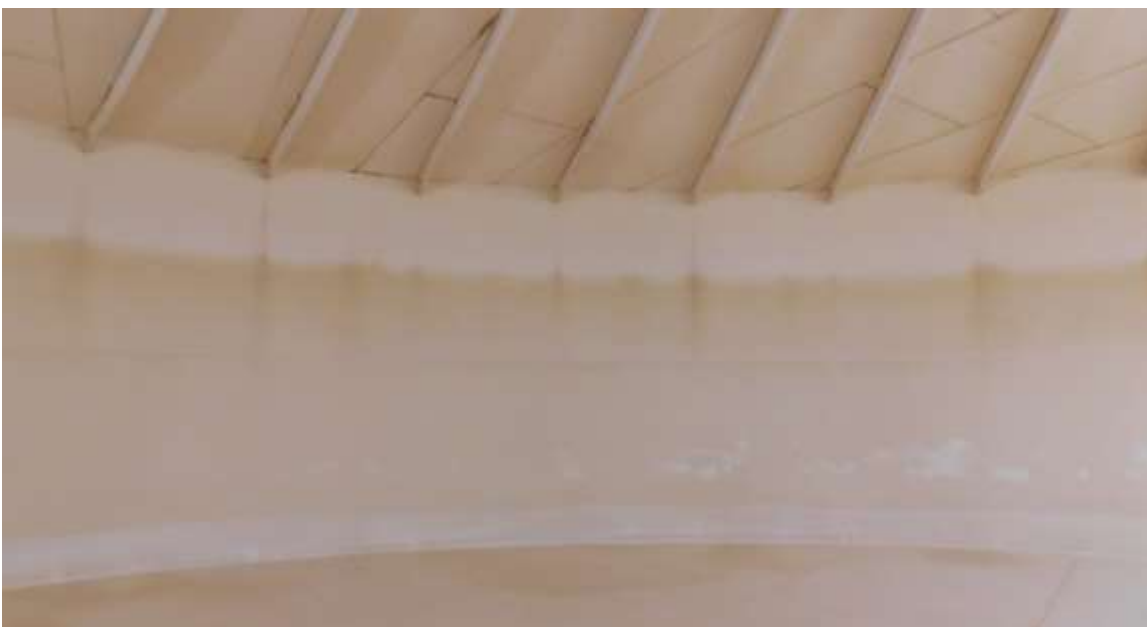
Photos show the tank interior coating system. The overall interior coating system appears to be in good condition. We recommend re-evaluating the tank interior at next inspection cycle.

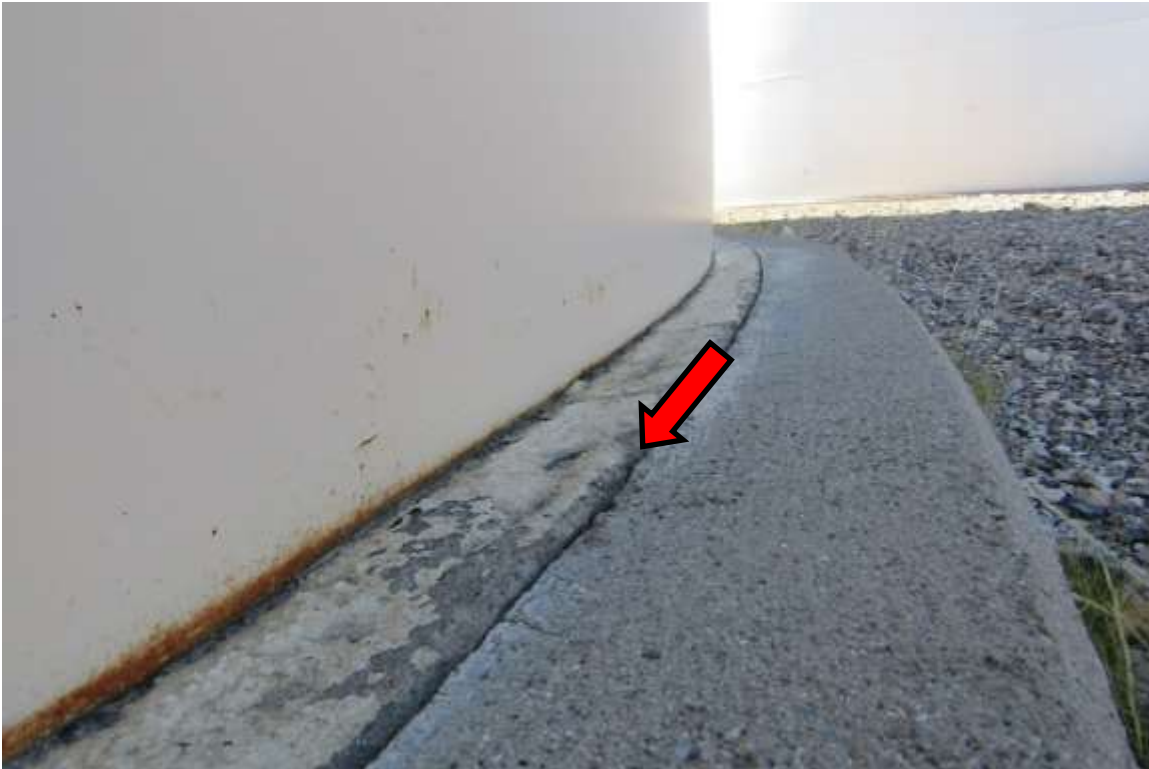
Photo shows the condition of the foundation. We recommend repairing any cracks and spalling in the concrete with a commercial non-shrinking grout, caulking/grouting around the base of the tank to foundation connection to prevent water from entering under the tank, then sealing the foundation with a sealant.

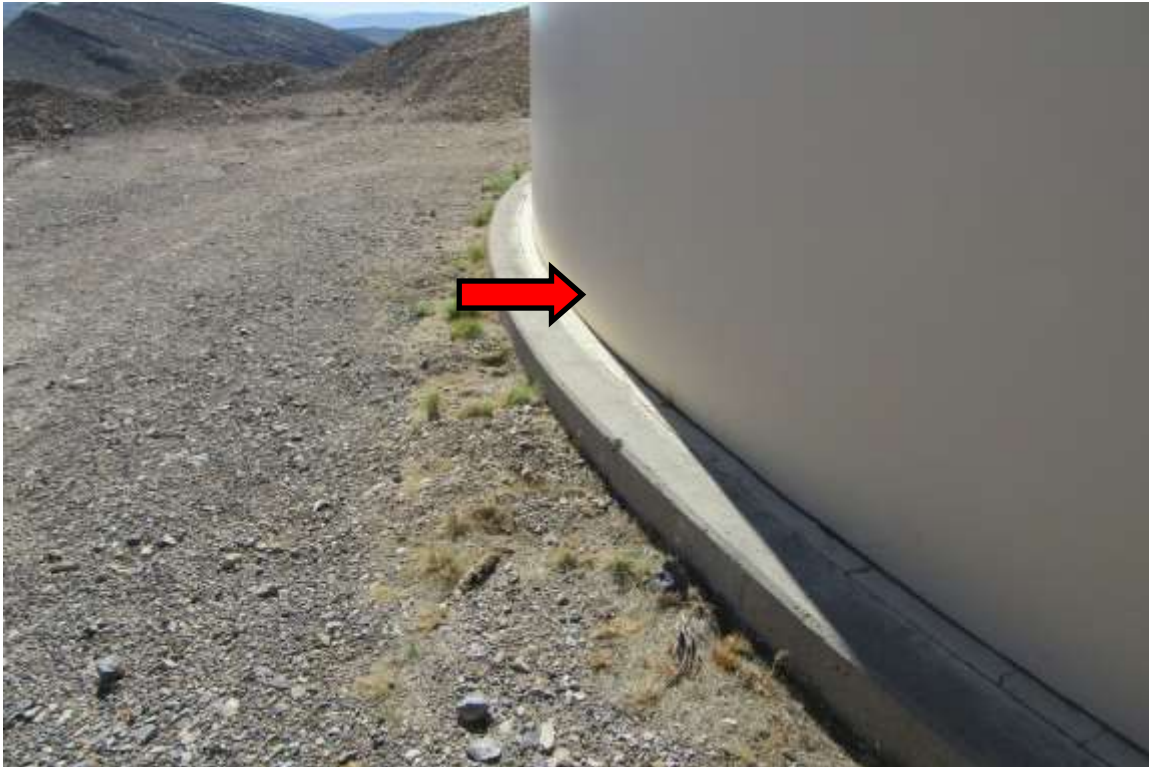
Photo shows the tank has no grounding system. We recommend electrically grounding the tank for lightning protection as required by **OSH Act of 1970 Section 5**.

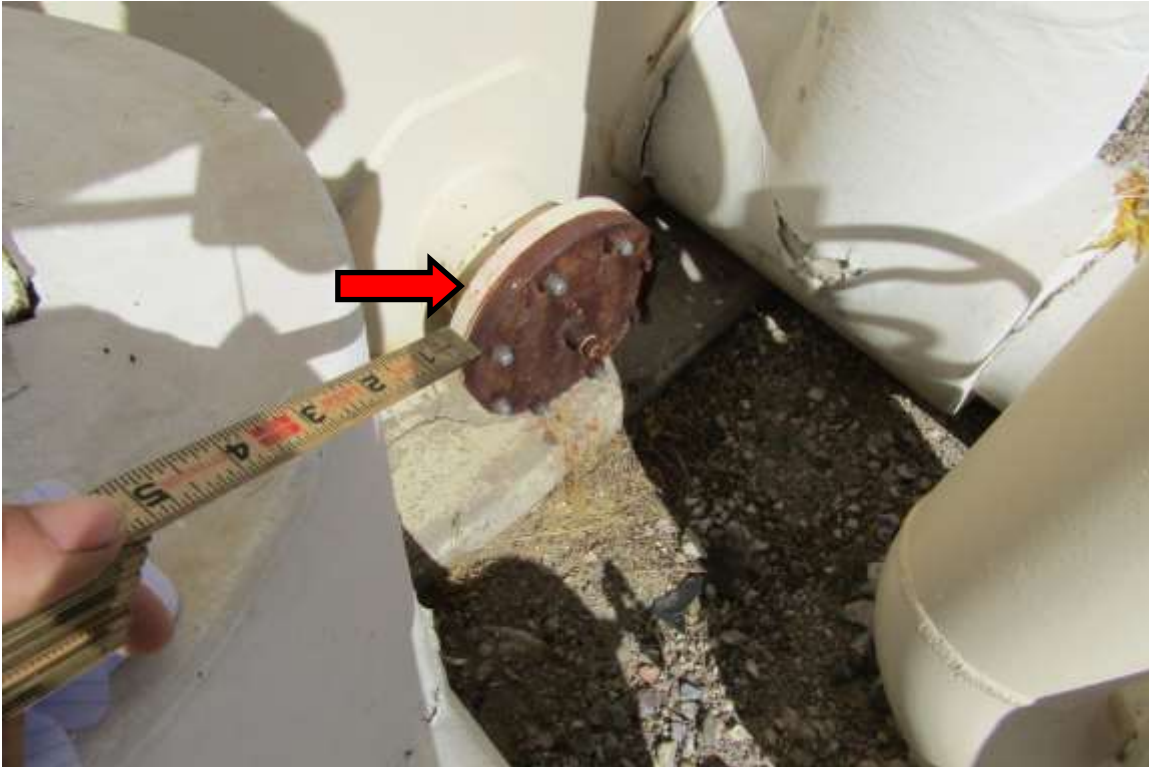
Photo shows the 8" flange. Currently there is no drain valve. We recommend installing a frost proof drain valve on the flange / threaded connection, complete with a locking device to prevent unauthorized draining of the tank and a splash pad to direct water away from the foundation.

**Splash pad to be installed by owner.*

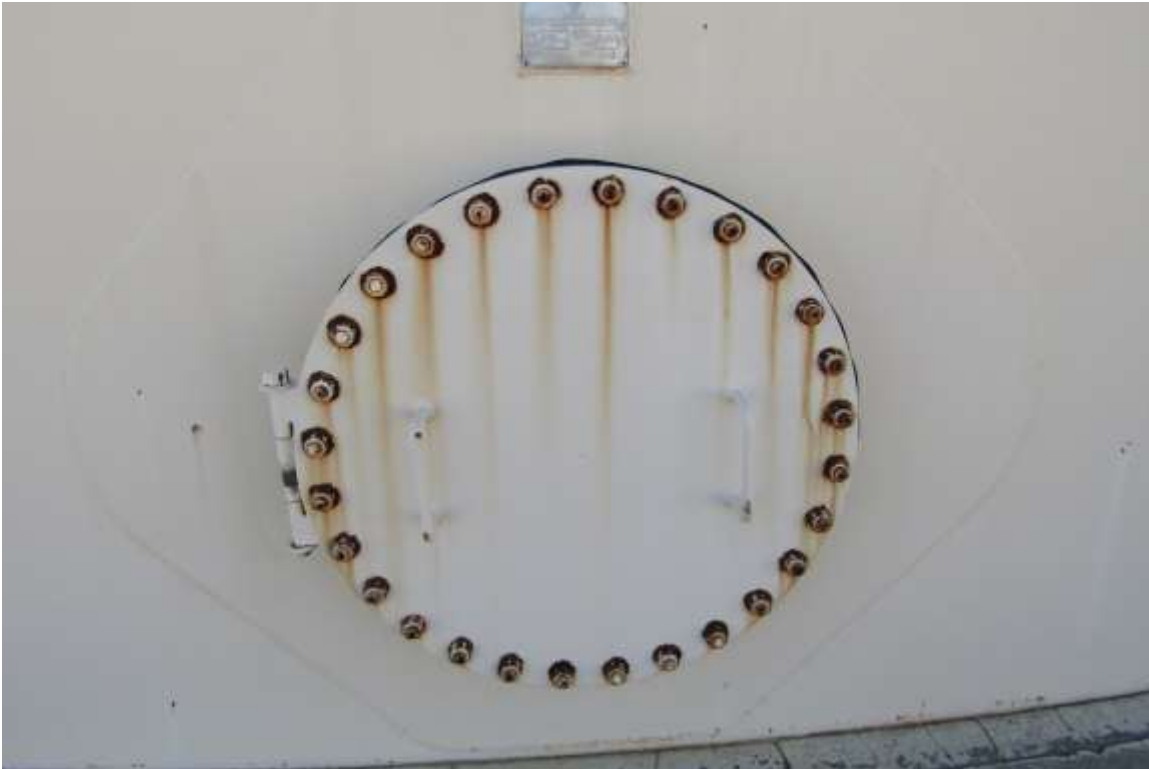
Photo shows the condition of the 24" primary shell manway. The following is required for the tank to be in compliance with **AWWA D100-11; 7.4.4 Shell man-holes** and **OSHA 1910.146(c)(2) Confined spaces**.

We recommend:

Install 30" secondary shell manway 180° from primary manway
Post **Confined Space Entry** sign
Install maintenance free galvanized steel bolts

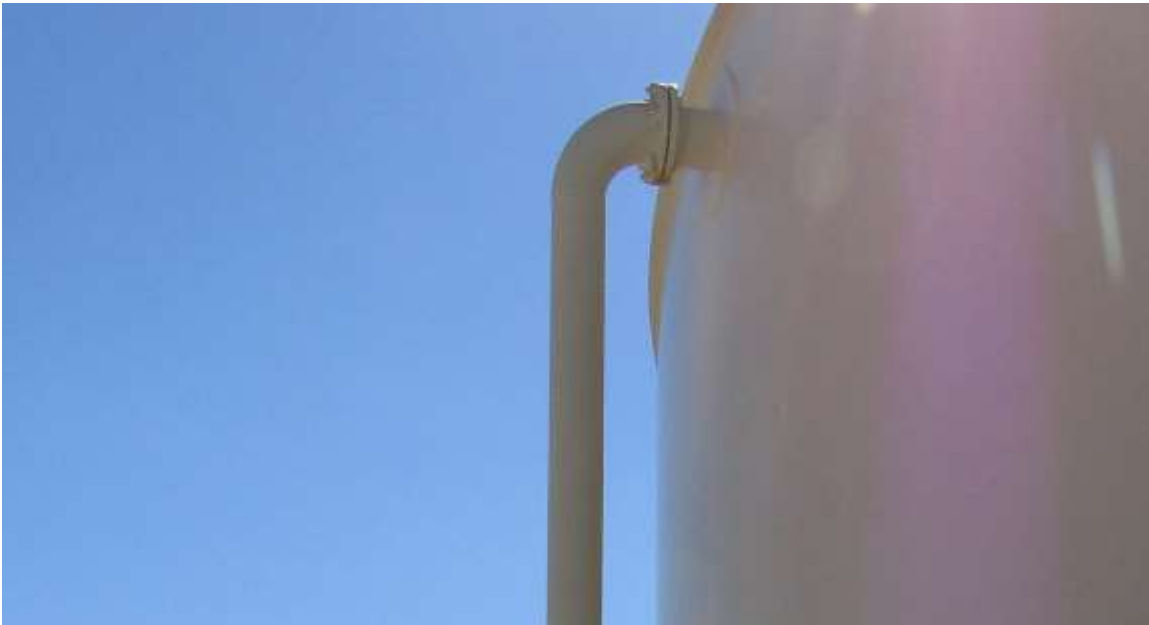
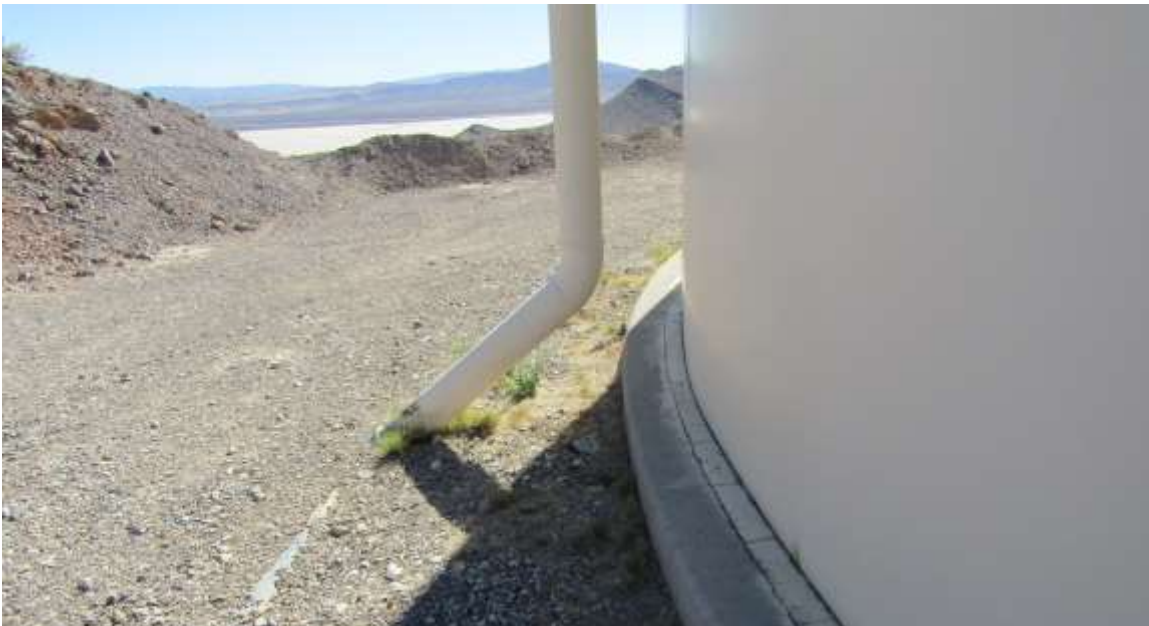
Photos show the condition of the 6" overflow pipe system. We recommend disconnecting the pipe from the underground drain then installing an air break complete with a flapper valve and screen to prevent the ingress of contaminants into the water supply.

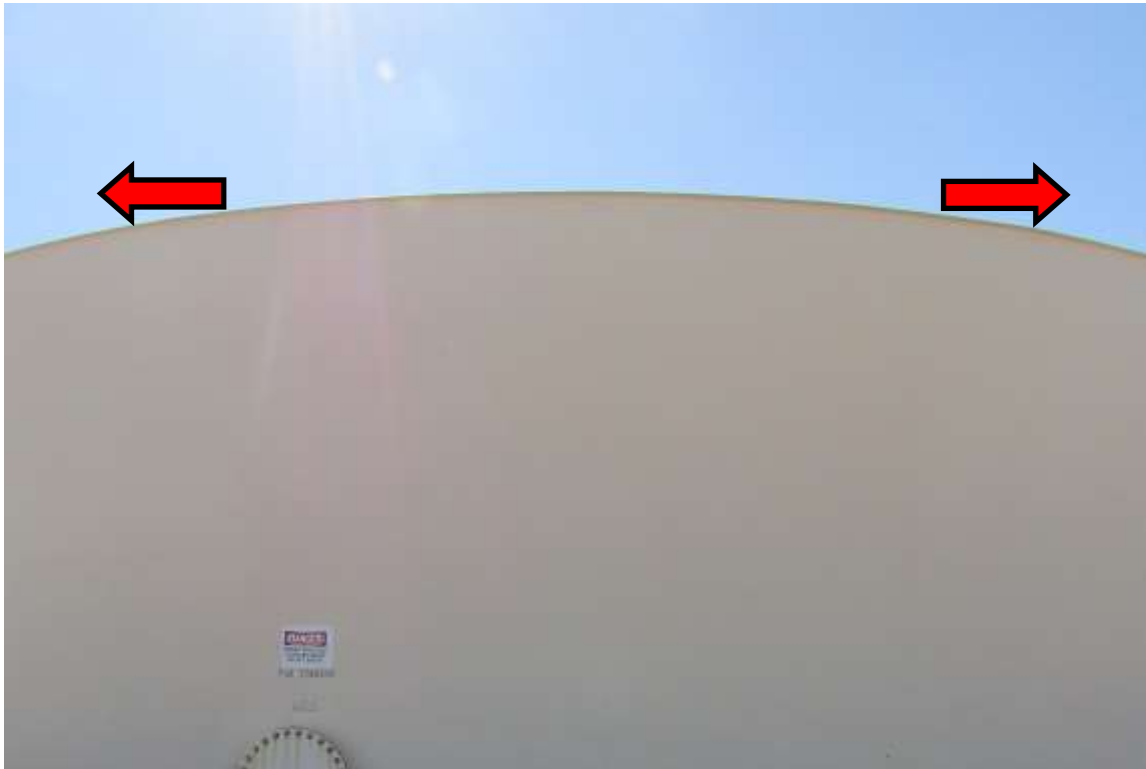
Photo shows the tank roof edge is not equipped with a required handrail system for fall protection. **OSHA 1910.28(b)(1)(i)** states, "...the employer must ensure that each employee on a walking-working surface with an unprotected side or edge that is 4 feet (1.2 m) or more above a lower level is protected from falling by one or more of the following: **1910.28(b)(1)(i)(A) Guardrail systems.**"

We recommend installing an **OSHA** compliant 42" high handrail system around the circumference of the tank roof, complete with intermediate rail, toeboard and a swing gate at the junction of the shell-to-roof access ladder and tank roof.

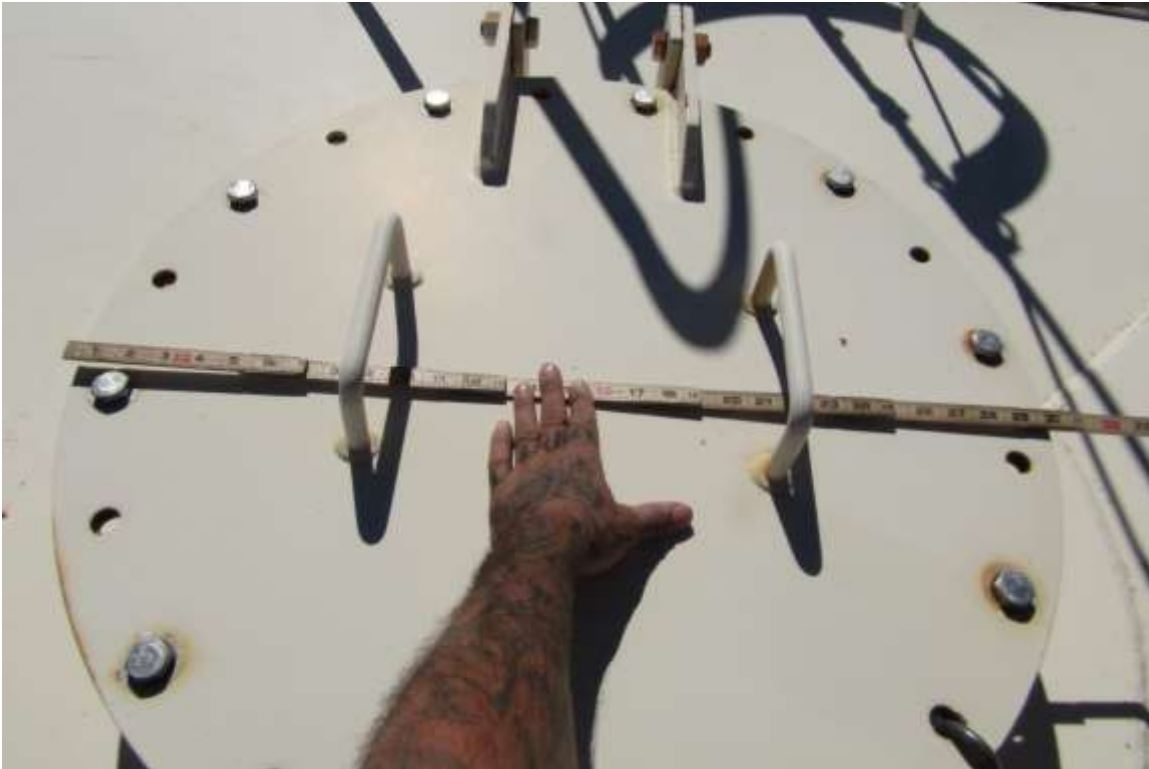
Photo shows the condition of the 24" primary roof hatch. Roof openings on this tank require the following to be in compliance with **AWWA D100-11; 7.4.3 Roof openings** and **OSHA 1910.146(c)(2) Confined spaces**.

We recommend:

We further recommend installing **OSHA** compliant interior access ladders complete with standoffs every 10' on center, and cable type ladder safety devices at the primary and suggested secondary roof hatches.

**In cold climates it's up to the owner's discretion on placement of internal ladders.*

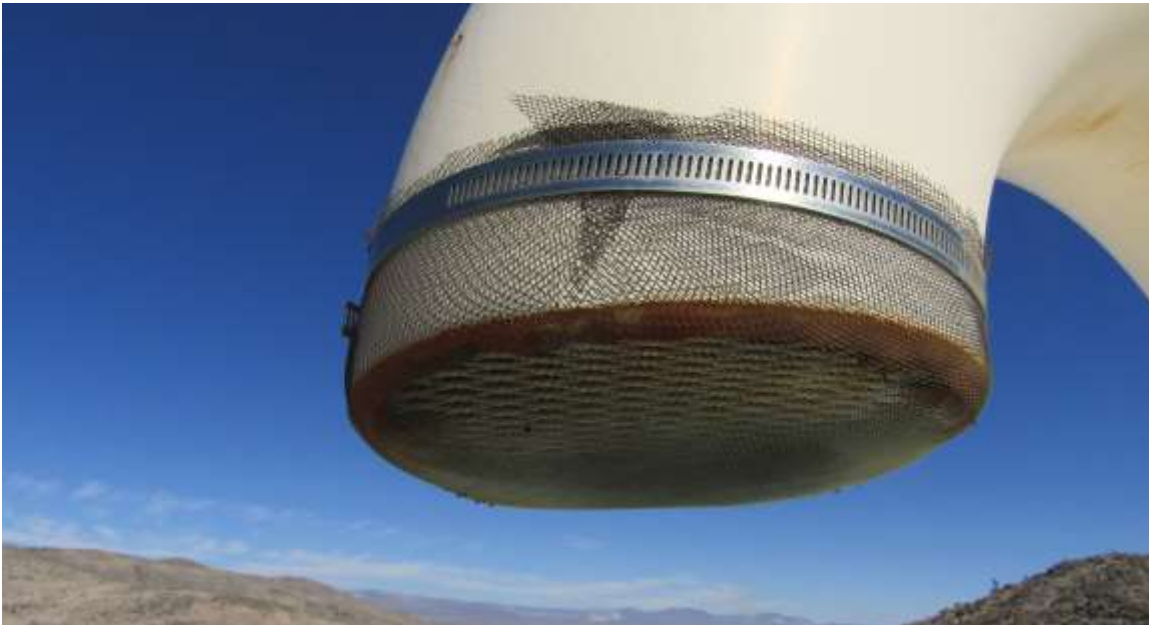
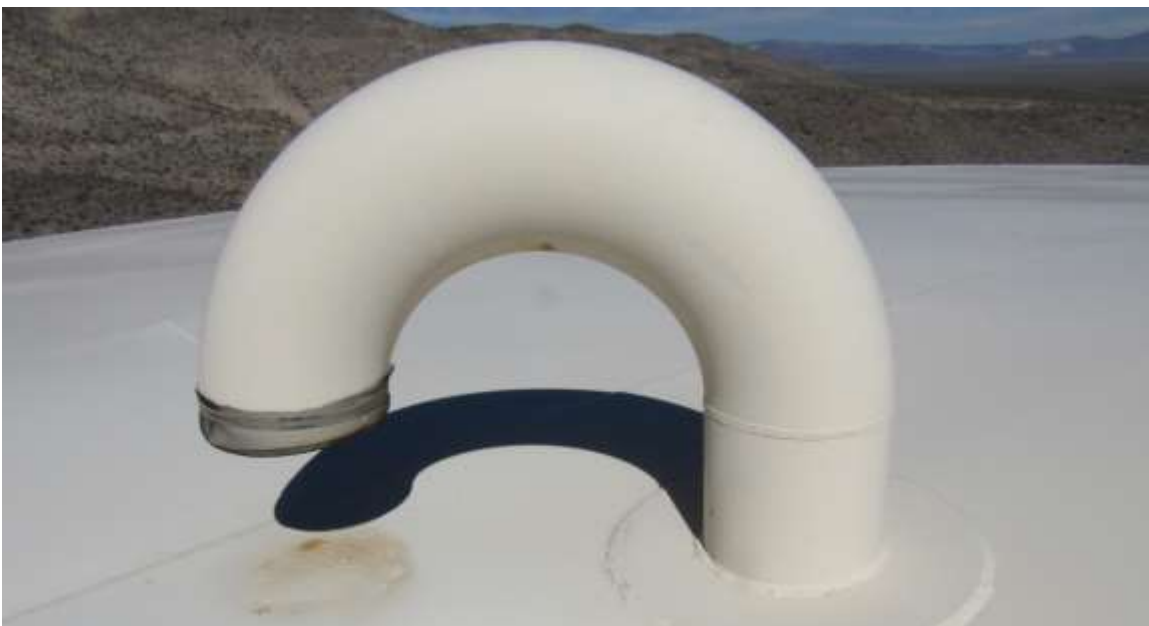
Photos show the condition of the existing 8" roof vent. **This vent is allowing the ingress of rain and wind-borne contaminants into the water system. An improperly vented tank may cause external pressure to act on the tank which can cause buckling even at low pressure differential.** We recommend replacing the existing roof vent with a vacuum-pressure, frost proof vent and screen.

This work should be performed on an emergency basis.

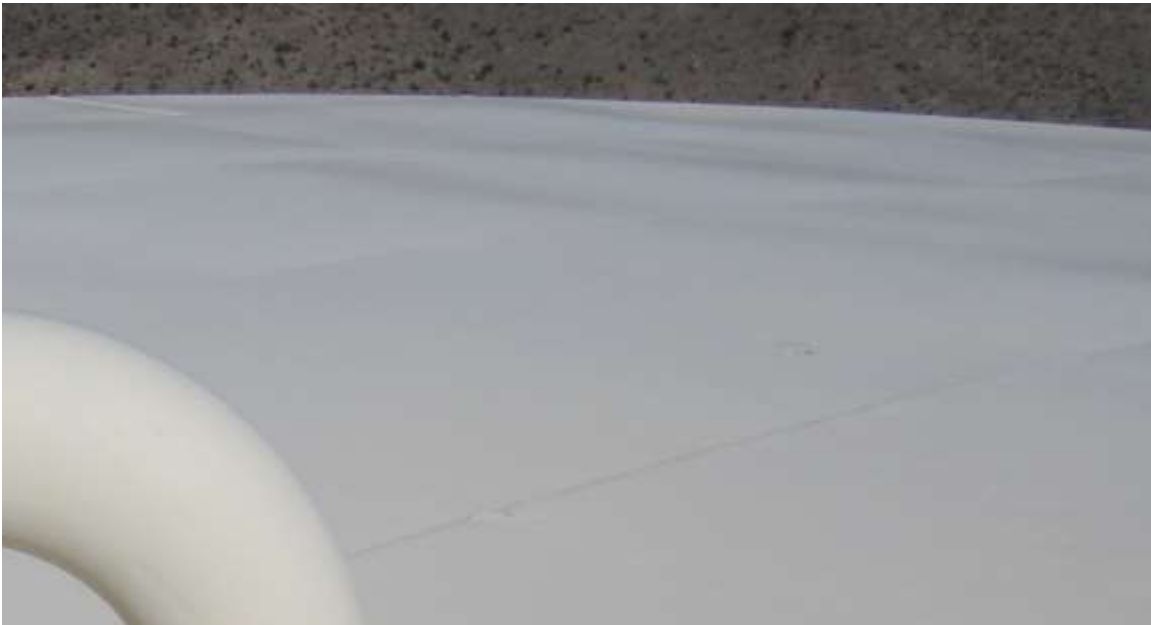
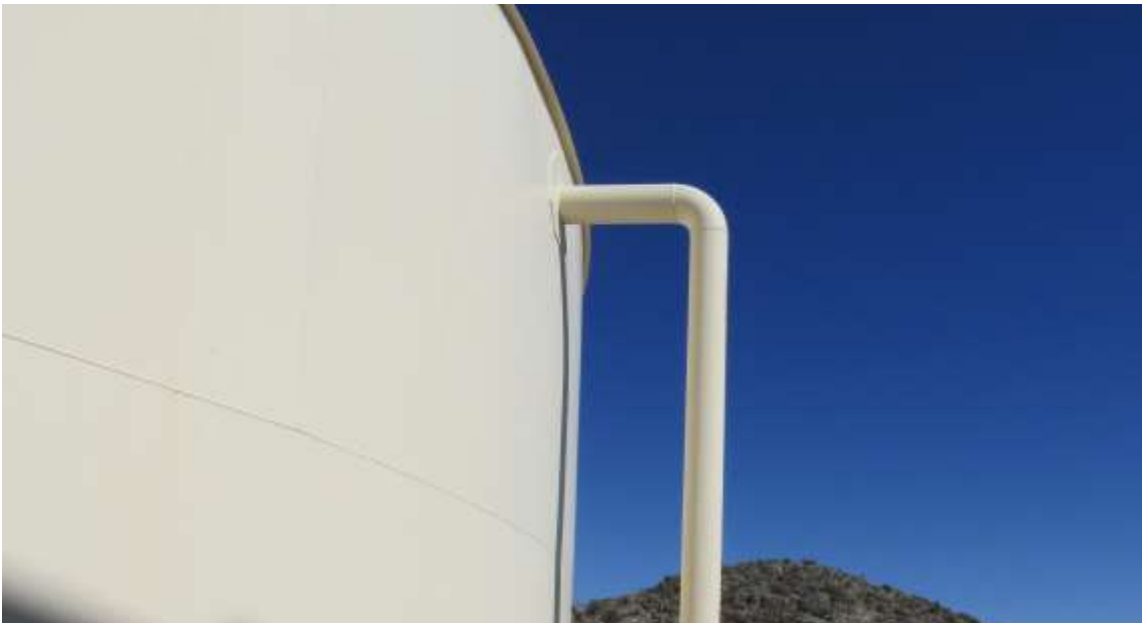
Photos show the tank exterior coating system. The overall exterior coating system appears to be in good condition. We recommend re-evaluating the tank exterior at next inspection cycle.

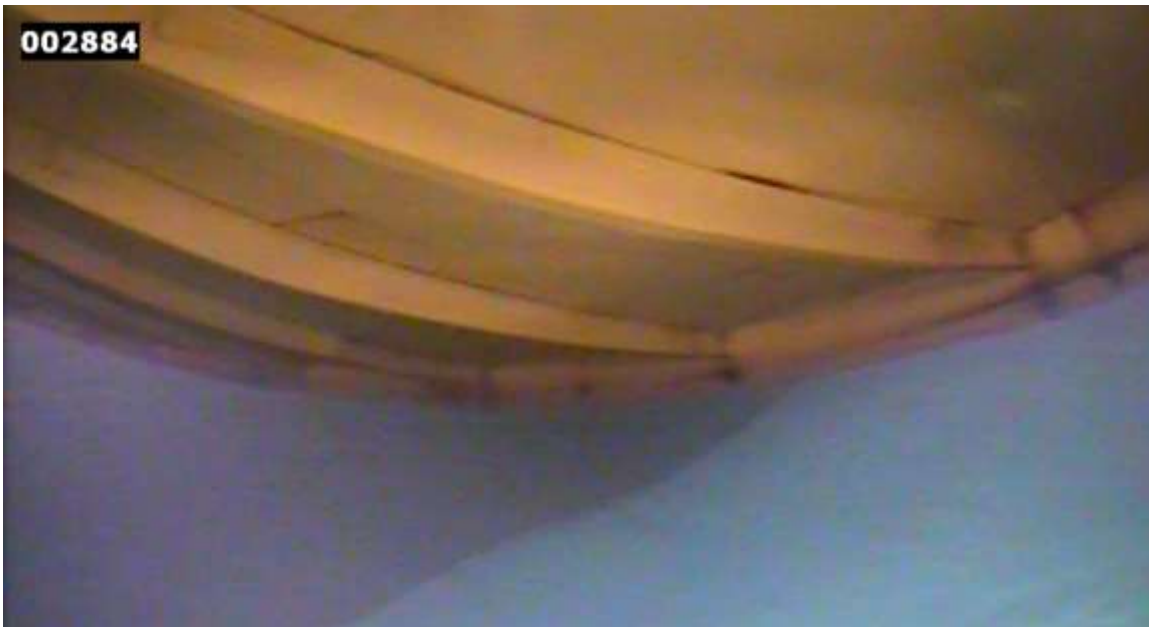
Top photo shows the interior roof lap seams, which appear to be in good condition.

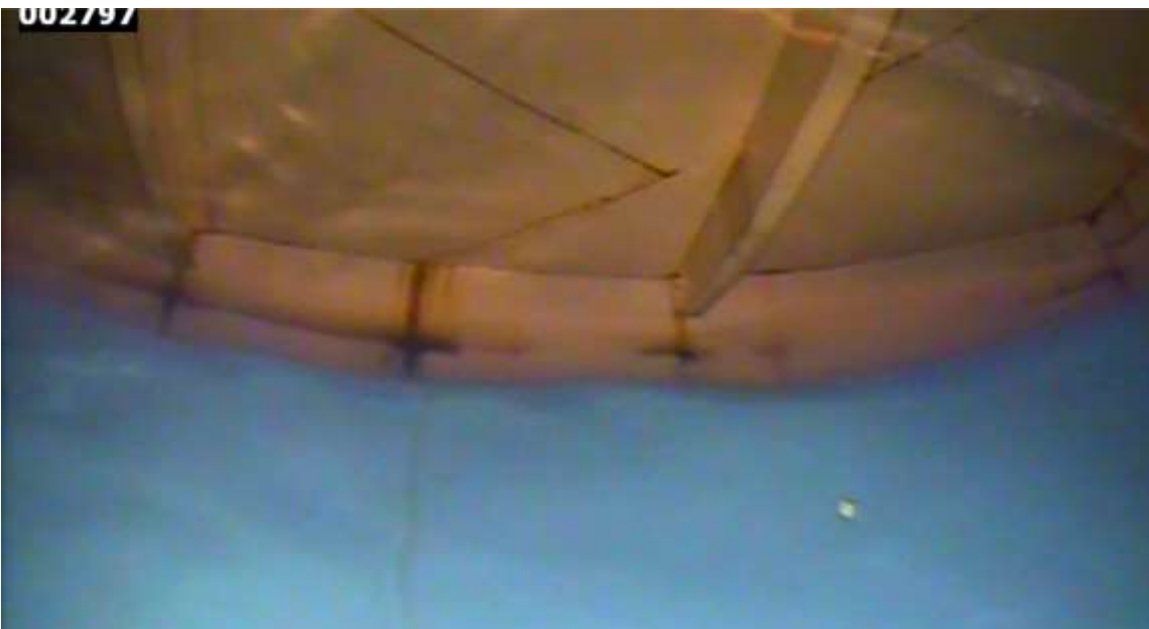
Bottom photo shows the interior roof-to-rim angle connection, which appears to be in good condition.

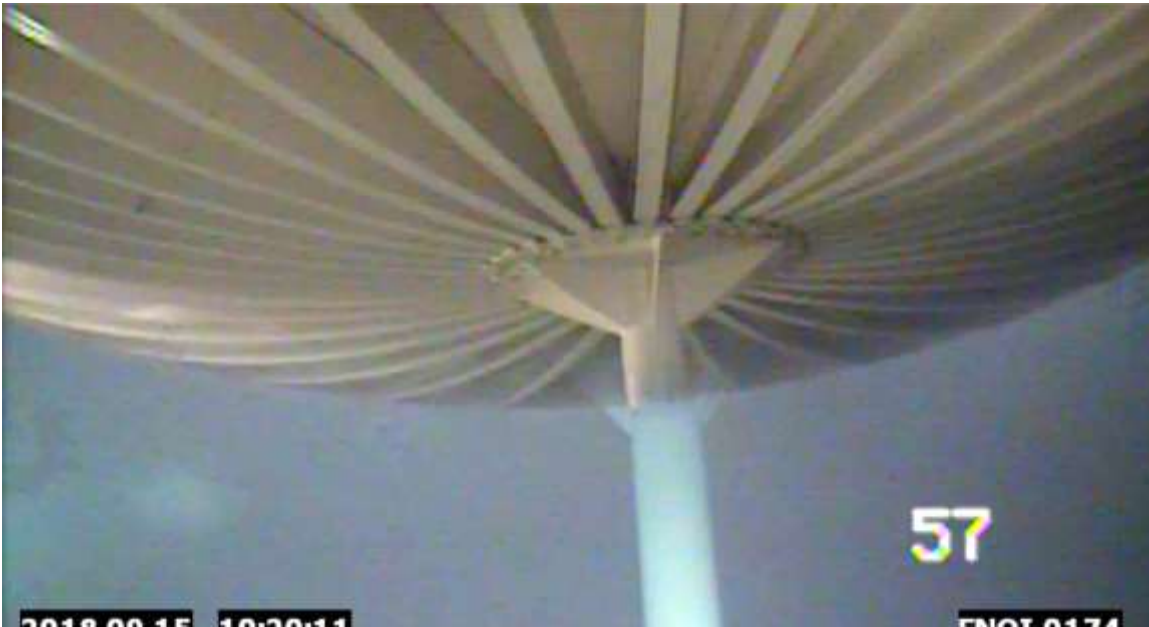
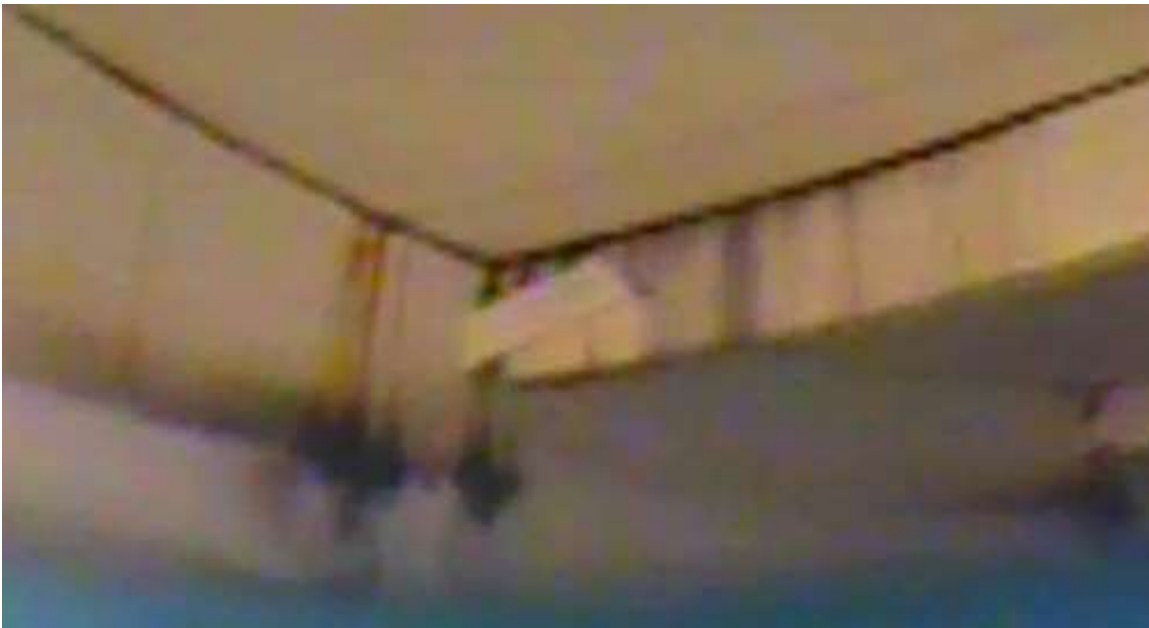
Photos show the rafter-to-support column and rafter-to-shell connections, which appear to be in good condition.

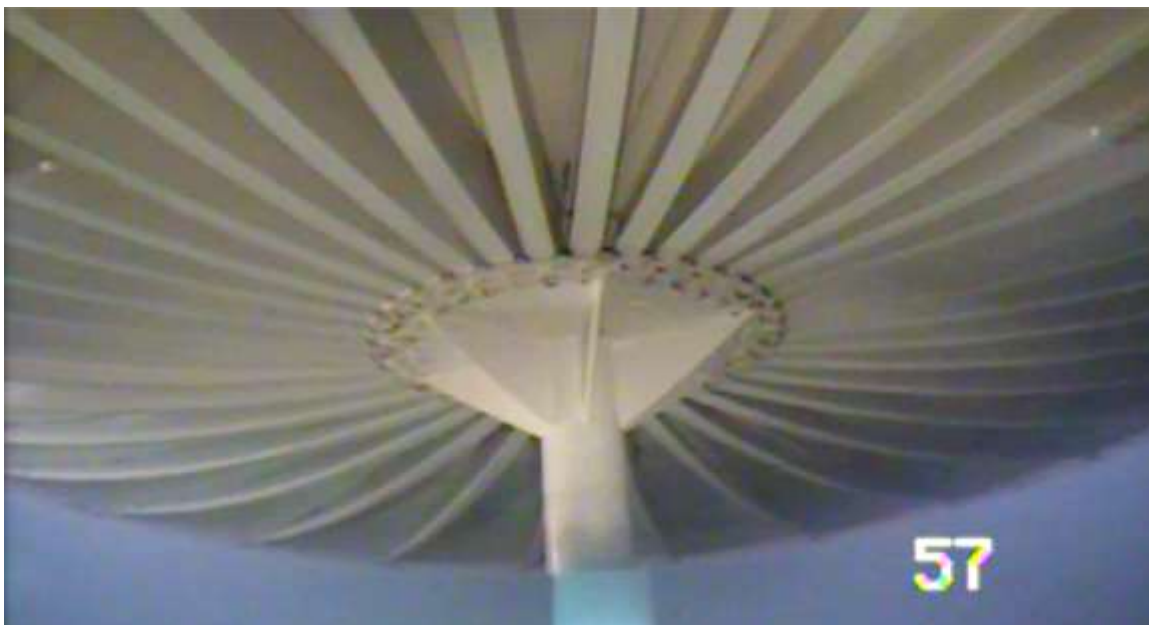
Top photo shows the center support column, which appears to be in good condition.

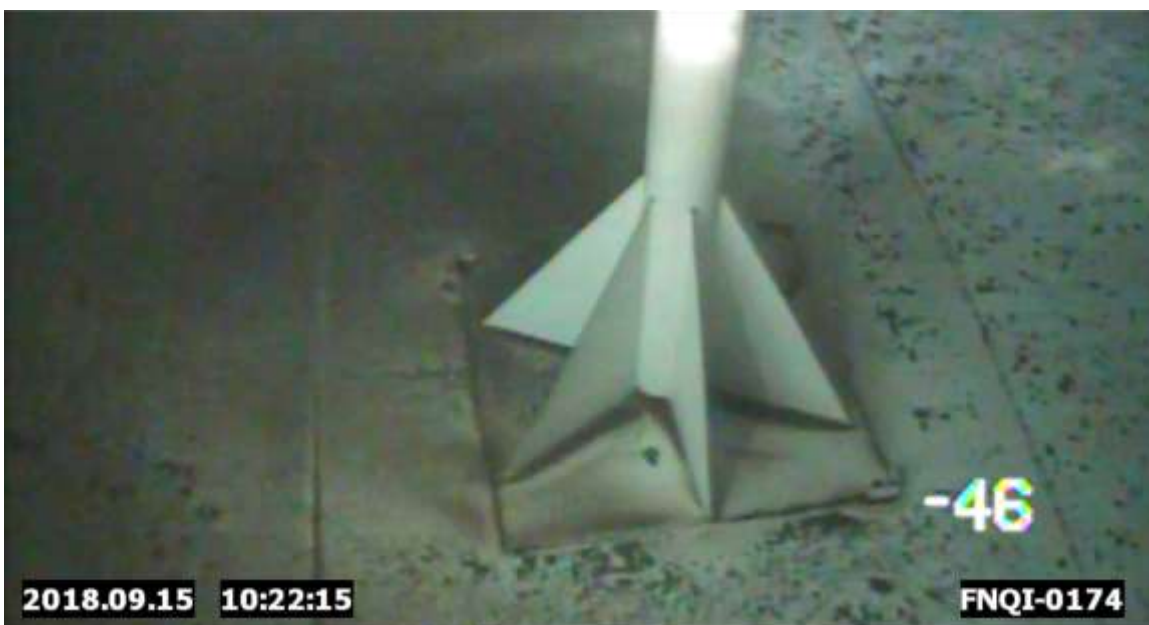
Bottom photo shows the support column baseplate-to-floor connection, which appears to be in good condition.

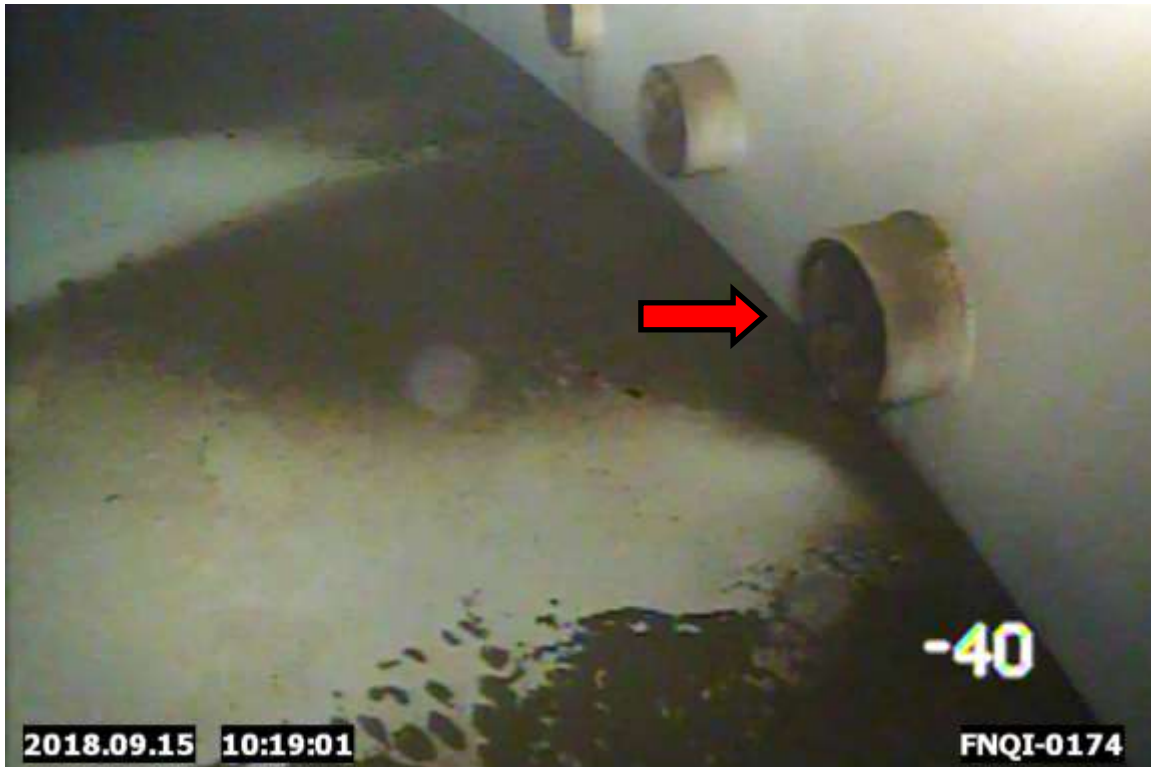
Photo shows a fill pipe on the tank interior. A temperature difference between the water in the top and bottom of a tank, even as little as 1-2 degrees Fahrenheit, is an indication of thermal stratification and the tank water not being completely mixed. Incomplete mixing would result in short-circuiting, and localized increase in water age would develop inside the tank. This typically leads to water quality problems, such as loss of residual, DBP spikes, HPC spikes, bacteria regrowth, formation of bio-film, changes in pH and dissolved oxygen. We recommend installing a mixing system. Electrical work to be done by others if required.

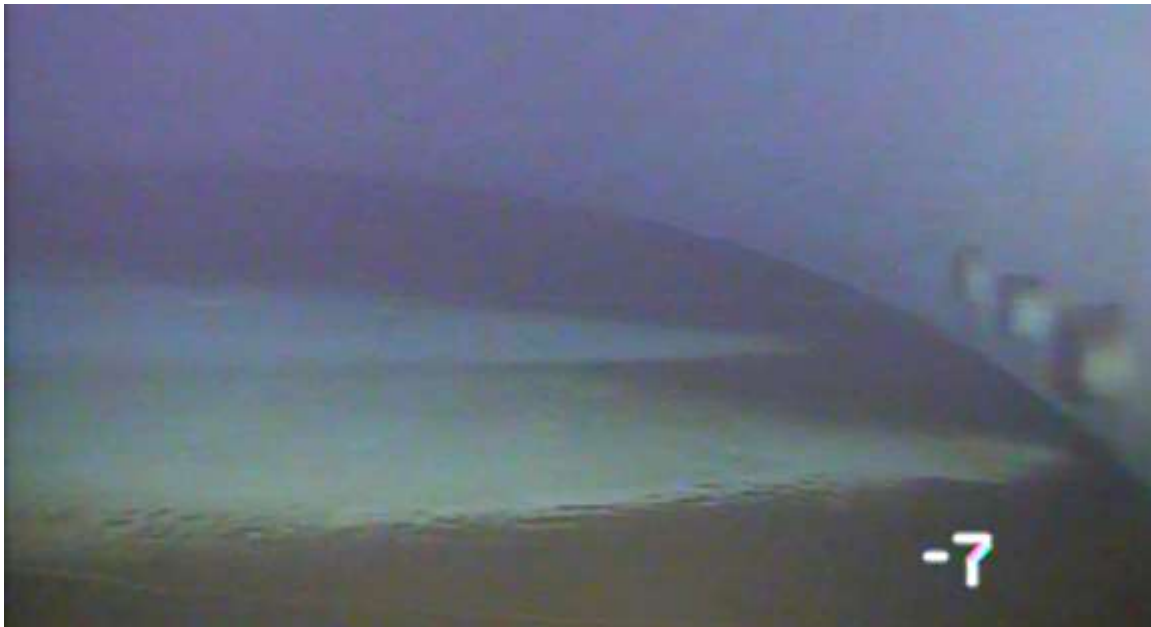
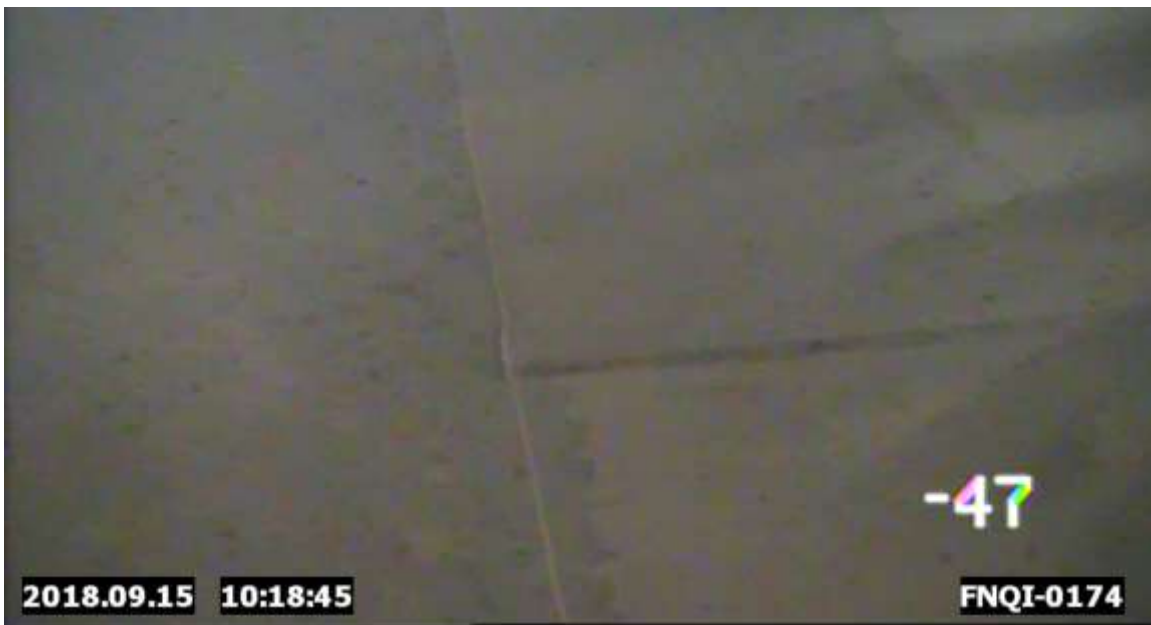
Photos show sediment and debris on the tank interior before a cleanout was performed.

We recommend installing a passive cathodic protection system.
