**Mission Support and Test Services, LLC
Nevada National Security Site
Mercury, NV 89023
RE: Mercury North (Area 23); Mercury, NV
1,500,000 Gallon GST
September 16, 2018
Mr. Kevin Olsen
Scientist 1
(702) 295-0485
Job No. 318448-A**

**Mission Support and Test Services, LLC
Nevada National Security Site
Mercury, NV 89023
RE: Camp South (Area 12); Mercury, NV
500,000 Gallon GST
September 13, 2018
Mr. Kevin Olsen
Scientist 1
(702) 295-0485
Job No. 318448-D**

**Mission Support and Test Services, LLC
Nevada National Security Site
Mercury, NV 89023
RE: Well 4/4a South (Area 6); Mercury, NV
150,000 Gallon GST
September 24, 2018
Mr. Kevin Olsen
Scientist 1
(702) 295-0485
Job No. 318448-H**

**Mission Support and Test Services, LLC
Nevada National Security Site
Mercury, NV 89023
RE: C-1 North (Area 6); Mercury, NV
50,000 Gallon GST
September 21, 2018
Mr. Kevin Olsen
Scientist 1
(702) 295-0485
Job No. 318448-O**

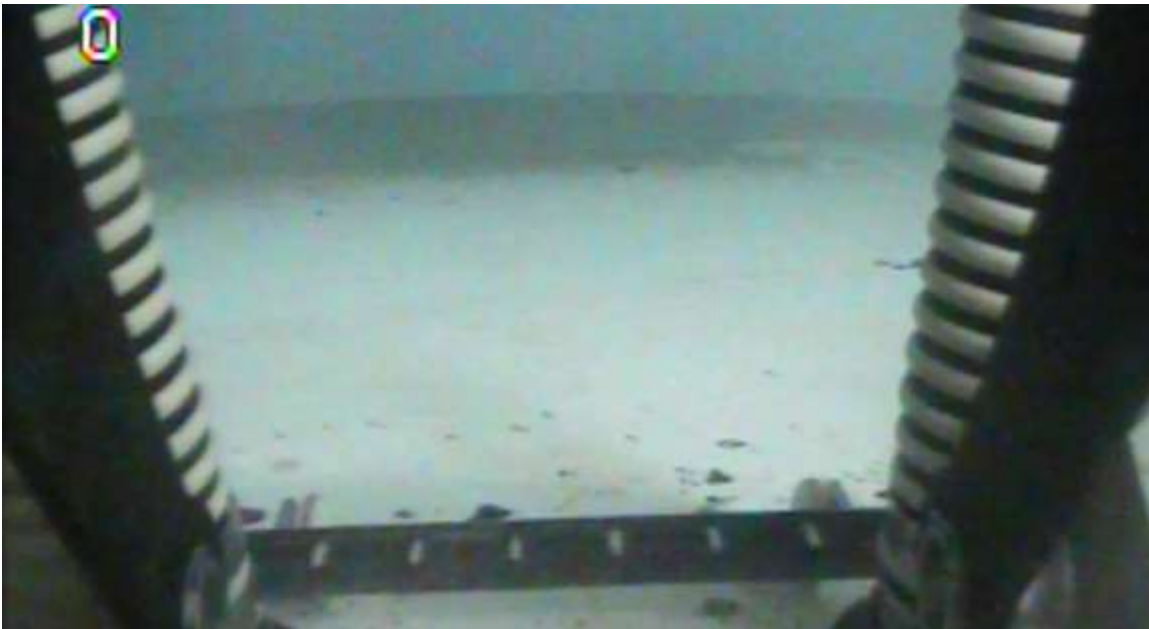
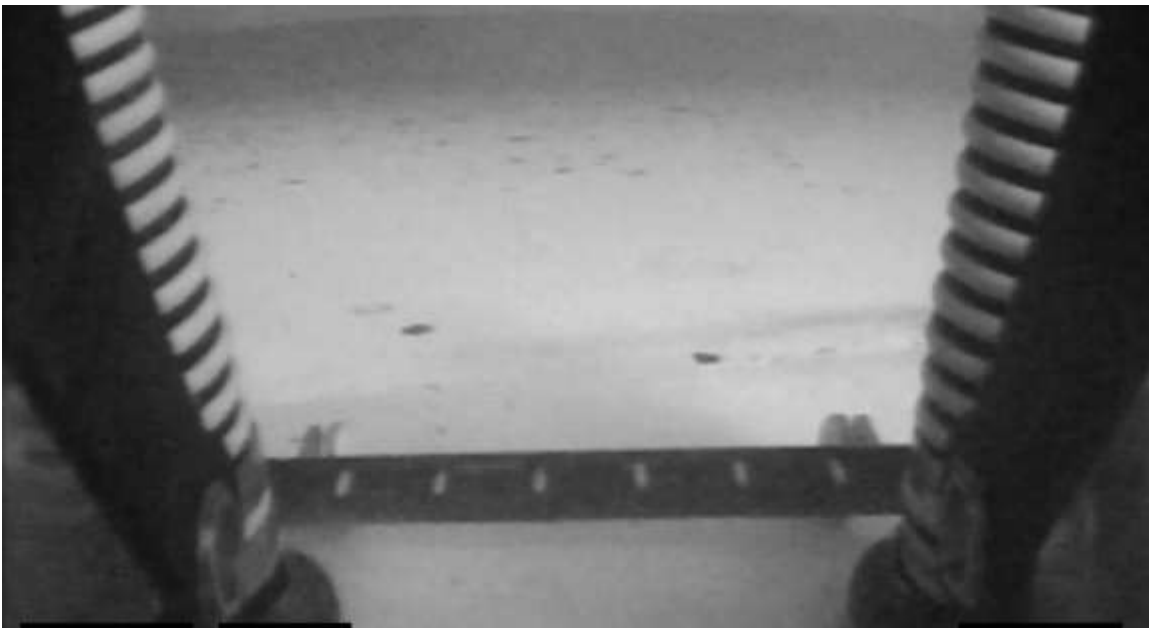
Photos show the tank interior during a cleanout.

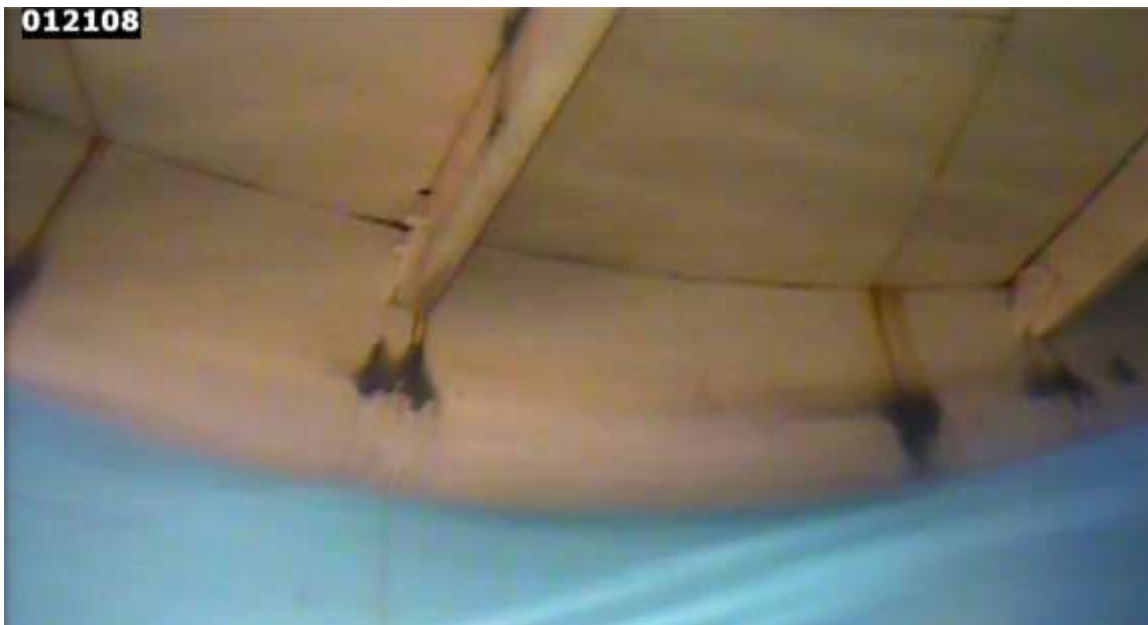
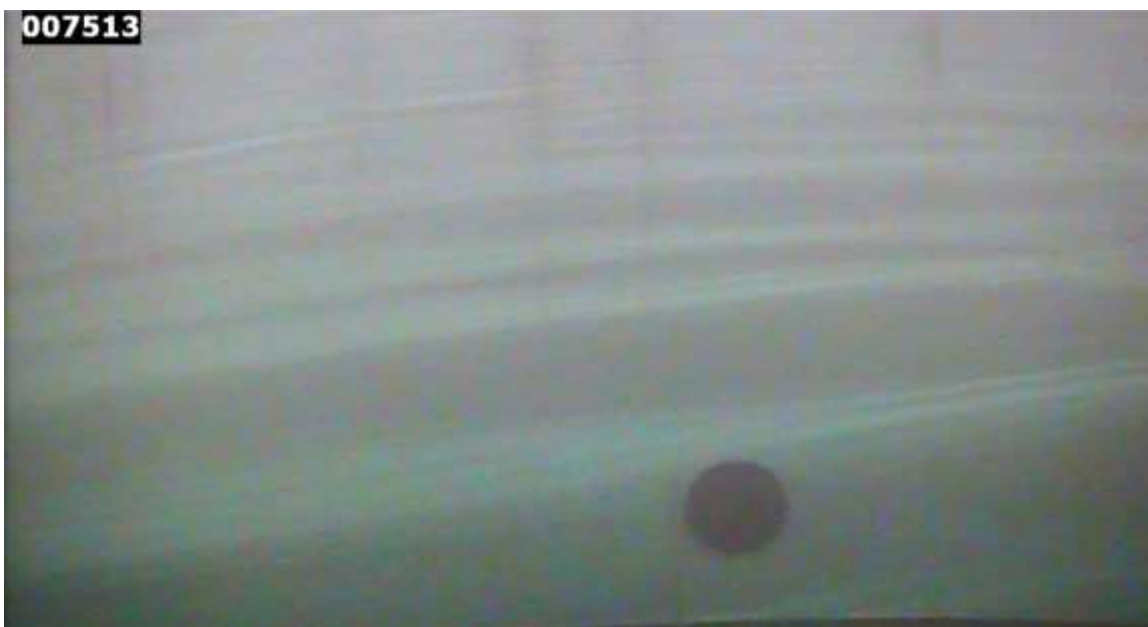
Photos show the tank interior coating system. The overall interior coating system appears to be in good condition. We recommend pressure washing the tank interior with biodegradable detergent injection (minimum 3,500 psi at 3.0 gpm), then re-evaluating the tank interior at next inspection cycle.

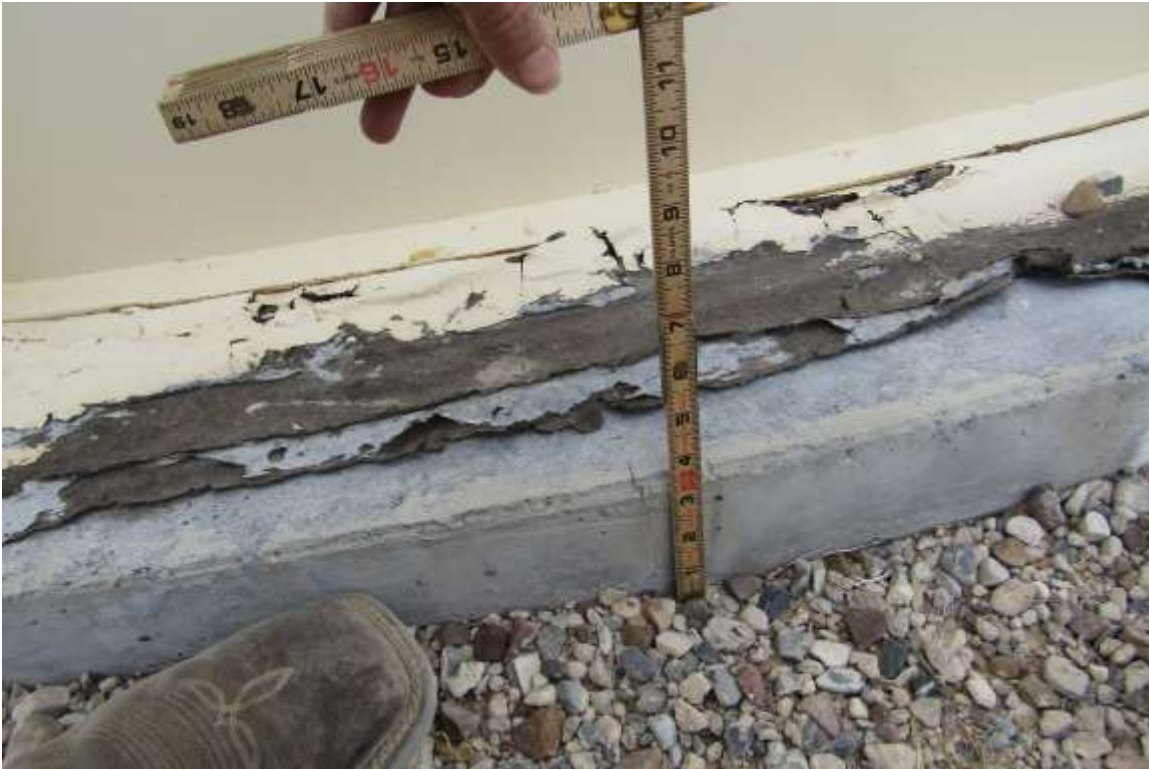
Photo shows the condition of the foundation. **AWWA D100-11; 12.7.1 Height aboveground** states, "The tops of the concrete foundations shall be a minimum of 6" above the finished grade, unless otherwise specified." We recommend clearing any dirt, debris and other loose gravel away from the tank foundation, down to a minimum 6" below top of foundation. This should be done by a local excavating company.

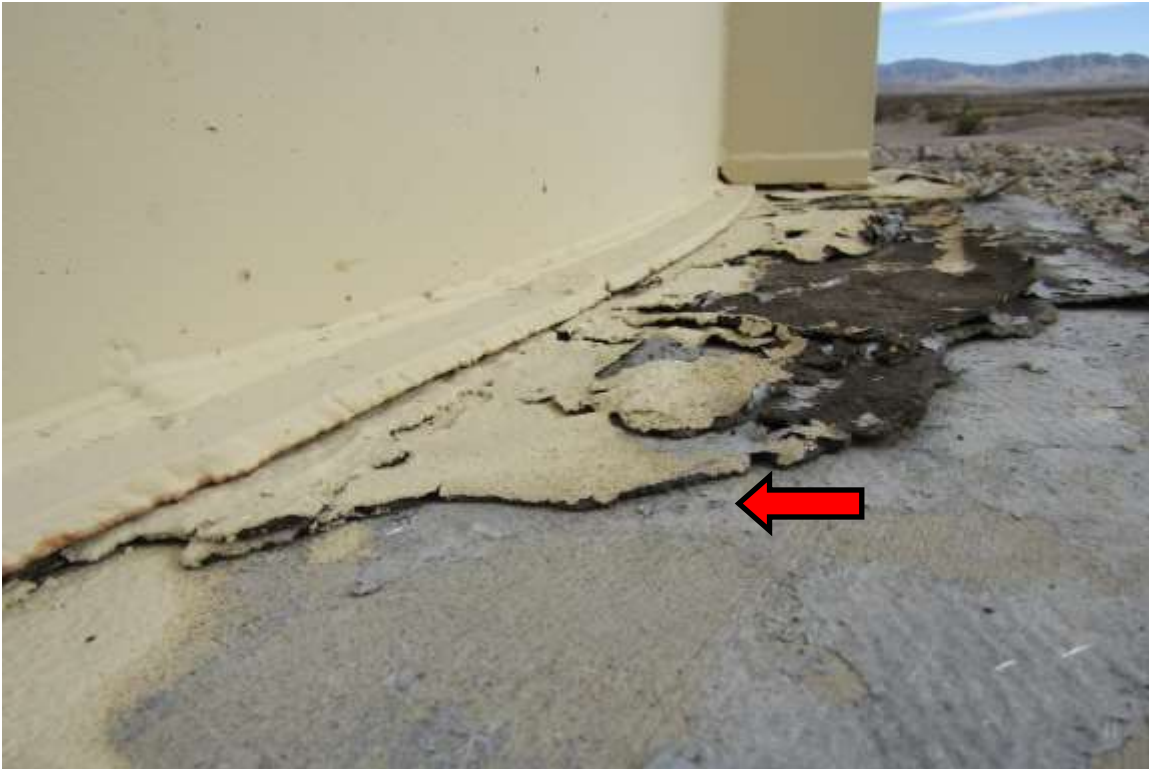
Photo shows the condition of the foundation. We recommend trimming the fiberboard back to where it comes in contact with the tank base. Once this is done allowing for a clean edge, apply caulk/grout around the base of the tank to foundation connection to prevent water from entering under the tank, then sealing the foundation with a sealant.

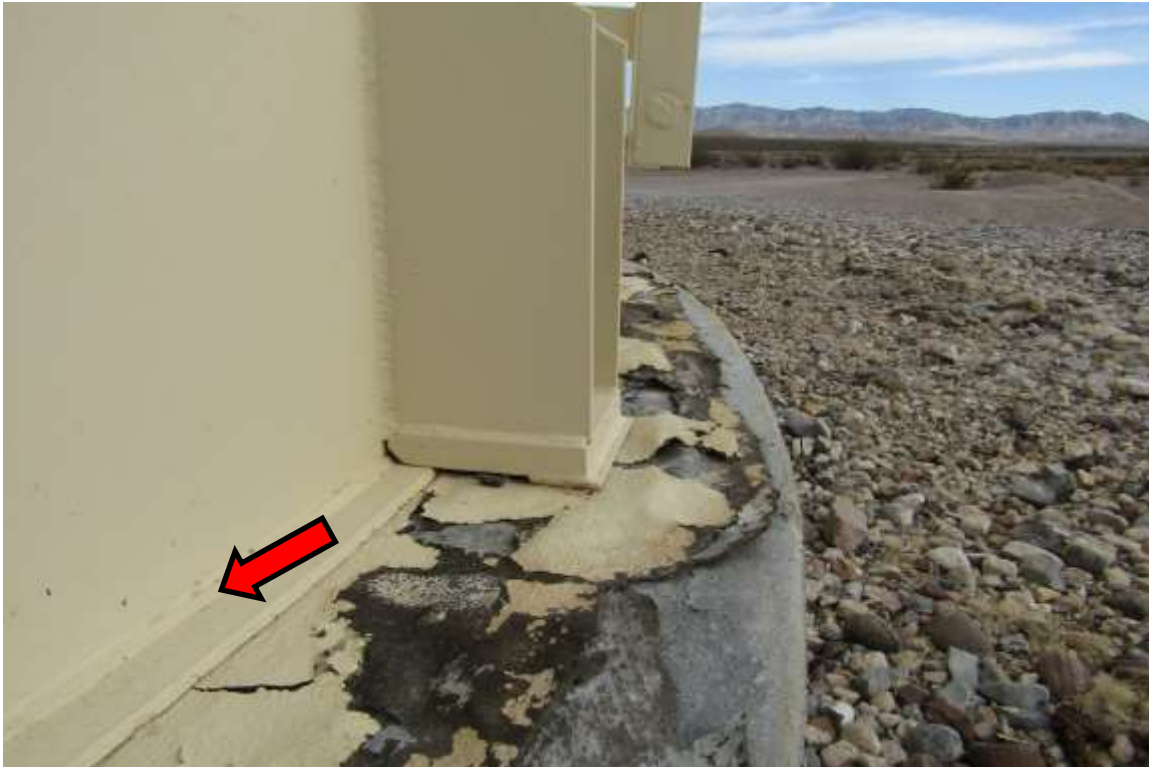
Photo shows the tank has no grounding system. We recommend electrically grounding the tank for lightning protection as required by **OSH Act of 1970 Section 5**.

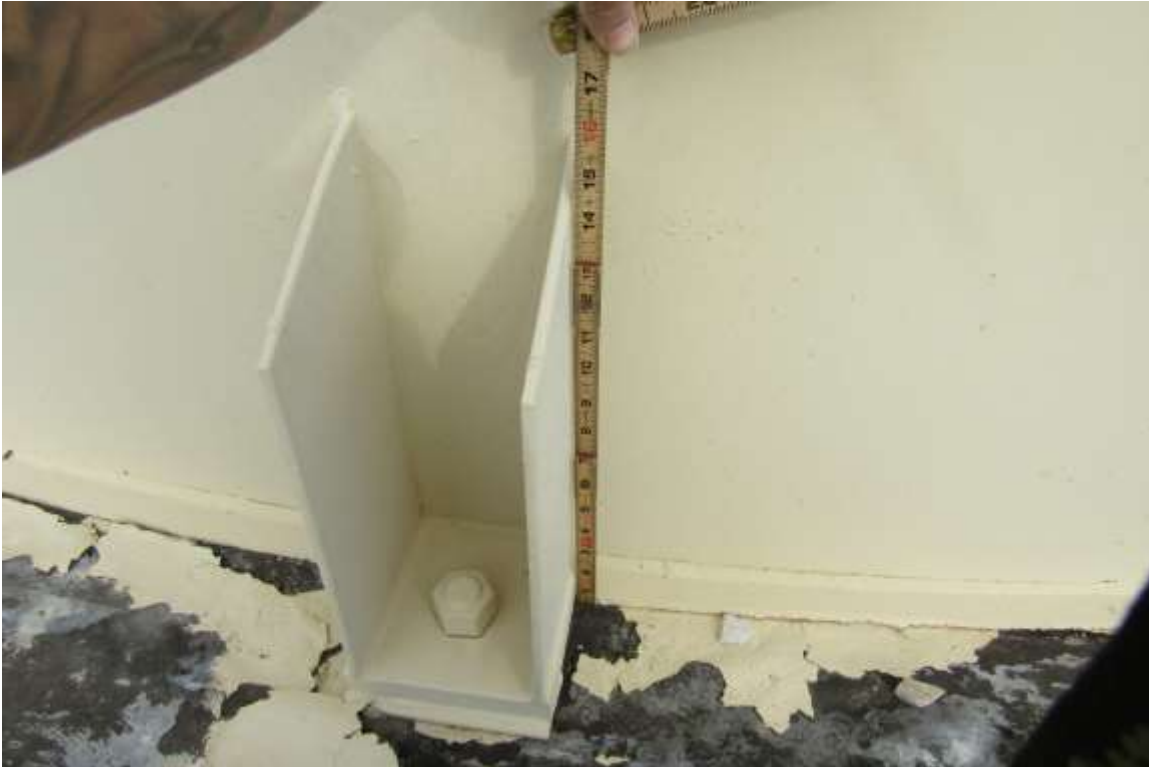
Photo shows the condition of one (1) of the twelve (12) anchor bolts. **AWWA D100-11; 3.8.1.1 Required anchorage** states, "For ground-supported flat-bottom reservoirs and standpipes, mechanical anchorage shall be provided when the wind or seismic loads exceed the limits for self-anchored tanks." We recommend cleaning the area around the anchor bolts, tightening the anchor nuts, then tack welding the circumference of the nut-to-base plate connections and bolt-to-nut connections to reinforce.

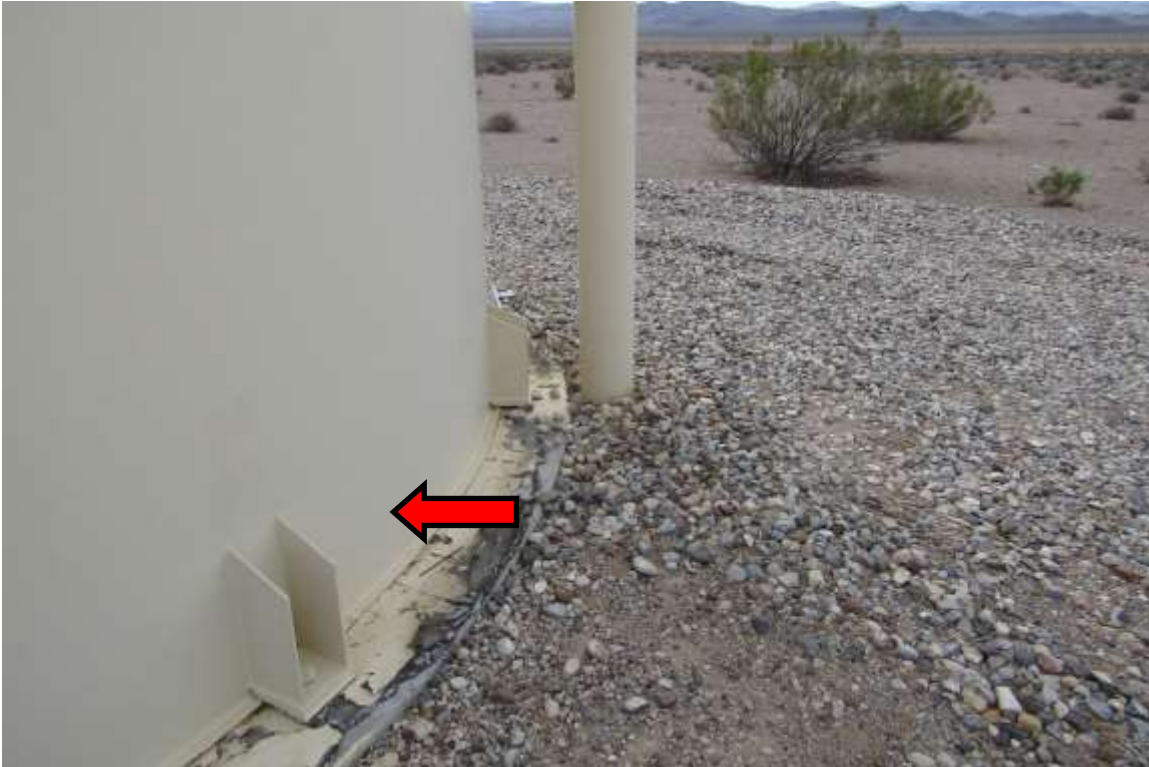
Photo shows the condition of the shell. Currently there is no drain valve. We recommend installing a frost proof drain valve near the shell-to-floor connection, complete with a locking device to prevent unauthorized draining of the tank and a splash pad to direct water away from the foundation.

**Splash pad to be installed by owner.*

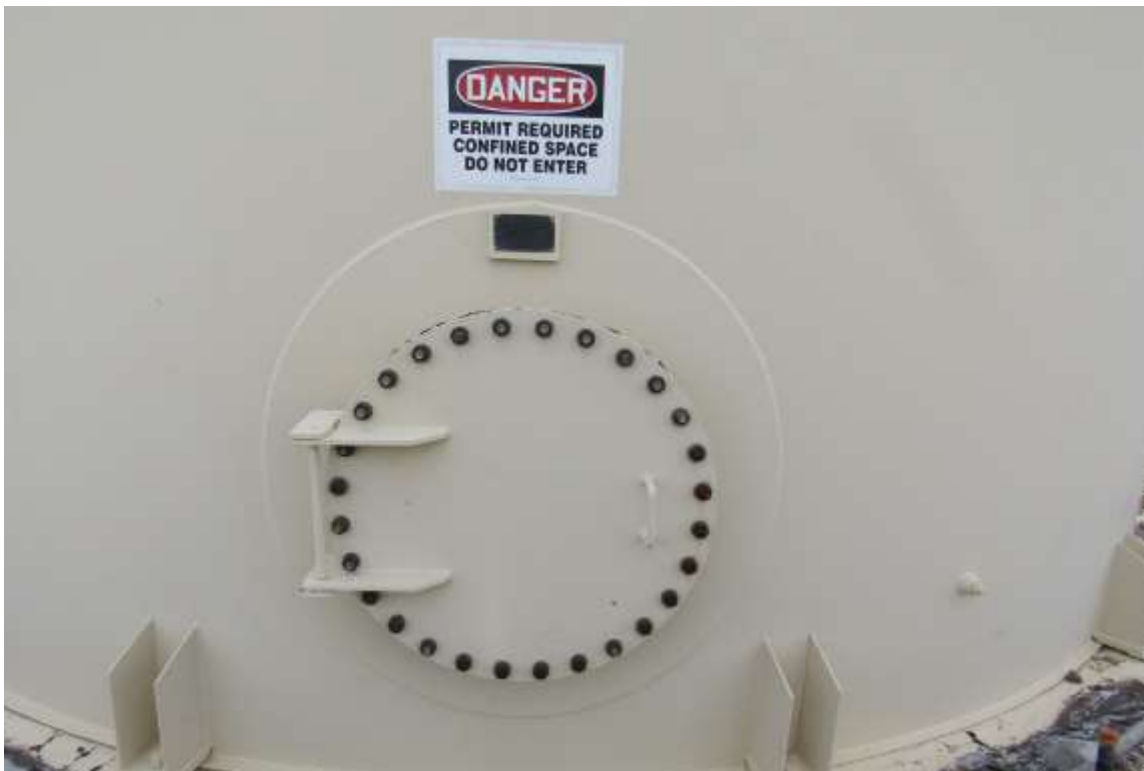
Photo shows the condition of the 24" primary shell manway. The following is required for the tank to be in compliance with **AWWA D100-11; 7.4.4 Shell man-holes** and **OSHA 1910.146(c)(2) Confined spaces**.

We recommend:

Install 30" secondary shell manway 180° from primary manway
Post **Confined Space Entry** sign

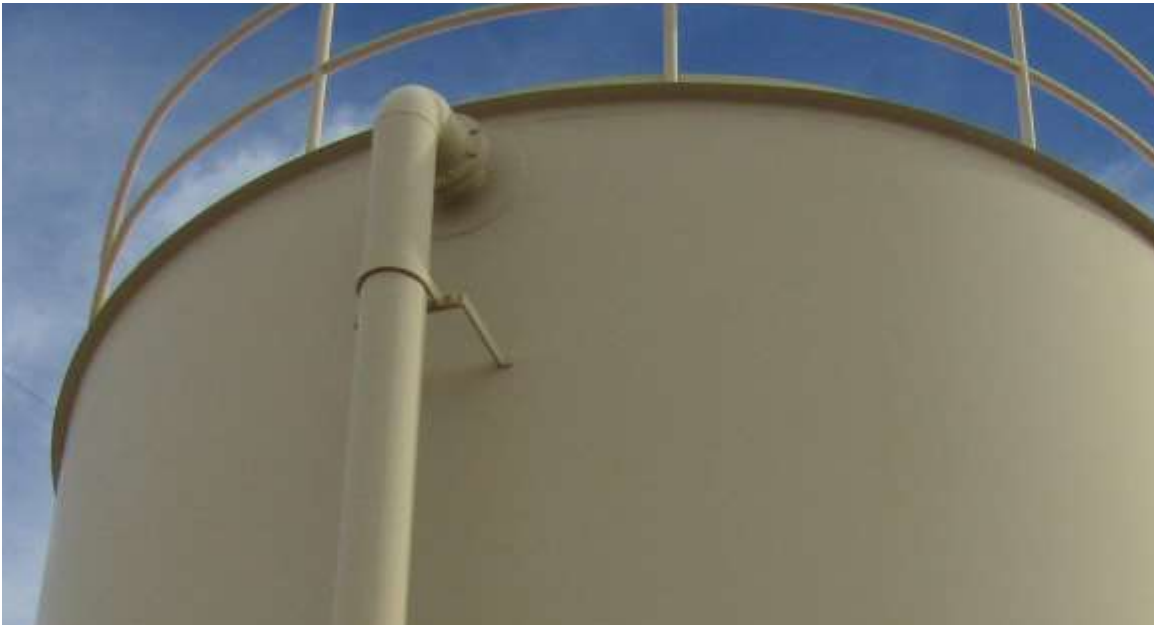
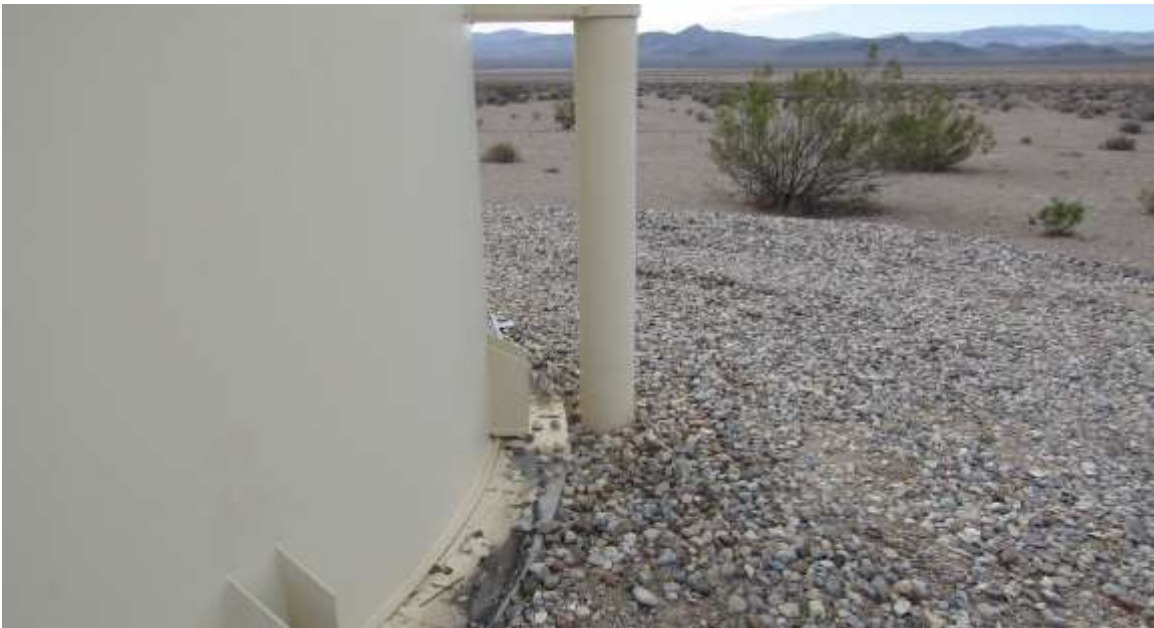
Photos show the condition of the 6" overflow pipe system. We recommend disconnecting the pipe from the underground drain then installing an air break complete with a flapper valve and screen to prevent the ingress of contaminants into the water supply, and a splash pad to direct the water away from the tank foundation.

**Splash pad to be installed by owner.*

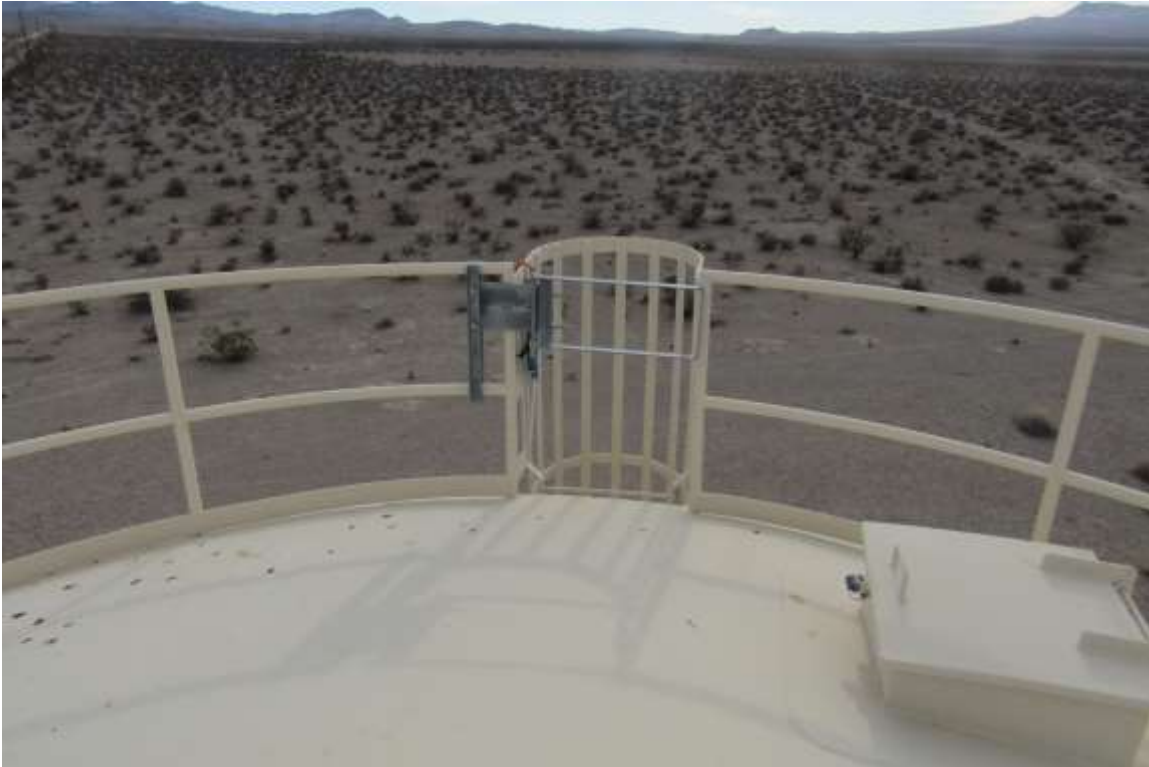
Photo shows the tank roof edge is equipped with a 43" high compliant handrail system for fall protection as required by **OSHA 1910.28(b)(1)**. The handrail system is equipped with an intermediate rail and toeboard.

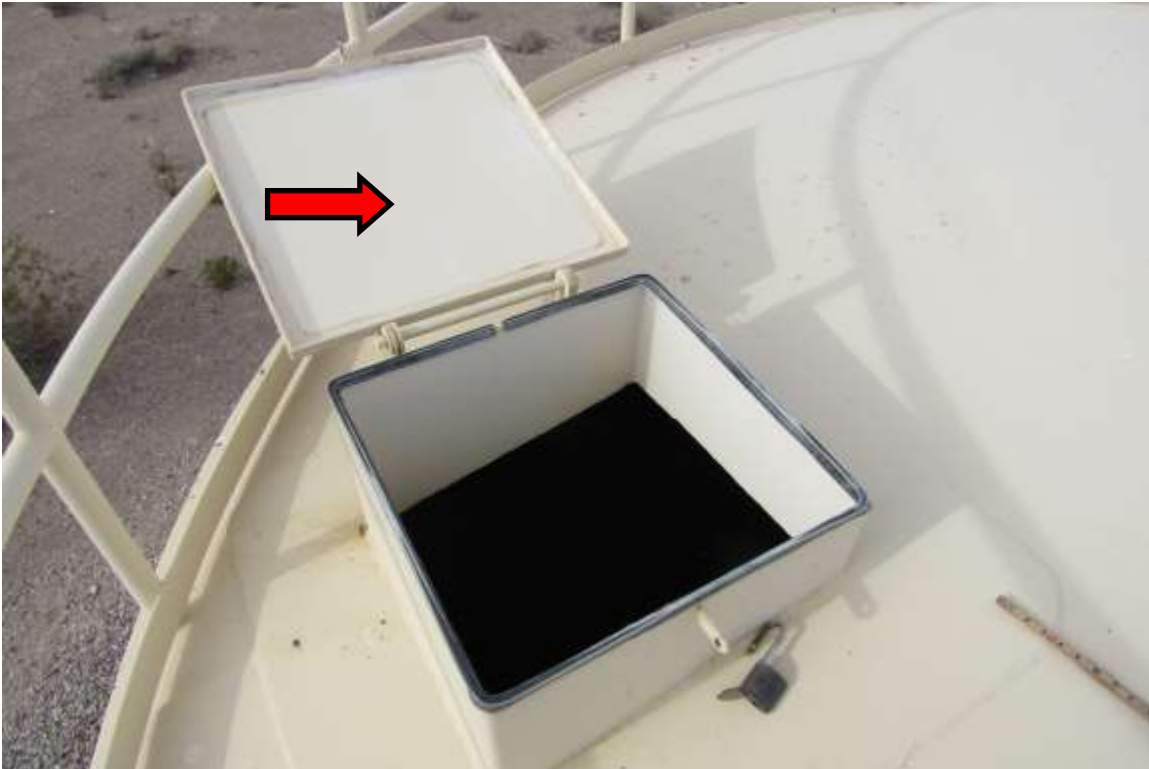
Photo shows the condition of the 24" primary roof hatch. Roof openings on this tank require the following to be in compliance with **AWWA D100-11; 7.4.3 Roof openings** and **OSHA 1910.146(c)(2) Confined spaces**.

We recommend:

We further recommend installing **OSHA** compliant interior access ladders complete with standoffs every 10' on center, and cable type ladder safety devices at the primary and suggested secondary roof hatches.

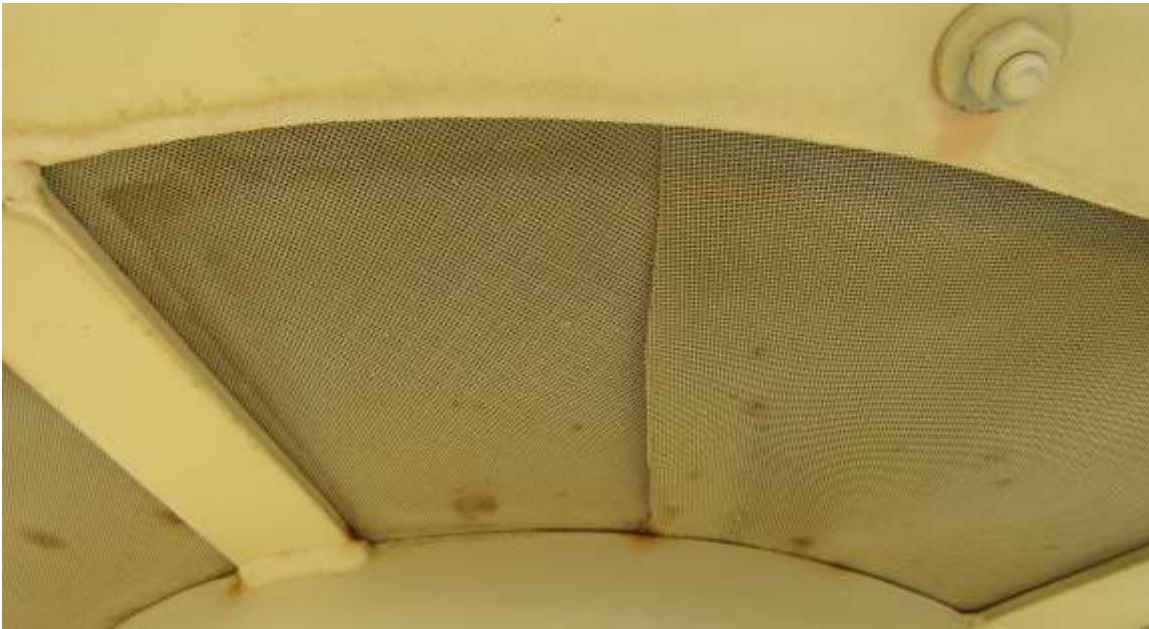
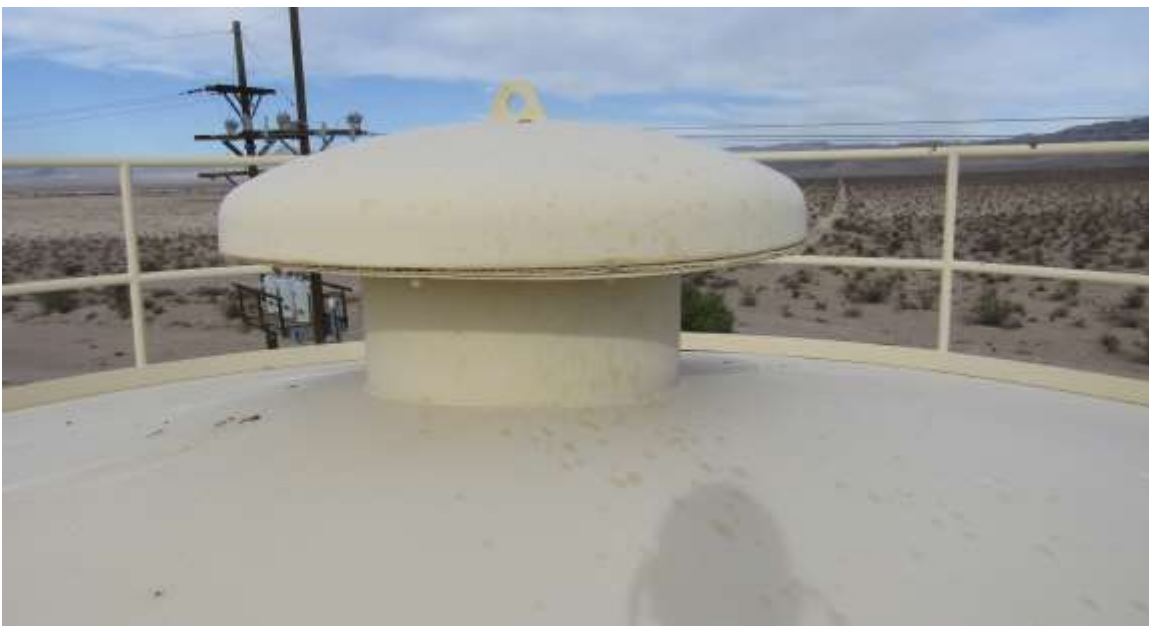
Photos show the condition of the existing 24" roof vent. **This vent is allowing the ingress of rain and wind-borne contaminants into the water system. An improperly vented tank may cause external pressure to act on the tank which can cause buckling even at low pressure differential.** We recommend replacing the existing roof vent with a vacuum-pressure, frost proof vent and screen.

This work should be performed on an emergency basis.

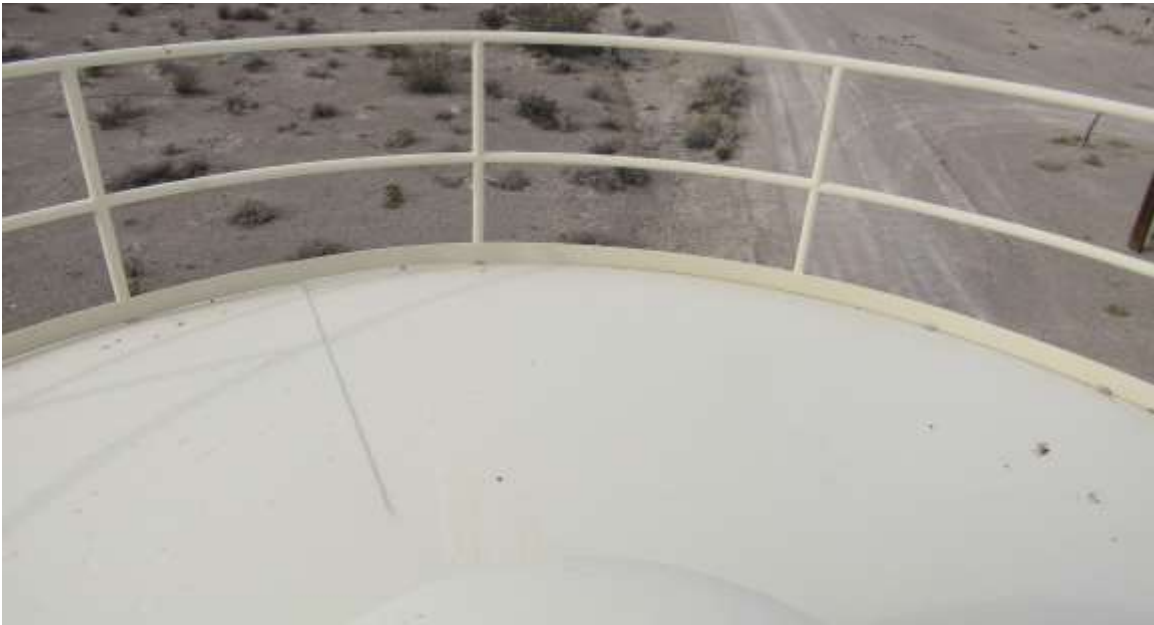
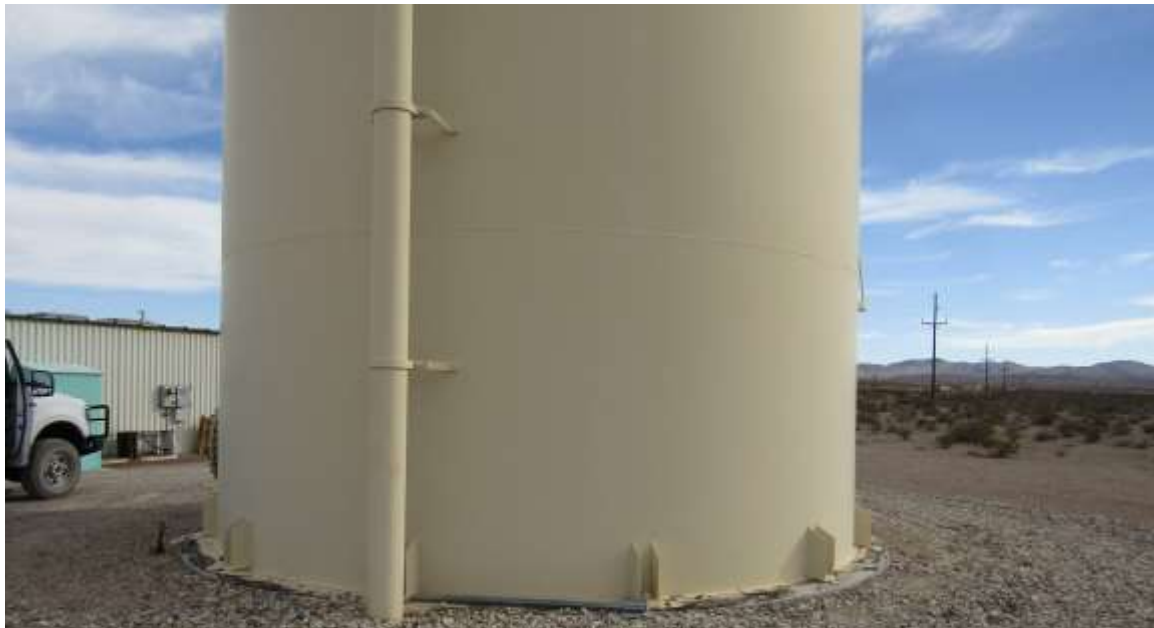
Photos show the tank exterior coating system. The overall exterior coating system appears to be in good condition. We recommend re-evaluating the tank exterior at next inspection cycle.

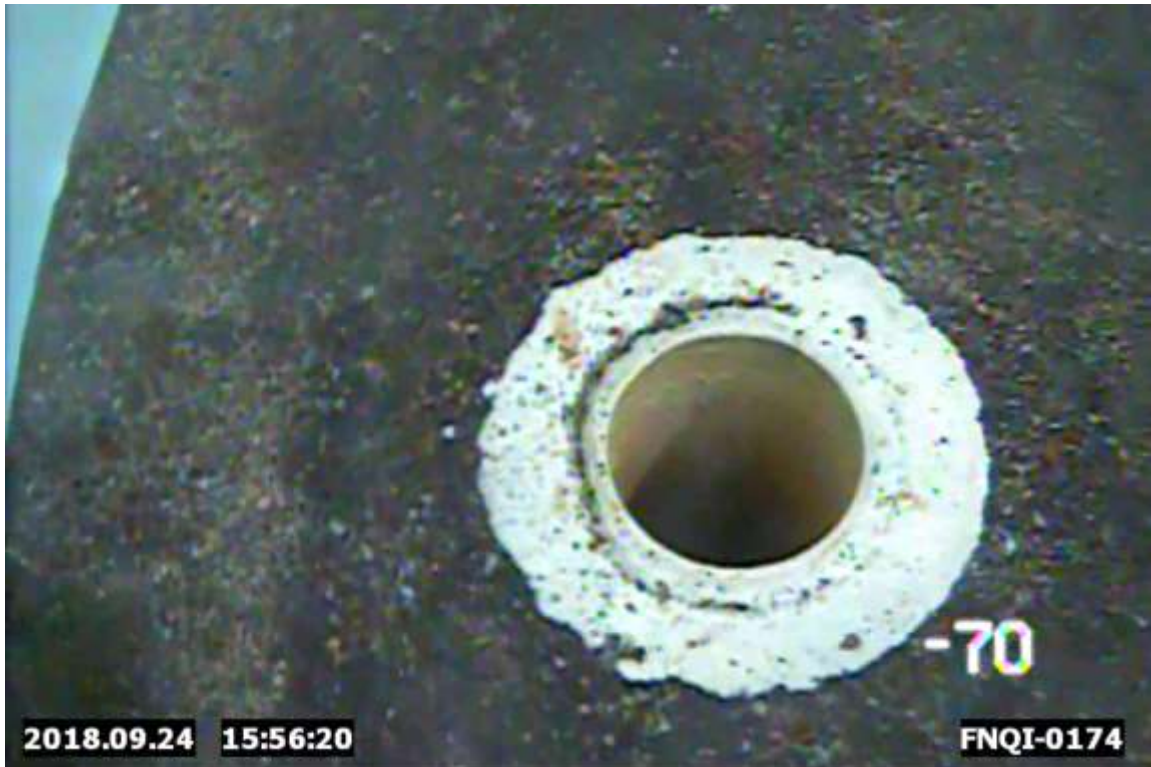
Photo shows an inlet/outlet pipe on the tank interior. A temperature difference between the water in the top and bottom of a tank, even as little as 1-2 degrees Fahrenheit, is an indication of thermal stratification and the tank water not being completely mixed. Incomplete mixing would result in short-circuiting, and localized increase in water age would develop inside the tank. This typically leads to water quality problems, such as loss of residual, DBP spikes, HPC spikes, bacteria regrowth, formation of bio-film, changes in pH and dissolved oxygen. We recommend installing a mixing system. Electrical work to be done by others if required.

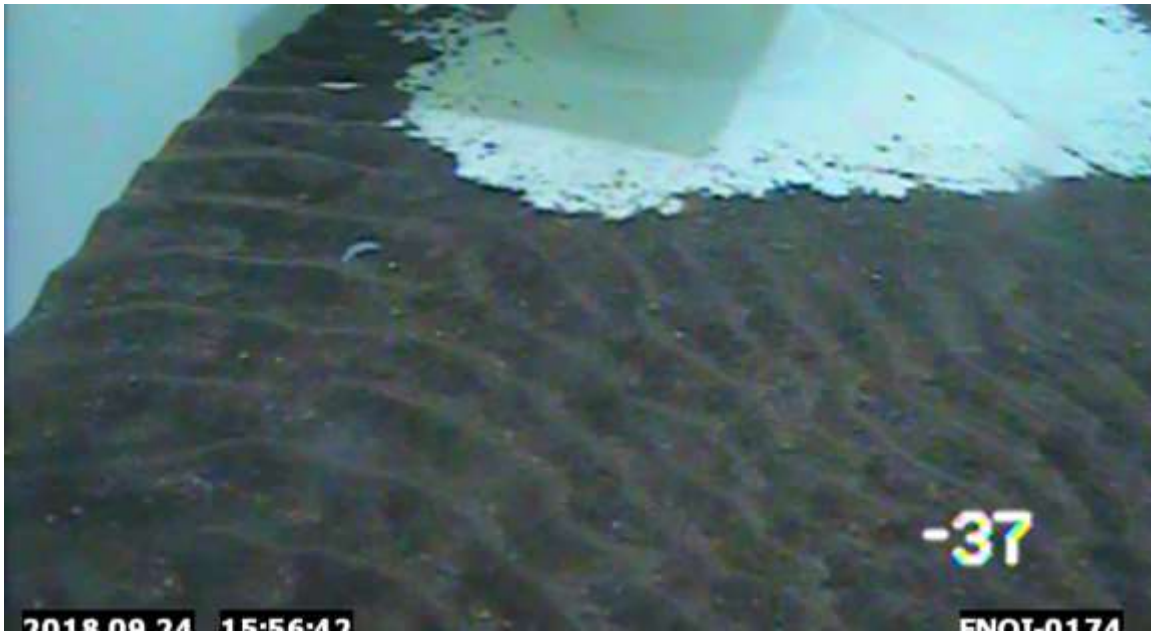
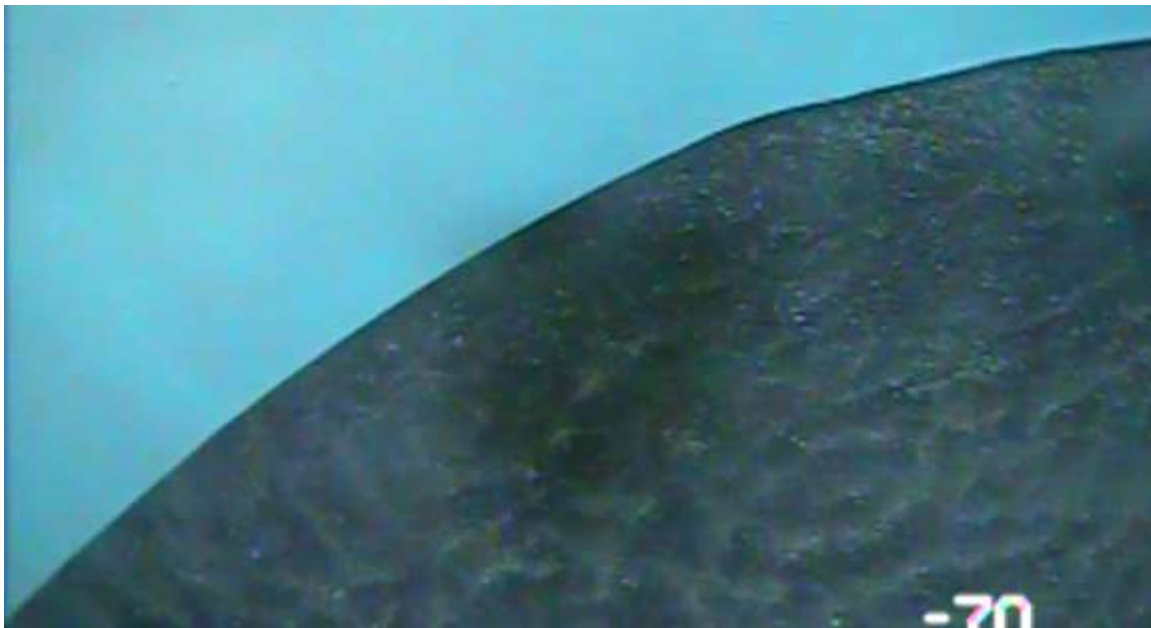
Photos show sediment and debris on the tank interior before a cleanout was performed.

We recommend installing a passive cathodic protection system.

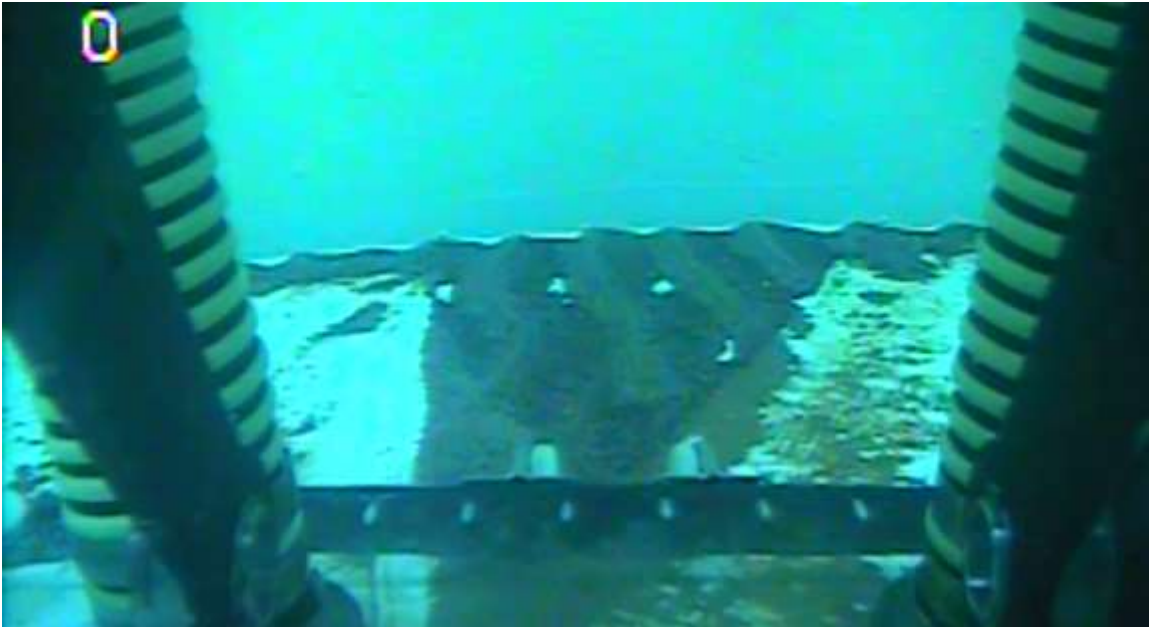
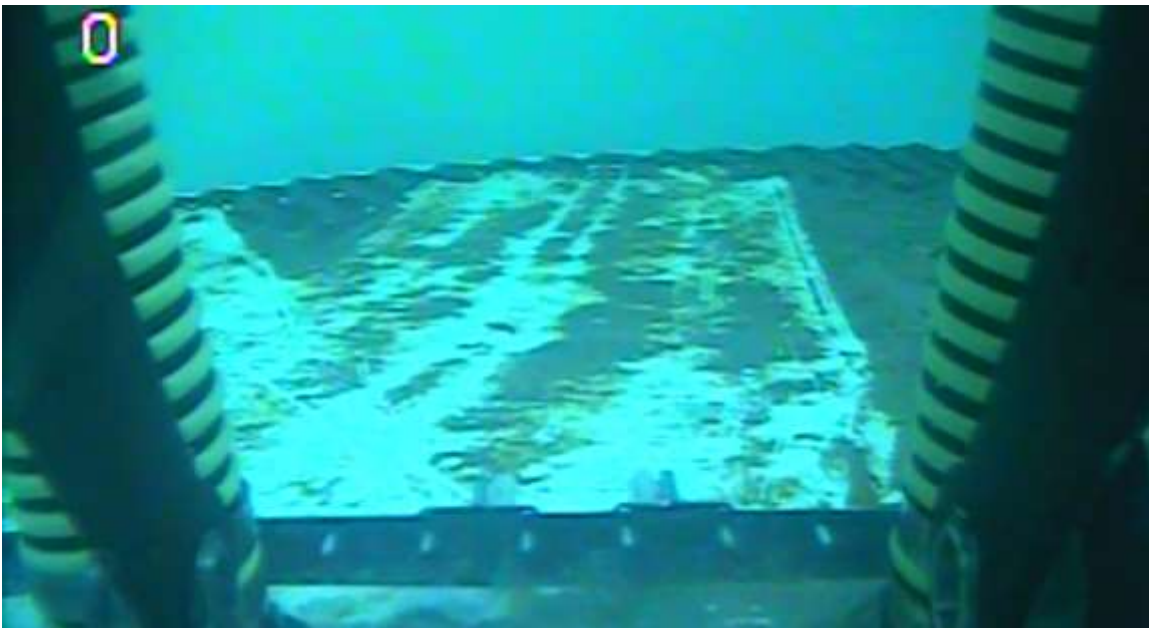
Photos show the tank interior during a cleanout.

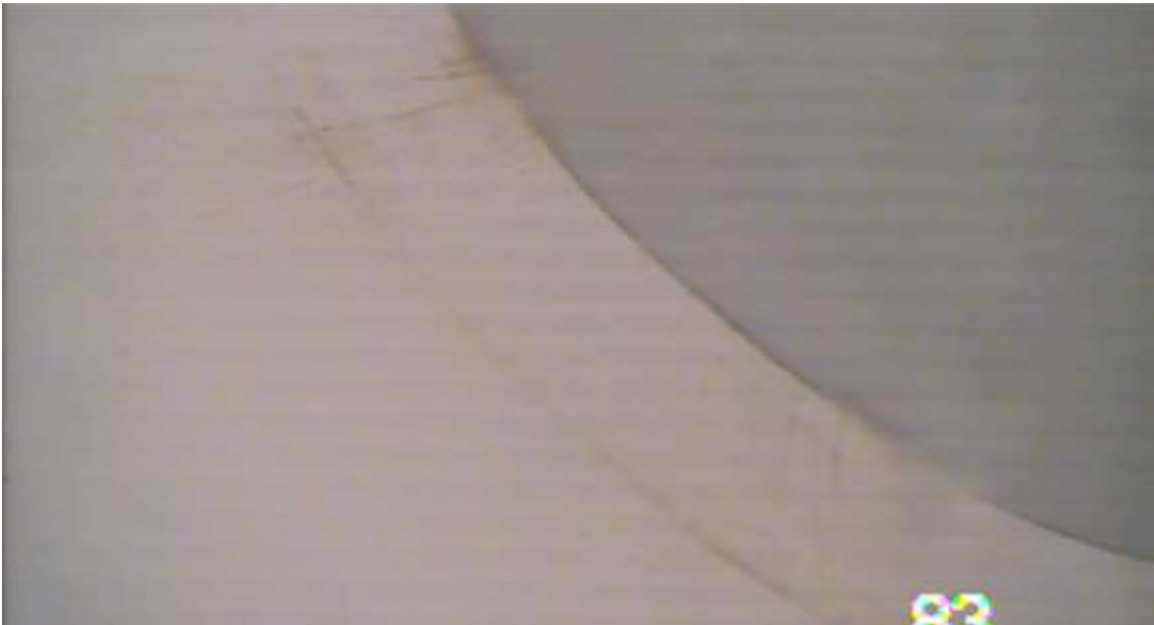
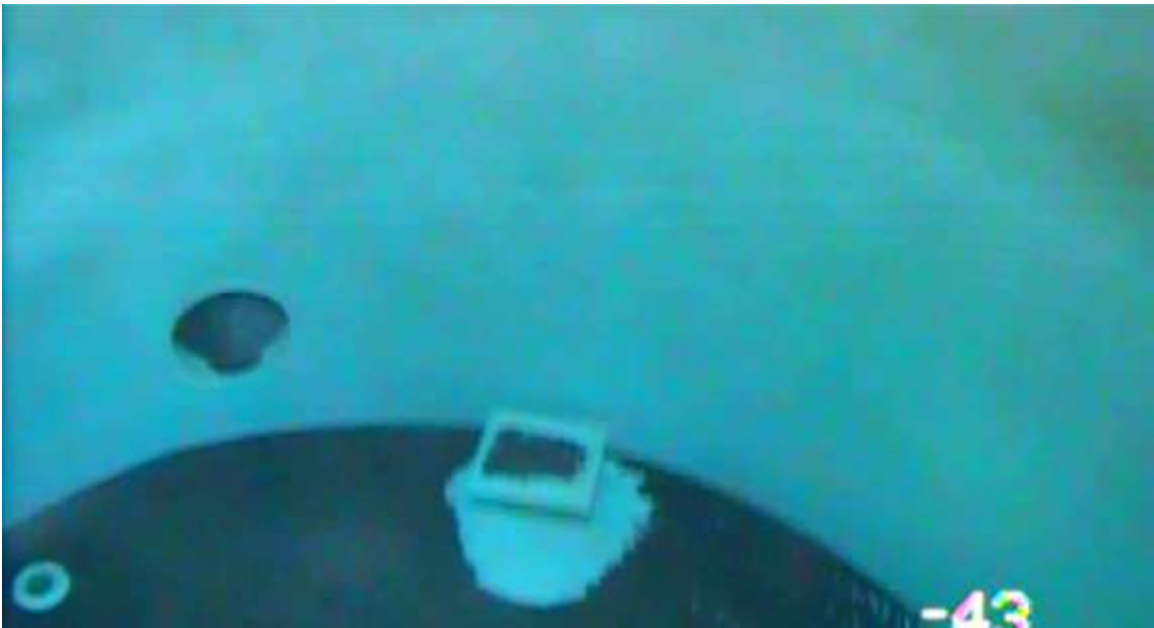
Photos show the tank interior coating system. The overall interior coating system appears to be in good condition. We recommend re-evaluating the tank interior at next inspection cycle.

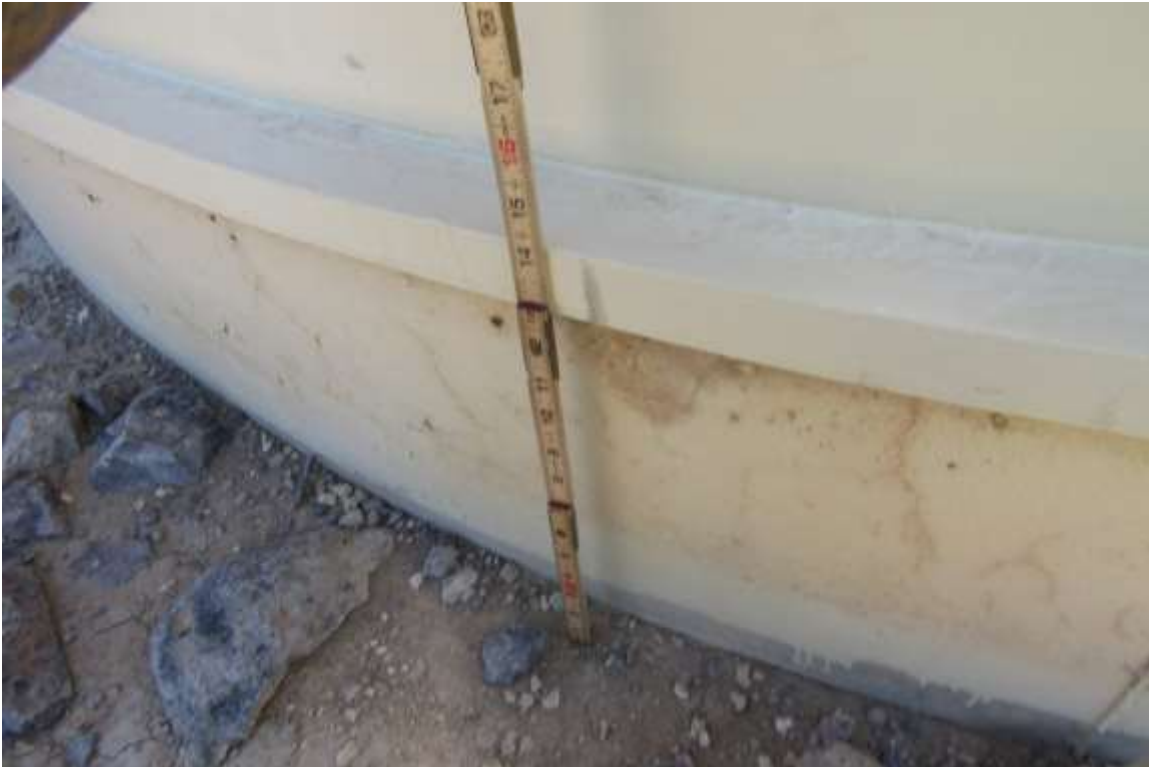
Photo shows the area around the tank foundation is properly graded and in compliance with **AWWA D100-11; 12.7.1 Height aboveground.**

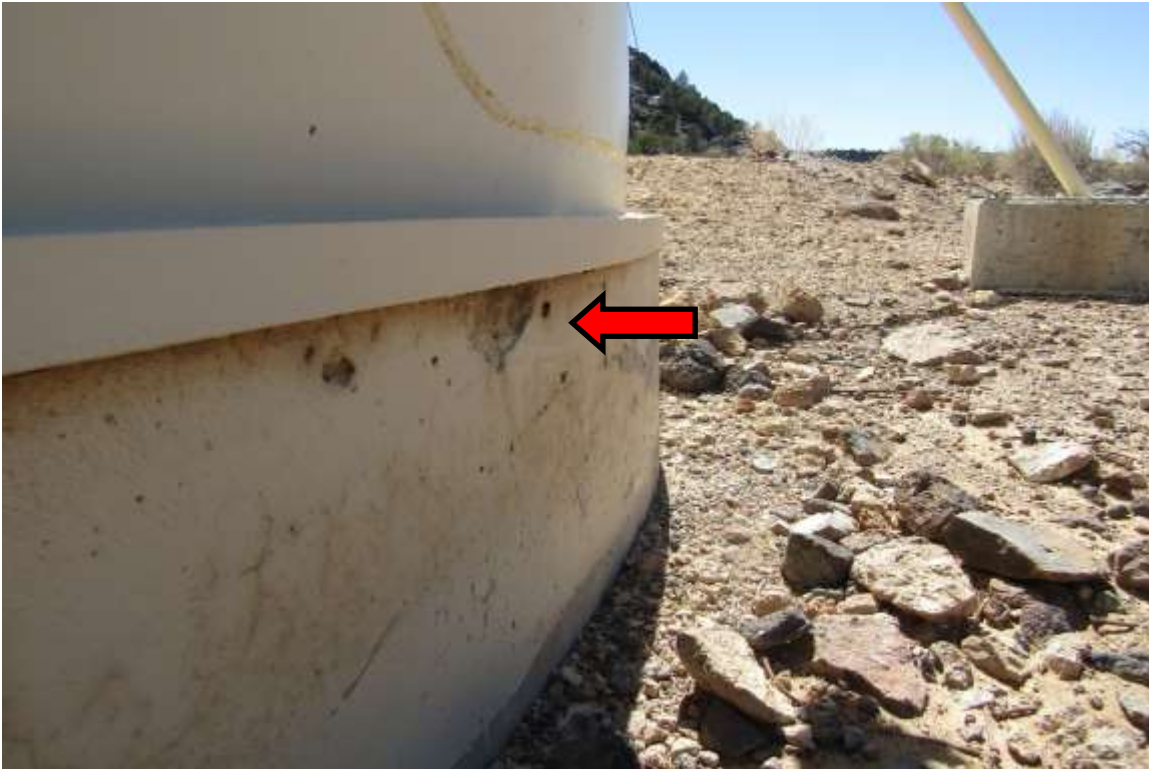
Photo shows the condition of the foundation. **NFPA 22-2018; 12.2.1.2** states, "... the junction of the tank bottom and the top of the concrete foundation shall be tightly sealed to prevent water from entering the base." We recommend repairing any cracks and spalling in the concrete with a commercial non-shrinking grout, then sealing the foundation with a sealant.
