**Mission Support and Test Services, LLC
Nevada National Security Site
Mercury, NV 89023
RE: Mercury North (Area 23); Mercury, NV
1,500,000 Gallon GST
September 16, 2018
Mr. Kevin Olsen
Scientist 1
(702) 295-0485
Job No. 318448-A**

**Mission Support and Test Services, LLC
Nevada National Security Site
Mercury, NV 89023
RE: Camp South (Area 12); Mercury, NV
500,000 Gallon GST
September 13, 2018
Mr. Kevin Olsen
Scientist 1
(702) 295-0485
Job No. 318448-D**

**Mission Support and Test Services, LLC
Nevada National Security Site
Mercury, NV 89023
RE: Well 4/4a South (Area 6); Mercury, NV
150,000 Gallon GST
September 24, 2018
Mr. Kevin Olsen
Scientist 1
(702) 295-0485
Job No. 318448-H**

**Mission Support and Test Services, LLC
Nevada National Security Site
Mercury, NV 89023
RE: C-1 North (Area 6); Mercury, NV
50,000 Gallon GST
September 21, 2018
Mr. Kevin Olsen
Scientist 1
(702) 295-0485
Job No. 318448-O**

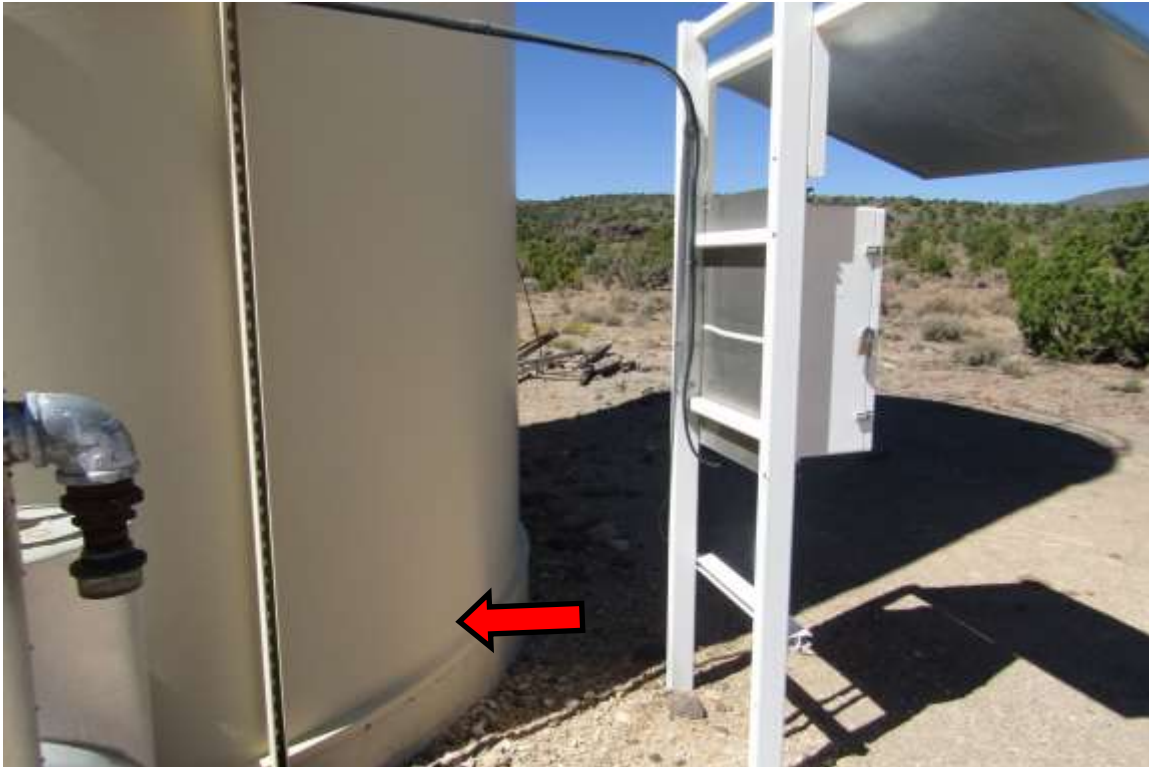
Photo shows the tank has no grounding system. We recommend electrically grounding the tank for lightning protection as required by **OSH Act of 1970 Section 5** and **NFPA 780-2017; 5.4 Metal Towers and Tanks**.

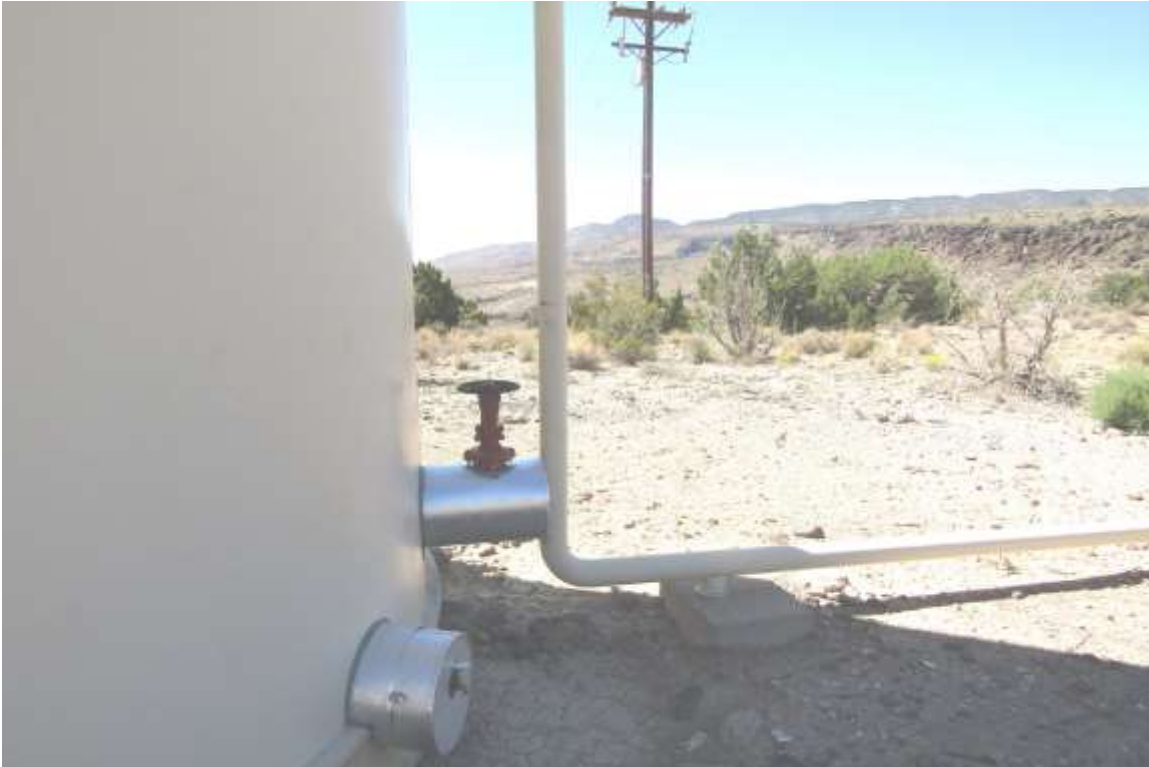
Photo shows the existing drain, which appears to be in good condition.

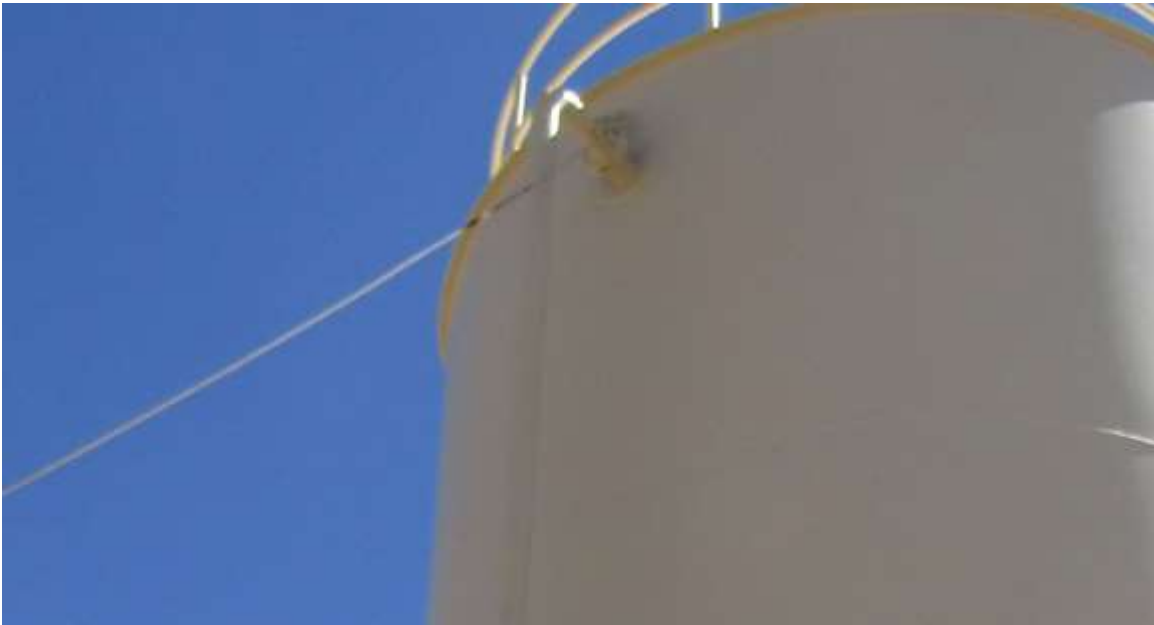
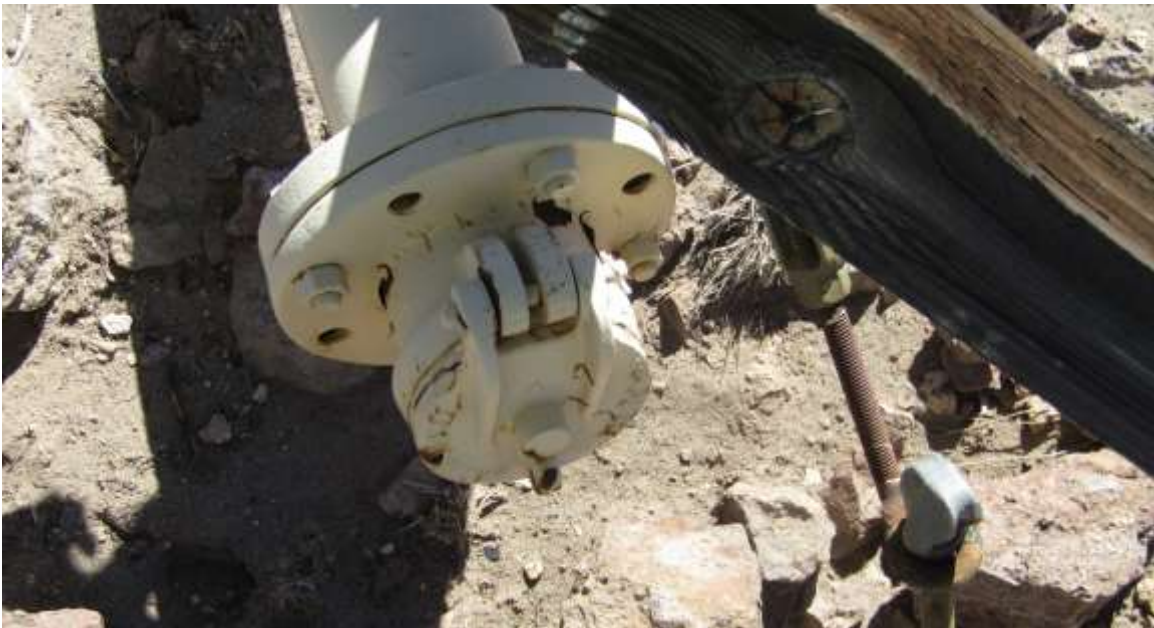
Photos show the 4" overflow pipe system, which is equipped with a flapper valve as required by **AWWA D100-11; 7.3 Overflow**. We recommend installing a splash pad to direct the water away from the tank foundation.

**Splash pad to be installed by owner.*

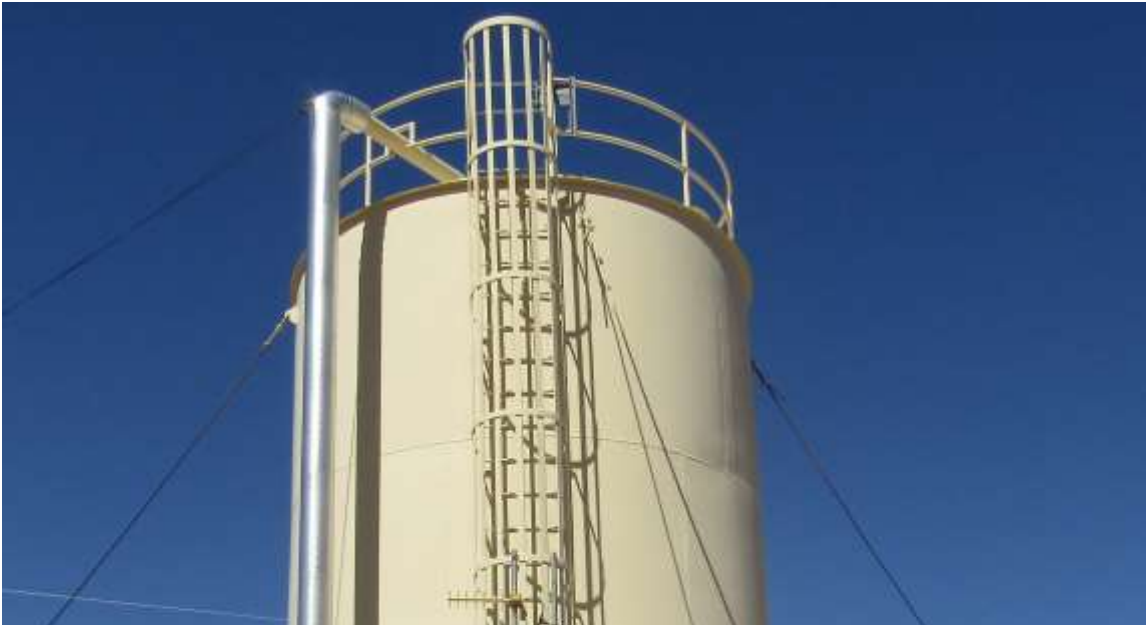
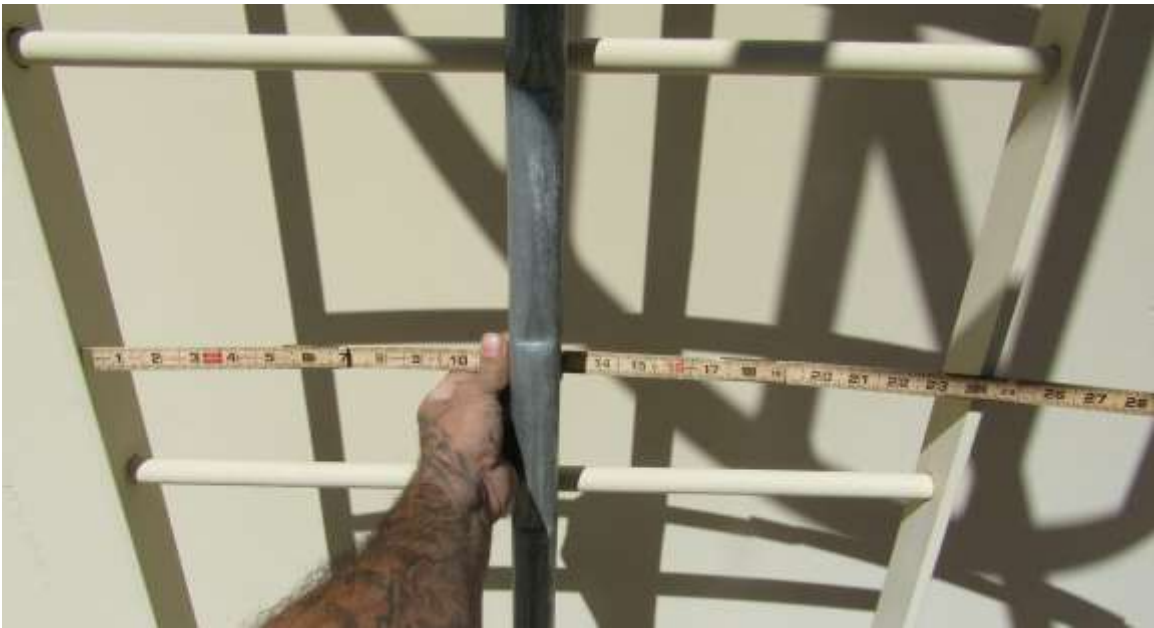
Shell access ladder in above photos is 24" wide, but is not equipped with anti-skid rungs. We recommend installing anti-skid rung covers, replacing the notched rail safety climb with a cable type ladder safety device, a lockable ladder guard to prevent unauthorized access, and posting a **Fall Protection Required** sign at the base of the ladder.

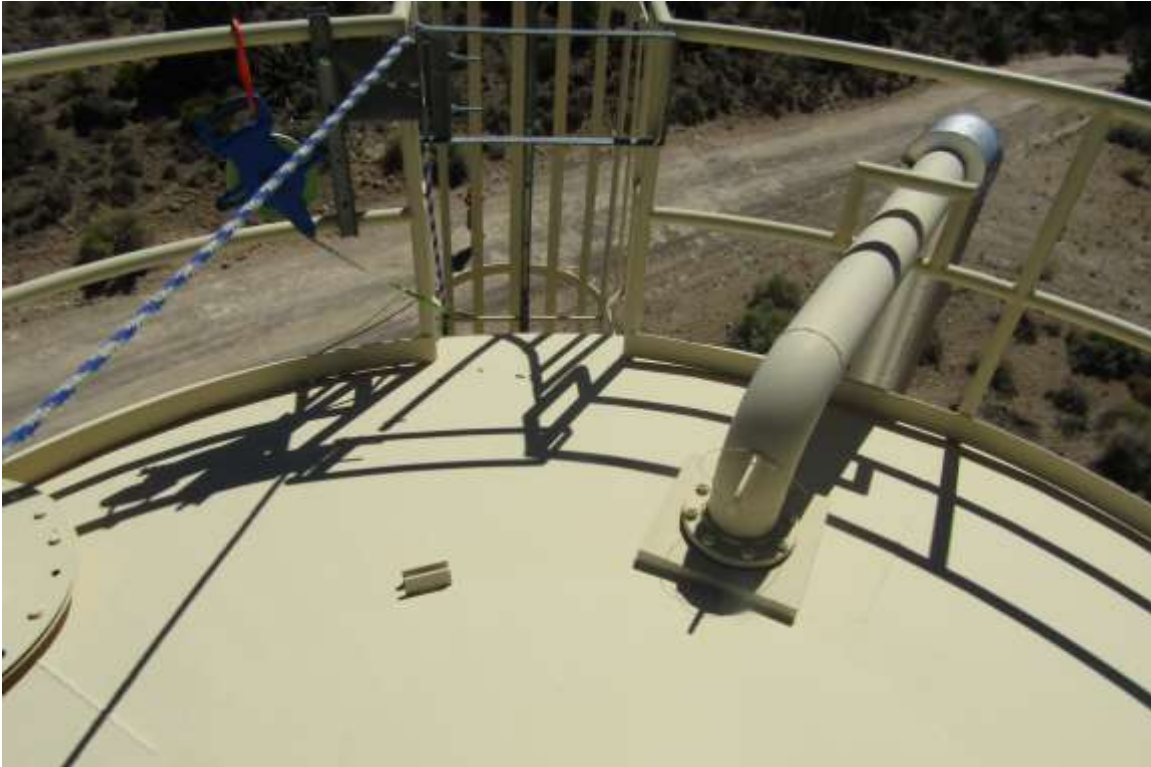
Photo shows the tank roof edge is equipped with a 43" high compliant handrail system for fall protection as required by **OSHA 1910.28(b)(1)**. The handrail system is equipped with an intermediate rail and toeboard.

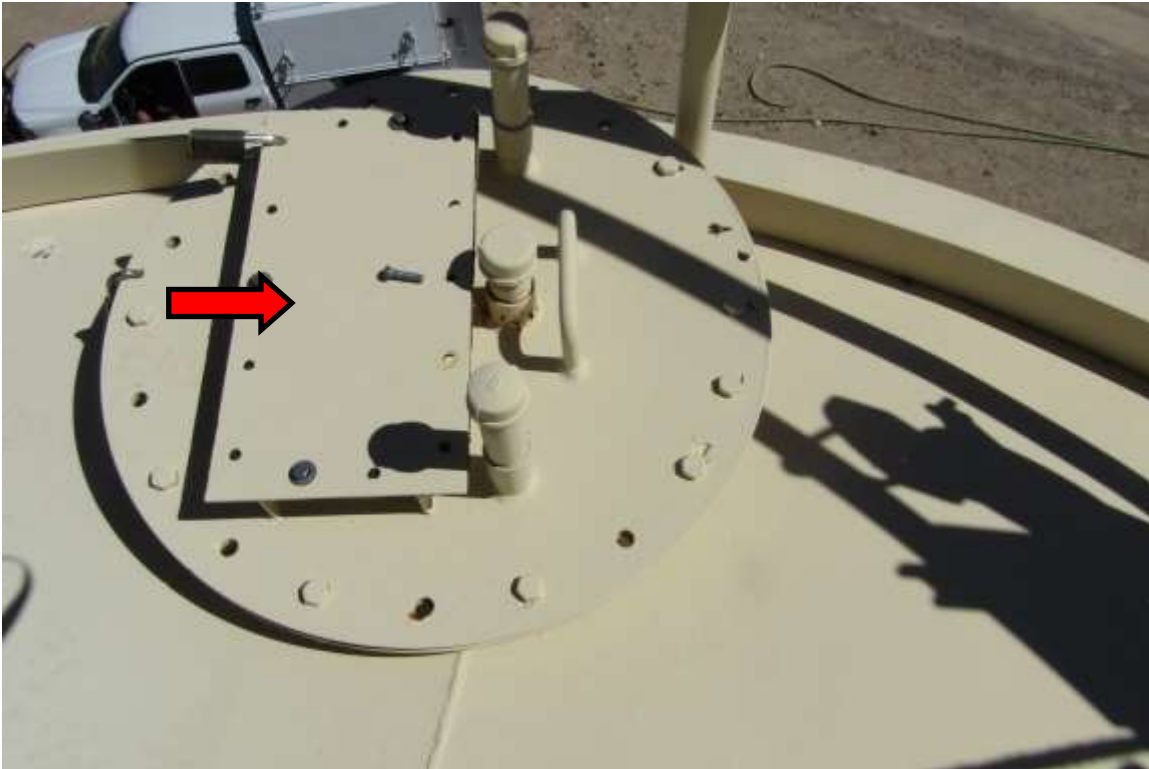
Photo shows the condition of the 24" primary roof hatch. Roof openings on this tank require the following to be in compliance with **AWWA D100-11; 7.4.3 Roof openings** and **OSHA 1910.146(c)(2) Confined spaces**.

We further recommend installing **OSHA** compliant interior access ladders complete with standoffs every 10' on center, and cable type ladder safety devices at the primary and suggested secondary roof hatches.

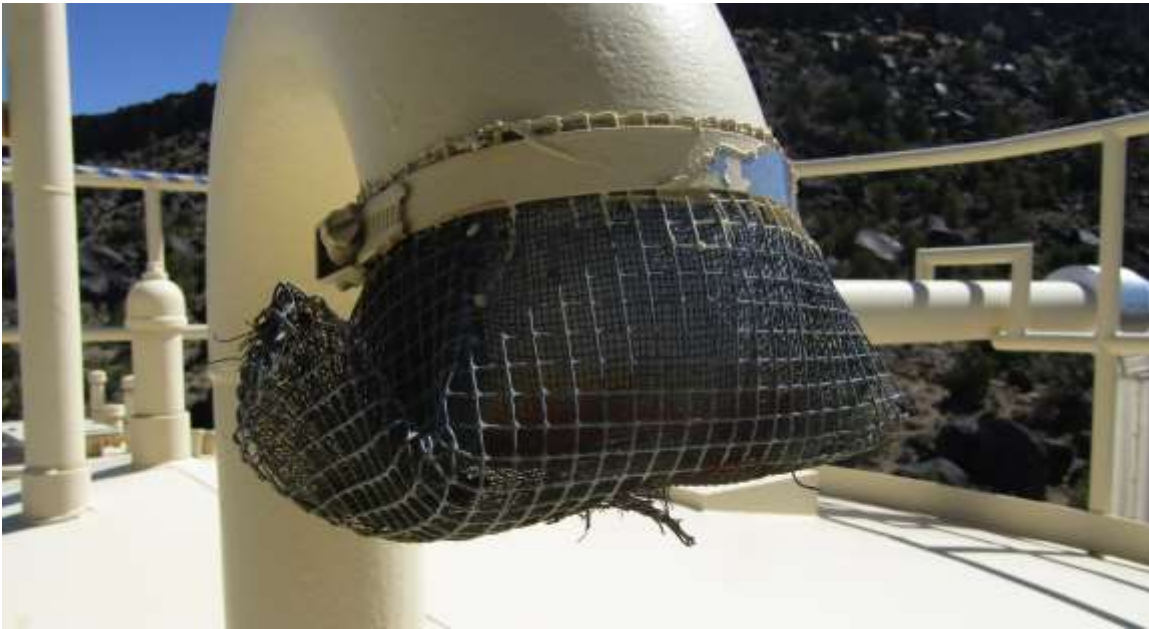
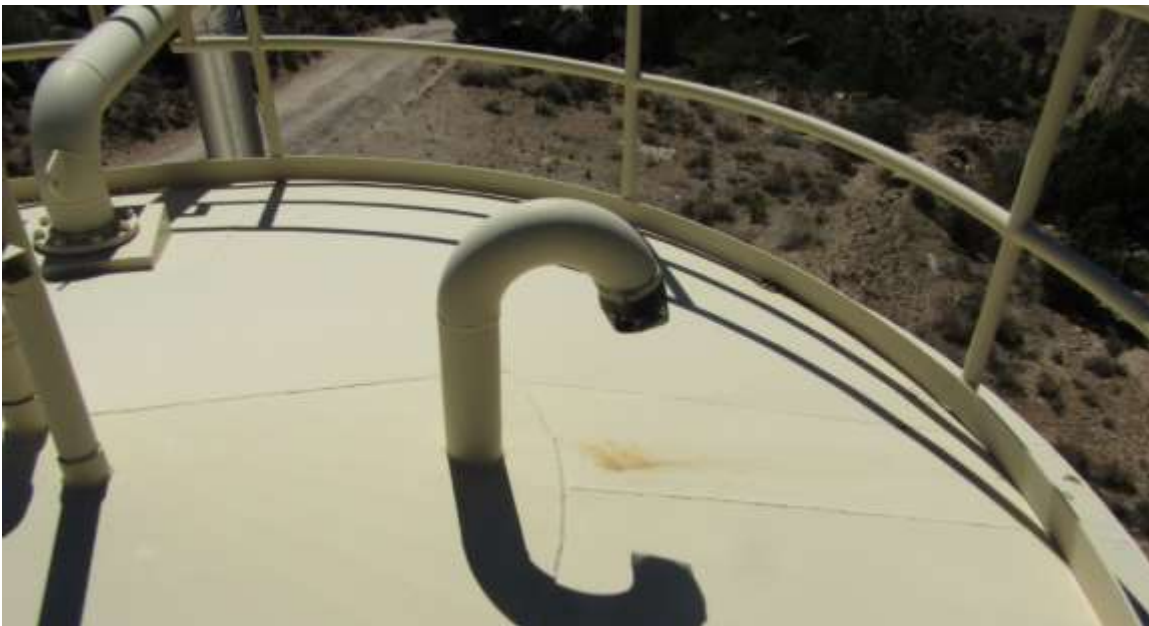
Photos show the condition of the existing 4" roof vent. **This vent is allowing the ingress of rain and wind-borne contaminants into the water system. An improperly vented tank may cause external pressure to act on the tank which can cause buckling even at low pressure differential.** We recommend replacing the existing roof vent with a vacuum-pressure, frost proof vent and screen.

This work should be performed on an emergency basis.

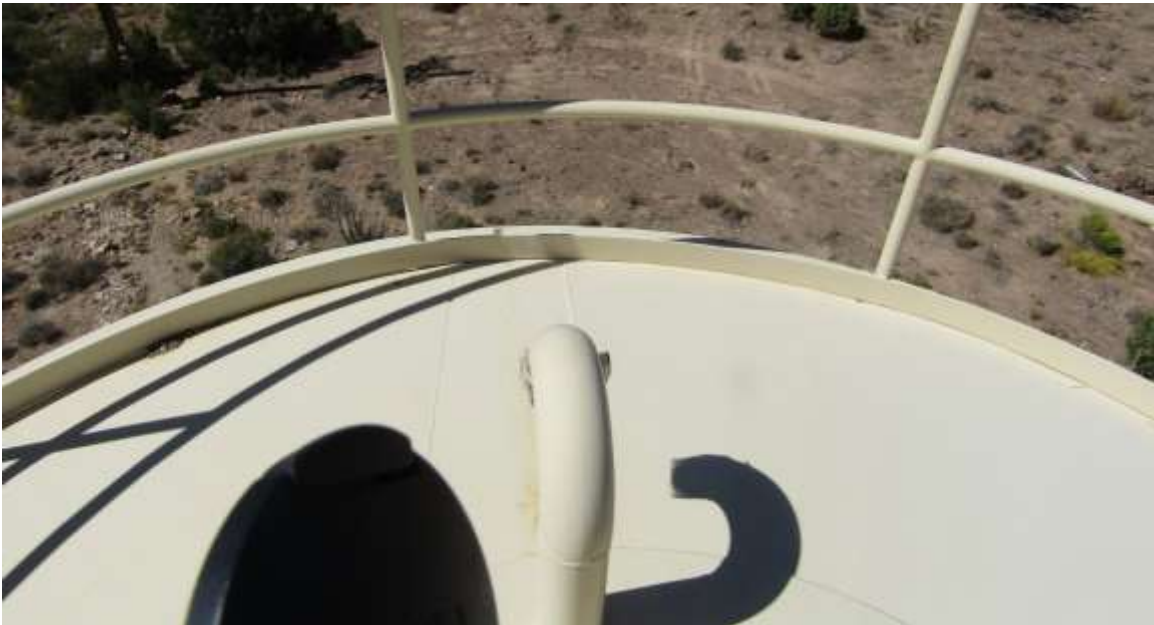
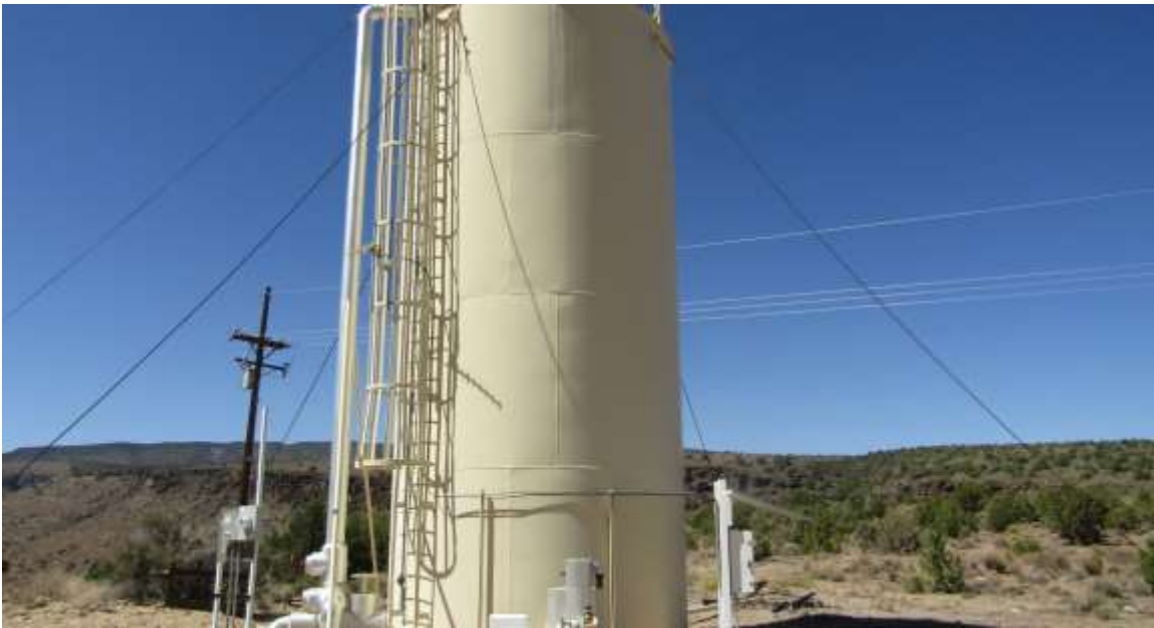
Photos show the tank exterior coating system. The overall exterior coating system appears to be in good condition. We recommend re-evaluating the tank exterior at next inspection cycle.

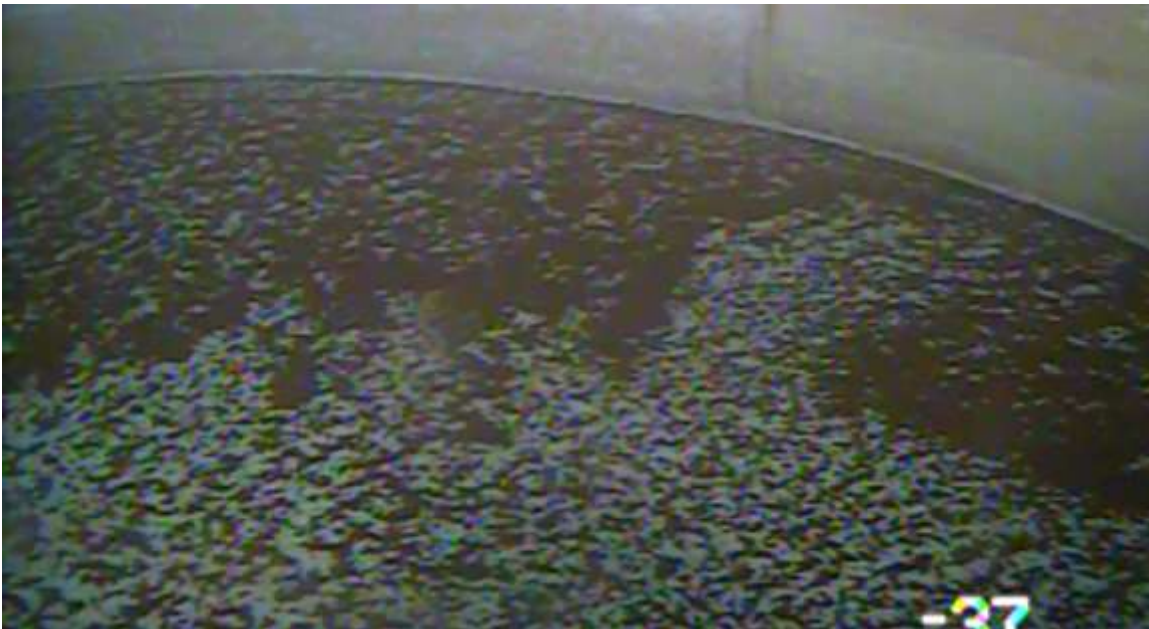
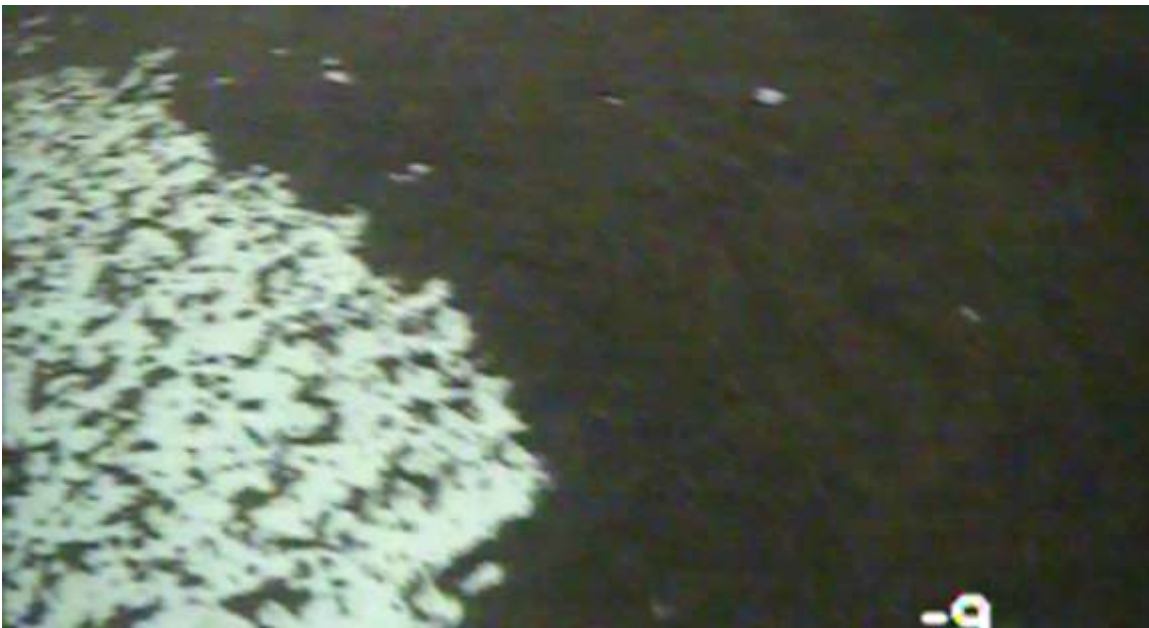
Photos show sediment and debris on the tank interior before a cleanout was performed.

We recommend installing a passive cathodic protection system.

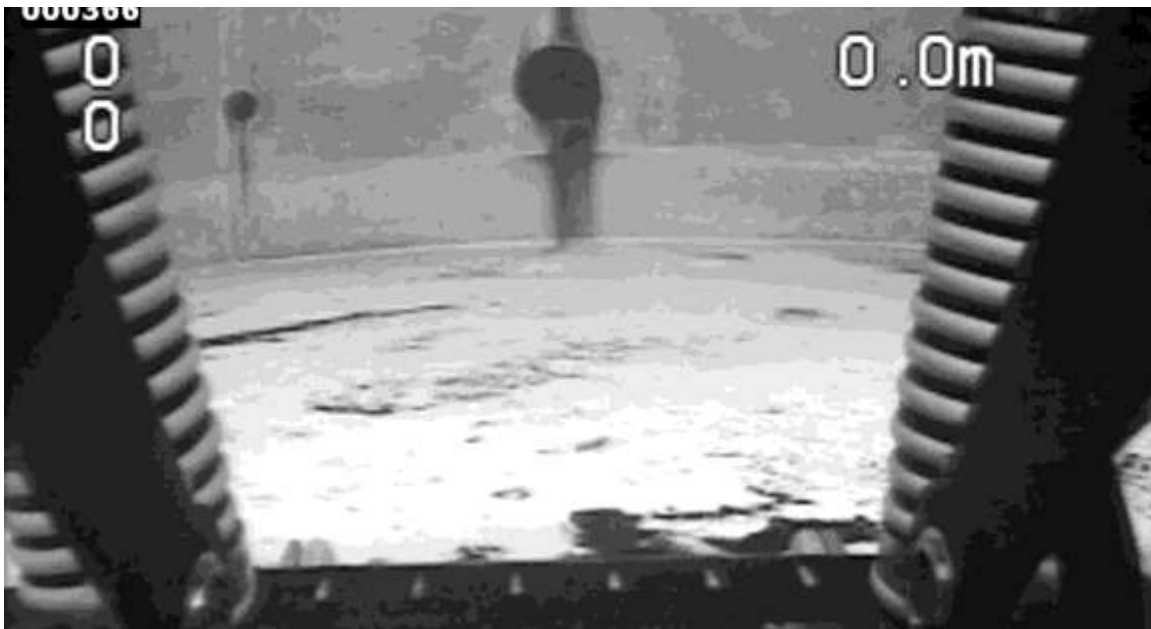
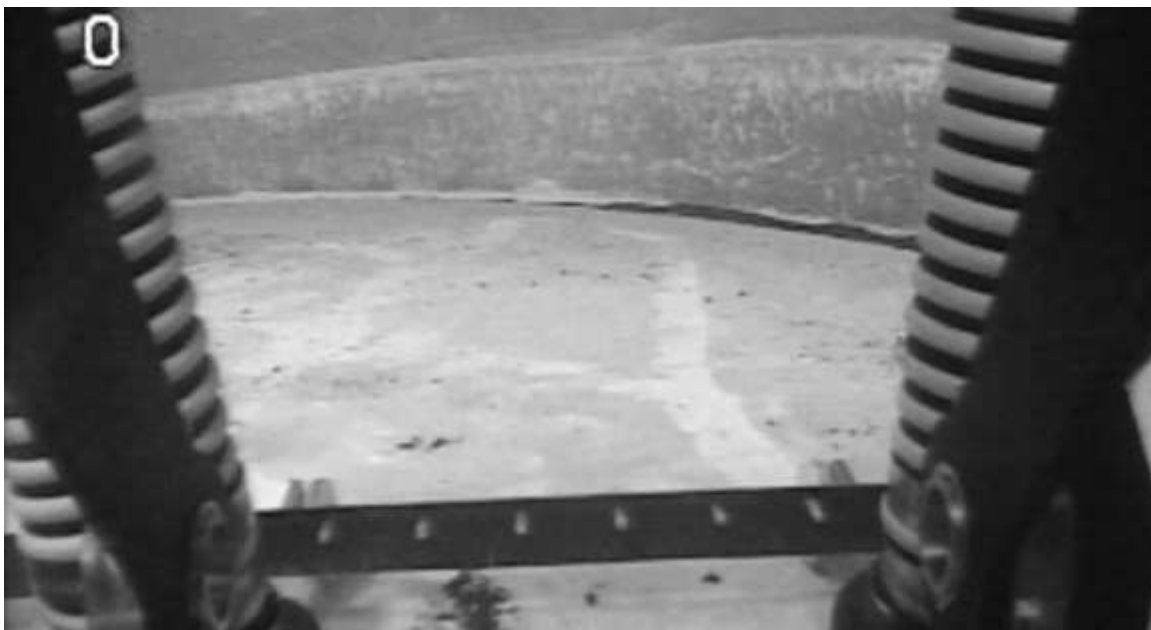
Photos show the tank interior during a cleanout.

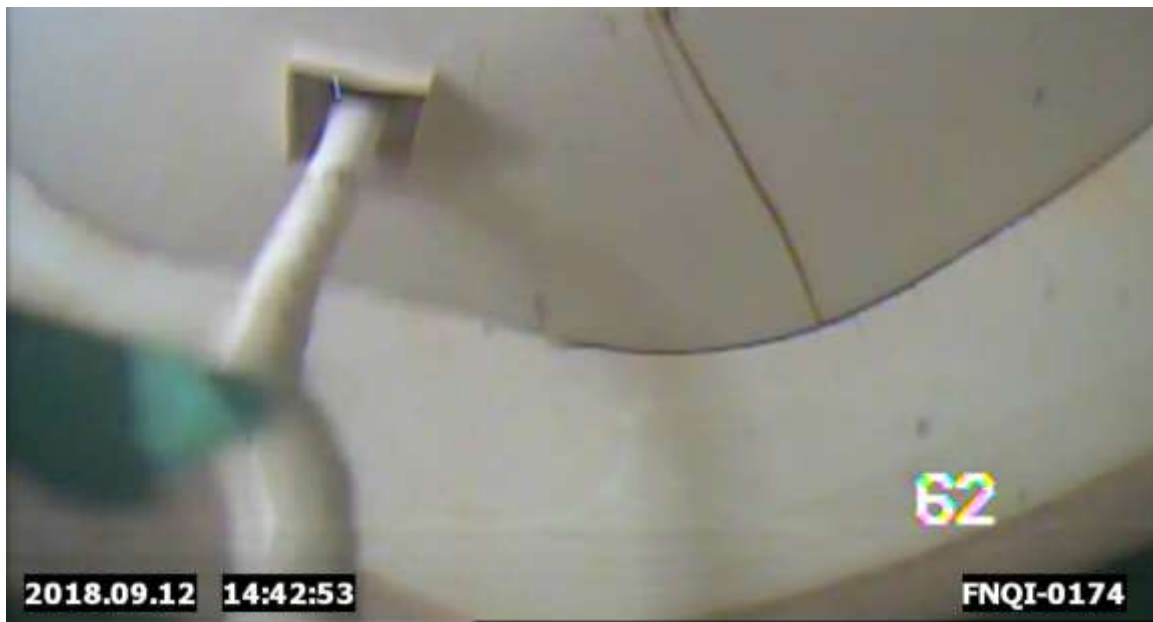
Photos show the tank interior coating system. The overall interior coating system appears to be in good condition. We recommend re-evaluating the tank interior at next inspection cycle.

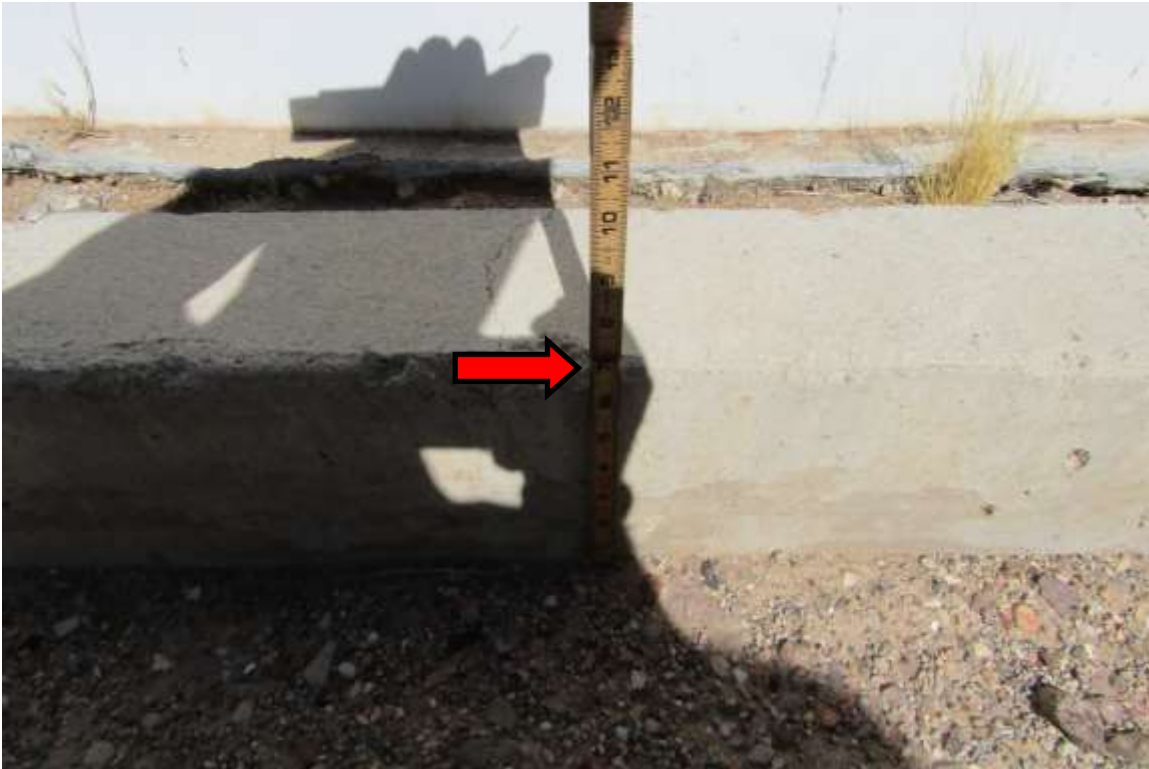
Photo shows the area around the tank foundation is properly graded and in compliance with **AWWA D100-11; 12.7.1 Height aboveground.**

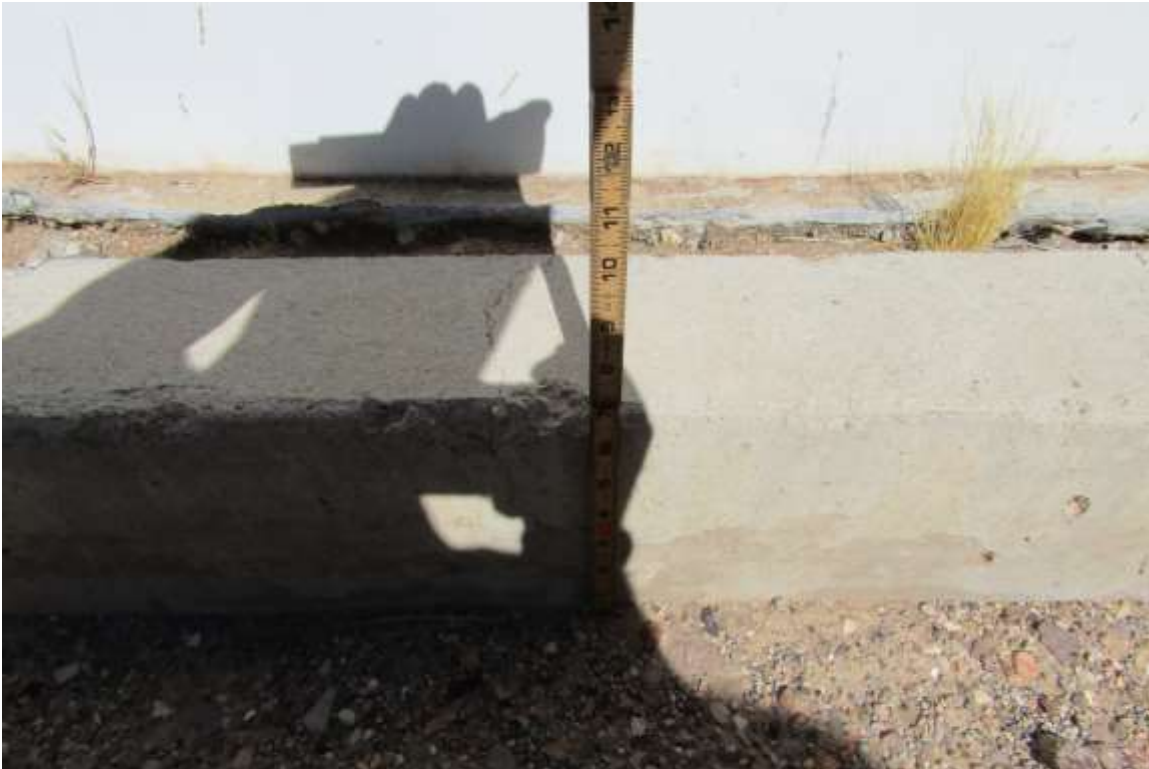
Photo shows the area around the tank foundation is properly graded and in compliance with **AWWA D100-11; 12.7.1 Height aboveground.**

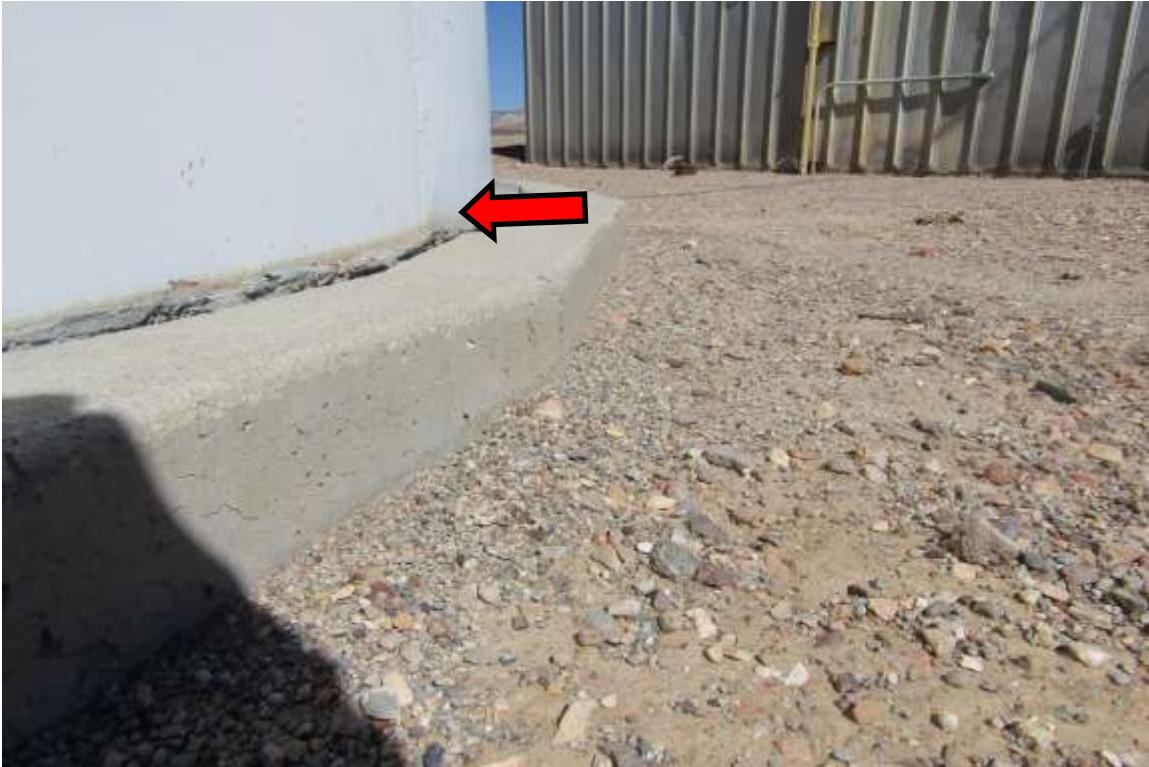
Photo shows the condition of the shell. Currently there is no drain valve. We recommend installing a frost proof drain valve near the shell-to-floor connection, complete with a locking device to prevent unauthorized draining of the tank and a splash pad to direct water away from the foundation.

**Splash pad to be installed by owner.*

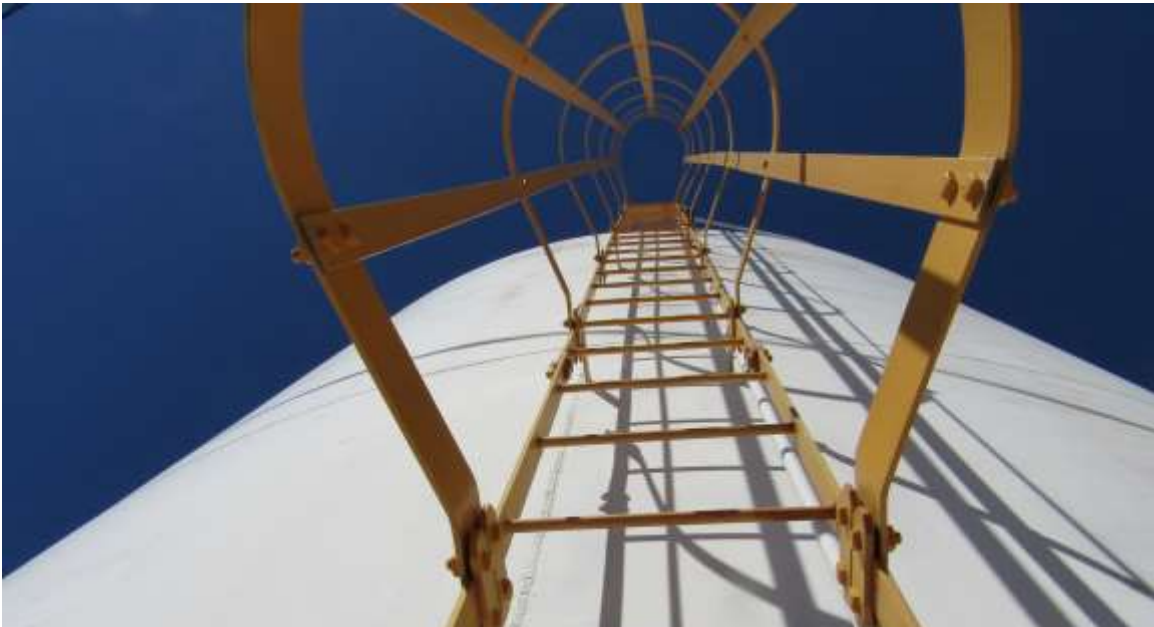
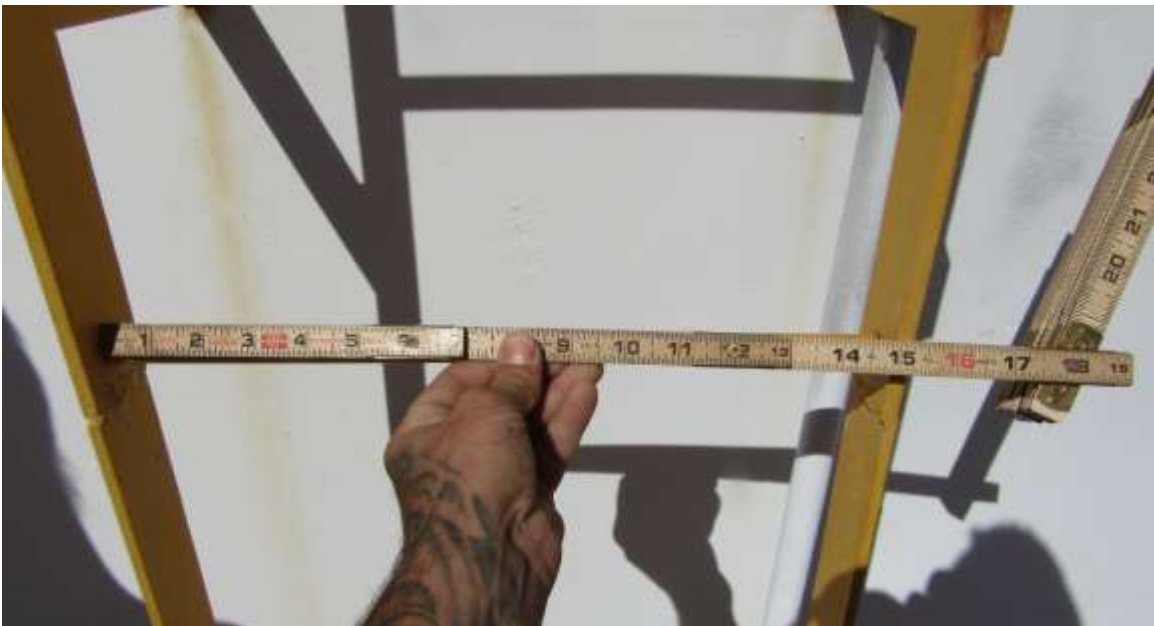
Shell access ladder in above photos is not equipped with anti-skid rungs, and is only 15" wide. **OSHA 1910.23(b)(4)** states, "Ladder rungs, steps, and cleats have a minimum clear width of... 16 inches (41 cm) (measured before installation of ladder safety systems) for fixed ladders,..." We recommend installing an **OSHA** compliant shell access ladder complete with standoffs every 10' on center, a cable type ladder safety device, a lockable ladder guard to prevent unauthorized access and posting a **Fall Protection Required** sign at the base of the ladder.

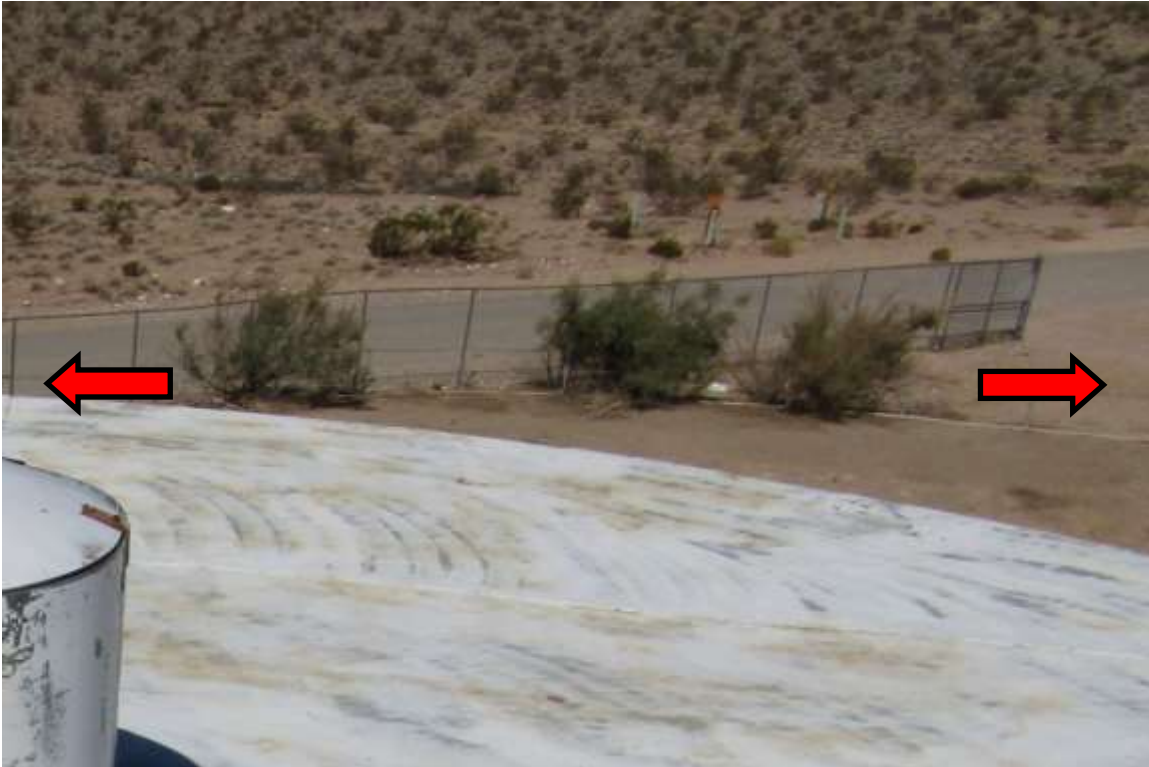
Photo shows the tank roof edge is not equipped with a required handrail system for fall protection. **OSHA 1910.28(b)(1)(i)** states, "...the employer must ensure that each employee on a walking-working surface with an unprotected side or edge that is 4 feet (1.2 m) or more above a lower level is protected from falling by one or more of the following: **1910.28(b)(1)(i)(A) Guardrail systems.**"

We recommend installing an **OSHA** compliant 42" high handrail system around the circumference of the tank roof, complete with intermediate rail, toeboard and a swing gate at the junction of the shell-to-roof access ladder and tank roof.

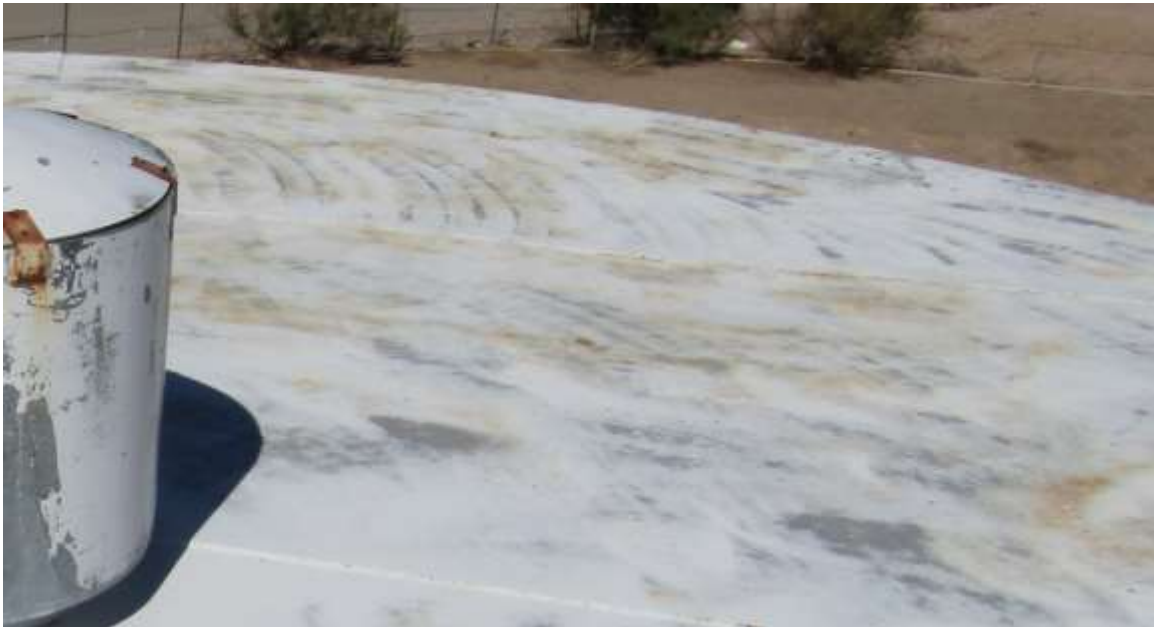
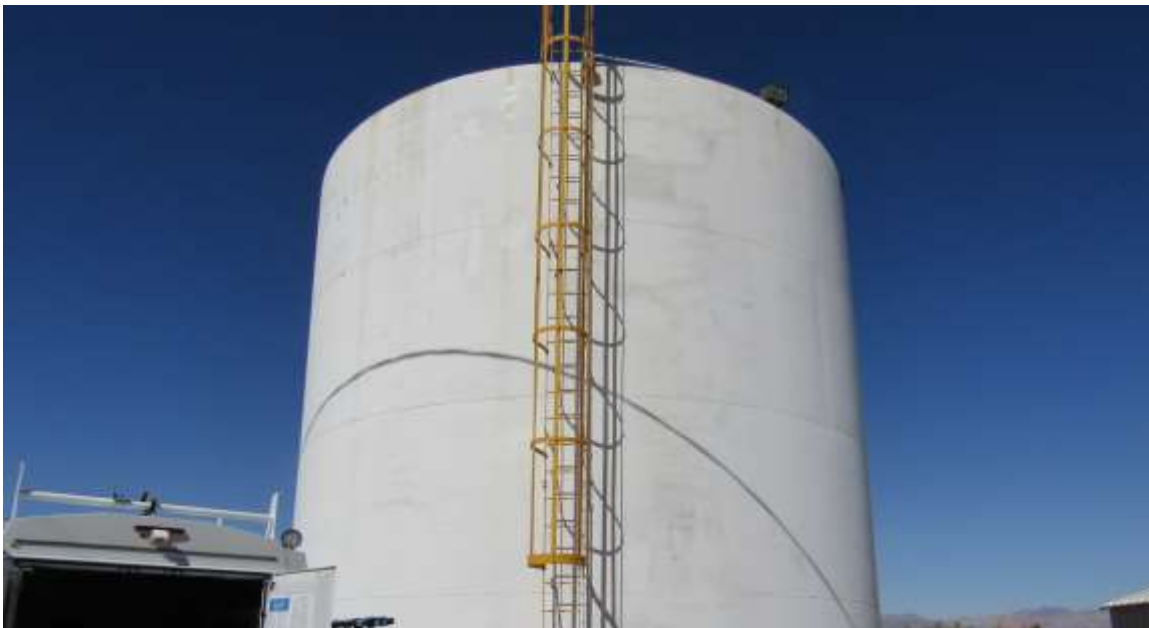
Photos show the tank exterior coating system. The overall exterior coating system appears to be in good condition. We recommend pressure washing the roof exterior with biodegradable detergent injection (minimum 3,500 psi at 3.0 gpm) then removing all loose rust and scale with wire brushes and hand scrapers in accordance with SSPC#2 (hand tool cleaning), spot priming and applying one (1) finish coat of acrylic paint. We further recommend re-evaluating the rest of the tank at next inspection cycle.

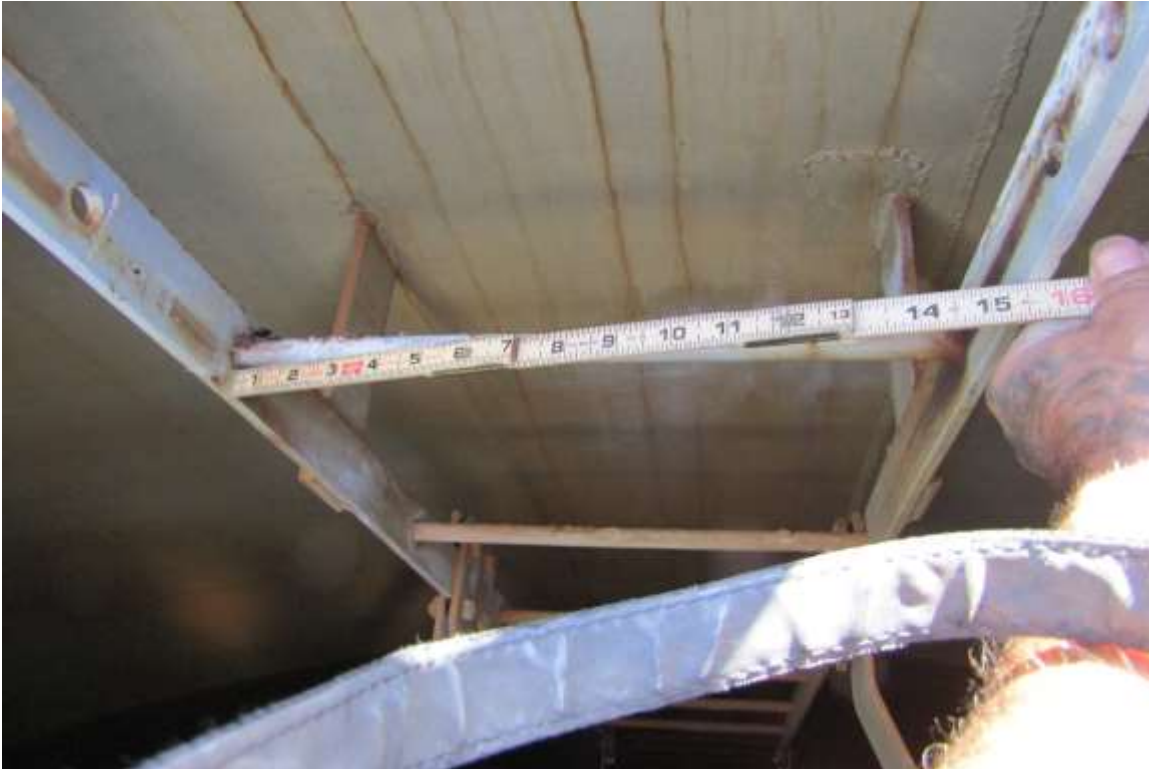
Primary interior access ladder in above photo is not equipped with anti-skid rungs, and is only 15" wide. **OSHA 1910.23(b)(4)** states, "Ladder rungs, steps, and cleats have a minimum clear width of... 16 inches (41 cm) (measured before installation of ladder safety systems) for fixed ladders..." We recommend installing an **OSHA** compliant interior access ladder complete with standoffs every 10' on center, and a cable type ladder safety device at the primary roof hatch.

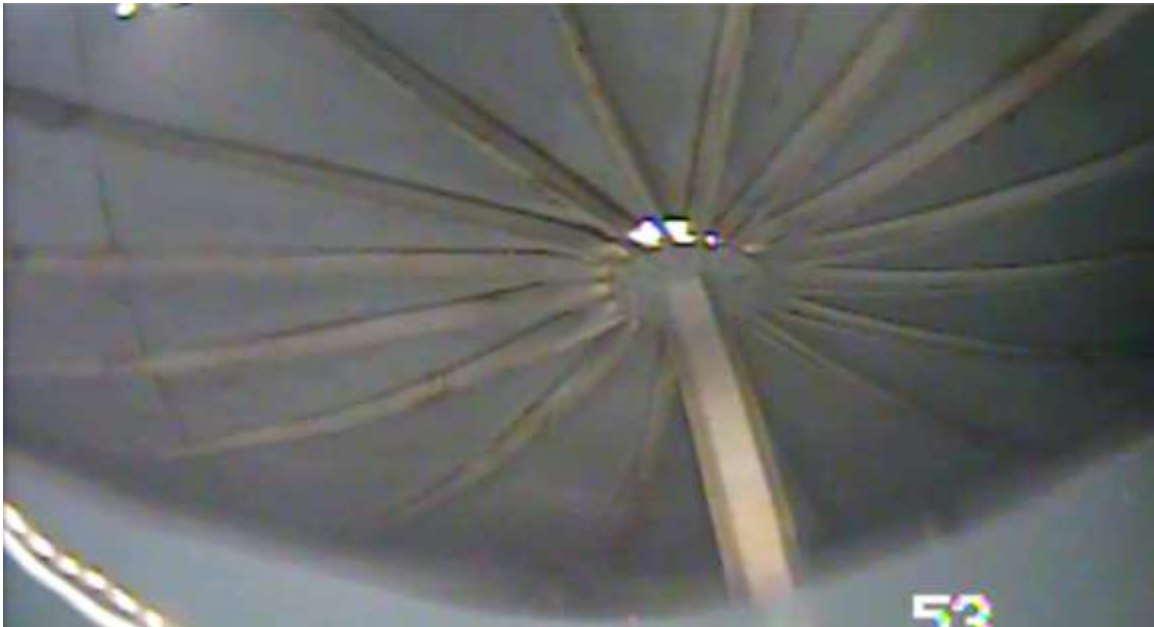
Top photo shows the interior roof lap seams, which appear to be in good condition.
