**Mission Support and Test Services, LLC
Nevada National Security Site
Mercury, NV 89023
RE: Mercury North (Area 23); Mercury, NV
1,500,000 Gallon GST
September 16, 2018
Mr. Kevin Olsen
Scientist 1
(702) 295-0485
Job No. 318448-A**

**Mission Support and Test Services, LLC
Nevada National Security Site
Mercury, NV 89023
RE: Camp South (Area 12); Mercury, NV
500,000 Gallon GST
September 13, 2018
Mr. Kevin Olsen
Scientist 1
(702) 295-0485
Job No. 318448-D**

**Mission Support and Test Services, LLC
Nevada National Security Site
Mercury, NV 89023
RE: Well 4/4a South (Area 6); Mercury, NV
150,000 Gallon GST
September 24, 2018
Mr. Kevin Olsen
Scientist 1
(702) 295-0485
Job No. 318448-H**

**Mission Support and Test Services, LLC
Nevada National Security Site
Mercury, NV 89023
RE: C-1 North (Area 6); Mercury, NV
50,000 Gallon GST
September 21, 2018
Mr. Kevin Olsen
Scientist 1
(702) 295-0485
Job No. 318448-O**

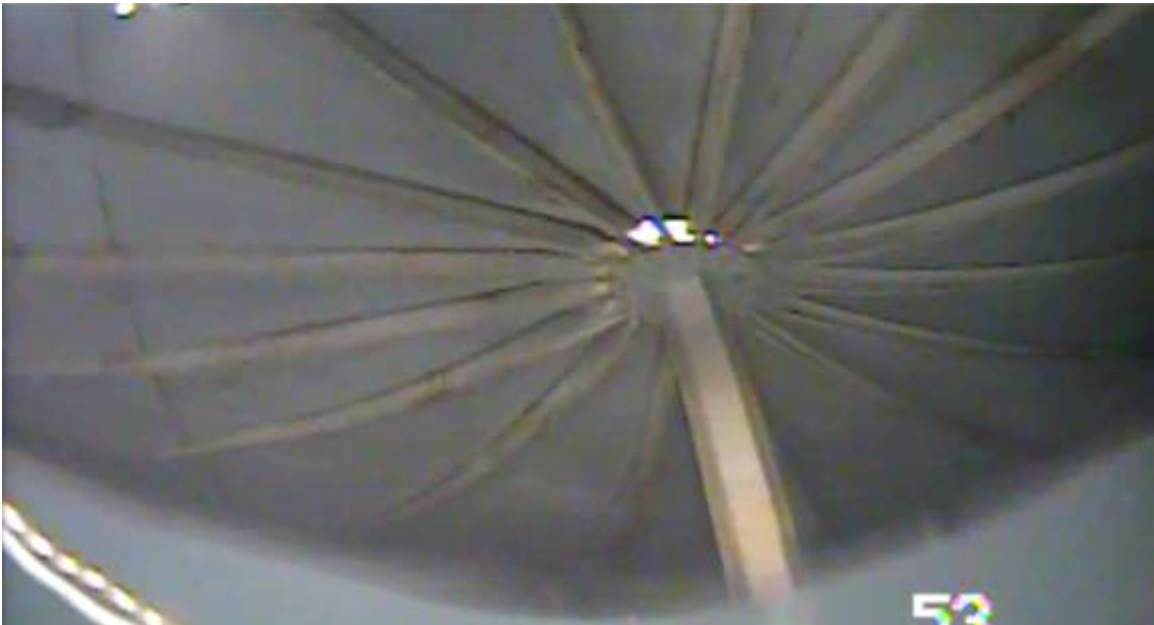
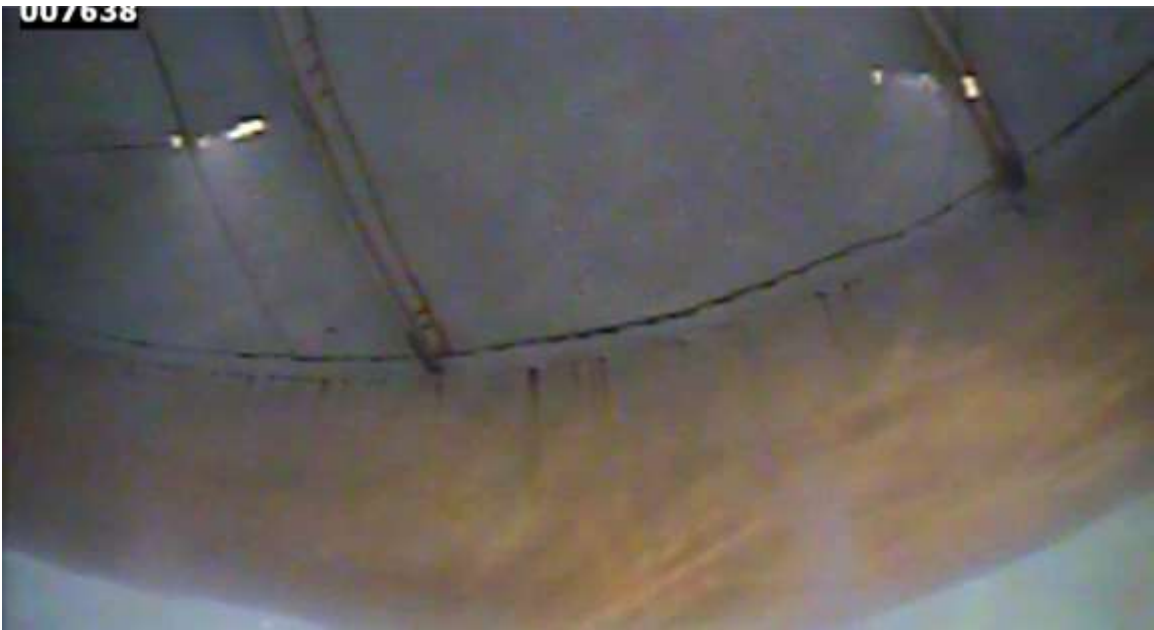
Photos show the rafter-to-support column and rafter-to-shell connections, which appear to be in good condition.

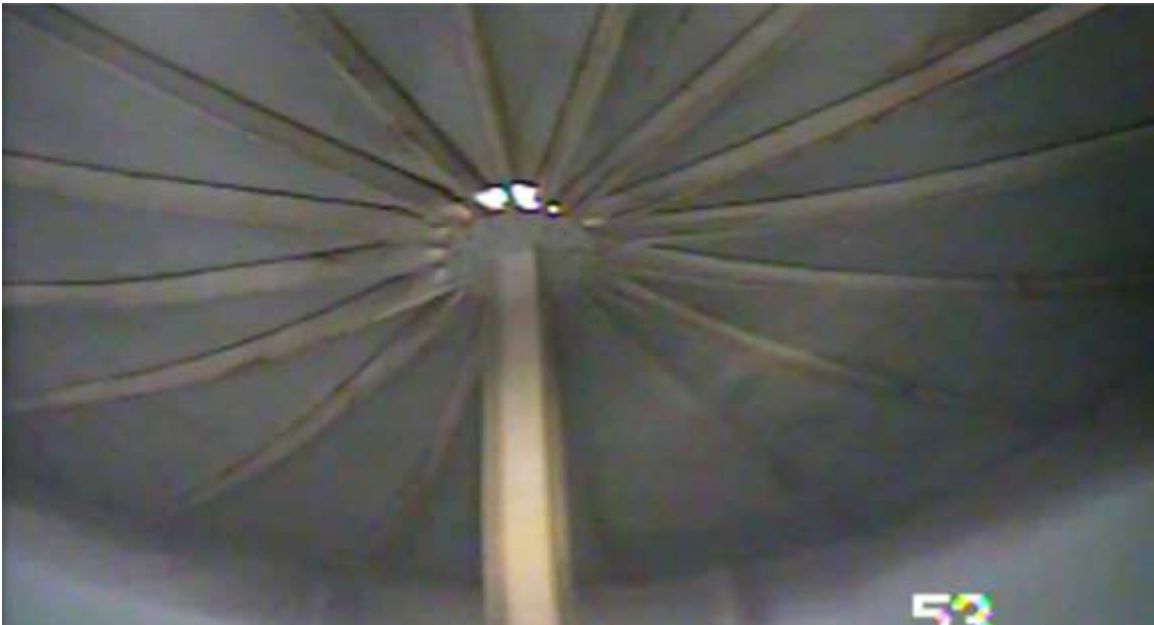
Top photo shows the center support column, which appears to be in good condition.

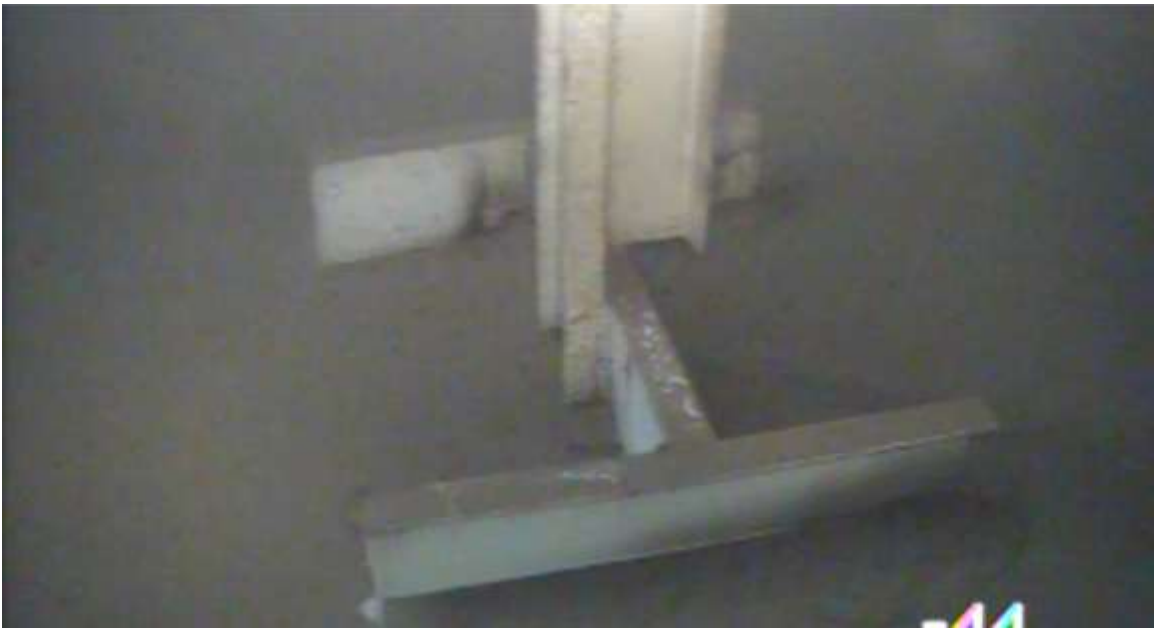
Bottom photo shows the support column baseplate-to-floor connection, which appears to be in good condition.

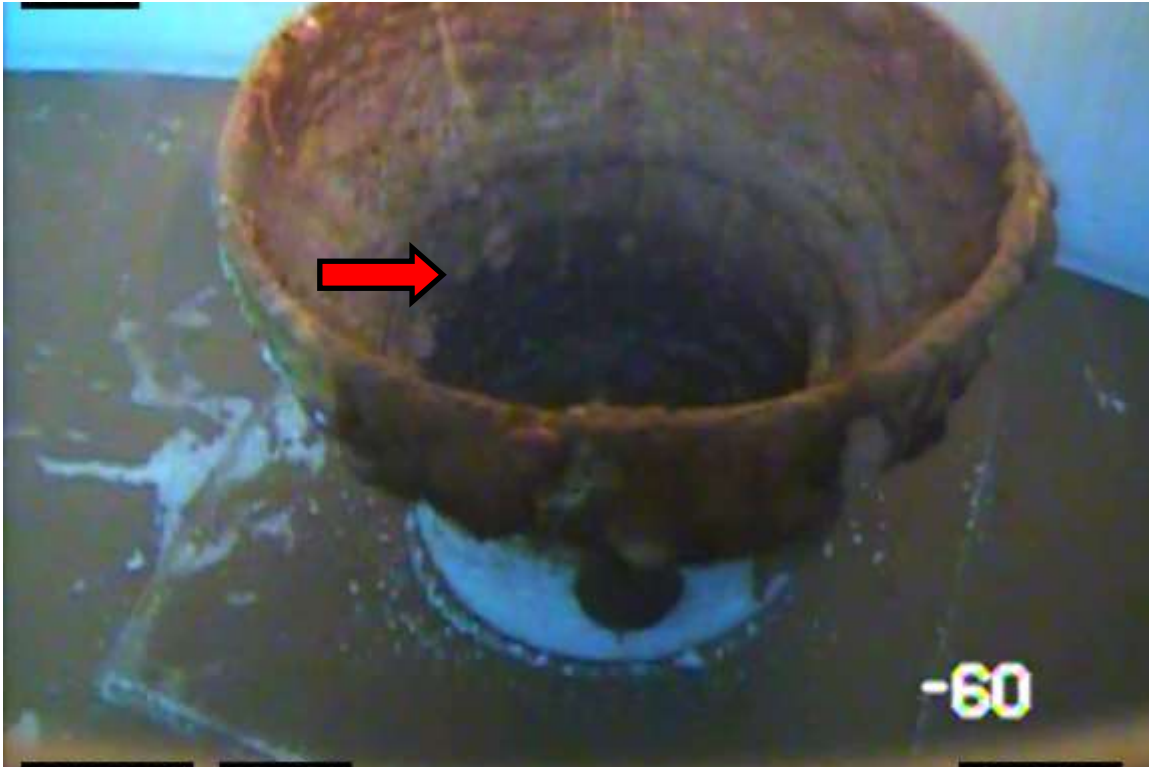
Photo shows a inlet/outlet pipe on the tank interior. A temperature difference between the water in the top and bottom of a tank, even as little as 1-2 degrees Fahrenheit, is an indication of thermal stratification and the tank water not being completely mixed. Incomplete mixing would result in short-circuiting, and localized increase in water age would develop inside the tank. This typically leads to water quality problems, such as loss of residual, DBP spikes, HPC spikes, bacteria regrowth, formation of bio-film, changes in pH and dissolved oxygen. We recommend installing a mixing system. Electrical work to be done by others if required.

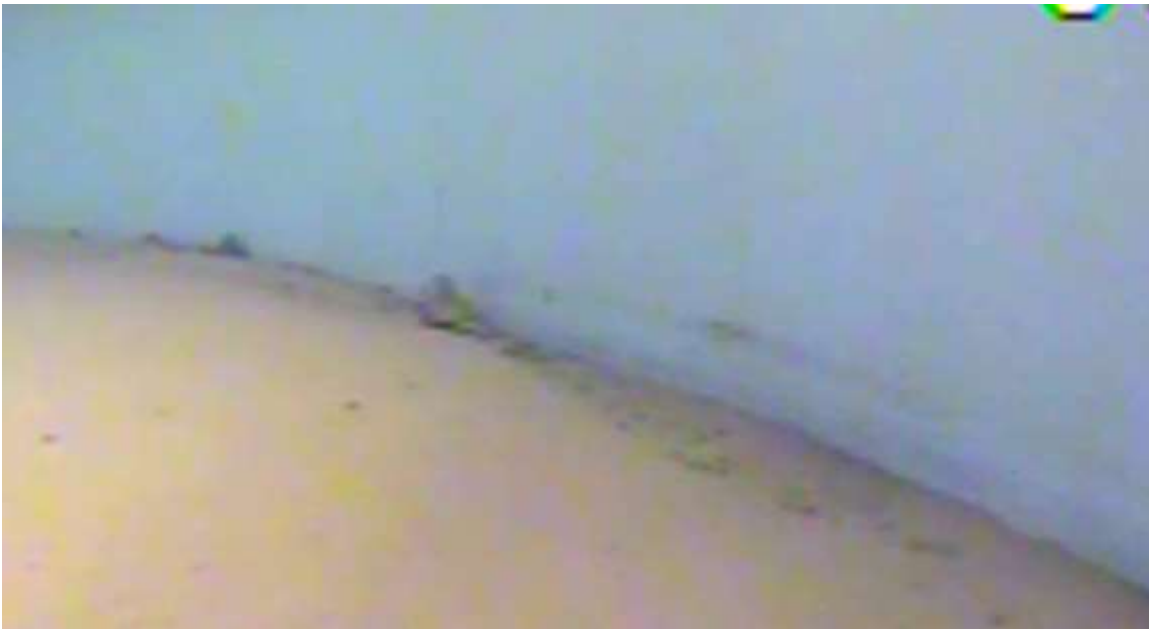
Photos show sediment and debris on the tank interior before a cleanout was performed.

We recommend installing a passive cathodic protection system.

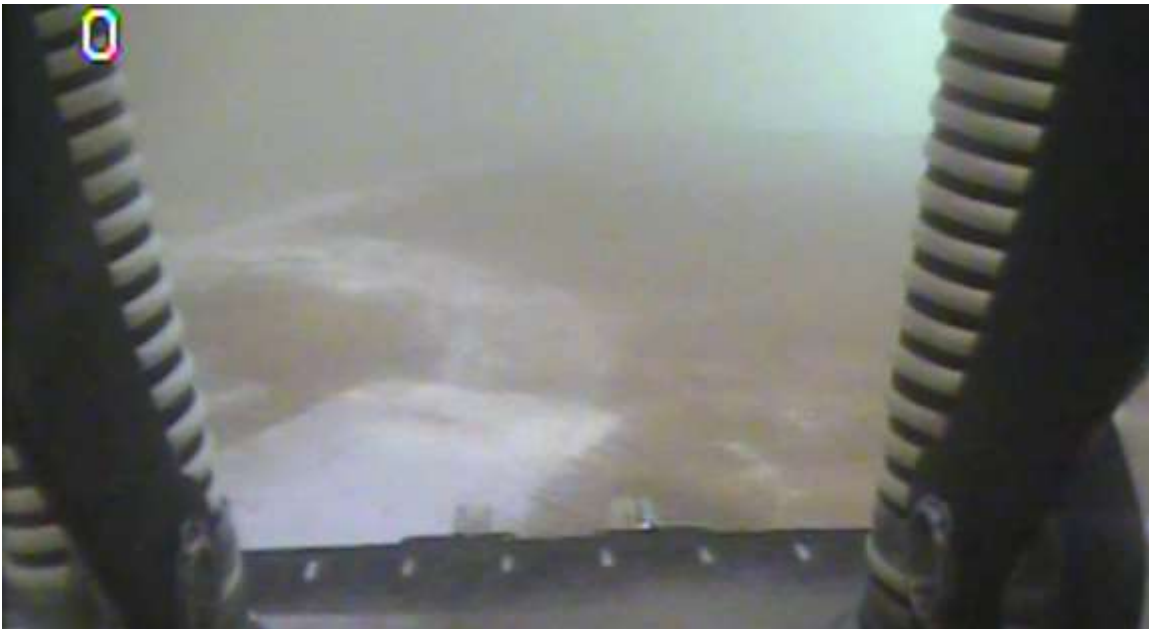
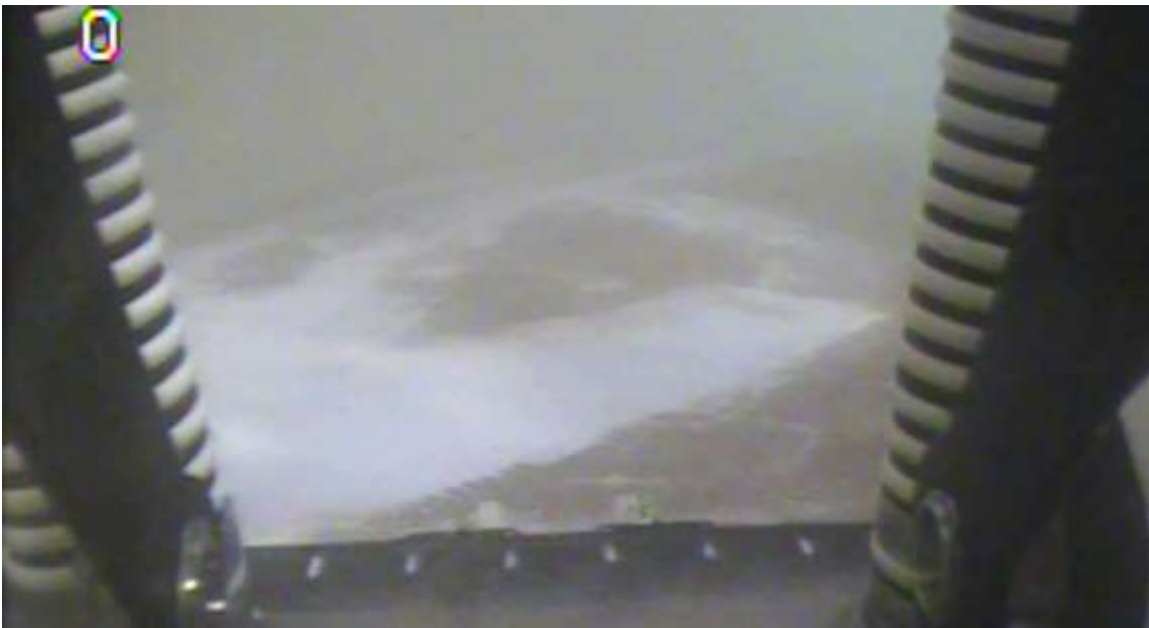
Photos show the tank interior during a cleanout.

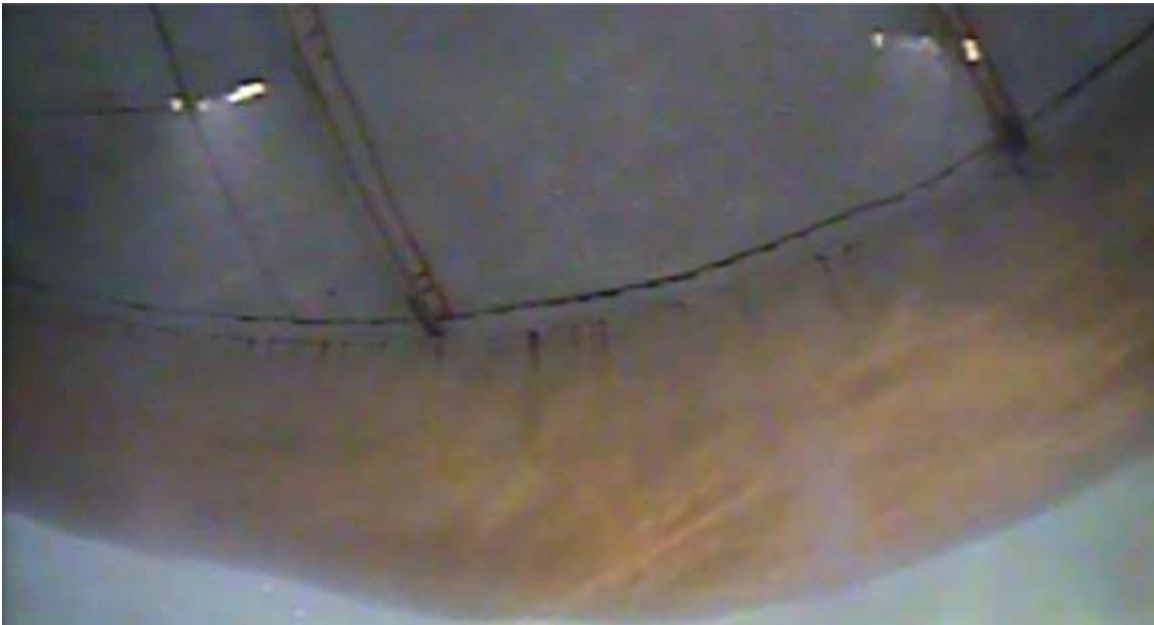
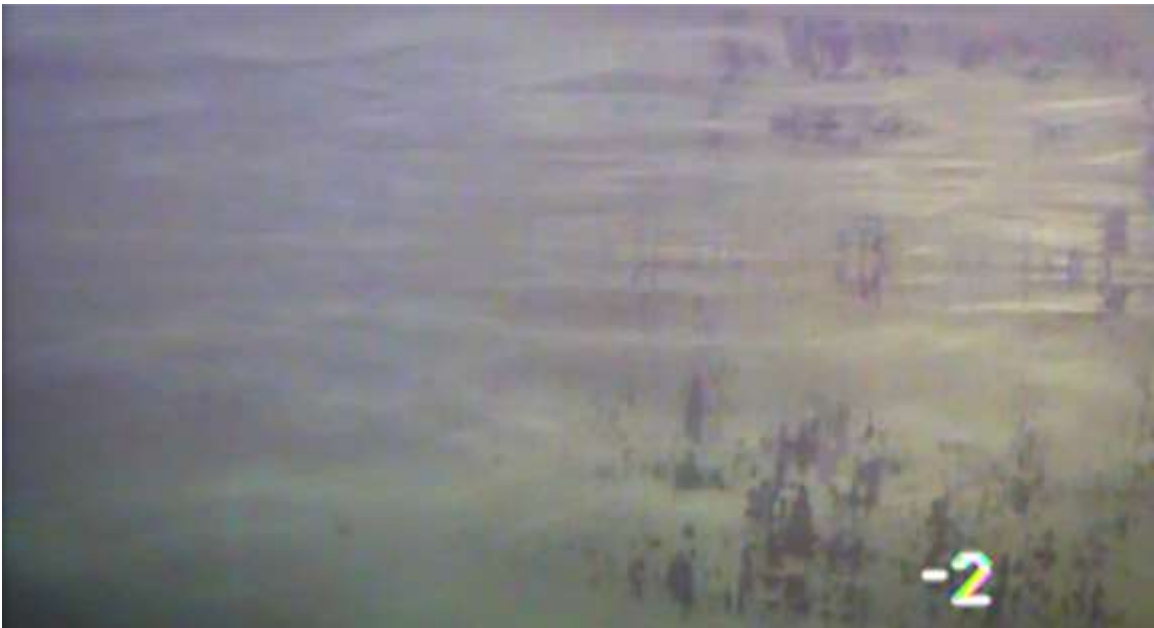
Photos show the tank interior coating system. The overall interior coating system appears to be in good condition. We recommend pressure washing the tank interior with biodegradable detergent injection (minimum 3,500 psi at 3.0 gpm), then re-evaluating the tank interior at next inspection cycle.

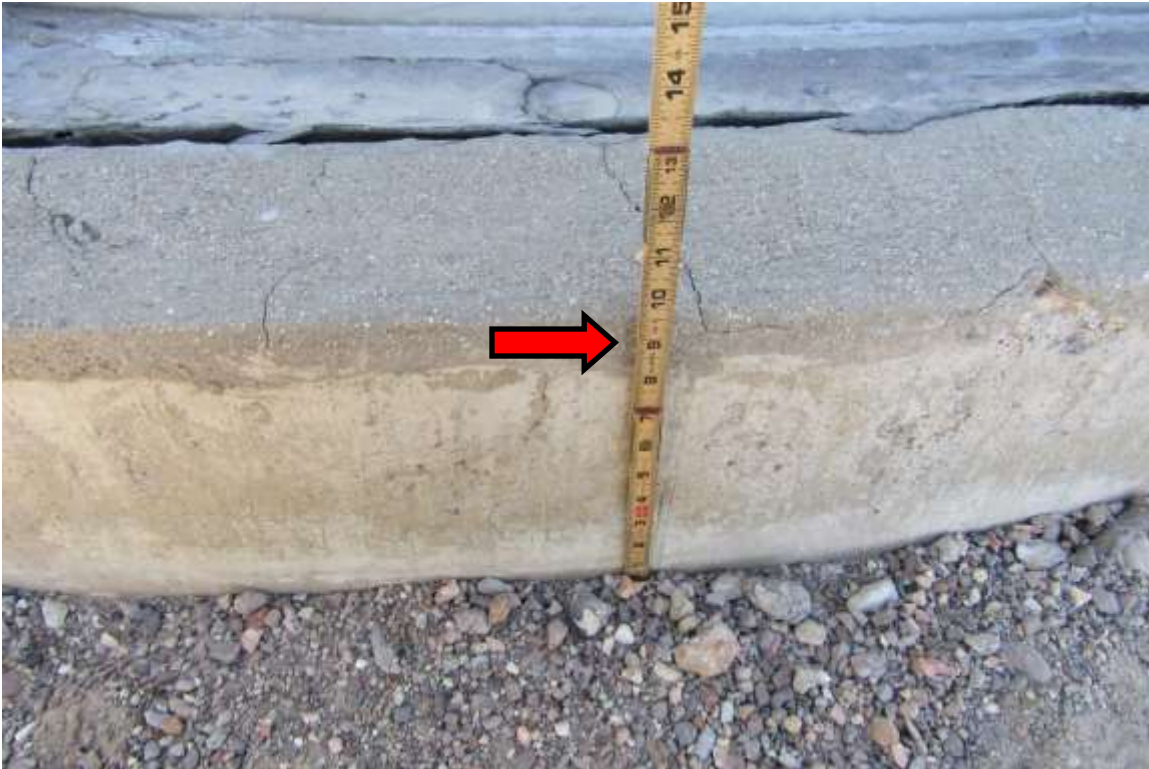
Photo shows the area around the tank foundation is properly graded and in compliance with **AWWA D100-11; 12.7.1 Height aboveground.**

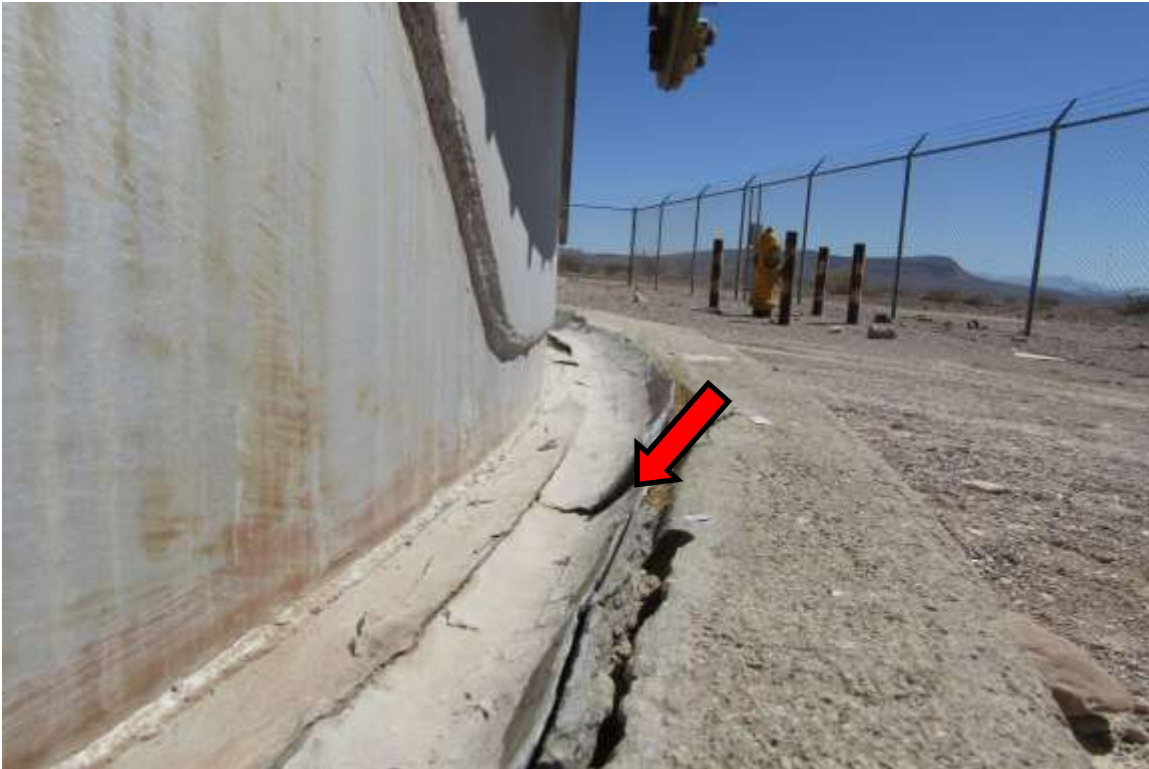
Photo shows the condition of the foundation. We recommend trimming the fiberboard back to where it comes in contact with the tank base. Once this is done allowing for a clean edge, apply caulk/grout around the base of the tank to foundation connection to prevent water from entering under the tank, then sealing the foundation with a sealant.

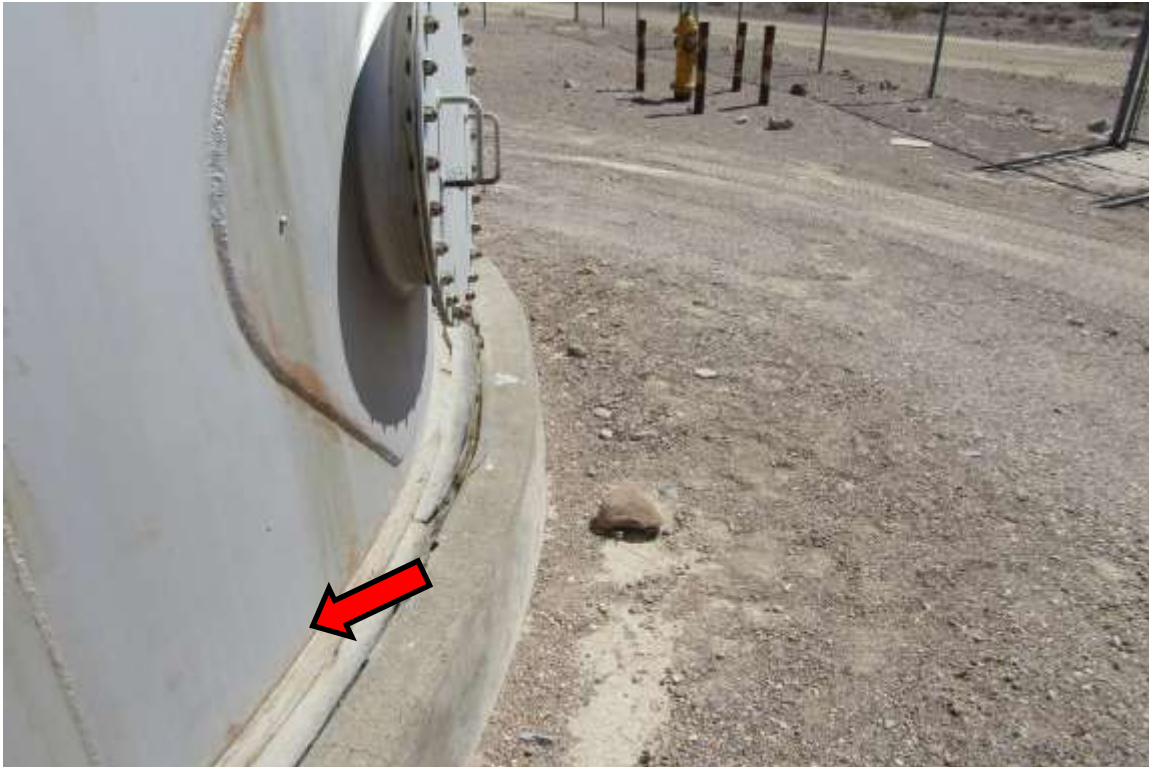
Photo shows the tank has no grounding system. We recommend electrically grounding the tank for lightning protection as required by **OSH Act of 1970 Section 5**.

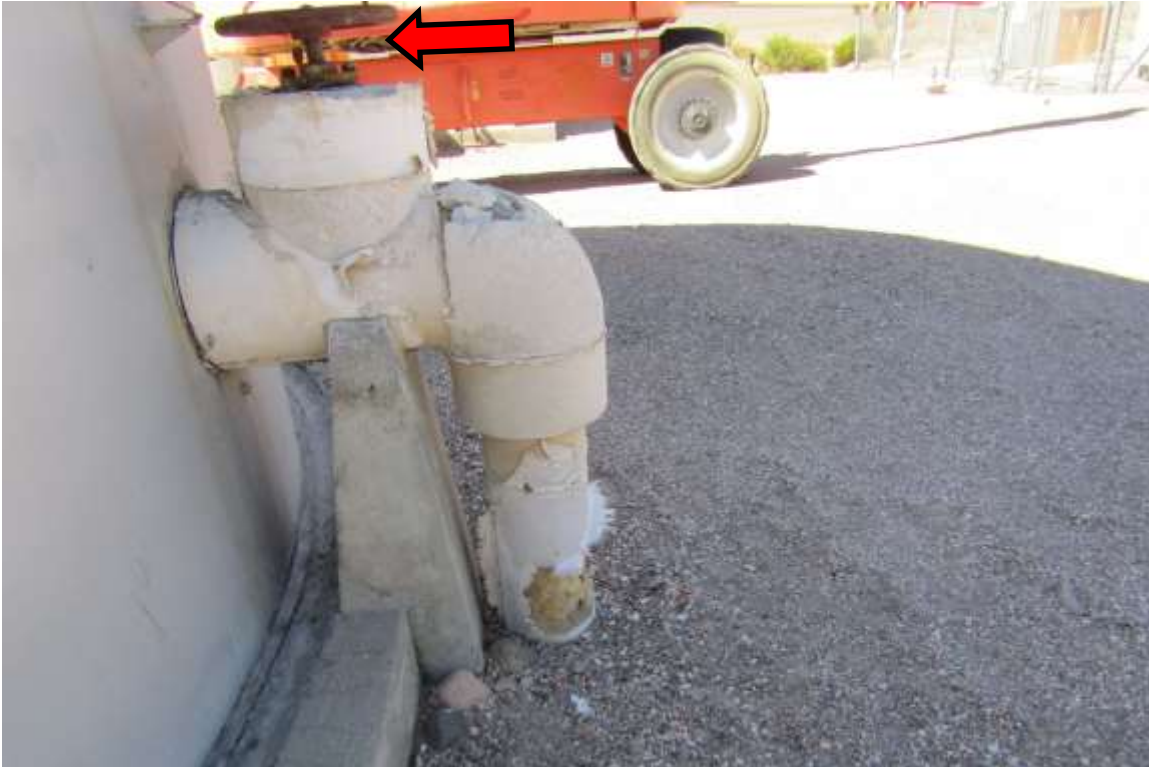
Photo shows the condition of the existing drain valve, which is not equipped with a locking device or splash pad. We recommend installing a locking device to prevent unauthorized draining of the tank.

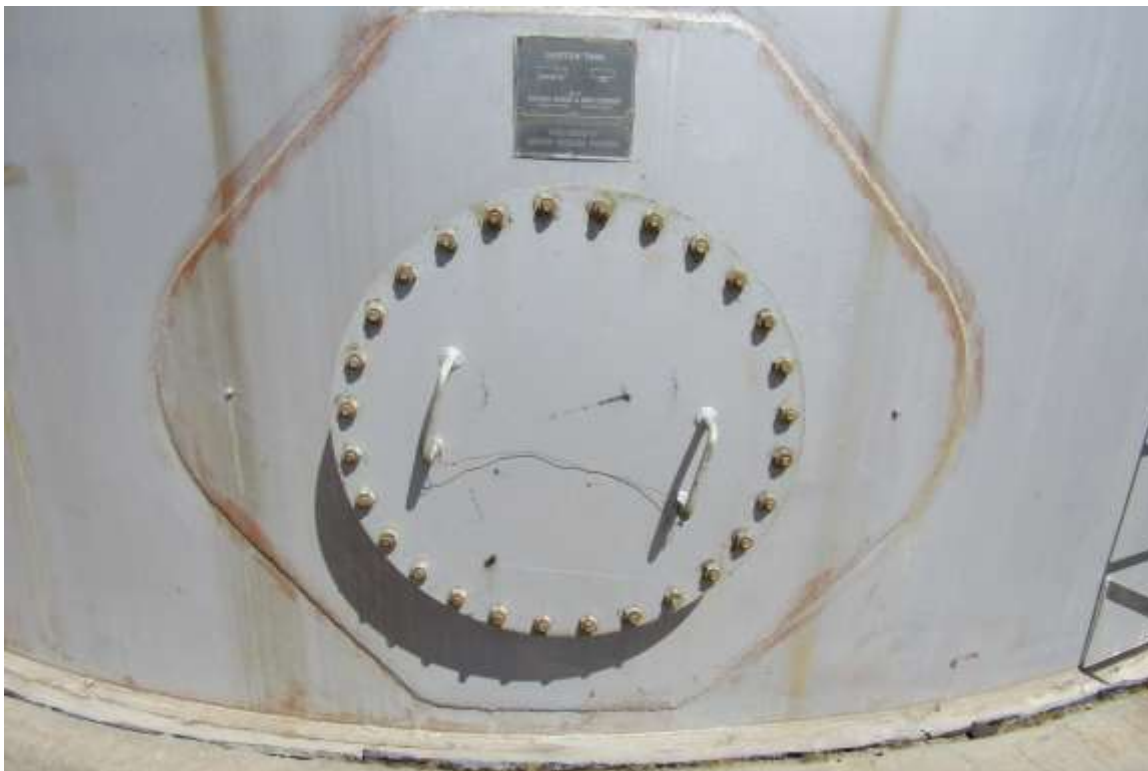
Photo shows the condition of the 24" primary shell manway. The following is required for the tank to be in compliance with **AWWA D100-11; 7.4.4 Shell man-holes** and **OSHA 1910.146(c)(2) Confined spaces**.

We recommend:

- Install a davit arm on primary shell manway
- Install 30" secondary shell manway 180° from primary manway
- Post **Confined Space Entry** signs
- Install maintenance free galvanized steel bolts

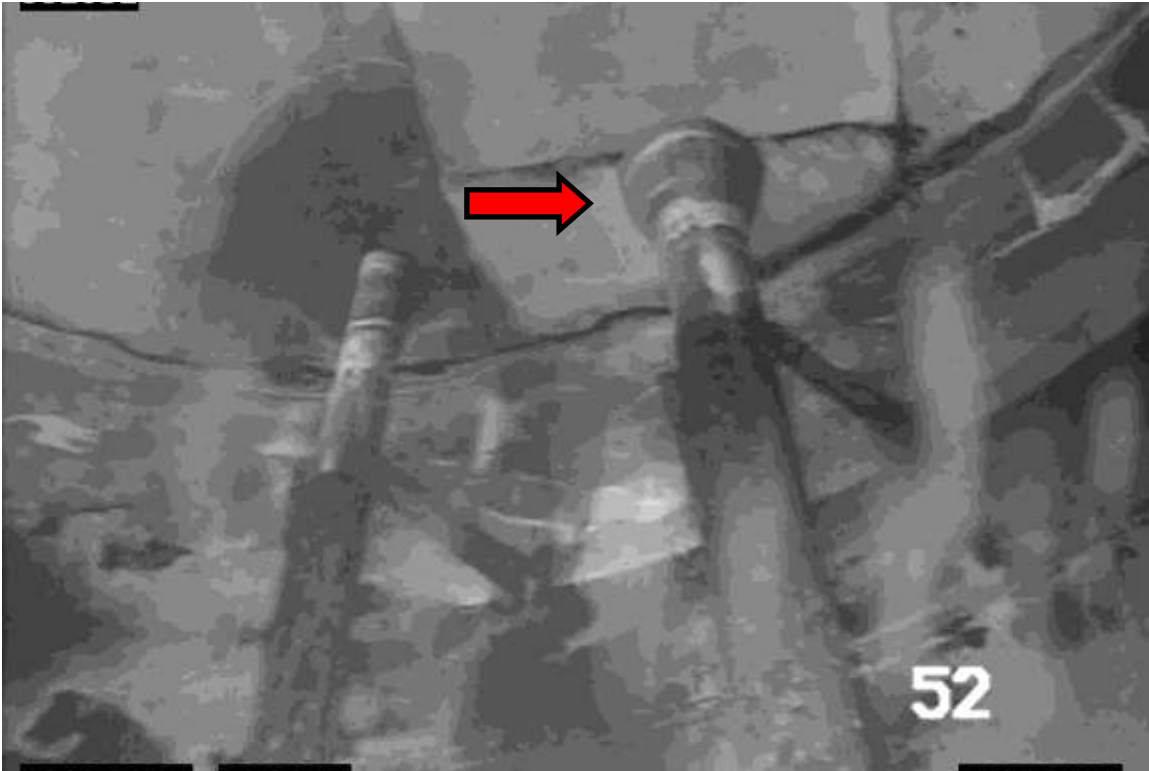
Photo shows the condition of the overflow pipe system. **AWWA D100-11; 7.3 Overflow** states, "An internal overflow is defined as an overflow with piping inside the tank container. The consequences of an overflow failure, which can empty the tank contents, shall be considered when an internal overflow is provided." We recommend replacing the internal overflow system with a properly sized exterior overflow system, which will be complete with a weir box on the interior, standoffs every 10' on center extended to grade, an elbow fitted with a flapper valve and screen to prevent the ingress of contaminants, and a splash pad to direct the water away from the tank foundation.

**Splash pad to be installed by owner.*

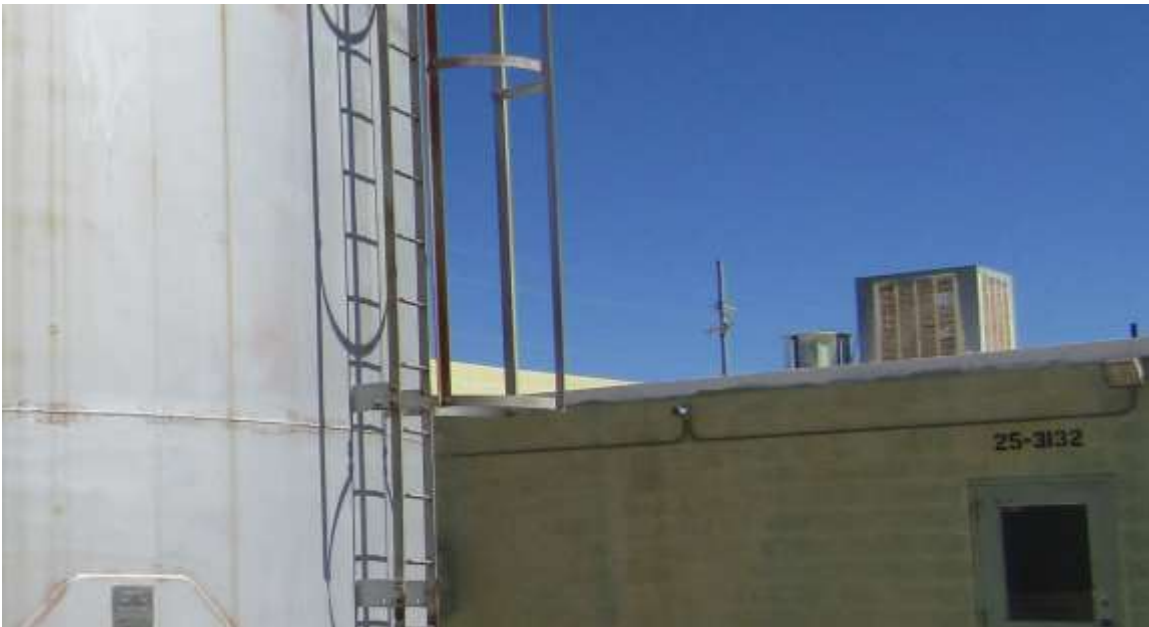
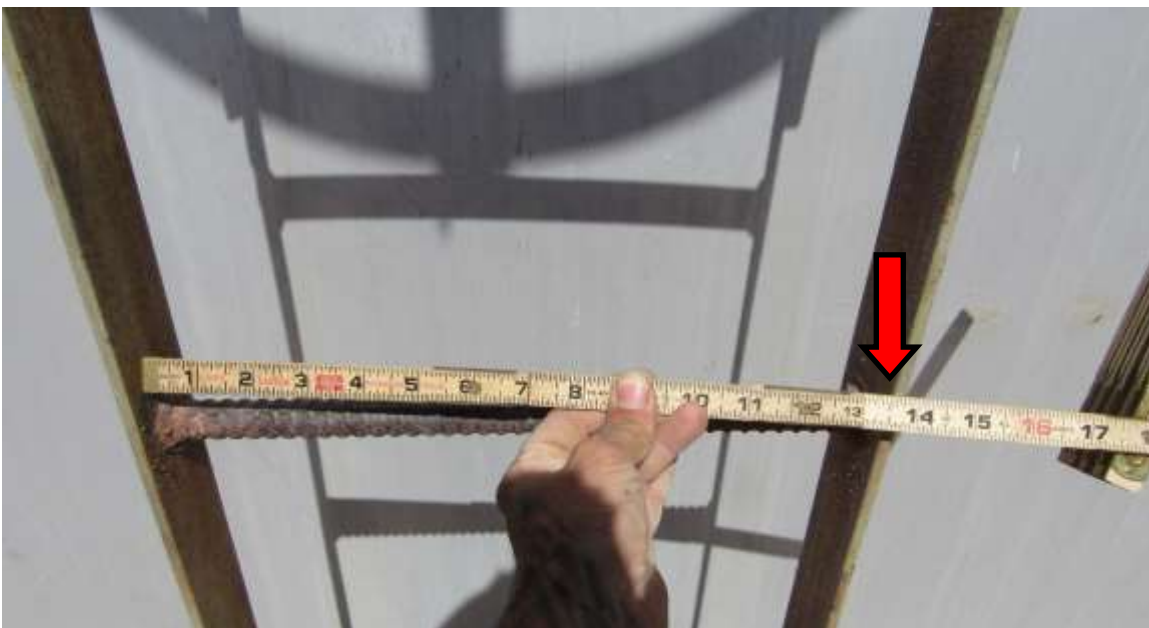
Shell access ladder in above photos is not equipped with anti-skid rungs, and is only 13" wide. **OSHA 1910.23(b)(4)** states, "Ladder rungs, steps, and cleats have a minimum clear width of... 16 inches (41 cm) (measured before installation of ladder safety systems) for fixed ladders,..." We recommend installing an **OSHA** compliant shell access ladder complete with standoffs every 10' on center, a cable type ladder safety device, a lockable ladder guard to prevent unauthorized access and posting a **Fall Protection Required** sign at the base of the ladder.

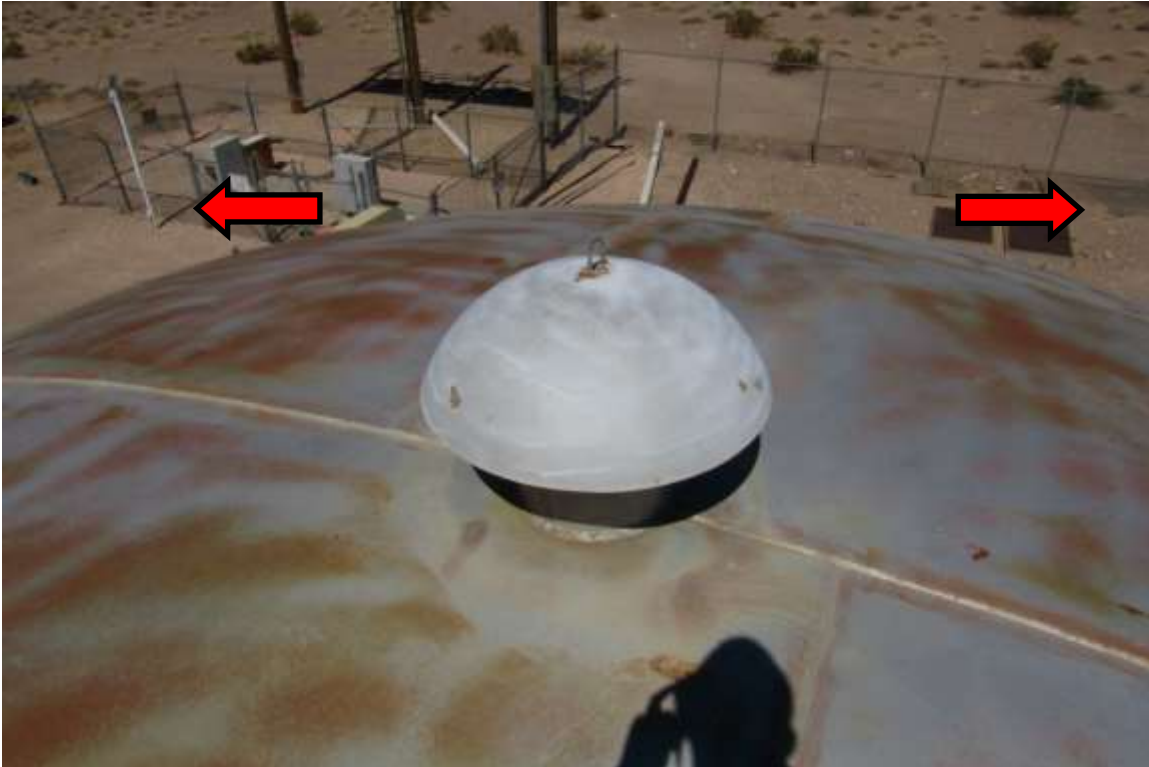
Photo shows the tank roof edge is not equipped with a required handrail system for fall protection. **OSHA 1910.28(b)(1)(i)** states, "...the employer must ensure that each employee on a walking-working surface with an unprotected side or edge that is 4 feet (1.2 m) or more above a lower level is protected from falling by one or more of the following: **1910.28(b)(1)(i)(A) Guardrail systems.**"

We recommend installing an **OSHA** compliant 42" high handrail system around the circumference of the tank roof, complete with intermediate rail, toeboard and a swing gate at the junction of the shell-to-roof access ladder and tank roof.

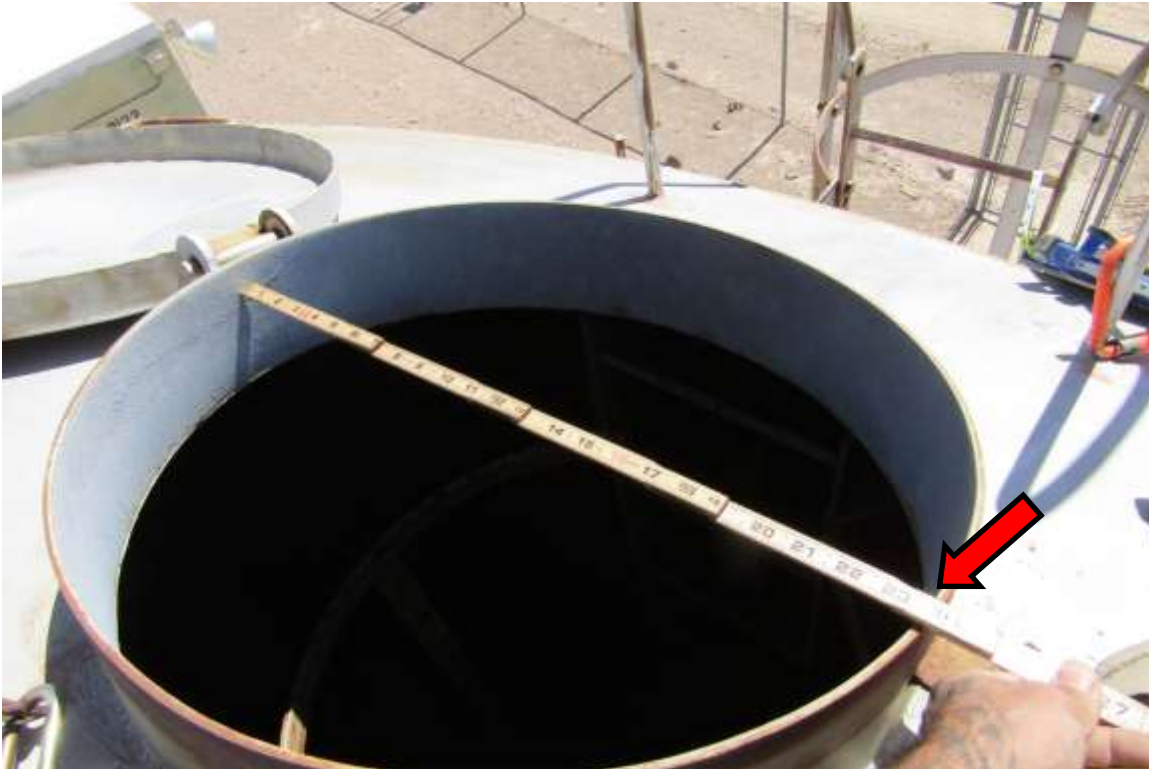
Photo shows the condition of the 24" primary roof hatch. Roof openings on this tank require the following to be in compliance with **AWWA D100-11; 7.4.3 Roof openings** and **OSHA 1910.146(c)(2) Confined spaces**.

We recommend:

We further recommend installing an **OSHA** compliant interior access ladder complete with standoffs every 10' on center, and a cable type ladder safety device at the suggested secondary roof hatch.

**In cold climates it's up to the owner's discretion on placement of internal ladders.*

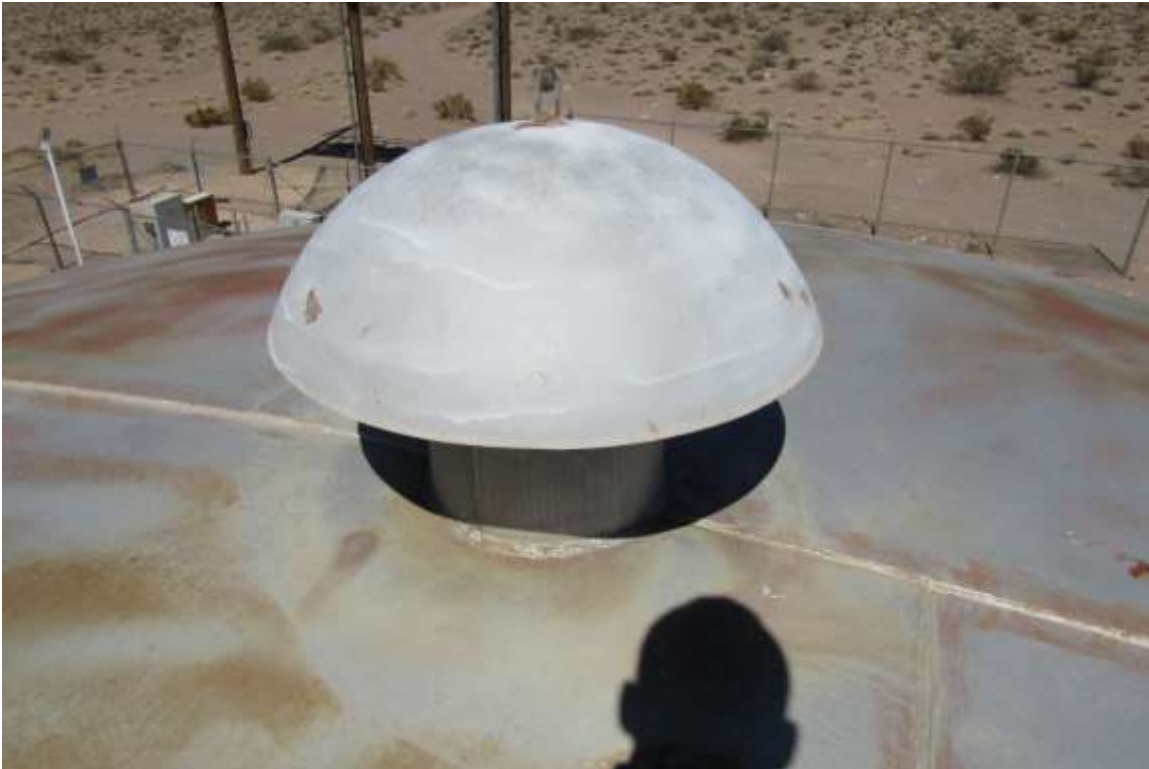
Photo shows the condition of the existing 12" roof vent. **This vent is allowing the ingress of rain and wind-borne contaminants into the water system. An improperly vented tank may cause external pressure to act on the tank which can cause buckling even at low pressure differential.** We recommend replacing the existing roof vent with a vacuum-pressure, frost proof vent and screen.

This work should be performed on an emergency basis.

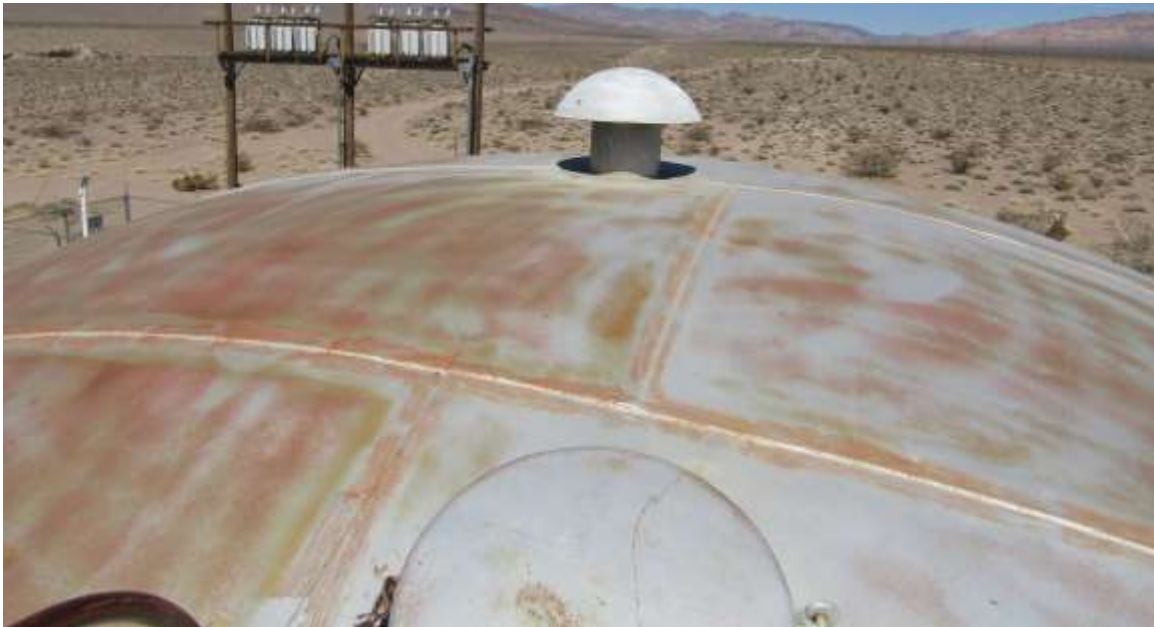
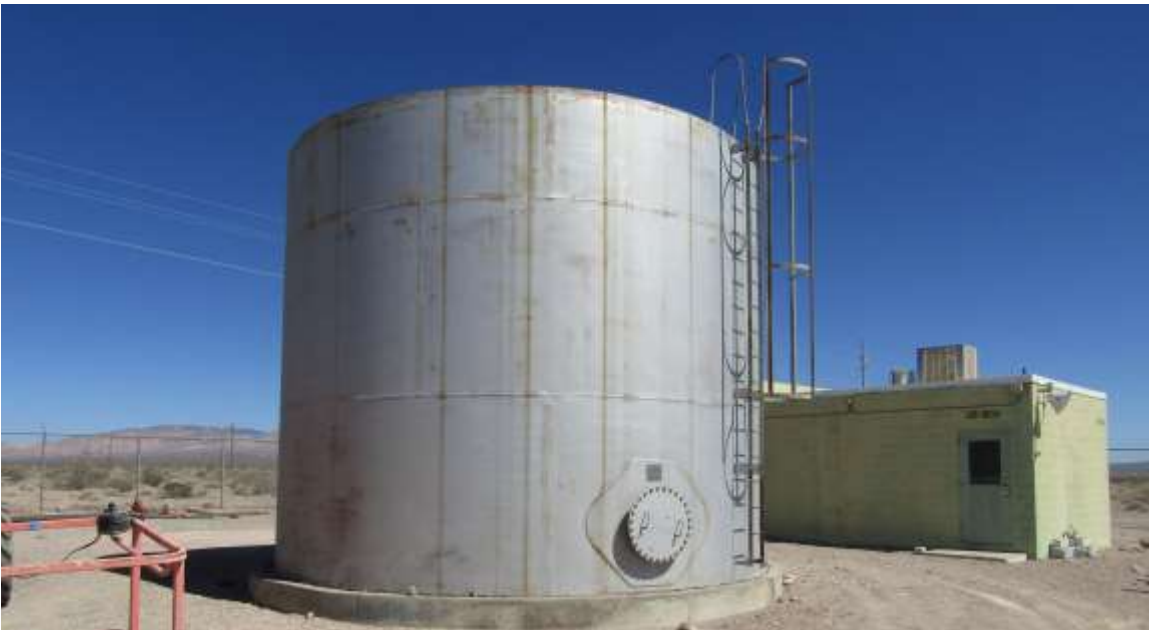
Photos show the tank exterior coating system. We recommend pressure washing the tank exterior with biodegradable detergent injection (minimum 3,500 psi at 3.0 gpm) then removing all loose rust and scale with wire brushes and hand scrapers in accordance with SSPC#2 (hand tool cleaning), spot priming and applying one (1) finish coat of aluminum paint.

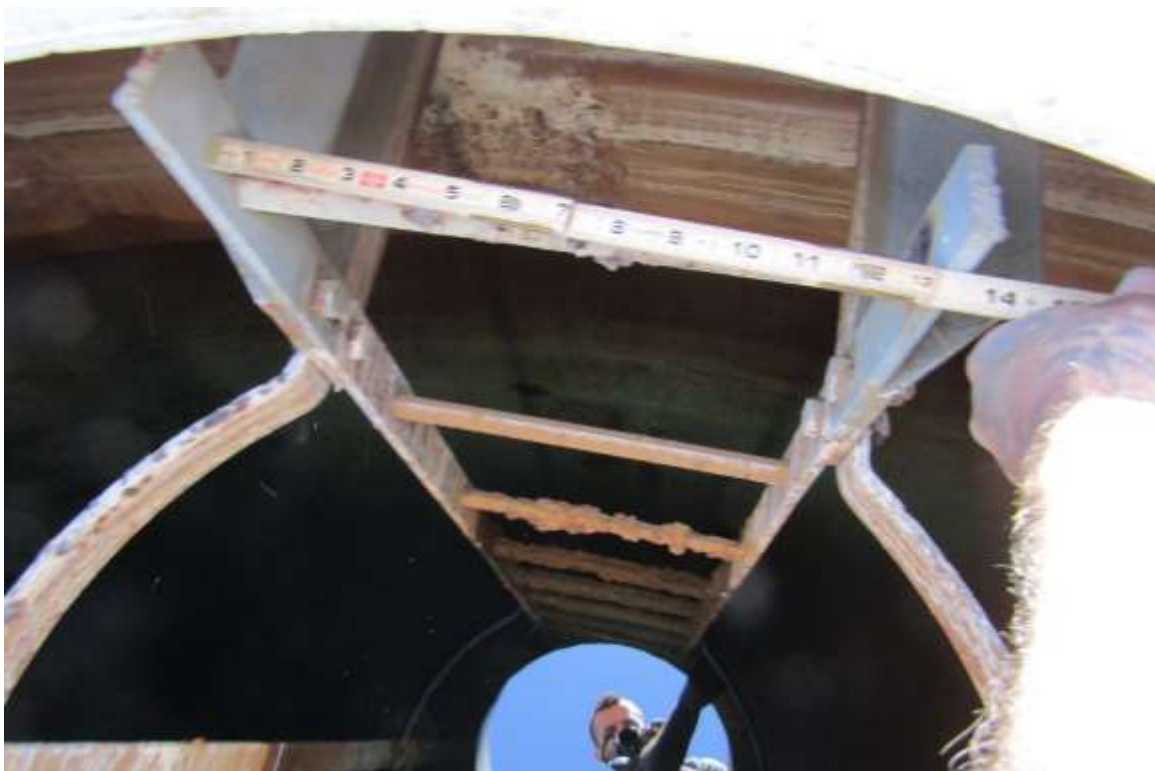
Primary interior access ladder in above photo is not equipped with anti-skid rungs, and is only 13" wide. **OSHA 1910.23(b)(4)** states, "Ladder rungs, steps, and cleats have a minimum clear width of... 16 inches (41 cm) (measured before installation of ladder safety systems) for fixed ladders..." **Notice the interior access ladder is equipped with a cage safety device. This would restrict access in the case of an emergency.** We recommend installing an **OSHA** compliant interior access ladder complete with standoffs every 10' on center, and a cable type ladder safety device at the primary roof hatch.

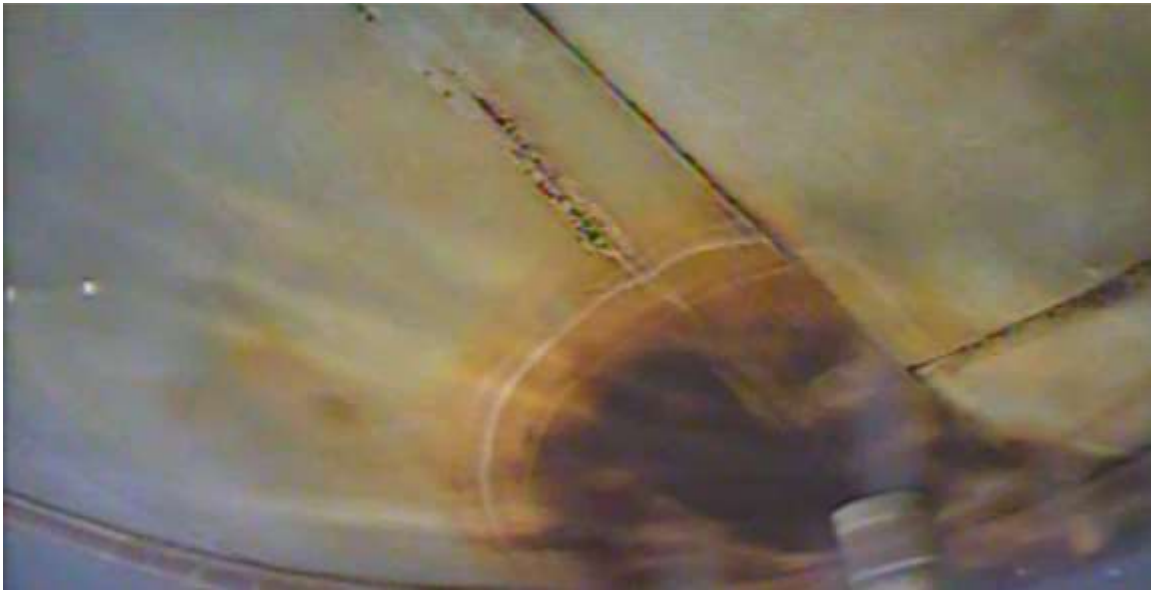
Top photo shows the condition of the interior roof. Notice the rust forming at the roof lap seams. We recommend seam sealing using Sikaflex® 1a on all unwelded interior roof lap seams to prevent failure of a new interior liner. This work is to be performed in conjunction with application of new interior liner.

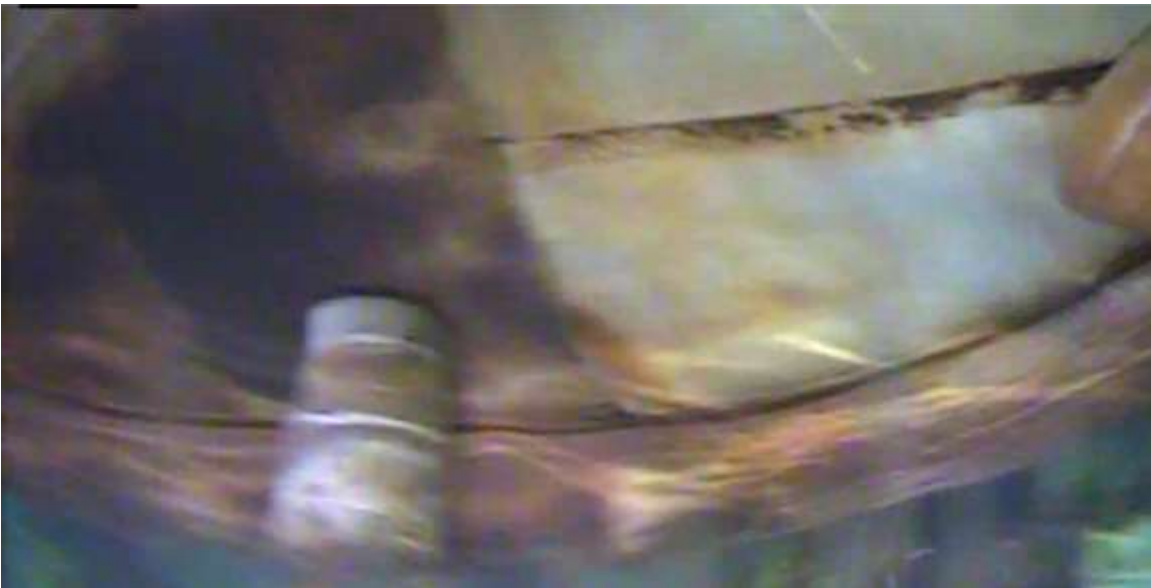
Bottom photo shows the condition of the interior roof-to-rim angle connection. Notice the rust forming in the crevice between the roof and rim angle. We recommend seam sealing using Sikaflex® 1a around the circumference of this connection to prevent failure of a new interior liner. This work is to be performed in conjunction with application of new interior liner.
