**Mission Support and Test Services, LLC
Nevada National Security Site
Mercury, NV 89023
RE: Mercury North (Area 23); Mercury, NV
1,500,000 Gallon GST
September 16, 2018
Mr. Kevin Olsen
Scientist 1
(702) 295-0485
Job No. 318448-A**

**Mission Support and Test Services, LLC
Nevada National Security Site
Mercury, NV 89023
RE: Camp South (Area 12); Mercury, NV
500,000 Gallon GST
September 13, 2018
Mr. Kevin Olsen
Scientist 1
(702) 295-0485
Job No. 318448-D**

**Mission Support and Test Services, LLC
Nevada National Security Site
Mercury, NV 89023
RE: Well 4/4a South (Area 6); Mercury, NV
150,000 Gallon GST
September 24, 2018
Mr. Kevin Olsen
Scientist 1
(702) 295-0485
Job No. 318448-H**

**Mission Support and Test Services, LLC
Nevada National Security Site
Mercury, NV 89023
RE: C-1 North (Area 6); Mercury, NV
50,000 Gallon GST
September 21, 2018
Mr. Kevin Olsen
Scientist 1
(702) 295-0485
Job No. 318448-O**

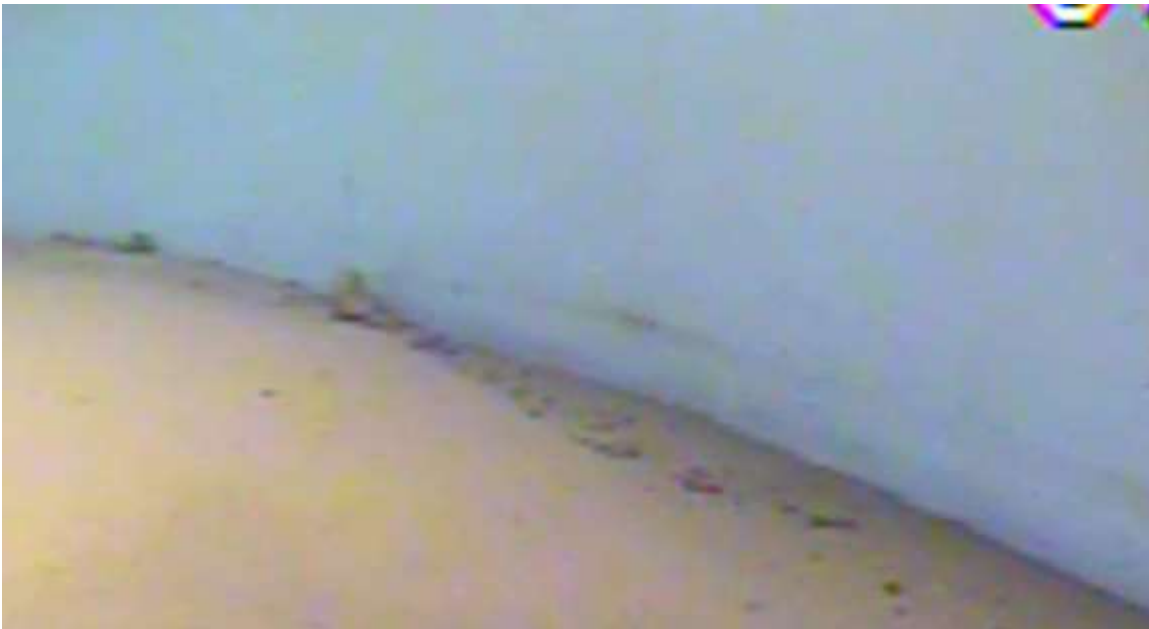
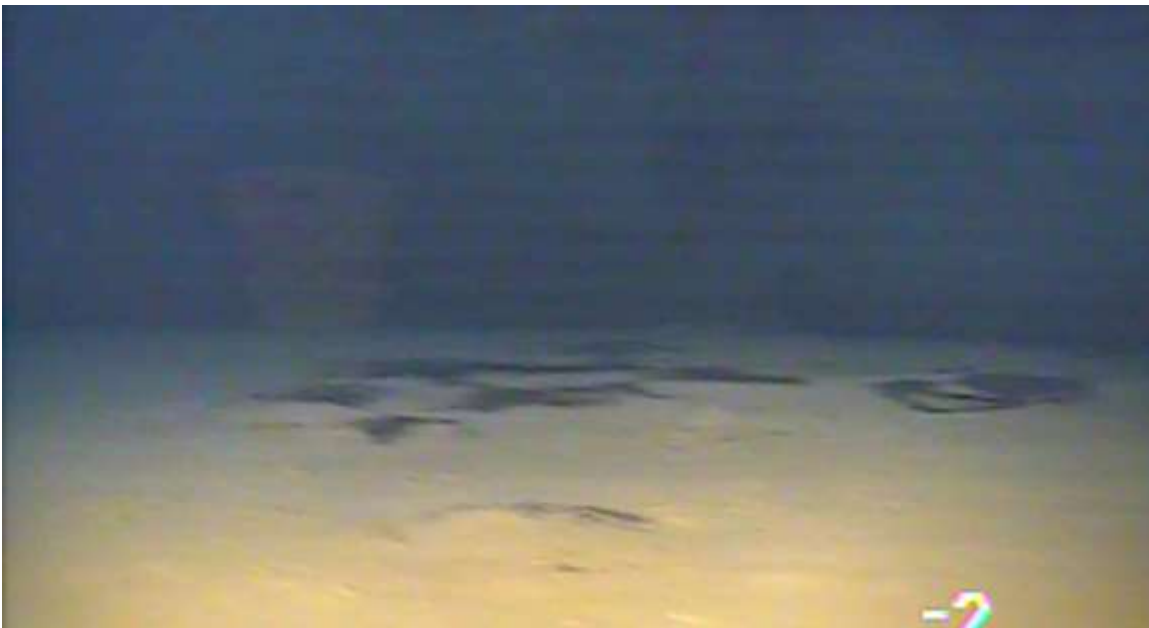
Photos show sediment and debris on the tank interior before a cleanout was performed.

We recommend installing a passive cathodic protection system.

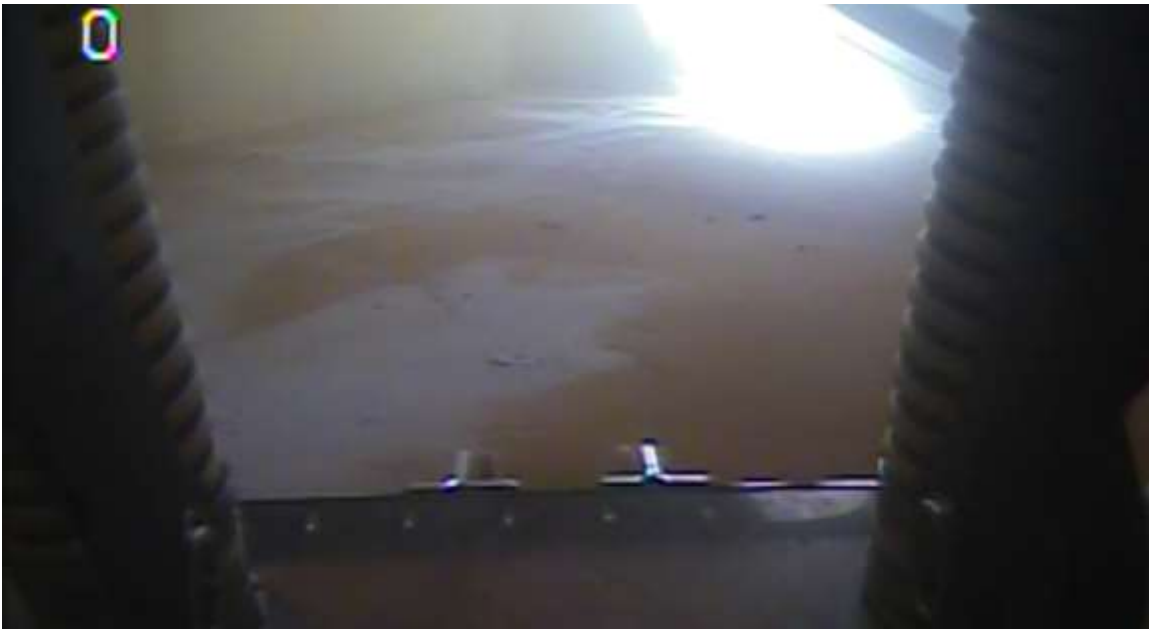
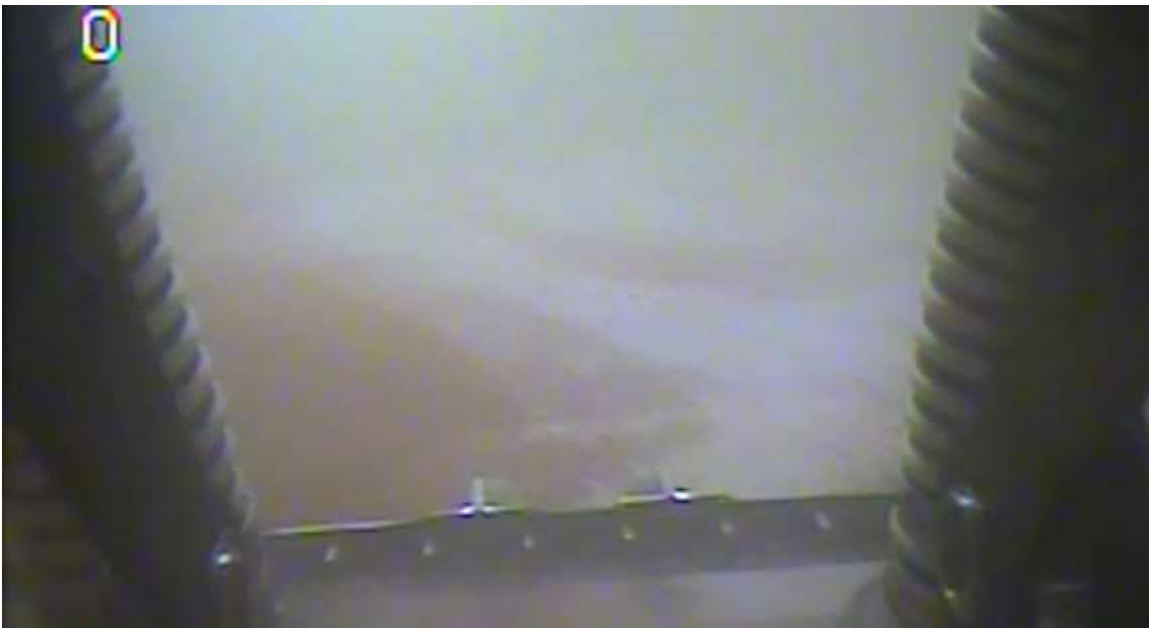
Photos show the tank interior during a cleanout.

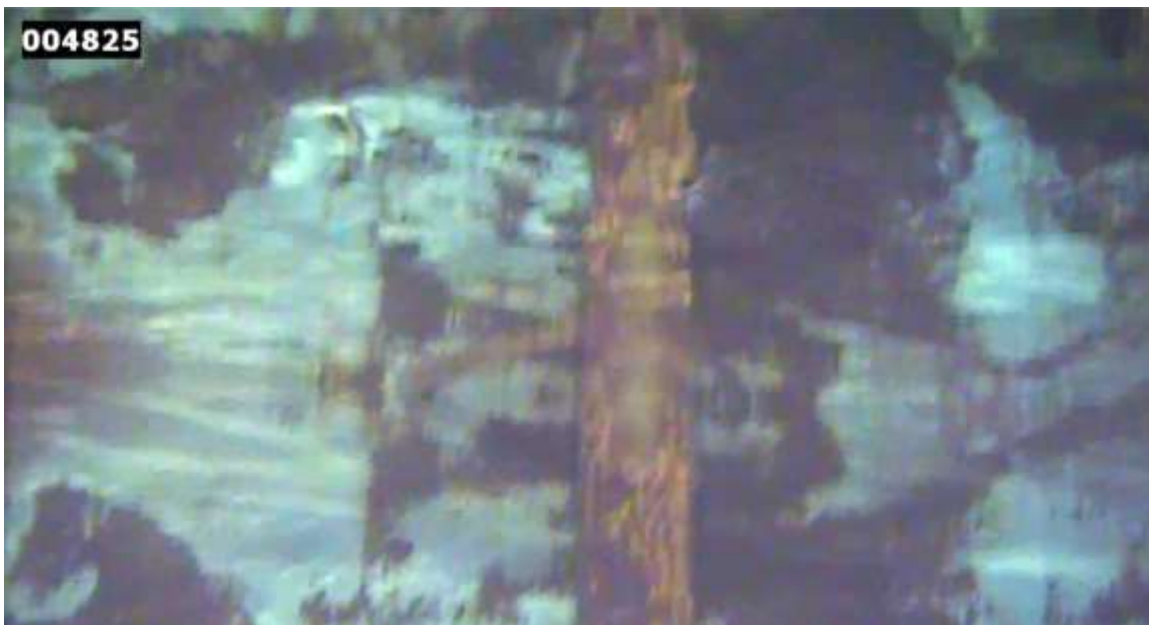
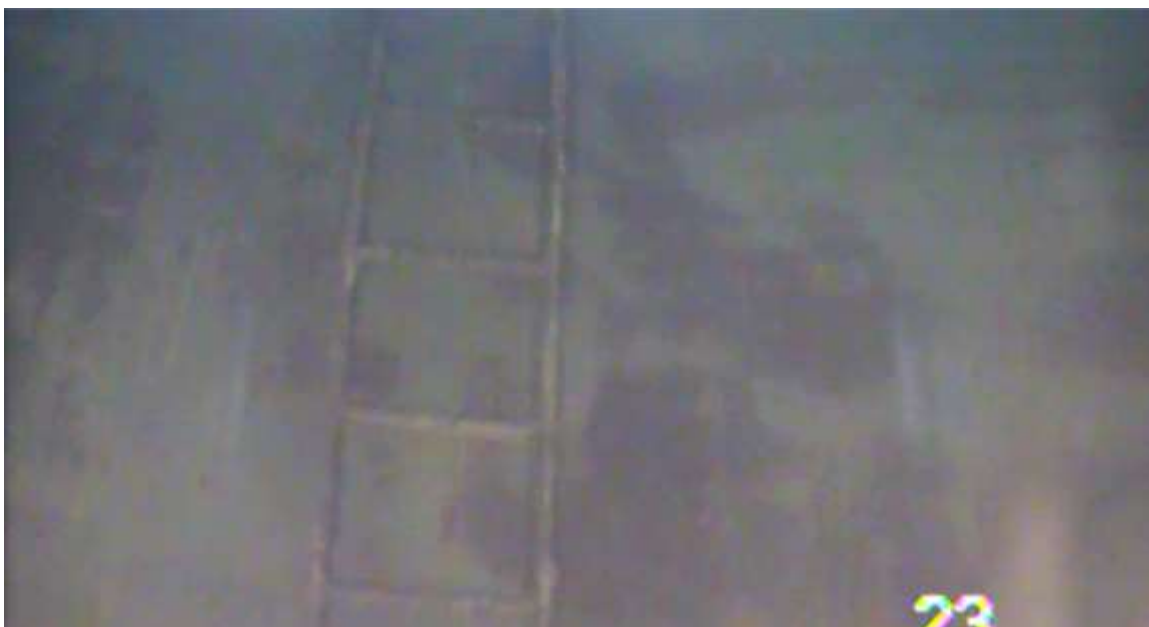
Photos show the tank interior coating system. We recommend sandblasting all interior areas to SSPC-SP10 (near white), apply one (1) stripe coat of epoxy primer to weld seams, then apply two (2) full coats of epoxy to the entire tank to achieve 8 to 10 mils of total dry film thickness.

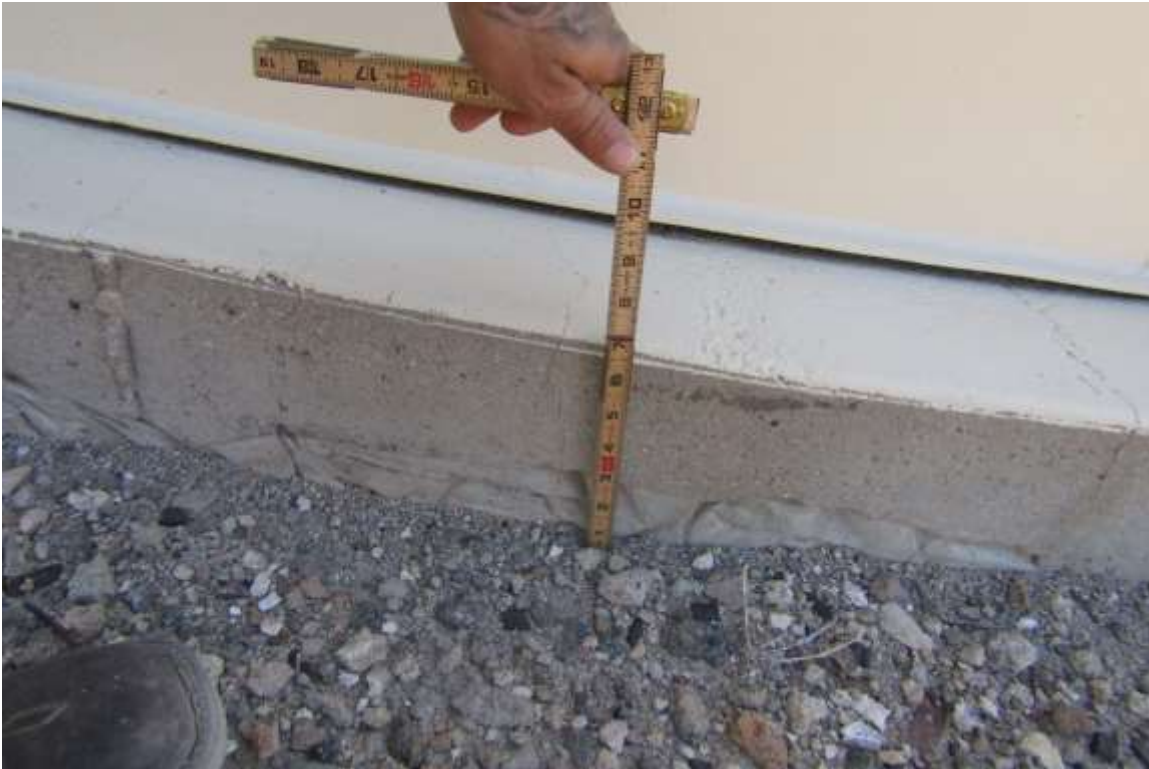
Photo shows the area around the tank foundation is properly graded and in compliance with **AWWA D100-11; 12.7.1 Height aboveground.**

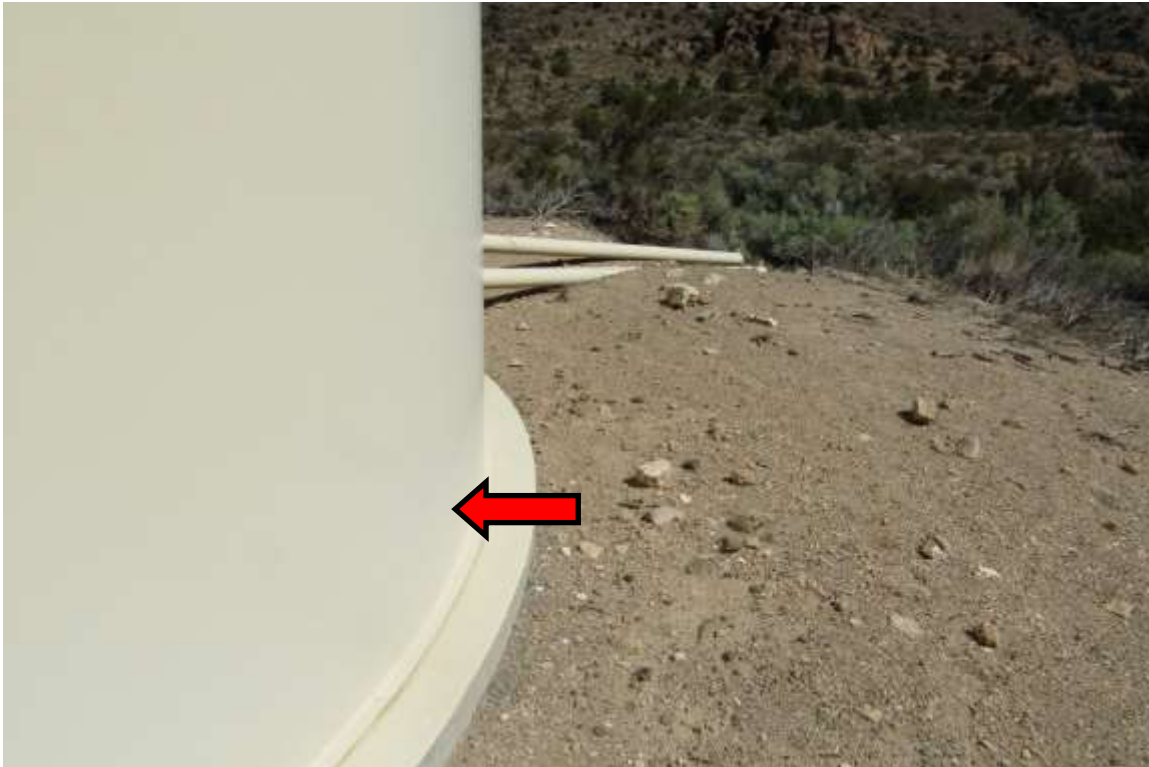
Photo shows the condition of the foundation. We recommend repairing any cracks and spalling in the concrete with a commercial non-shrinking grout, caulking/grouting around the base of the tank to foundation connection to prevent water from entering under the tank, then sealing the foundation with a sealant.

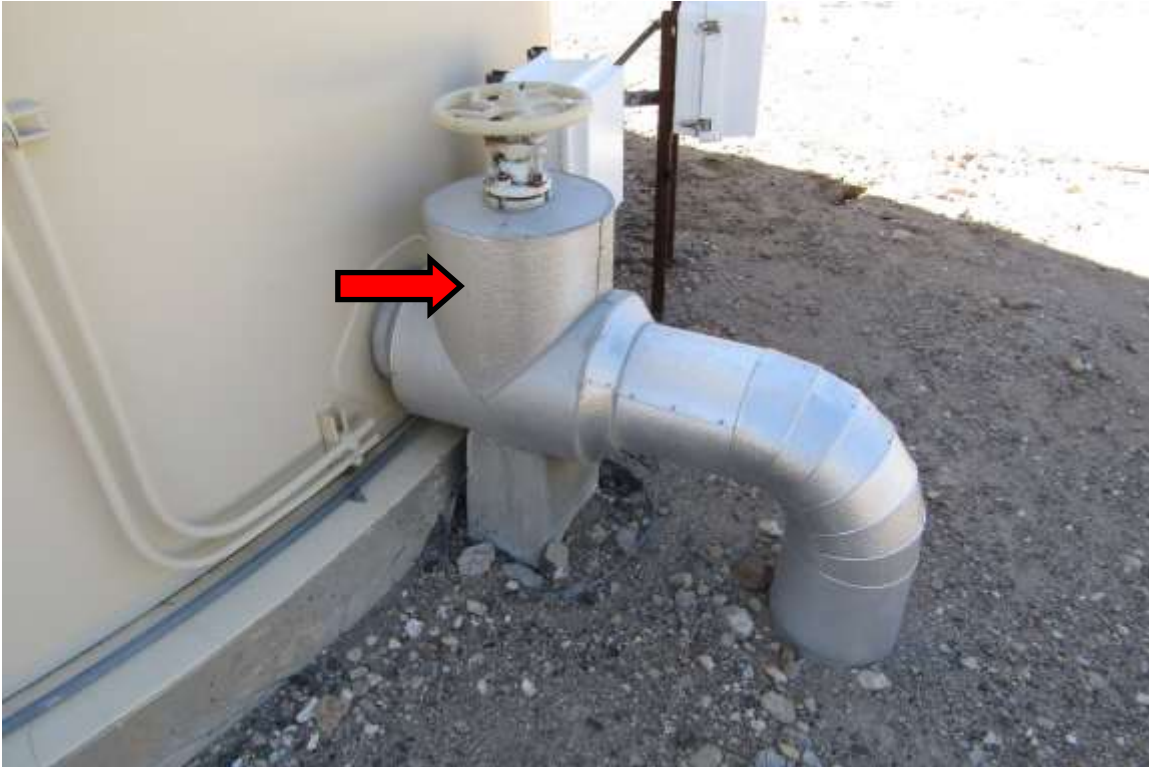
Photo shows the tank has no grounding system. We recommend electrically grounding the tank for lightning protection as required by **OSH Act of 1970 Section 5**.

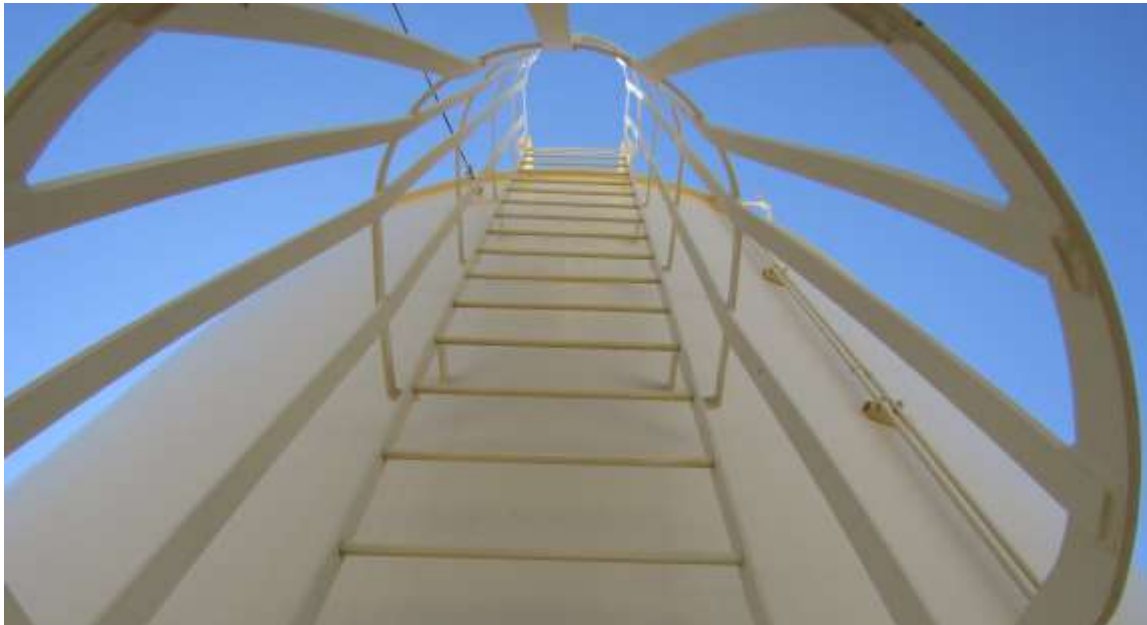
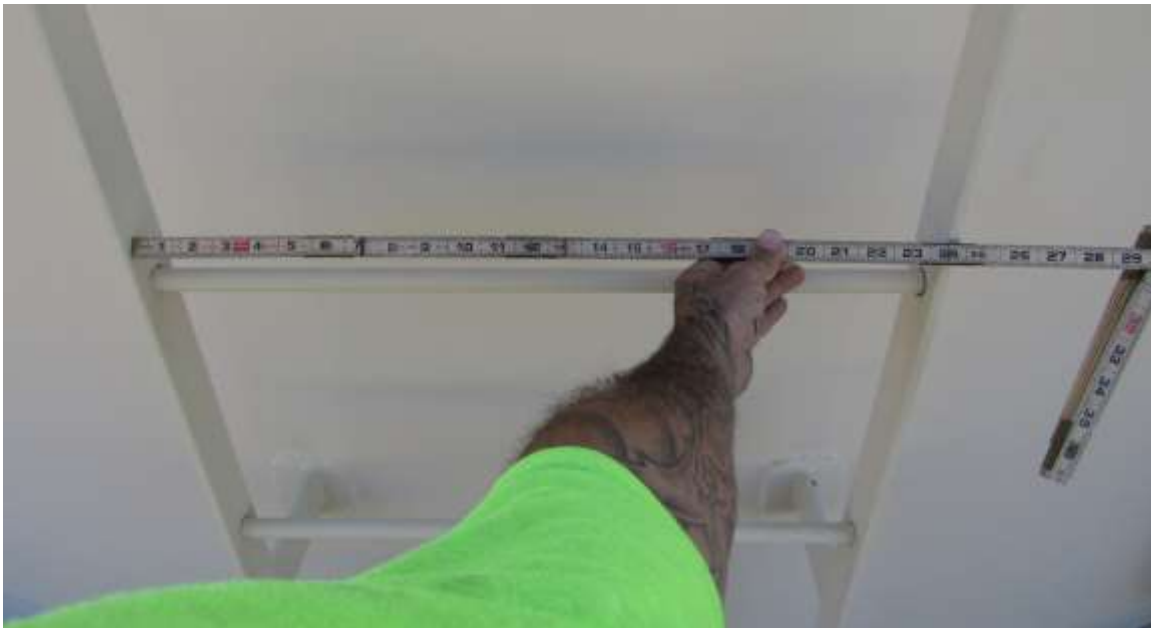
Photos show the 6" overflow pipe system, which appears to be in good condition.

Shell access ladder in above photos is 24" wide, but is not equipped with anti-skid rungs. We recommend installing anti-skid rung covers, a cable type ladder safety device, a lockable ladder guard to prevent unauthorized access, and posting a **Fall Protection Required** sign at the base of the ladder.

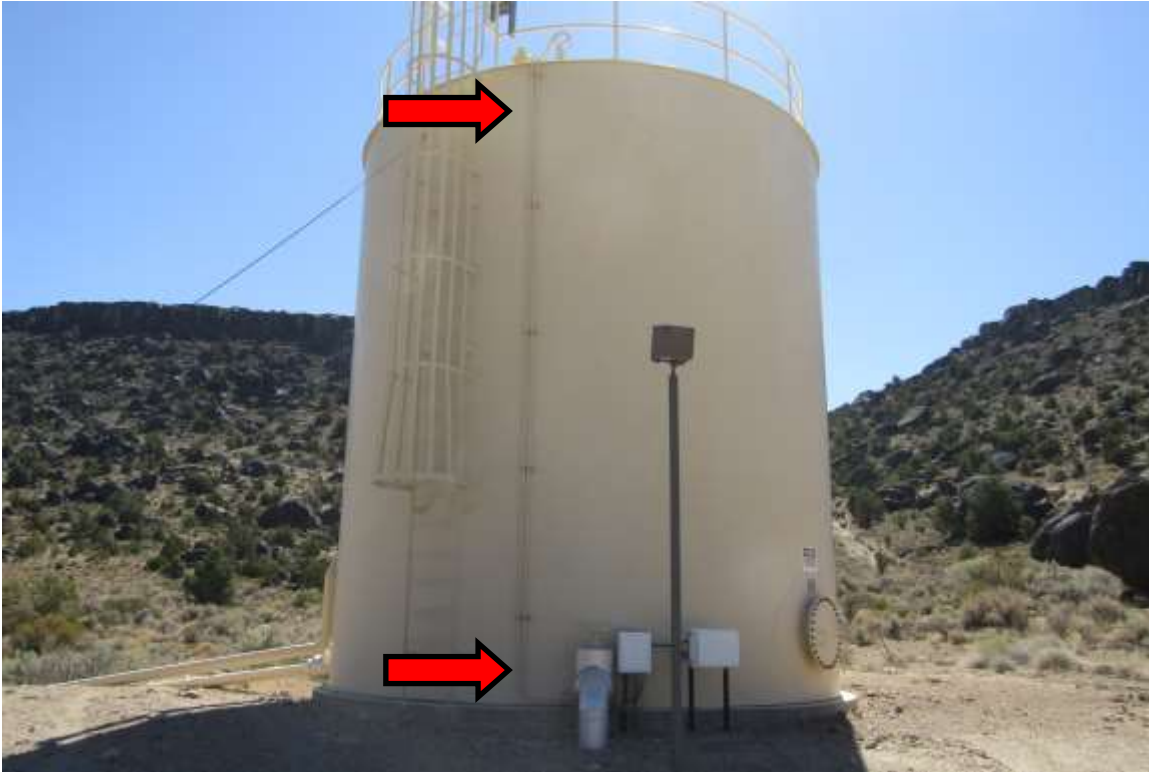
Photos show the condition of the liquid level indicator. **NFPA 22-2018; 14.1.8* Water-Level Gauge** states, "A water-level gauge of suitable design shall be provided. It shall be carefully installed, adjusted, and properly maintained." Due to the condition of the indicator, we recommend replacing the existing liquid level indicator.

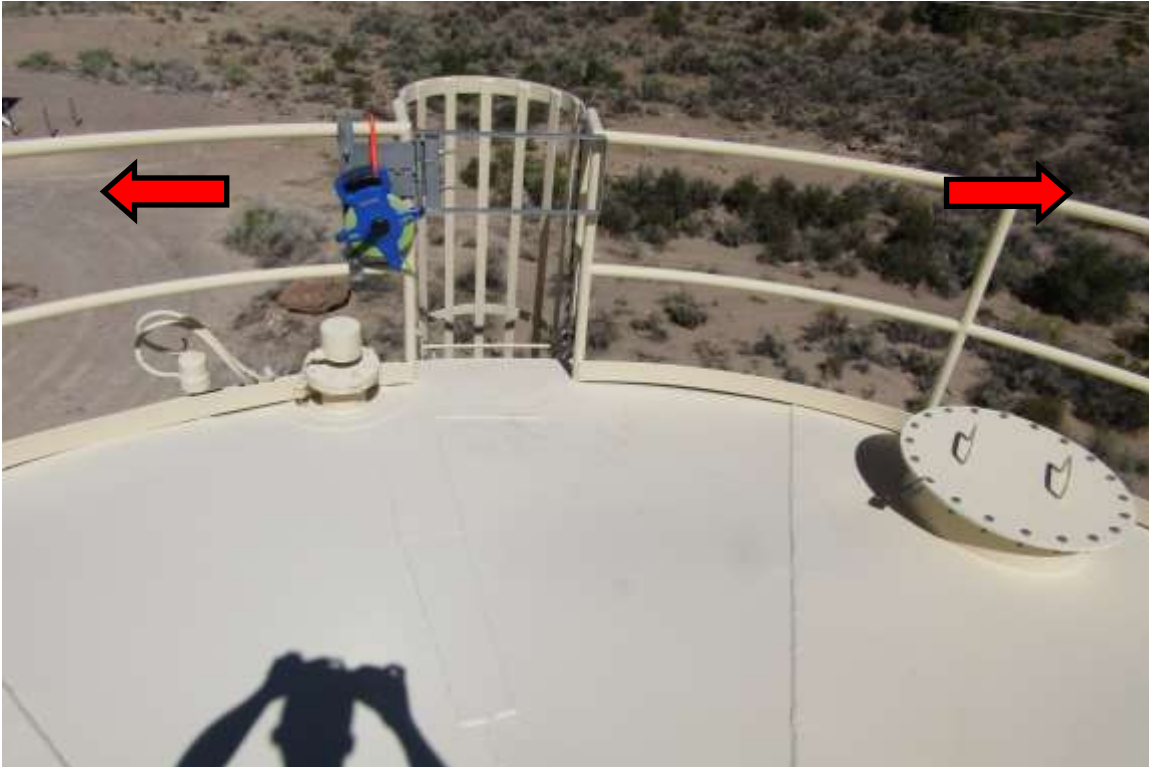
Photo shows the tank roof edge is equipped with a 43" high compliant handrail system for fall protection as required by **OSHA 1910.28(b)(1)**. The handrail system is equipped with an intermediate rail and toeboard.

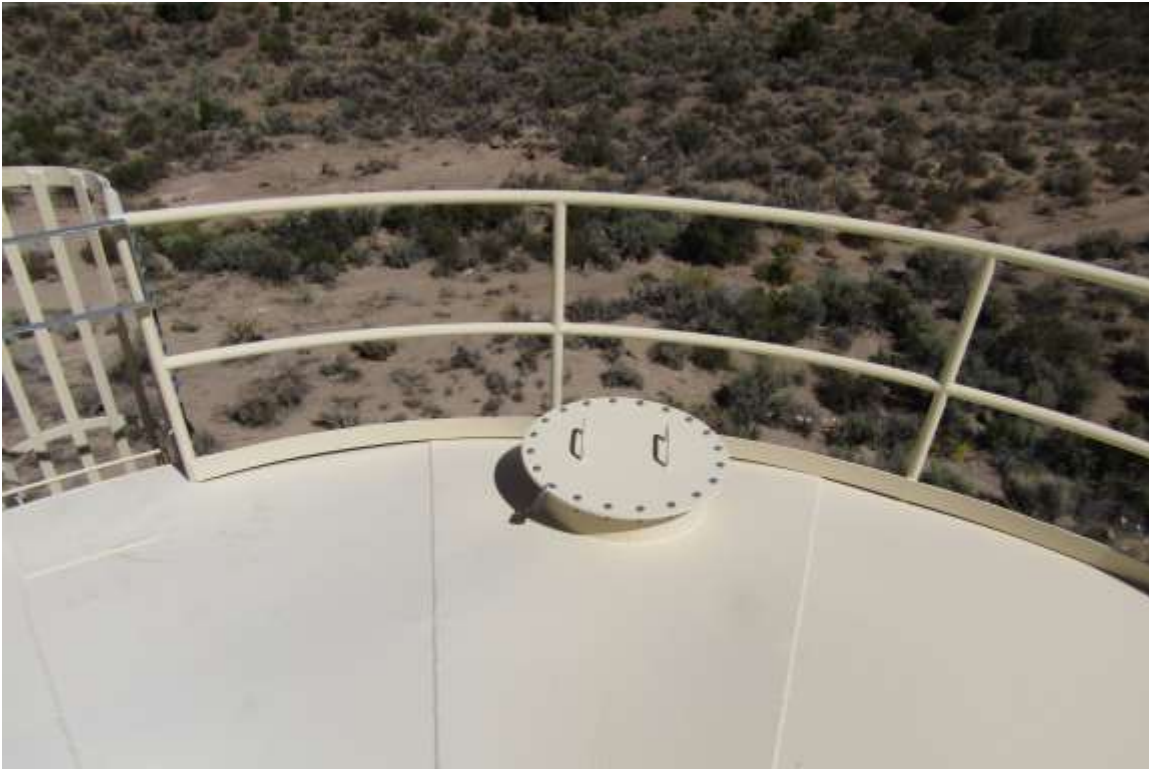
Photo shows the condition of the 24" primary roof hatch. Roof openings on this tank require the following to be in compliance with **AWWA D100-11; 7.4.3 Roof openings** and **OSHA 1910.146(c)(2) Confined spaces**.

We recommend:

We further recommend installing **OSHA** compliant interior access ladders complete with standoffs every 10' on center, and cable type ladder safety devices at the primary and suggested secondary roof hatches.

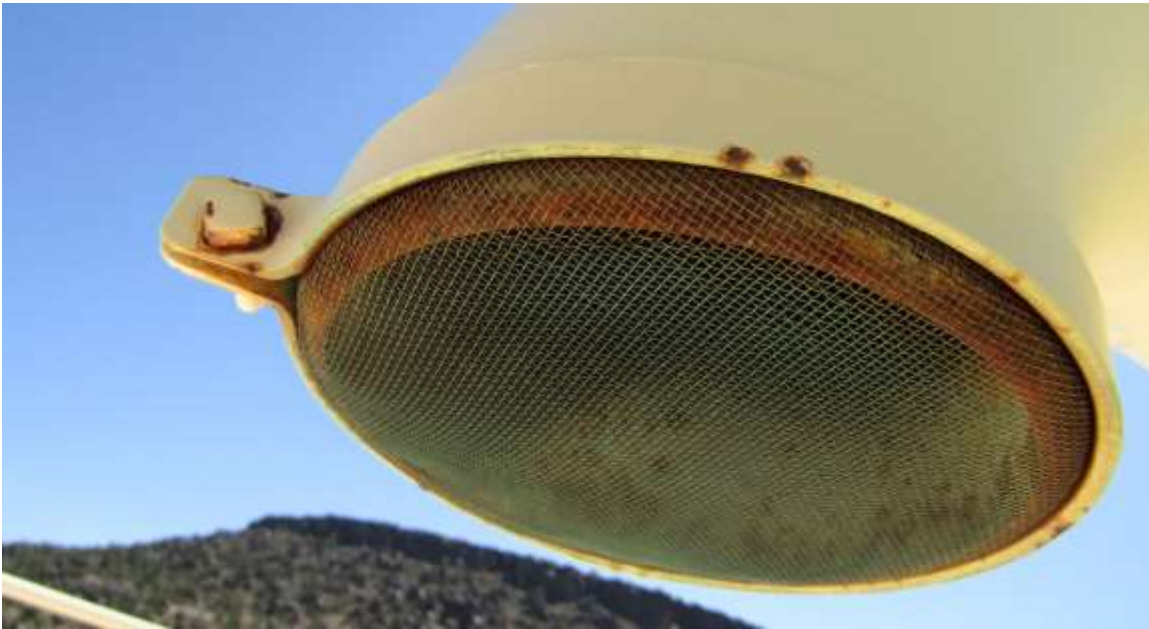
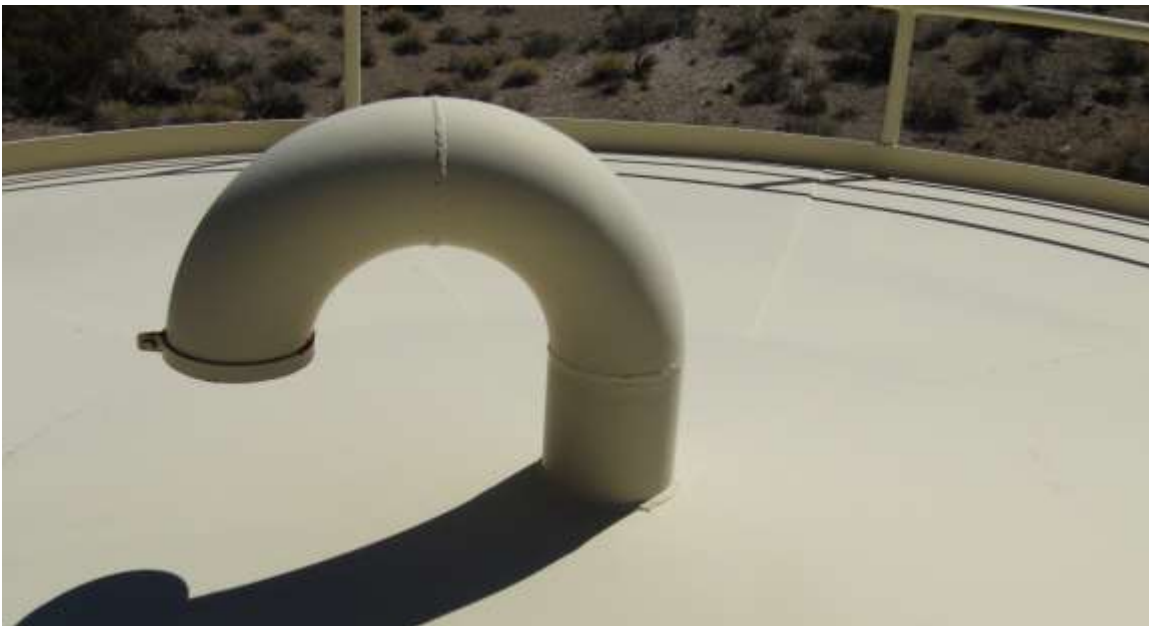
Photos show the condition of the existing 8" roof vent. **This vent is allowing the ingress of rain and wind-borne contaminants into the water system. An improperly vented tank may cause external pressure to act on the tank which can cause buckling even at low pressure differential.** We recommend replacing the existing roof vent with a vacuum-pressure, frost proof vent and screen.

This work should be performed on an emergency basis.

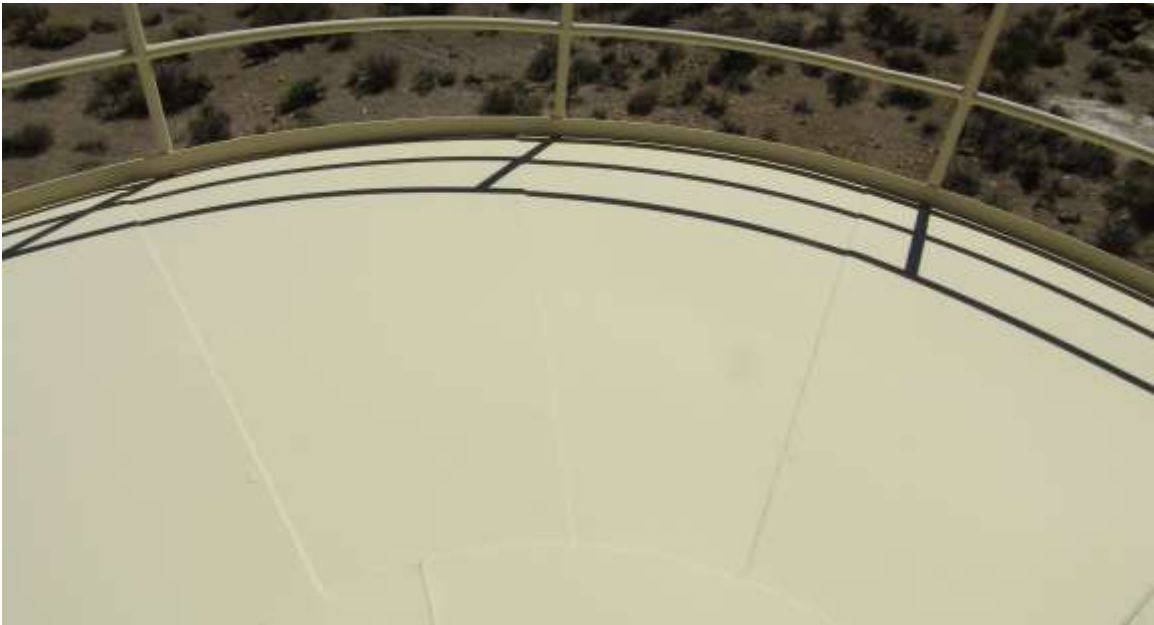
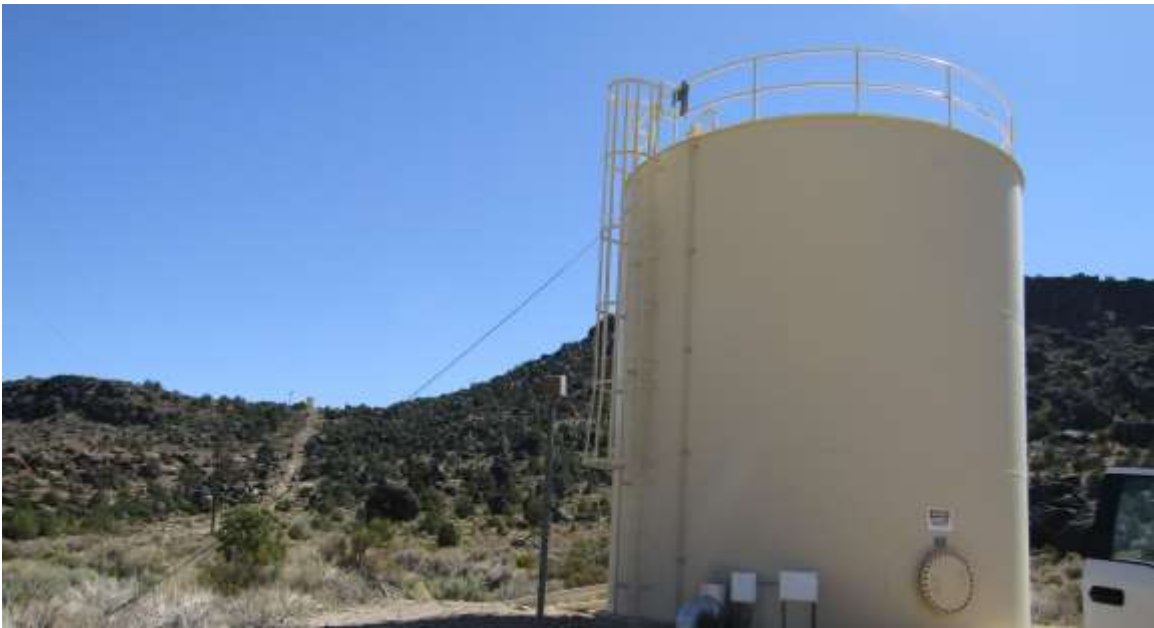
Photos show the tank exterior coating system. The overall exterior coating system appears to be in good condition. We recommend re-evaluating the tank exterior at next inspection cycle.

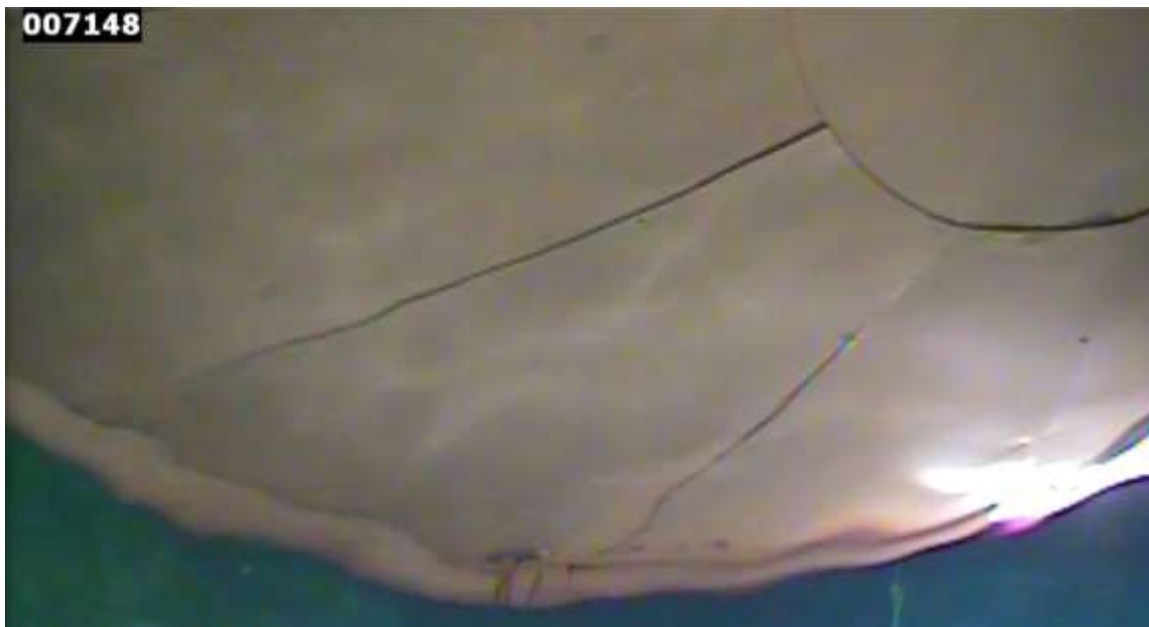
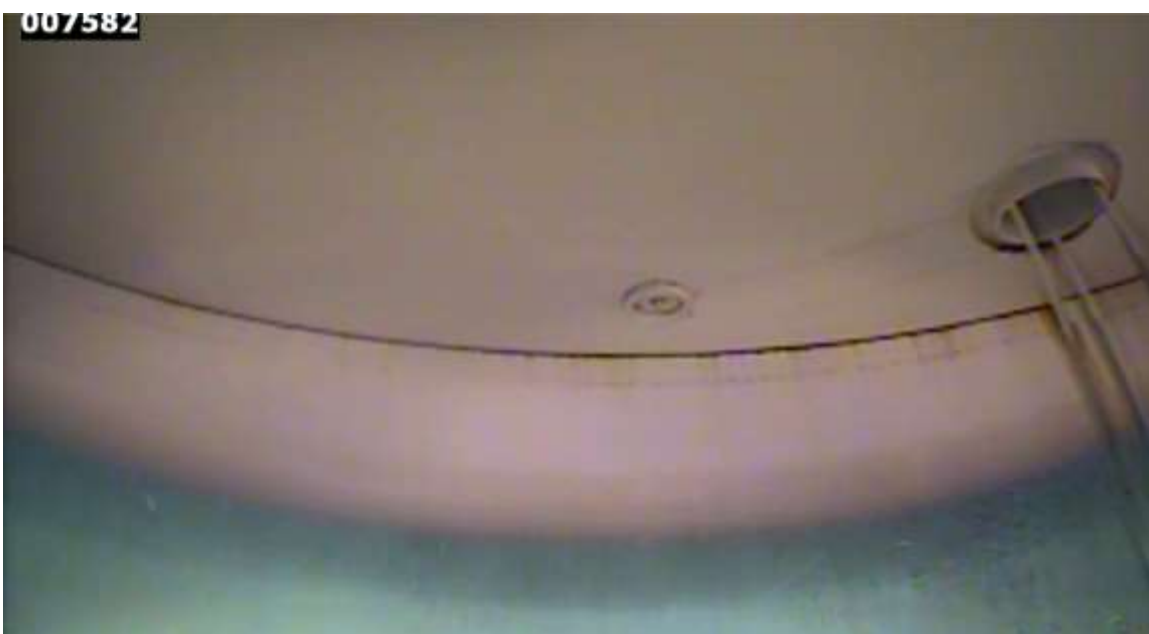
Top photo shows the interior roof lap seams, which appear to be in good condition.

Bottom photo shows the interior roof-to-rim angle connection, which appears to be in good condition.

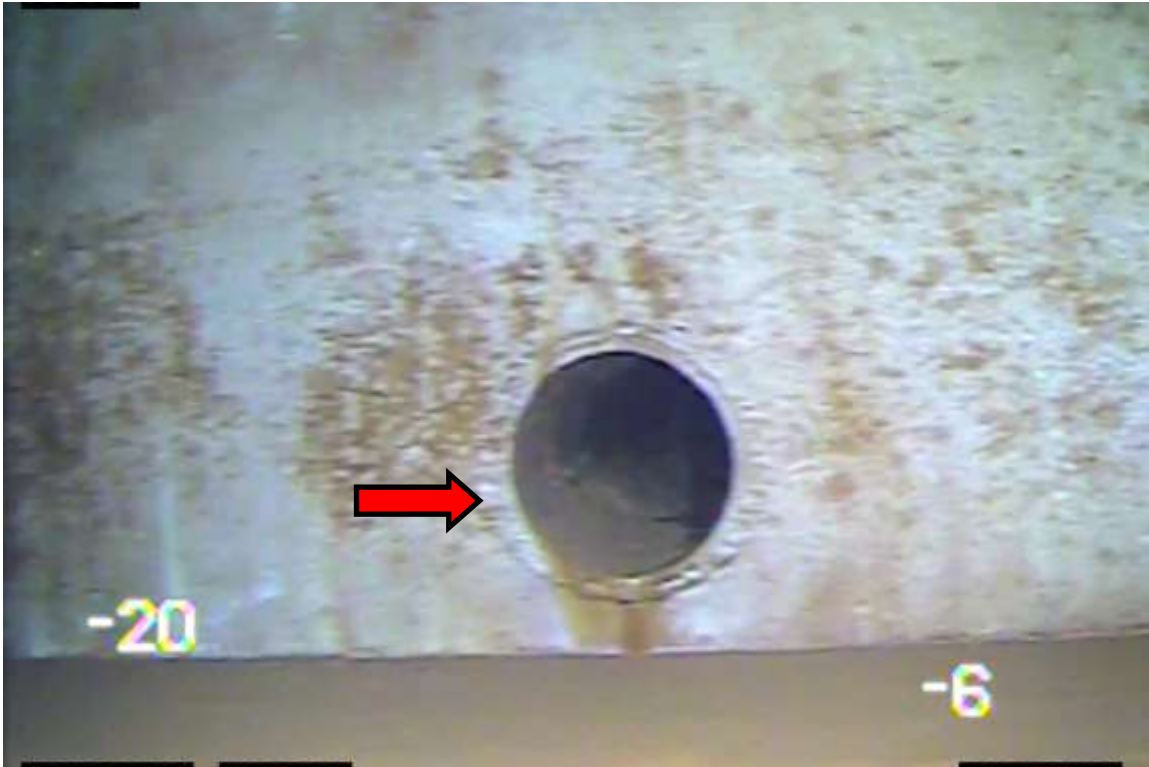
Photo shows a fill pipe on the tank interior. A temperature difference between the water in the top and bottom of a tank, even as little as 1-2 degrees Fahrenheit, is an indication of thermal stratification and the tank water not being completely mixed. Incomplete mixing would result in short-circuiting, and localized increase in water age would develop inside the tank. This typically leads to water quality problems, such as loss of residual, DBP spikes, HPC spikes, bacteria regrowth, formation of bio-film, changes in pH and dissolved oxygen. We recommend installing a mixing system. Electrical work to be done by others if required.

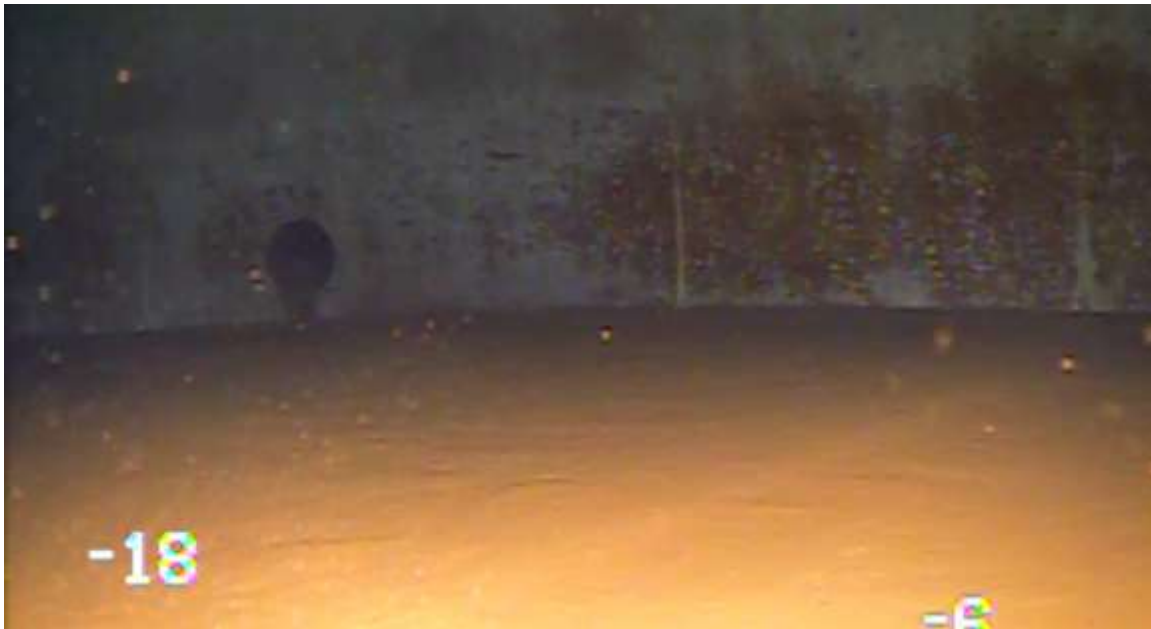
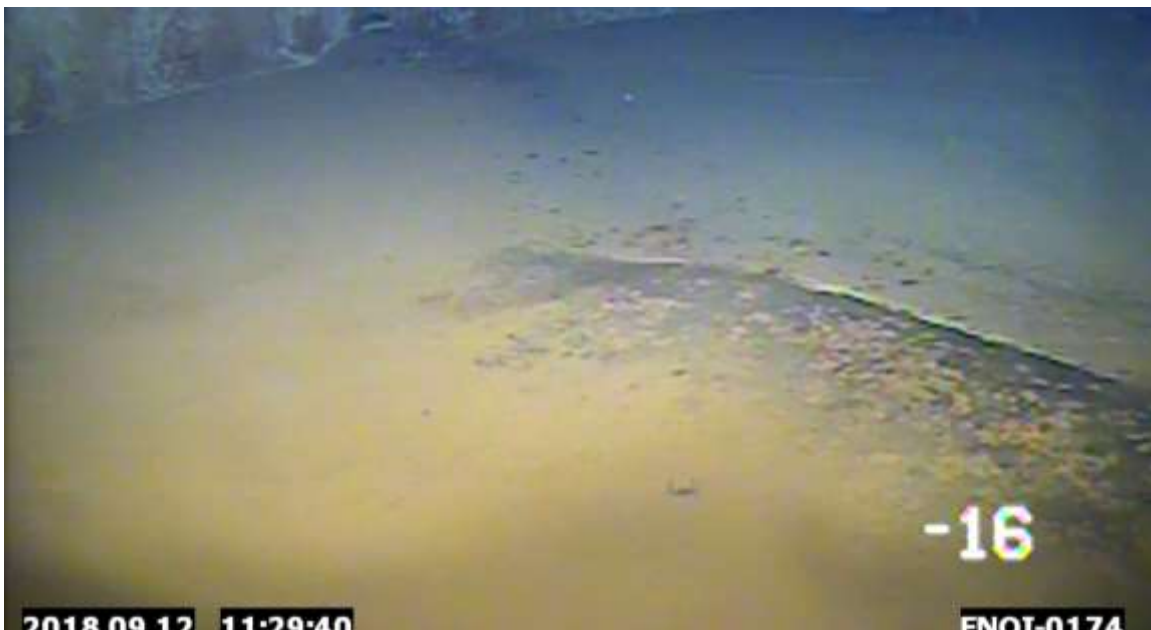
Photos show sediment and debris on the tank interior before a cleanout was performed.

We further recommend installing a passive cathodic protection system.

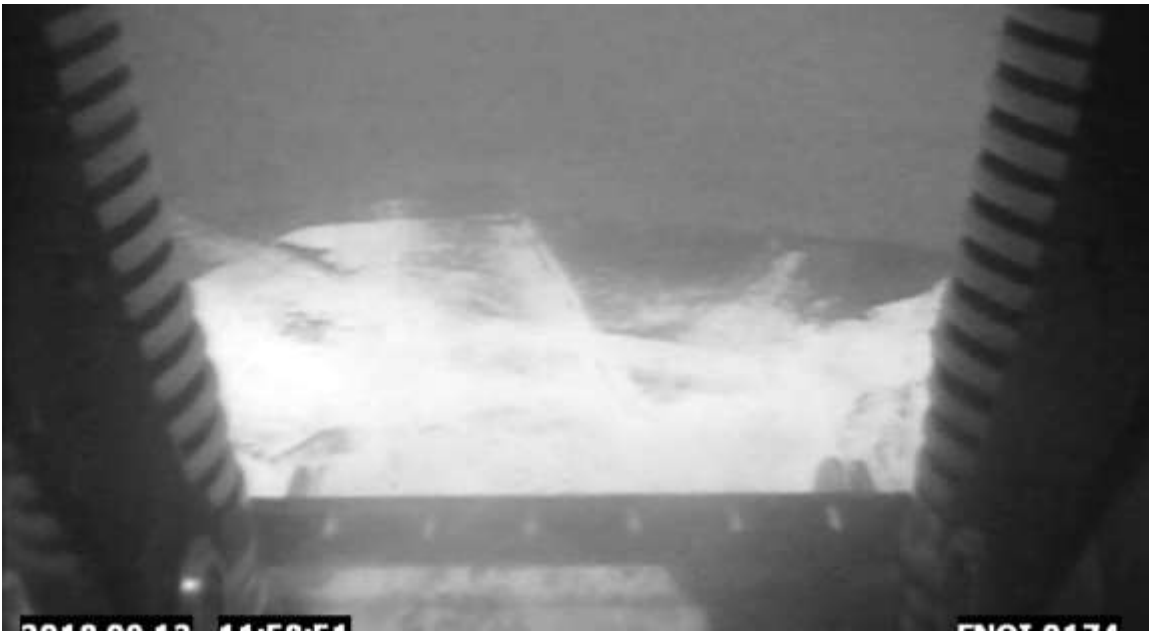
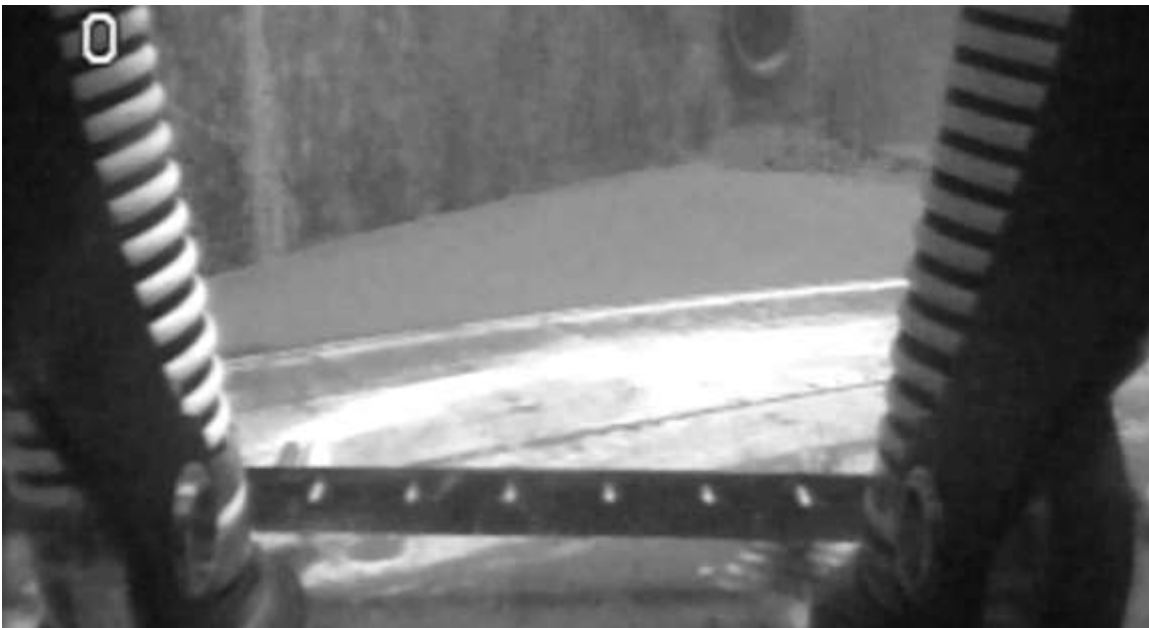
Photos show the tank interior during a cleanout.

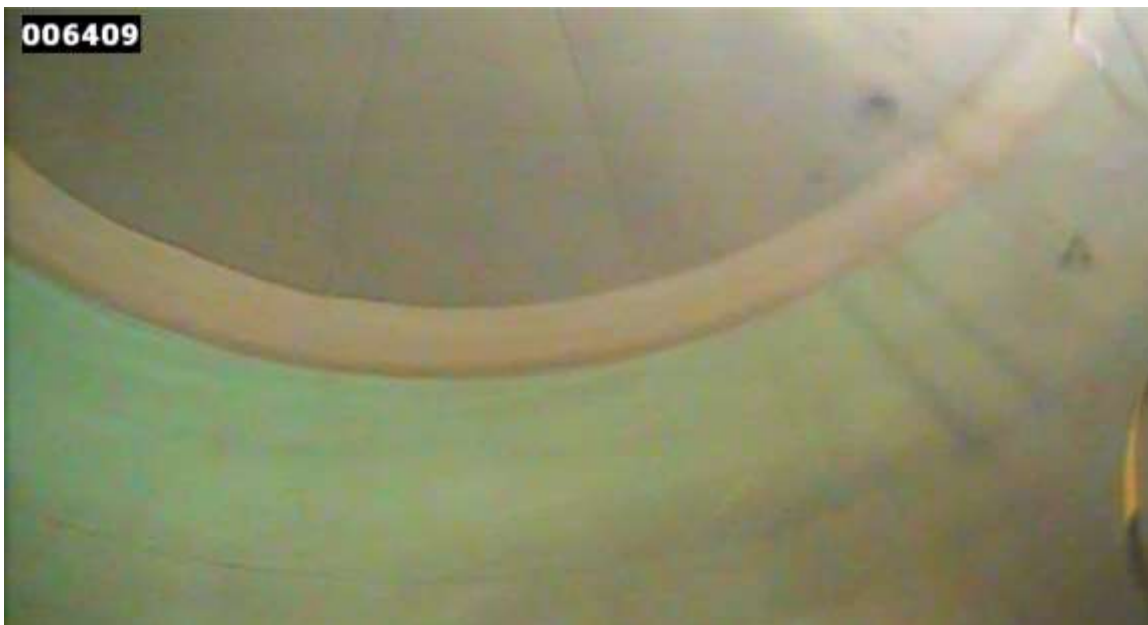
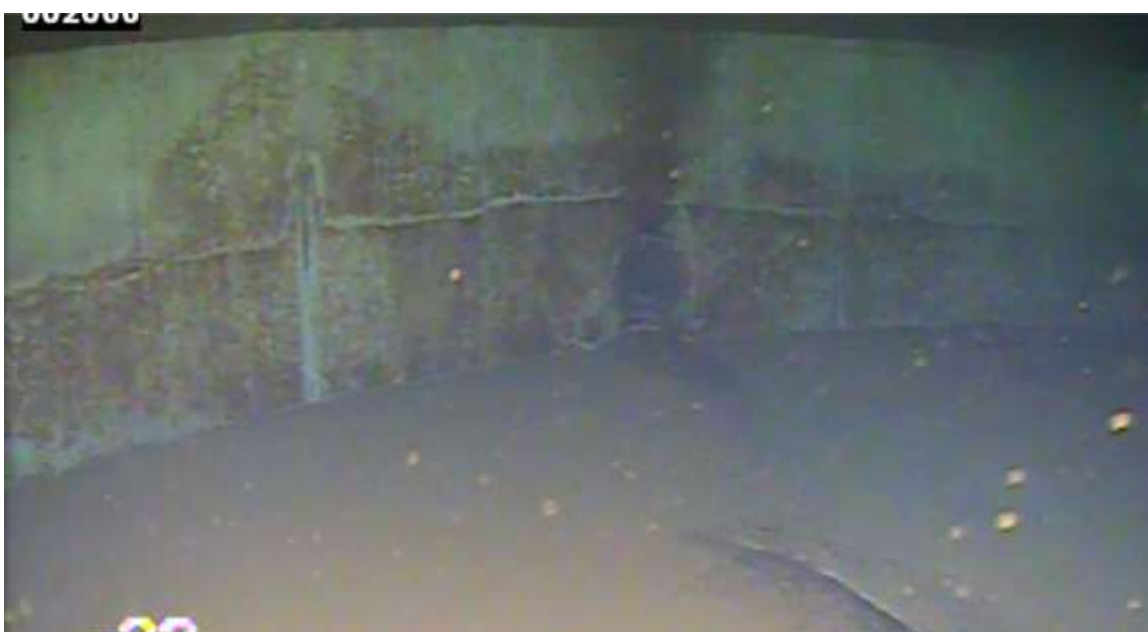
Photos show the tank interior coating system. The overall interior coating system appears to be in good condition. We recommend pressure washing the tank interior with biodegradable detergent injection (minimum 3,500 psi at 3.0 gpm), then re-evaluating the tank interior at next inspection cycle.

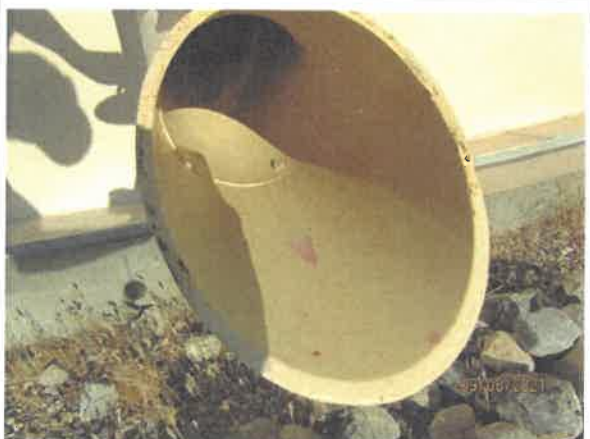
5 - Interior overflow pipe with no screen

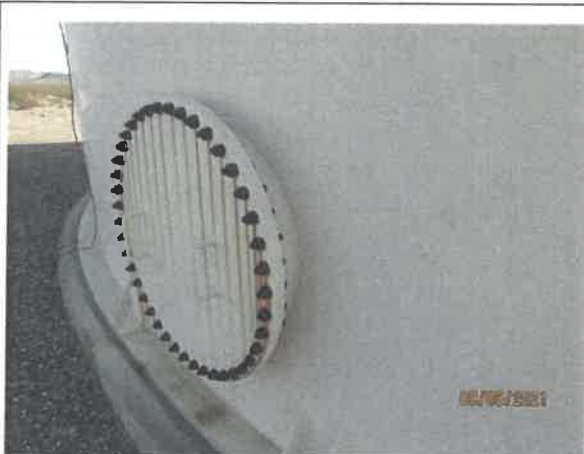
There are two 30-in diameter manholes on opposing sides of the lower shell. The hatch bolts have corrosion and there is corrosion staining on both manholes. There are no signs of leaks.

7 - Shell manhole with corrosion on bolts

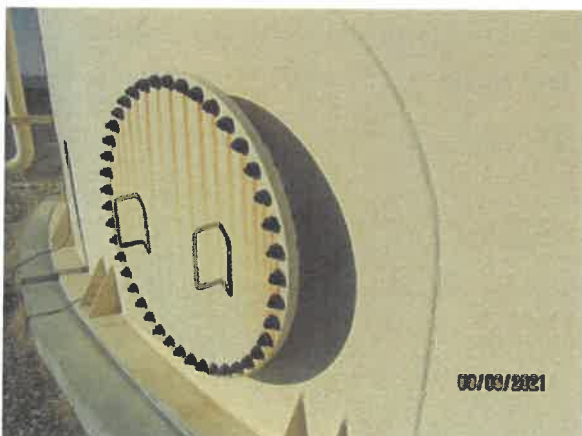
10 - Second shell manhole with corrosion on bolts
