**Mission Support and Test Services, LLC
Nevada National Security Site
Mercury, NV 89023
RE: Mercury North (Area 23); Mercury, NV
1,500,000 Gallon GST
September 16, 2018
Mr. Kevin Olsen
Scientist 1
(702) 295-0485
Job No. 318448-A**

**Mission Support and Test Services, LLC
Nevada National Security Site
Mercury, NV 89023
RE: Camp South (Area 12); Mercury, NV
500,000 Gallon GST
September 13, 2018
Mr. Kevin Olsen
Scientist 1
(702) 295-0485
Job No. 318448-D**

**Mission Support and Test Services, LLC
Nevada National Security Site
Mercury, NV 89023
RE: Well 4/4a South (Area 6); Mercury, NV
150,000 Gallon GST
September 24, 2018
Mr. Kevin Olsen
Scientist 1
(702) 295-0485
Job No. 318448-H**

**Mission Support and Test Services, LLC
Nevada National Security Site
Mercury, NV 89023
RE: C-1 North (Area 6); Mercury, NV
50,000 Gallon GST
September 21, 2018
Mr. Kevin Olsen
Scientist 1
(702) 295-0485
Job No. 318448-O**

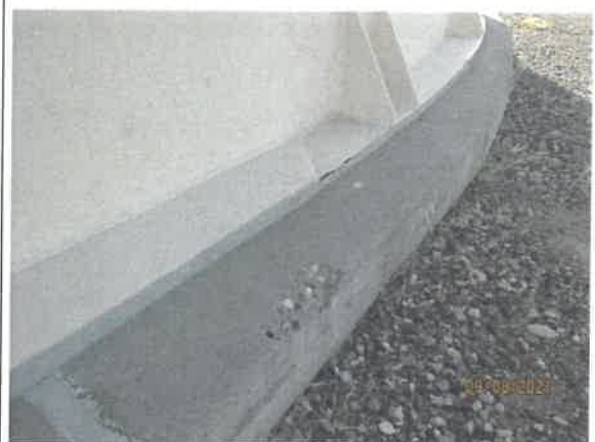
The tank foundation has minor cracks and spalls around the tank. There is one spot with grout separating from the concrete between foundation sections. The chime grout is intact, with several areas of general corrosion. There is one area where the grout is separating from the foundation. The anchor bolts are free from major corrosion and are all engaged.

17 - Small spall on tank foundation

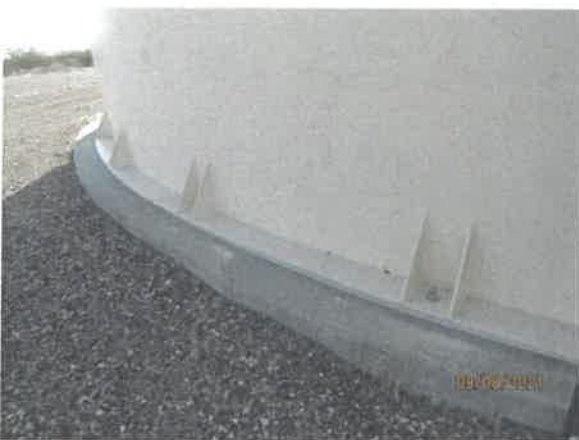
15 - Tank foundation typical condition

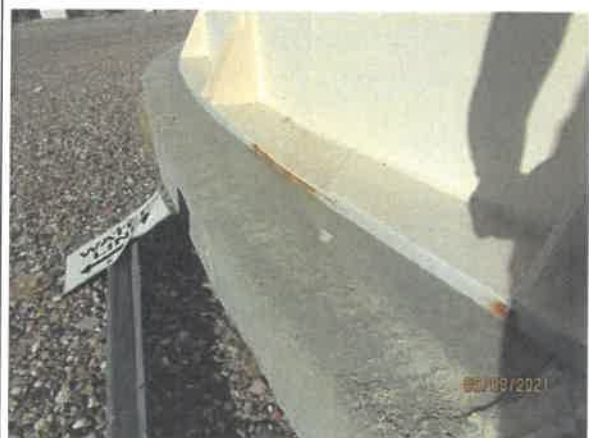
16 - Foundation grouting separating

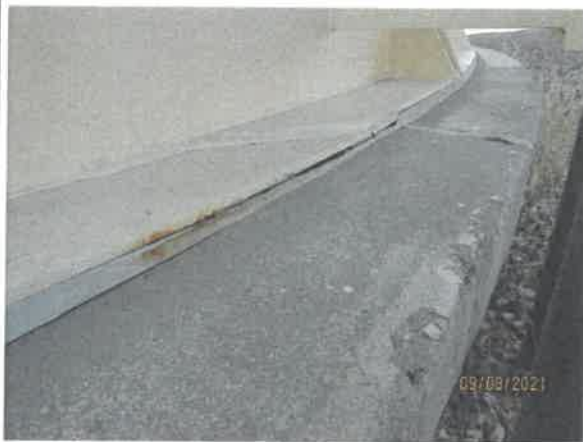
19 - Corrosion on chime plate

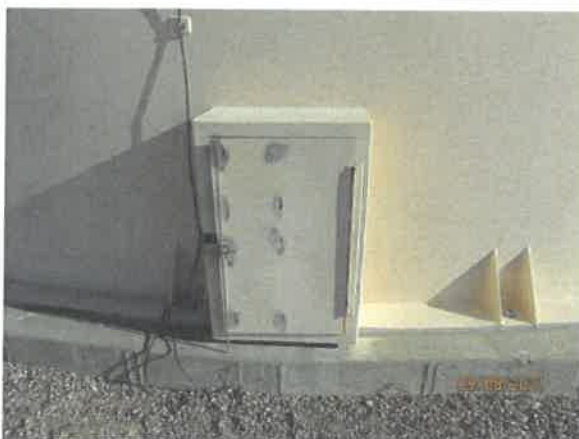
24 – Intact grounding wire

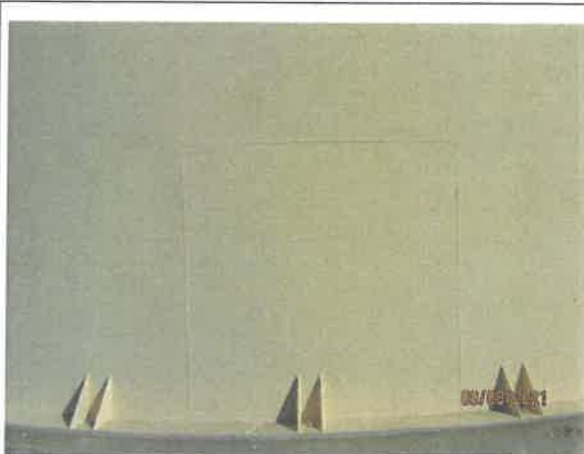
25 - Shell plate coating intact

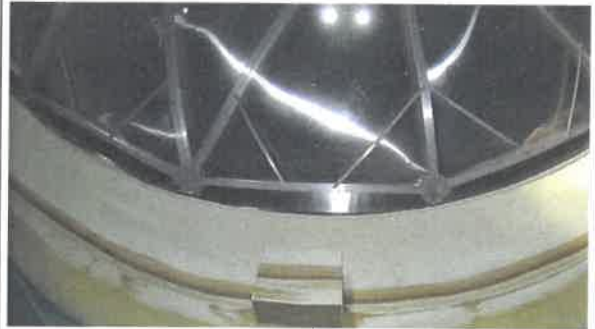
00:54 - Sediment staining on shell in fluctuation zone

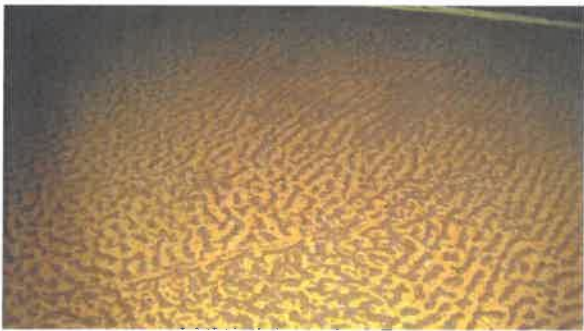
4:50 – Minor dusting of sediment on tank floor, coating is intact and free of corrosion

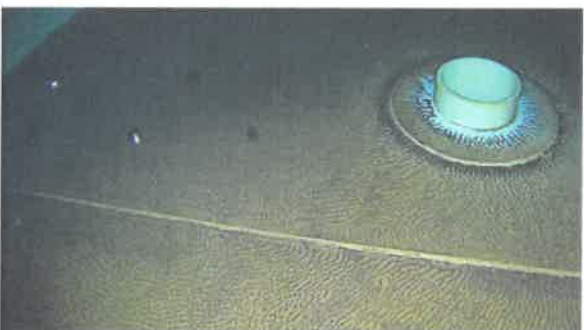
4:53 - Outlet pipe with sediment ring and dusting of sediment

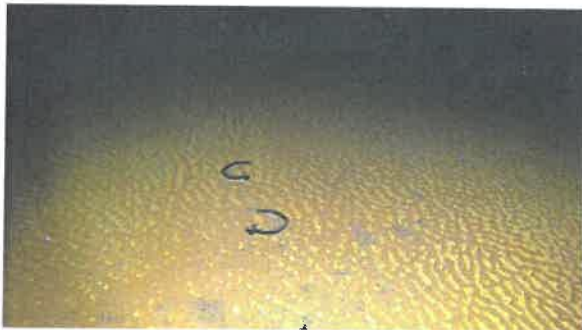
8:28 - Debris on floor of tank

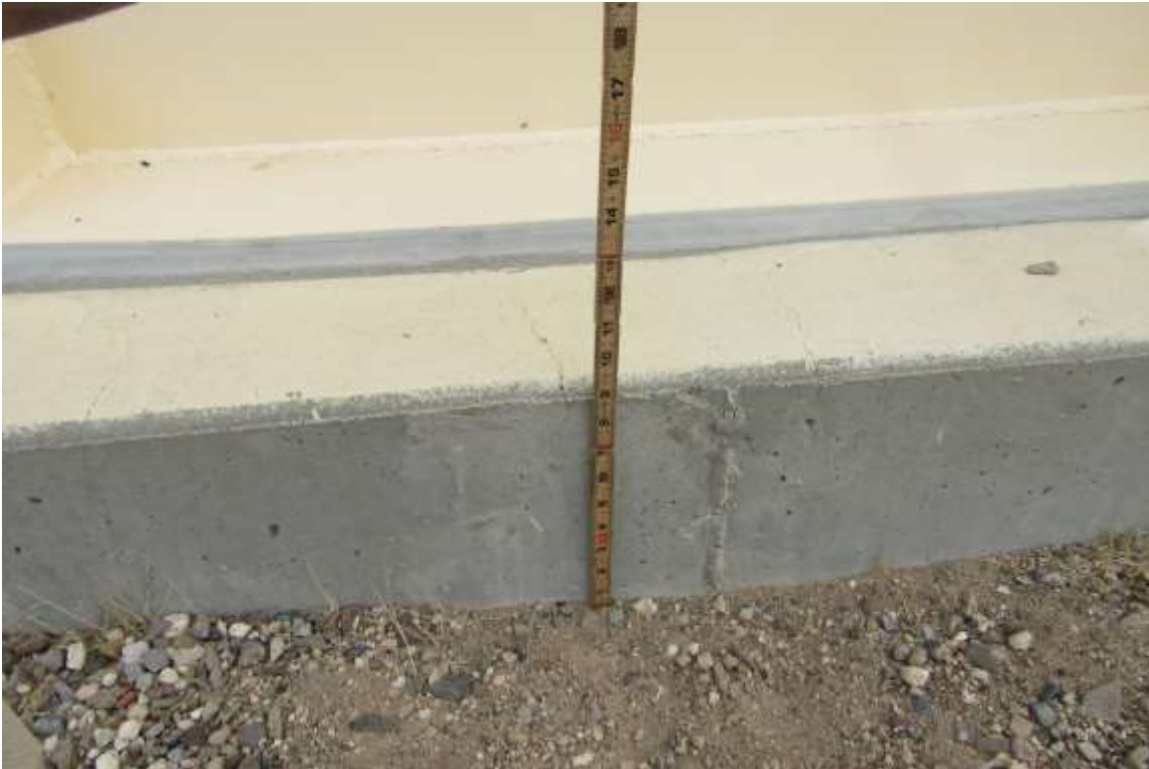
Photo shows the area around the tank foundation is properly graded and in compliance with **AWWA D100-11; 12.7.1 Height aboveground.**

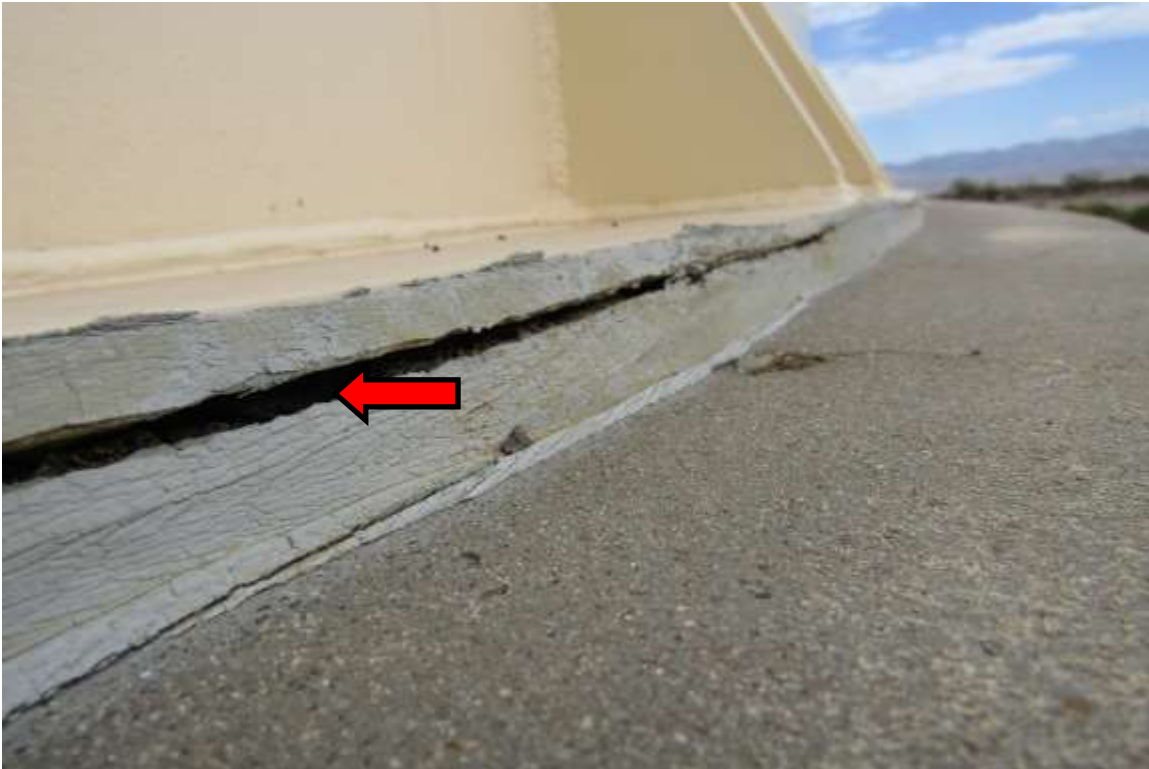
Photo shows the condition of the foundation. We recommend repairing any cracks and spalling in the concrete with a commercial non-shrinking grout, caulking/grouting around the base of the tank to foundation connection to prevent water from entering under the tank, then sealing the foundation with a sealant.

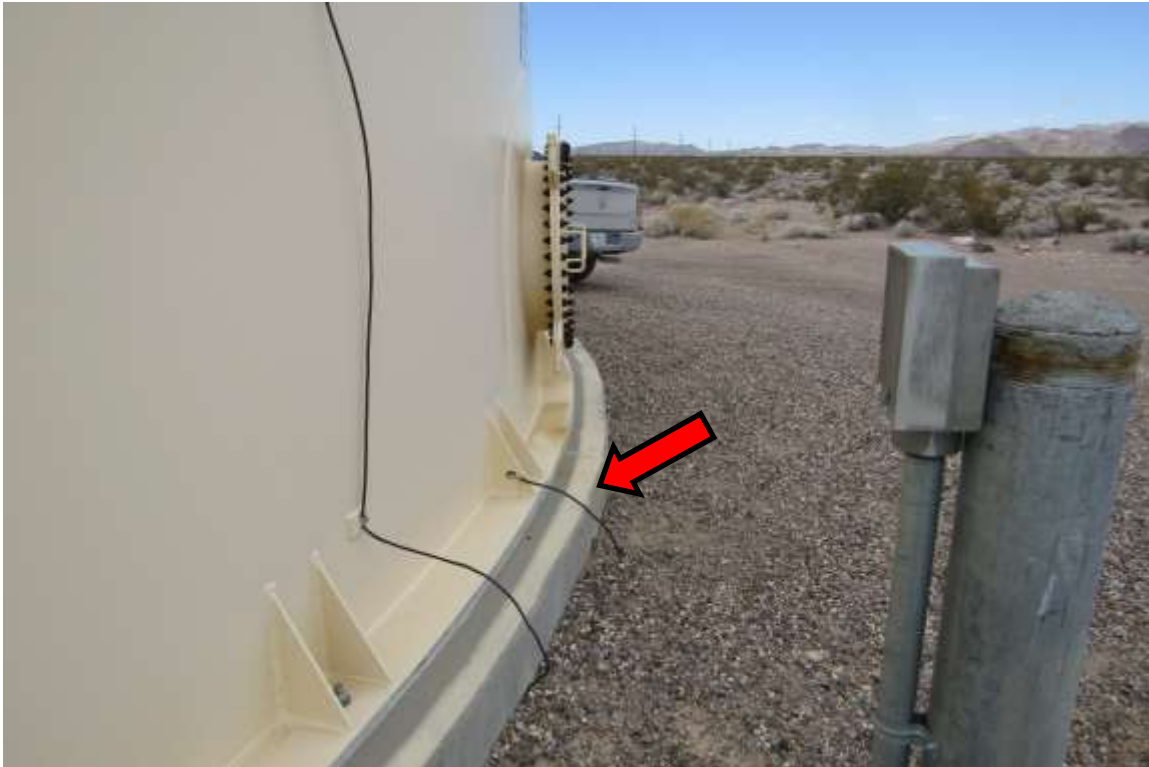
Photo shows the tank is electrically grounded for lightning protection as required by **OSH Act of 1970 Section 5** and **NFPA 780-2017; 5.4 Metal Towers and Tanks** and appears to be in good condition.

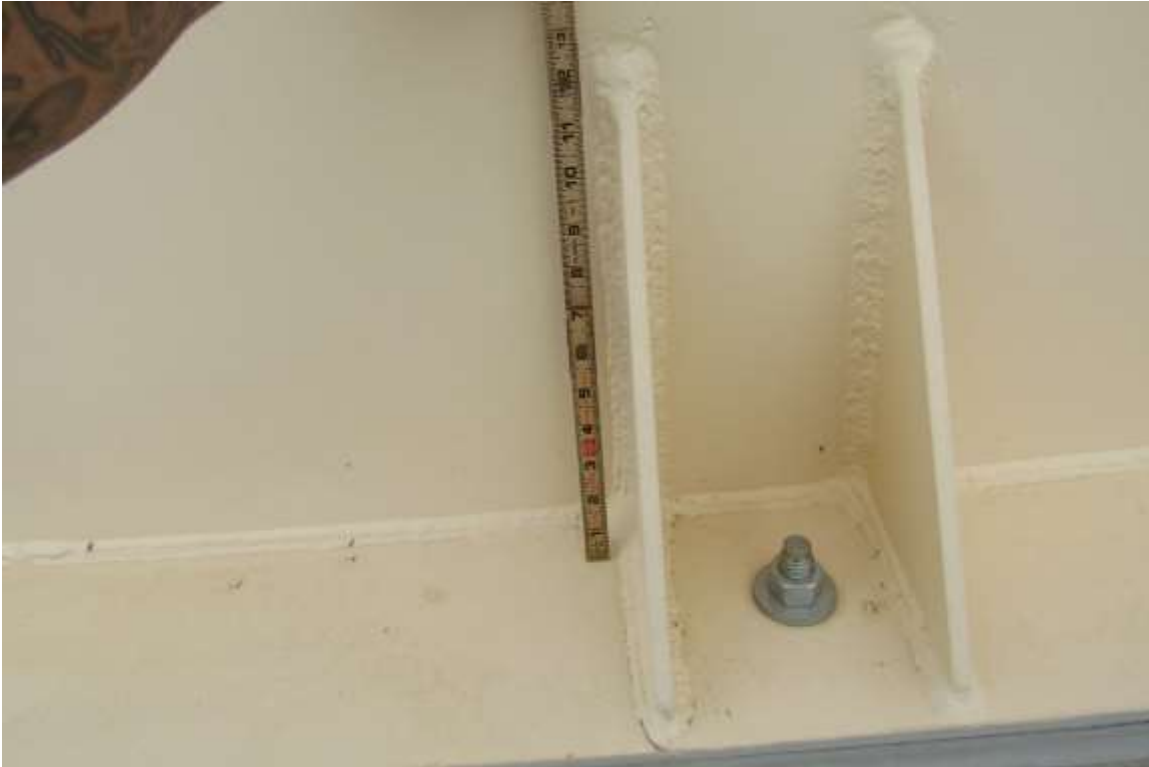
Photo shows the condition of one (1) of the thirty-six (36) anchor bolts. **AWWA D100-11; 3.8.1.1 Required anchorage** states, "For ground-supported flat-bottom reservoirs and standpipes, mechanical anchorage shall be provided when the wind or seismic loads exceed the limits for self-anchored tanks." We recommend cleaning the area around the anchor bolts, tightening the anchor nuts, then tack welding the circumference of the nut-to-base plate connections and bolt-to-nut connections to reinforce.

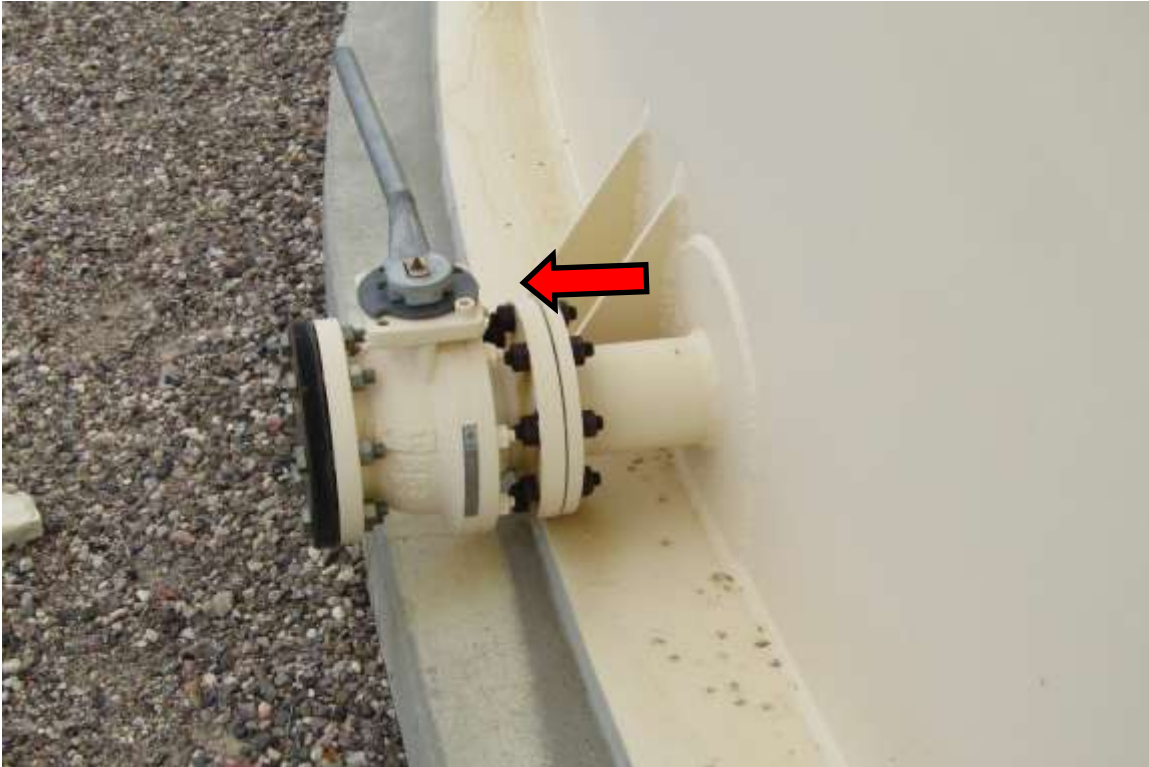
Photo shows the condition of the existing 4" drain valve, which is not equipped with a locking device or splash pad. We recommend installing a locking device to prevent unauthorized draining of the tank.

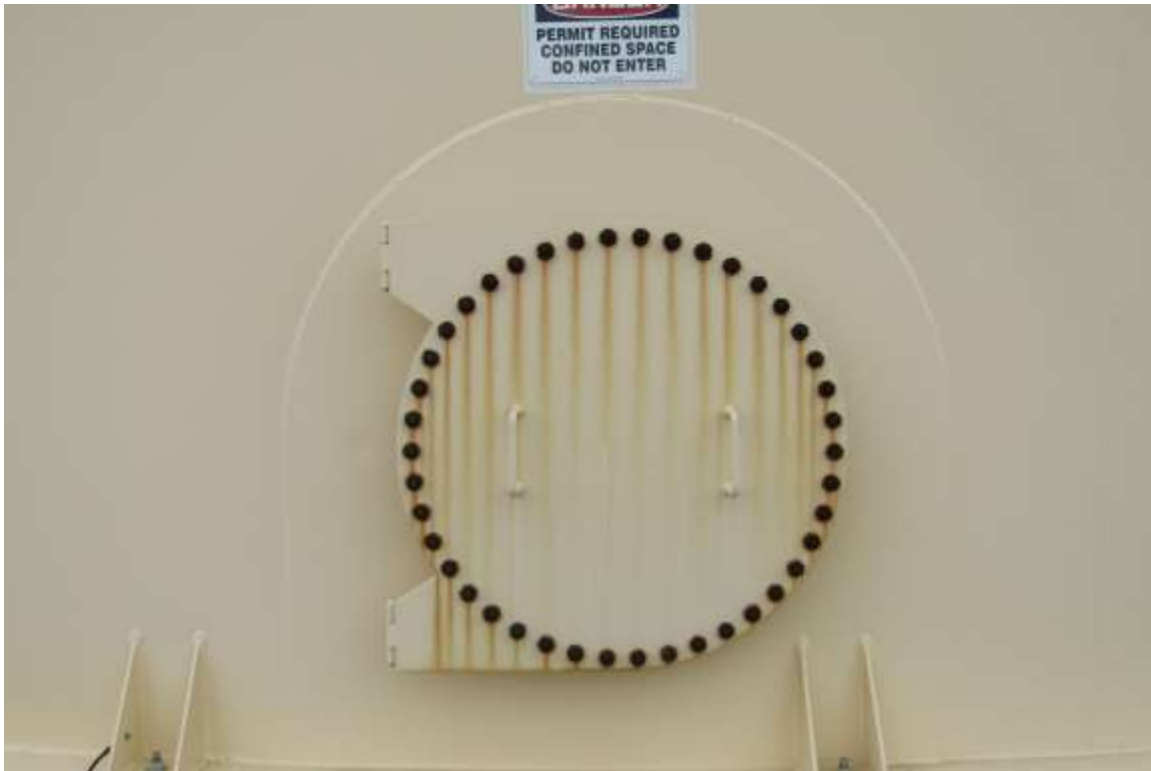
Photo shows the condition of the 30" primary shell manway, which is in compliance with [AWWA D100-11; 7.4.4 Shell manholes](#), [NFPA 22-2018; 14.7.2.1.1](#) and [OSHA 1910.146\(c\)\(2\) Confined spaces](#).

Install maintenance free galvanized steel bolts as a preventive measure

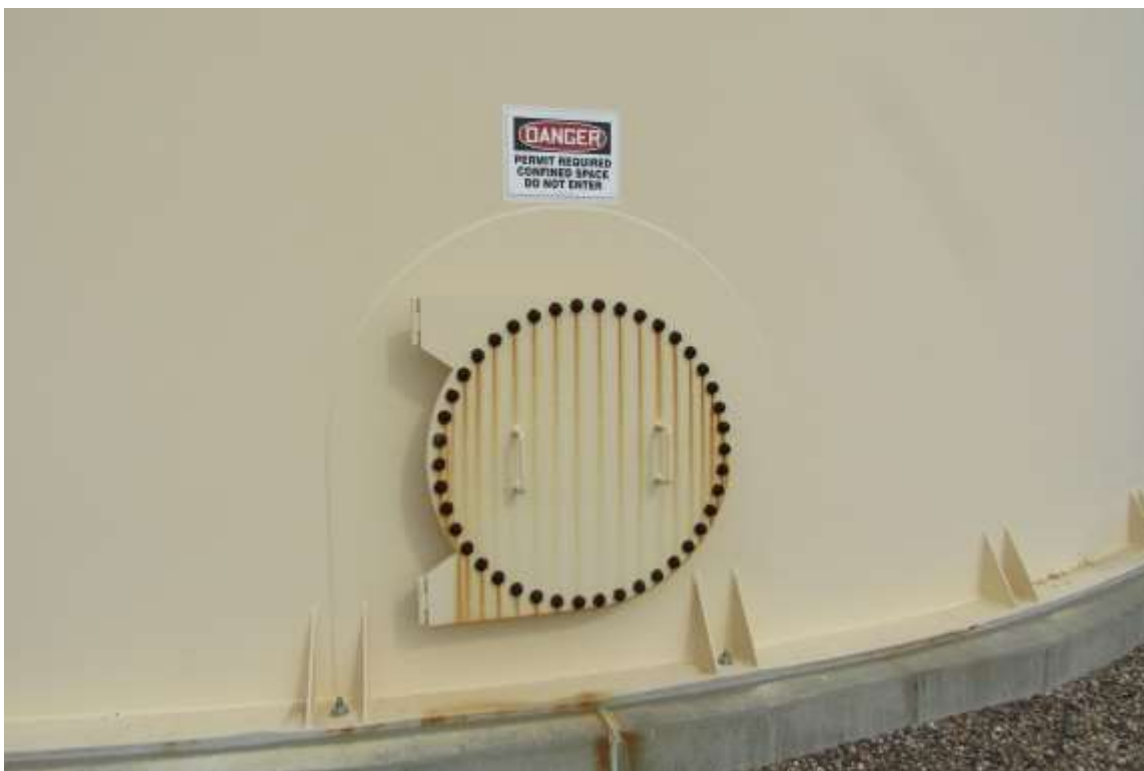
Photo shows the condition of the 30" secondary shell manway, which is in compliance with [AWWA D100-11; 7.4.4 Shell manholes](#), [NFPA 22-2018; 14.7.2.1.1](#) and [OSHA 1910.146\(c\)\(2\) Confined spaces](#).

Install maintenance free galvanized steel bolts as a preventive measure

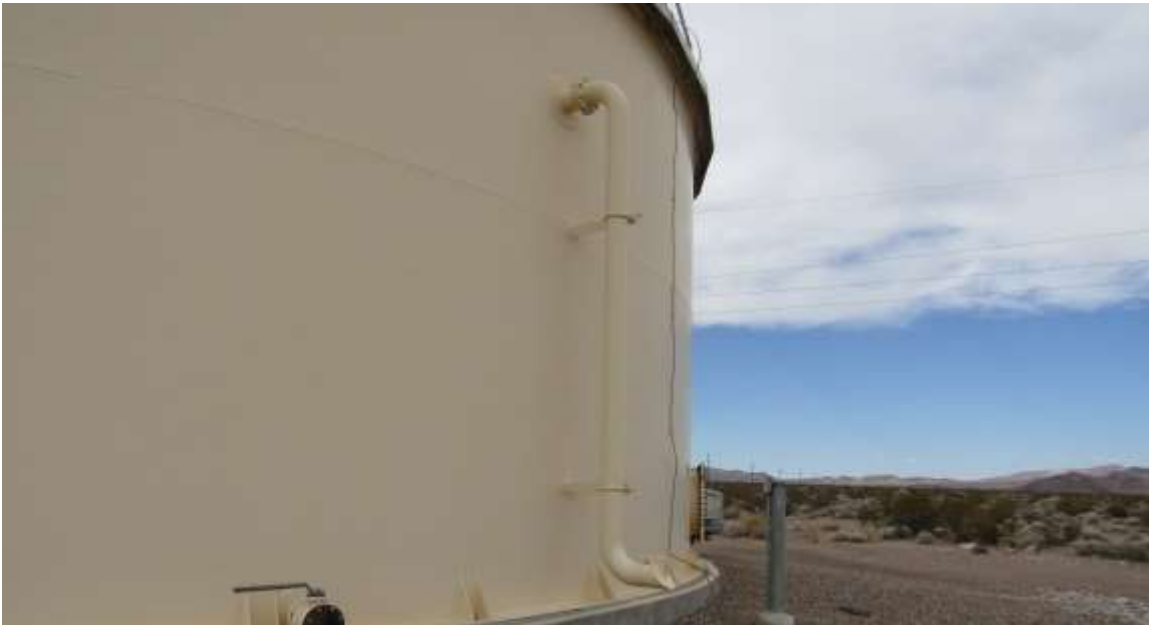
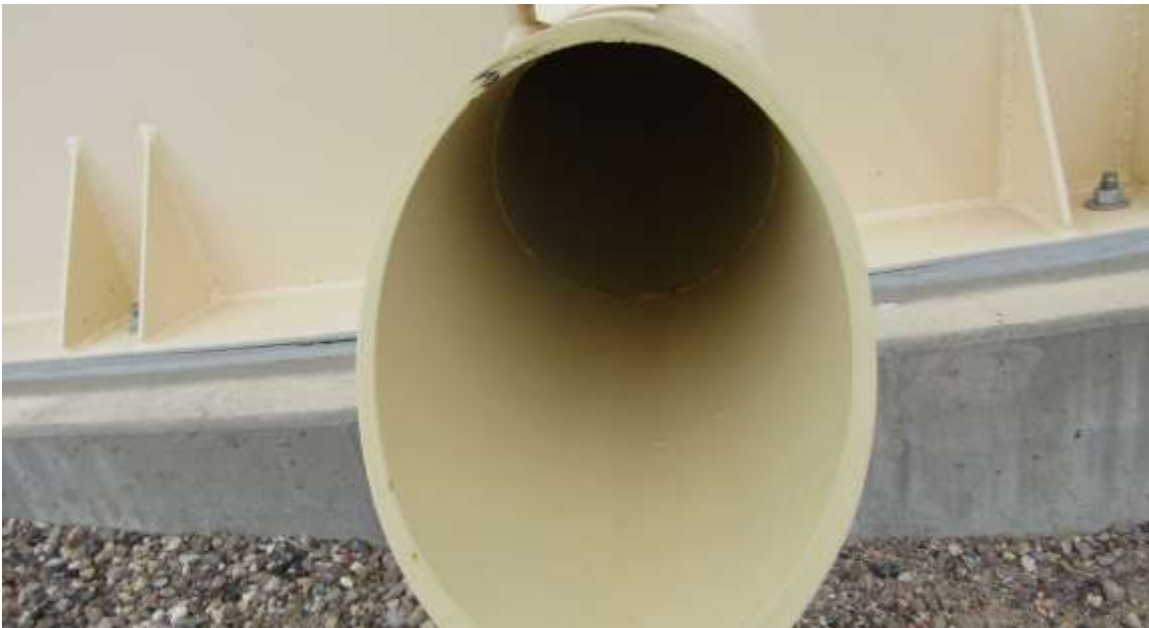
Photos show the 6" overflow pipe system, which is equipped with a flapper valve as required by **AWWA D100-11; 7.3 Overflow**. We recommend installing a new screen on the existing overflow pipe elbow.

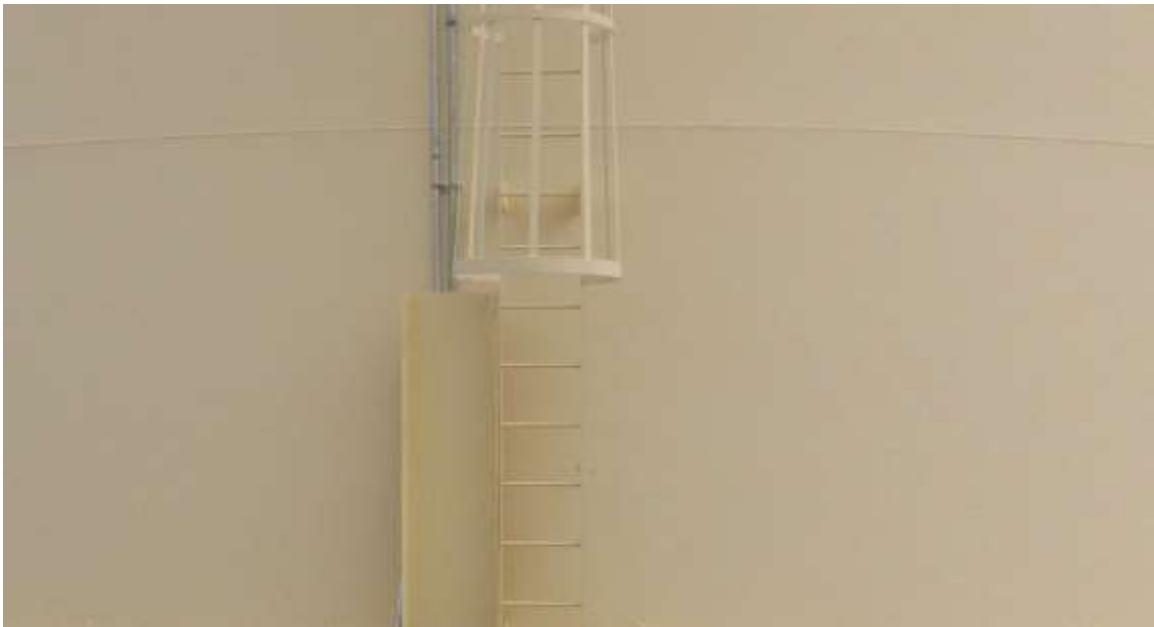
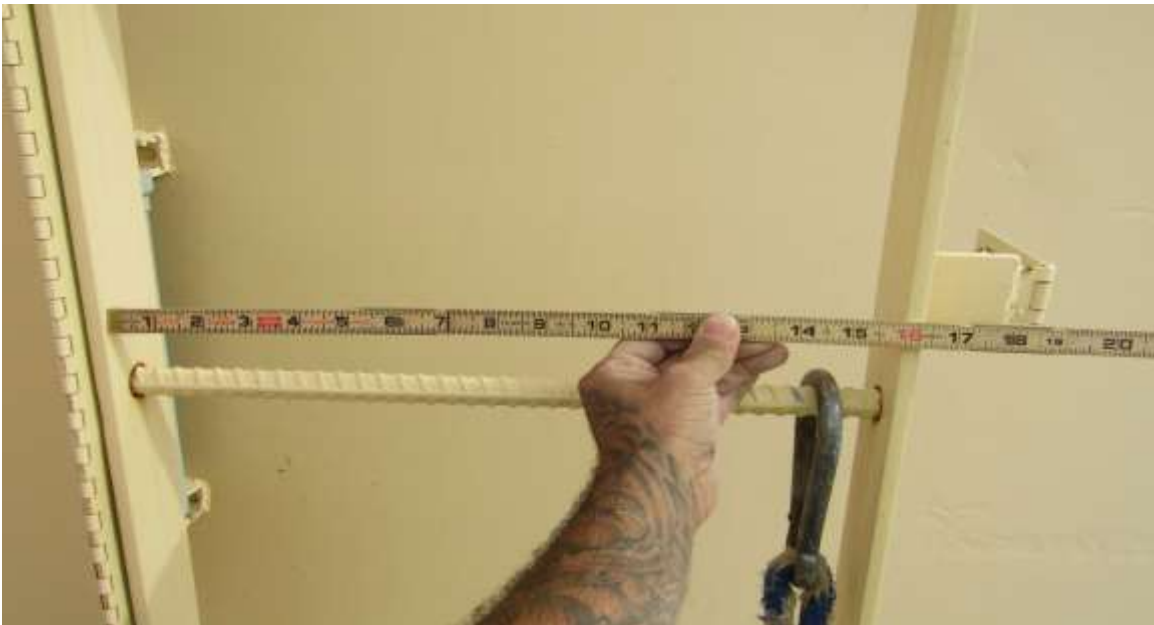
Shell access ladder in above photos is 16" wide as required by **OSHA 1910.23 Ladders** and **AWWA D100-11; 7.4.2 Ladders**. We recommend installing a cable type ladder safety device, and posting a **Fall Protection Required** sign at the base of the ladder.

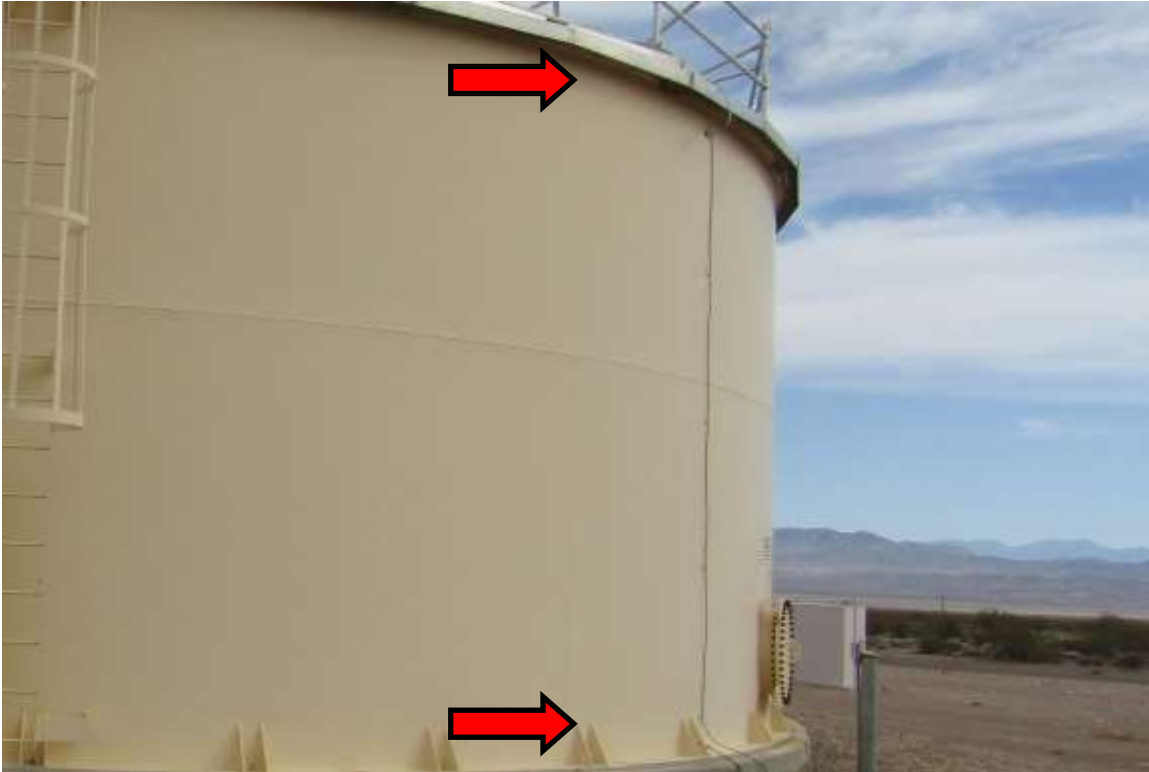
Photo shows the tank is not equipped with a liquid level indicator. We recommend installing a liquid level indicator, complete with target board and float.

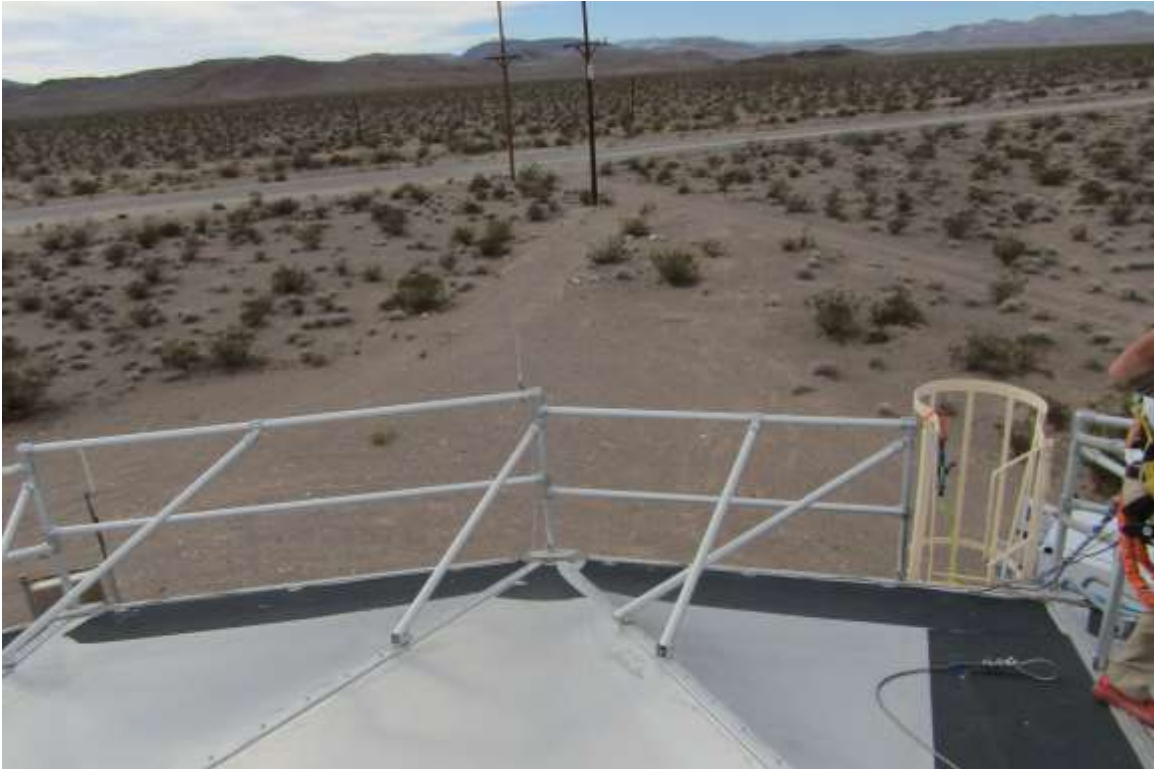
Photo shows the tank roof edge is equipped with a 38" high compliant handrail system for fall protection as required by **OSHA 1910.28(b)(1)**. The handrail system is equipped with an intermediate rail and toeboard.

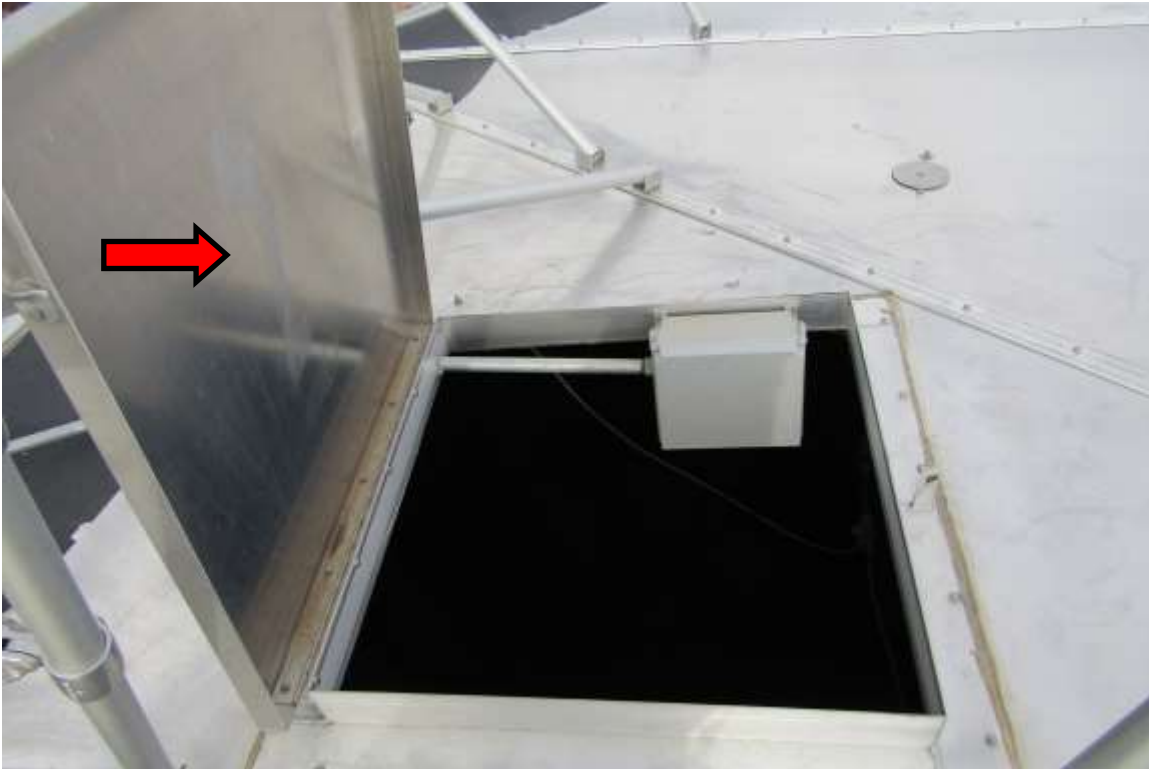
Photo shows the condition of the 36" primary roof hatch. Roof openings on this tank require the following to be in compliance with **AWWA D100-11; 7.4.3 Roof openings** and **OSHA 1910.146(c)(2) Confined spaces**.

We further recommend installing an **OSHA** compliant interior access ladder complete with standoffs every 10' on center, and a cable type ladder safety device at the primary roof hatch.

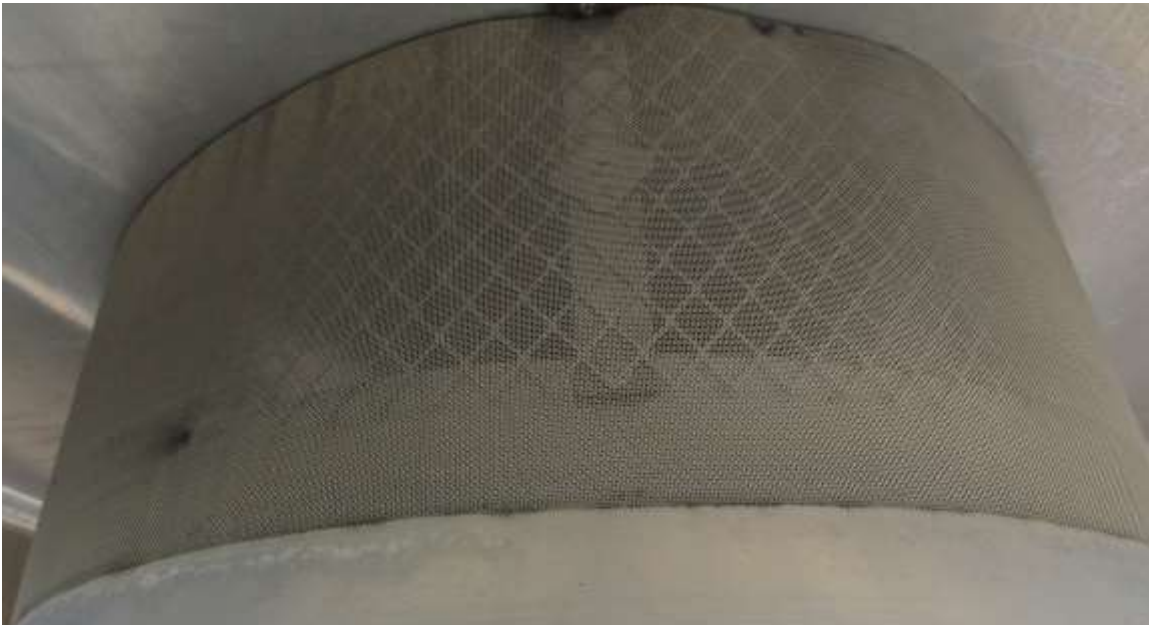
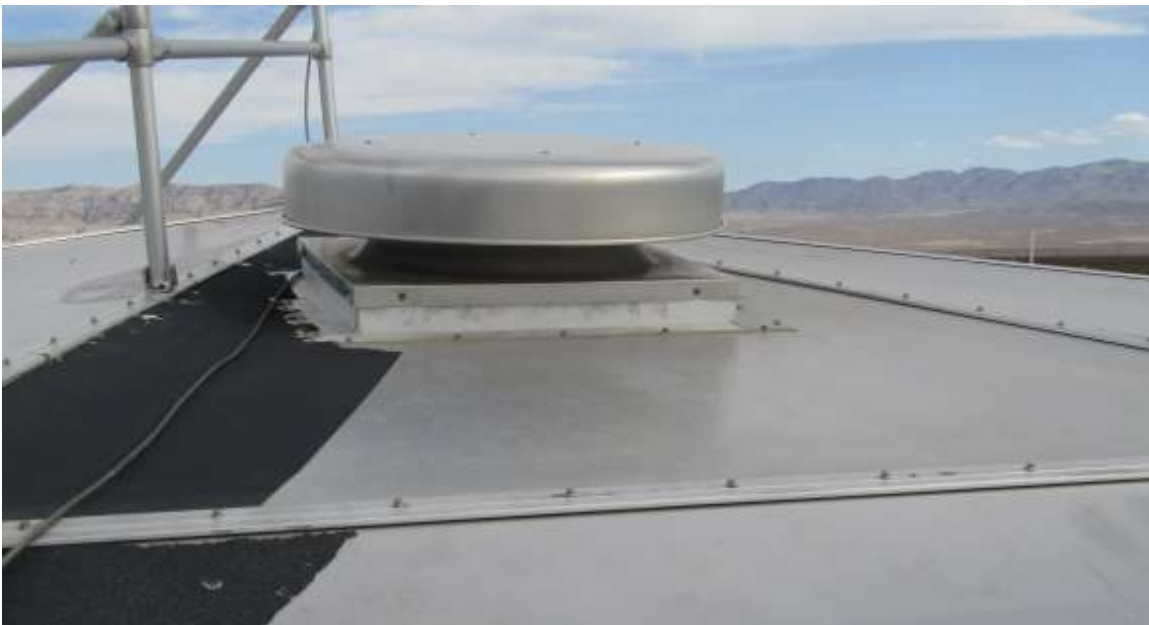
Photos show the existing roof vent, which appears to be in good condition.

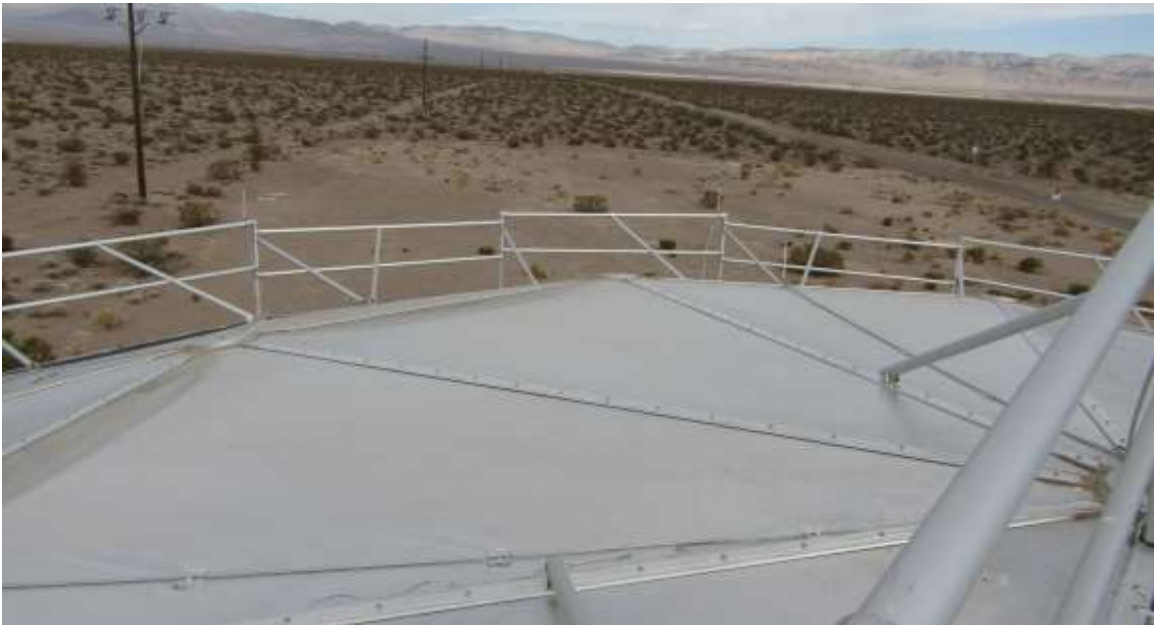
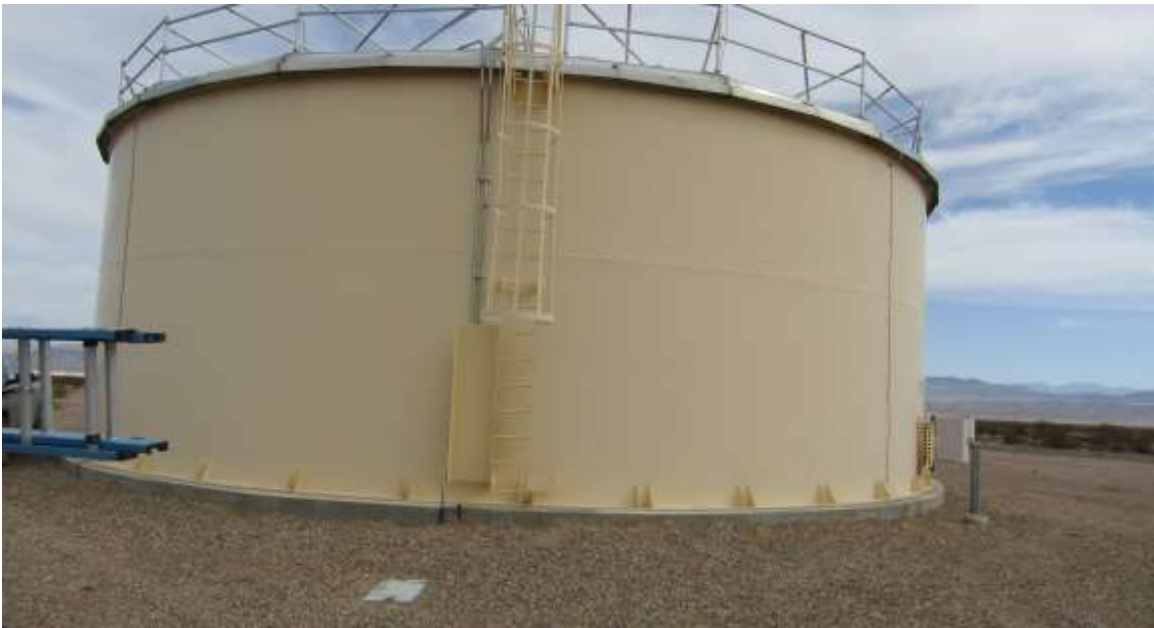
Photos show the tank exterior coating system. The overall exterior coating system appears to be in good condition. We recommend re-evaluating the tank exterior at next inspection cycle.

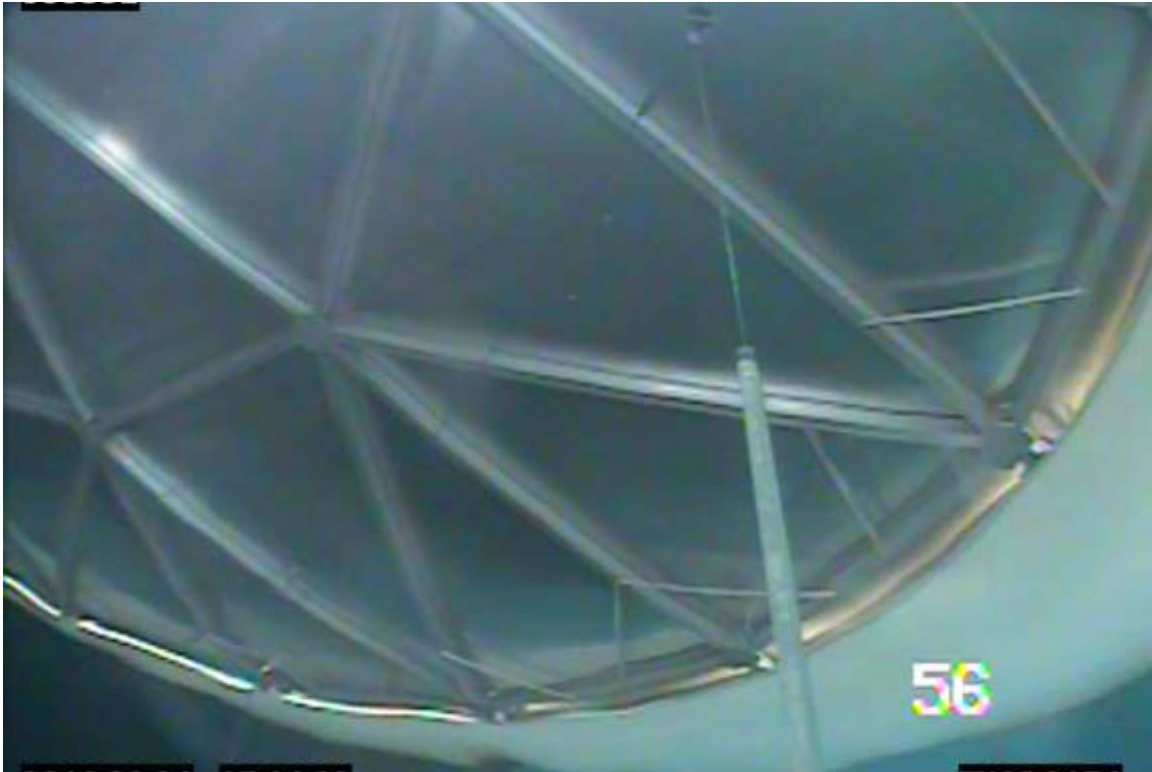
Photo shows the interior roof, which appears to be in good condition.

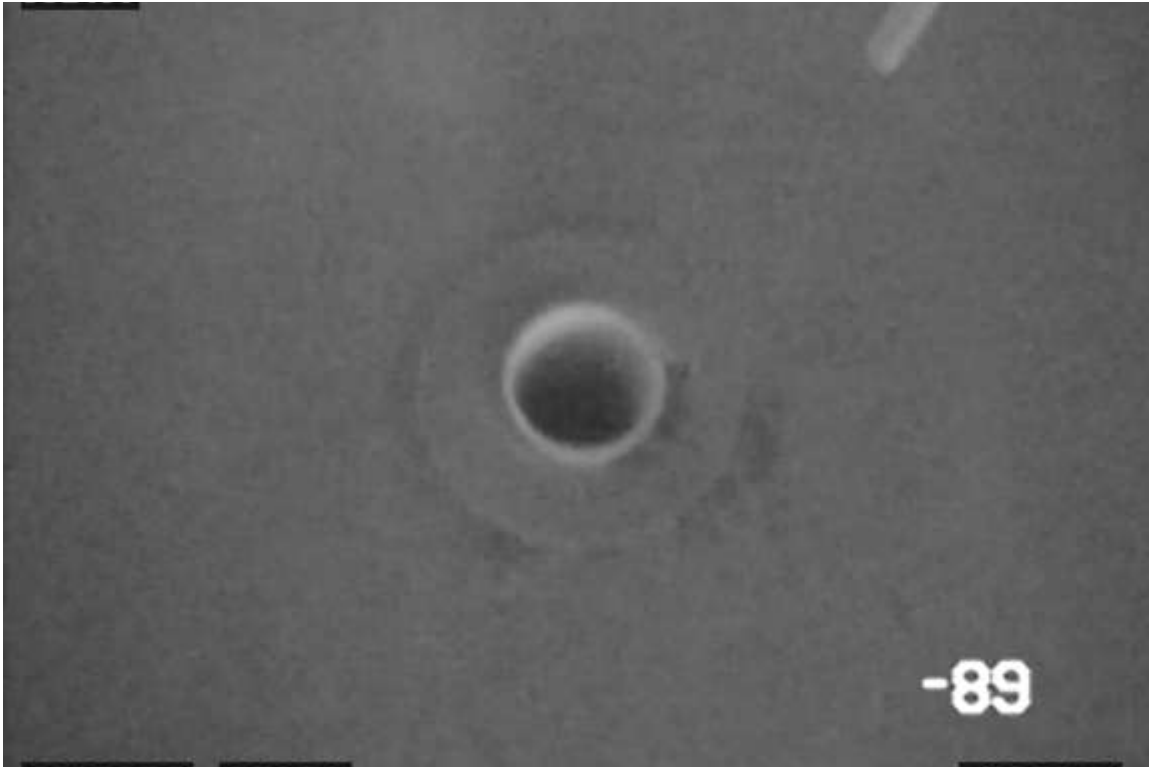
Photo shows an fill pipe on the tank interior. A temperature difference between the water in the top and bottom of a tank, even as little as 1-2 degrees Fahrenheit, is an indication of thermal stratification and the tank water not being completely mixed. Incomplete mixing would result in short-circuiting, and localized increase in water age would develop inside the tank. This typically leads to water quality problems, such as loss of residual, DBP spikes, HPC spikes, bacteria regrowth, formation of bio-film, changes in pH and dissolved oxygen. We recommend installing a mixing system. Electrical work to be done by others if required.

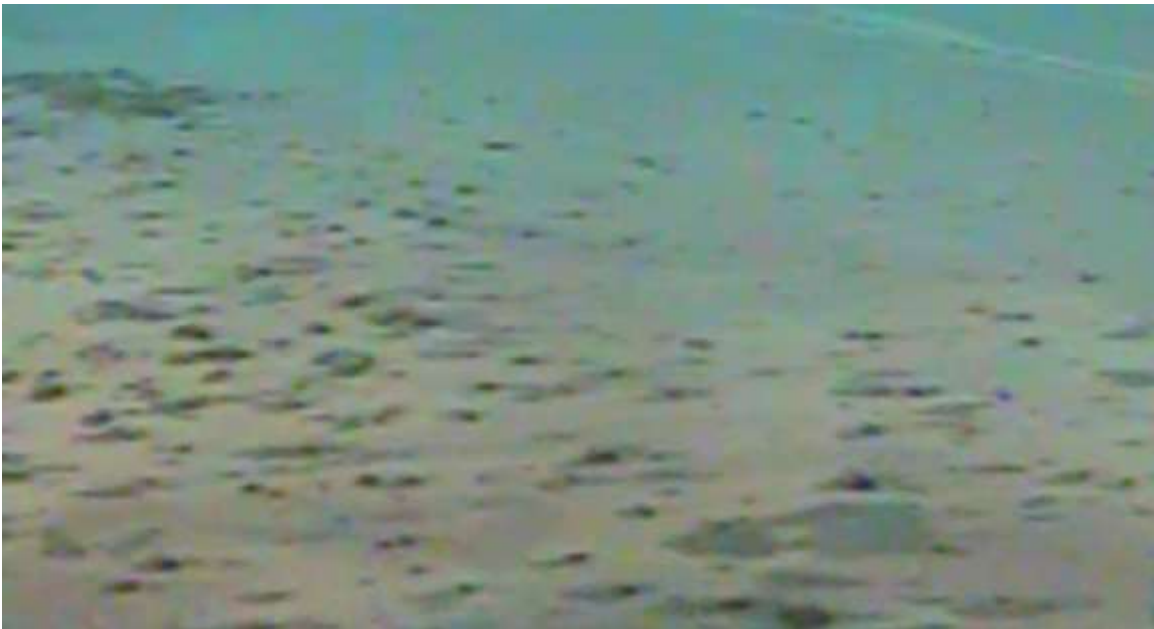
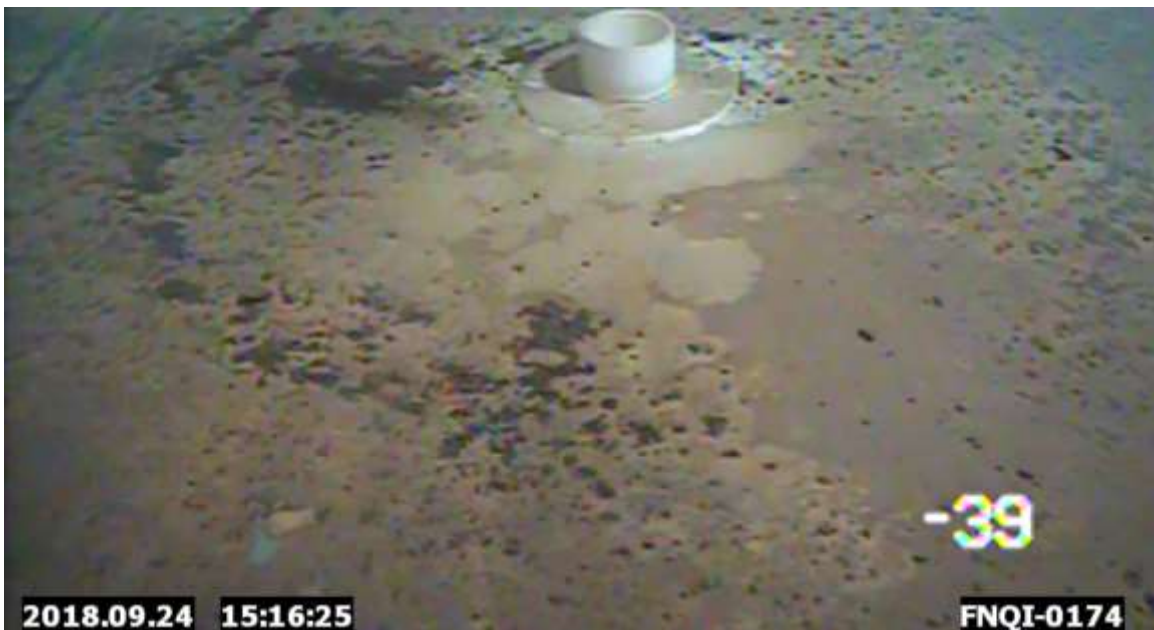
Photos show sediment and debris on the tank interior before a cleanout was performed.

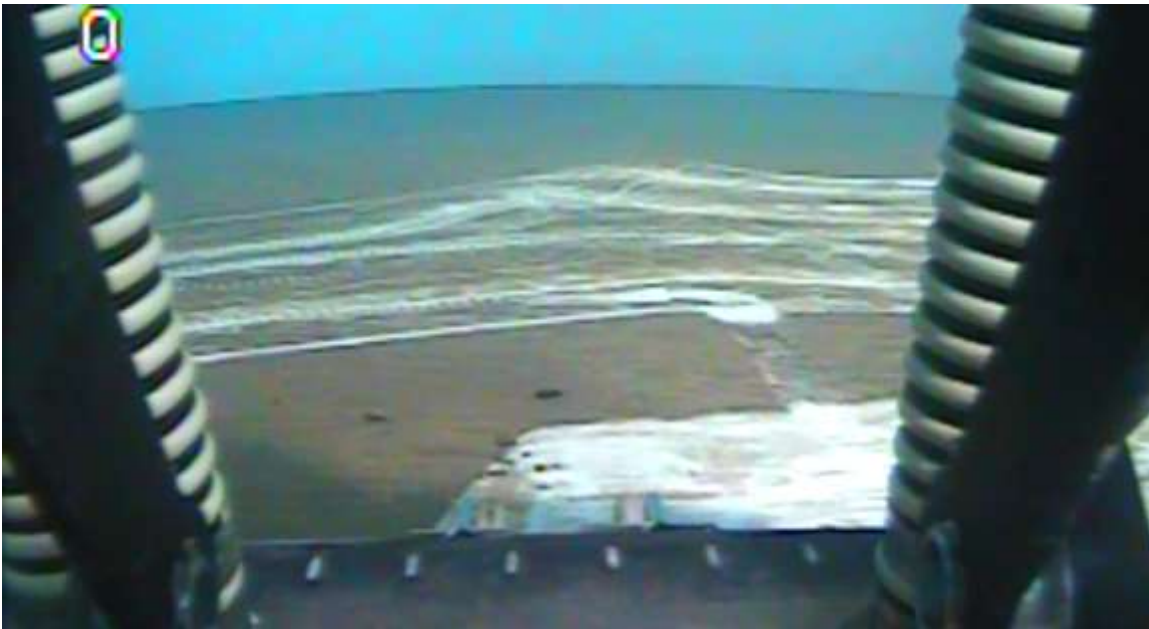
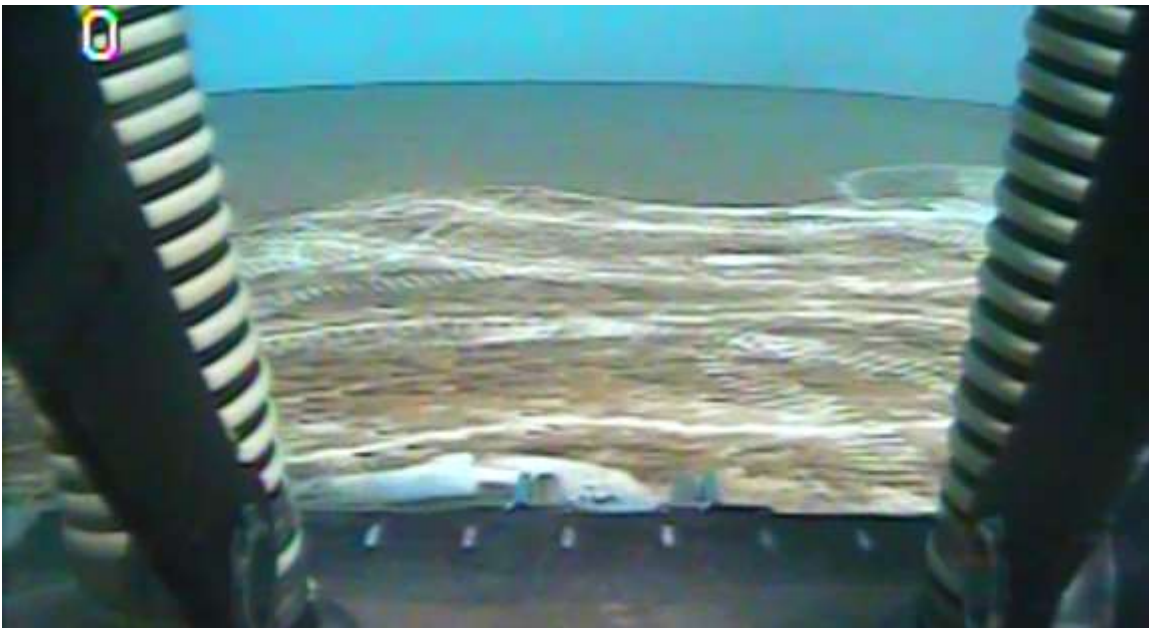
Photos show the tank interior during a cleanout.
