**Mission Support and Test Services, LLC
Nevada National Security Site
Mercury, NV 89023
RE: Mercury North (Area 23); Mercury, NV
1,500,000 Gallon GST
September 16, 2018
Mr. Kevin Olsen
Scientist 1
(702) 295-0485
Job No. 318448-A**

**Mission Support and Test Services, LLC
Nevada National Security Site
Mercury, NV 89023
RE: Camp South (Area 12); Mercury, NV
500,000 Gallon GST
September 13, 2018
Mr. Kevin Olsen
Scientist 1
(702) 295-0485
Job No. 318448-D**

**Mission Support and Test Services, LLC
Nevada National Security Site
Mercury, NV 89023
RE: Well 4/4a South (Area 6); Mercury, NV
150,000 Gallon GST
September 24, 2018
Mr. Kevin Olsen
Scientist 1
(702) 295-0485
Job No. 318448-H**

**Mission Support and Test Services, LLC
Nevada National Security Site
Mercury, NV 89023
RE: C-1 North (Area 6); Mercury, NV
50,000 Gallon GST
September 21, 2018
Mr. Kevin Olsen
Scientist 1
(702) 295-0485
Job No. 318448-O**

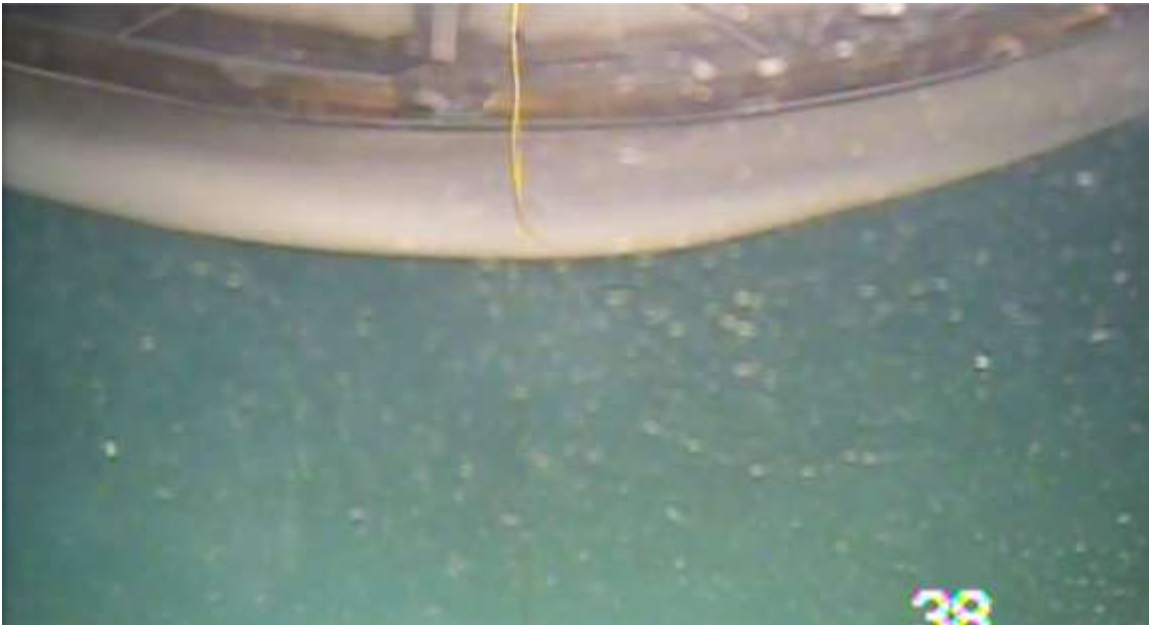
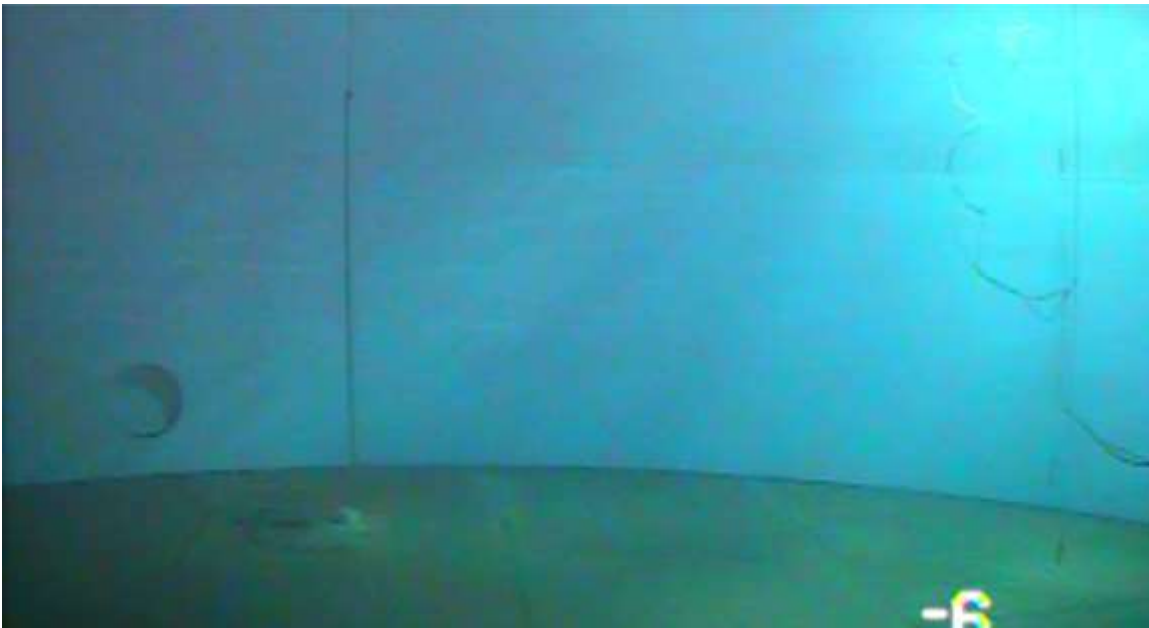
Photos show the tank interior coating system. The overall interior coating system appears to be in good condition. We recommend re-evaluating the tank interior at next inspection cycle.
